"About the House"

Summary #: 14802

Review. Items that need further evaluation for repair or replacing.

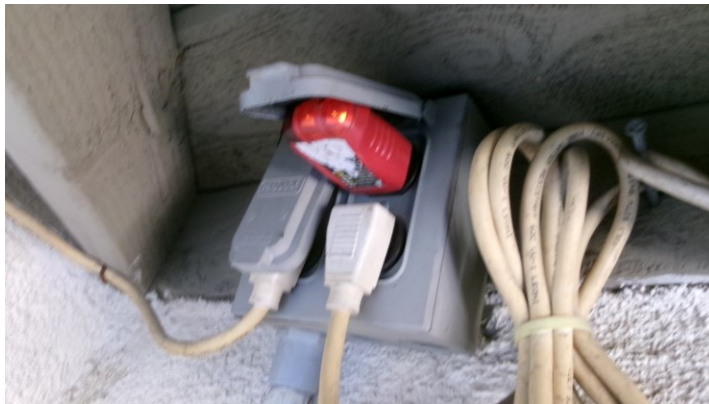
1. Ground fault protection should be installed at aftermarket outlets under rear eaves, as required, to enhance safety. GFI protection was required either when this home was constructed or when upgrades were made.

Electricians review is advised.

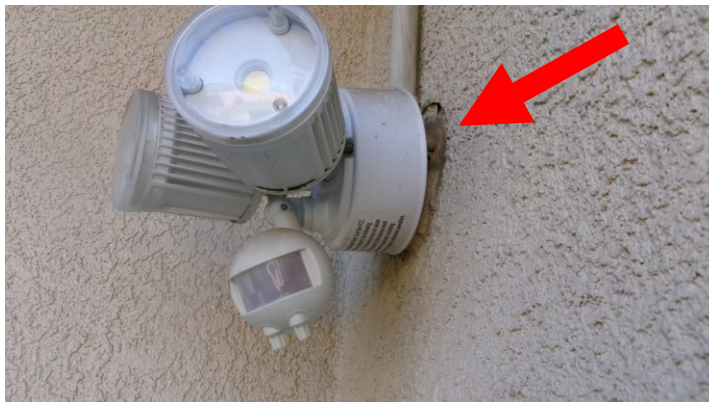
2. Improperly fitted light at the above location should be fitter to wall and caulked to prevent water and pest intrusion.

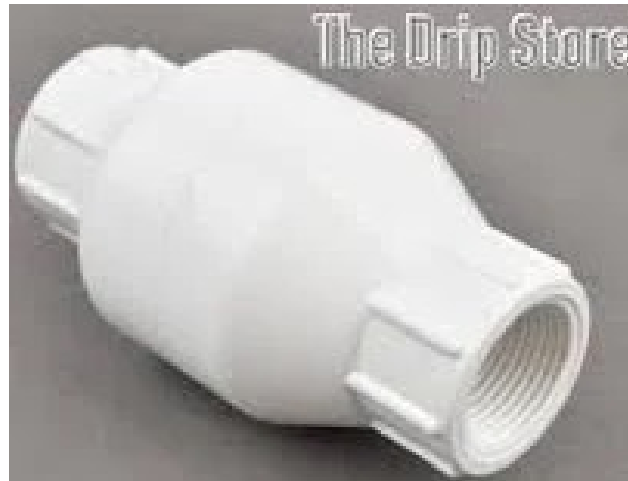
1113. Sprinkler

Non-potable sprinkler pipe is connected directly to potable water supply.

We suggest installing a backflow (anti siphon) device where non-potable water piping is connected to potable water supply. Plumbers installation is advised.

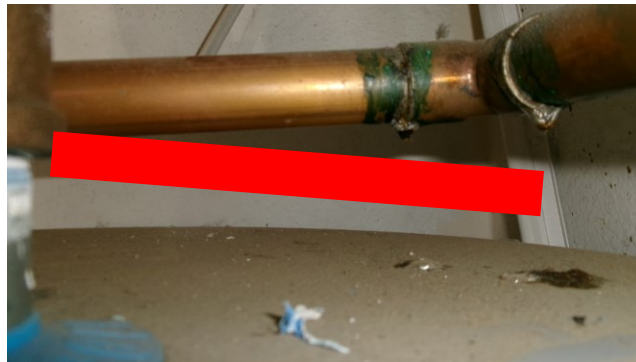
1710. Water Heater

Review. Discharge pipe from the TPV is elevated (trap). If TPV leaks, water can collect in the pipe and create a clog from mineral deposits left behind. This can cause back pressure if steam or high pressure needs to be released. We suggest a review by a licensed plumber for proper installation to ensure safety.

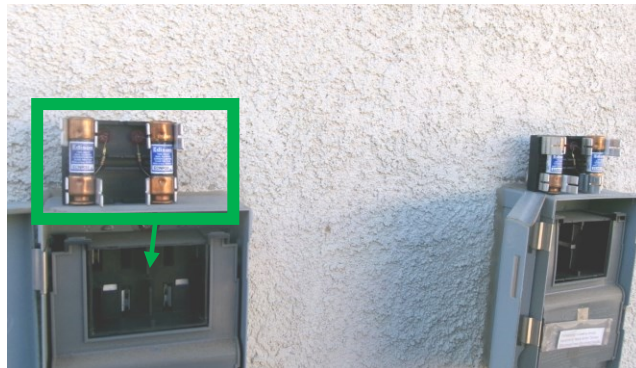
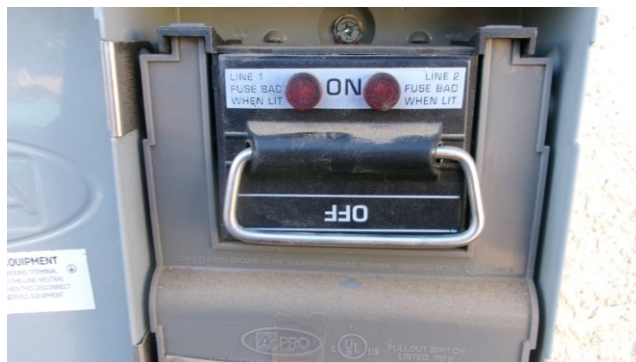
1910. Air Conditioning User friendly fuses are provided at the A/C service disconnect panel.

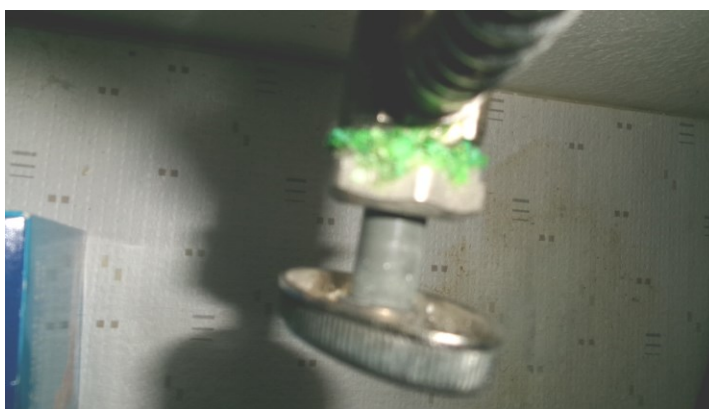
Bathroom at Front Bedroom2420.
Traps/Drains/Supply**Review.**

1. Water hammer detected when tub faucet is closed. This indicates air in the line.
2. Corrosion observed at the cold water angle stop under the sink. No leaks observed at time of inspection.

We recommend review by a licensed plumber for repair or replacement, as necessary.

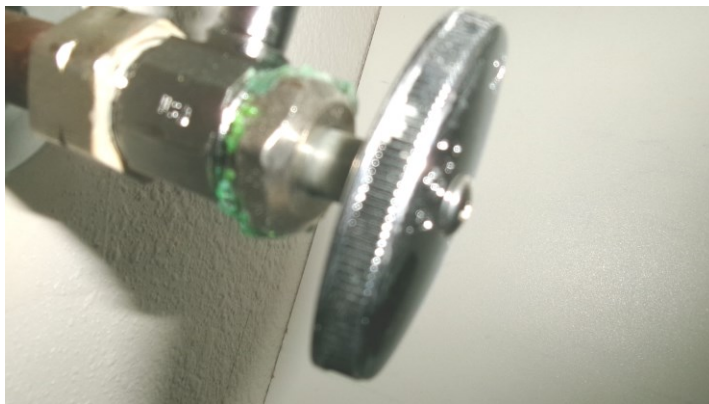
Laundry Area2514. Laundry Area
Comments

Corrosion observed at angle stops. No leaks observed at time of inspection. We recommend review by a licensed plumber for repair or replacement, as necessary.

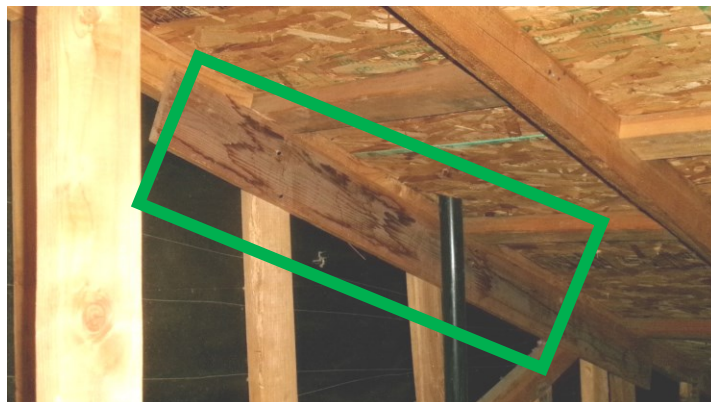
2704. Evidence of Leaking A scrap board was used at right gable end. This board is not stained from the roof. It appears to be used as a spacer for vent pipe.

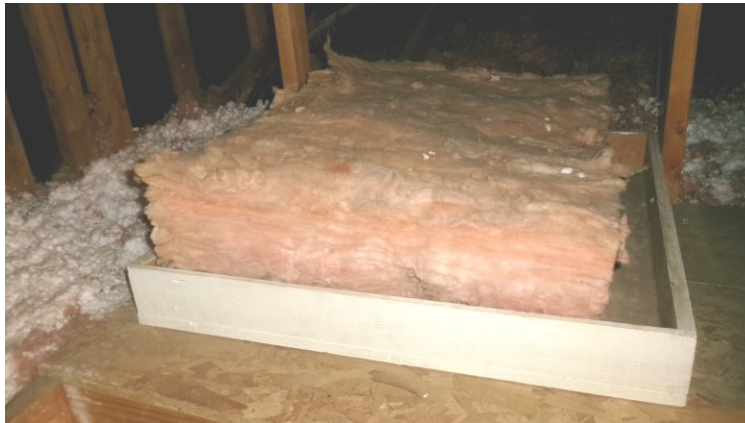
2712. Attic Comments **Review.** Access panel is not 5/8 fire rated drywall.

We advise installing proper materials for fire safety.

Installing drywall at ceiling side and painting will restore the fire rating.
