Home Inspection Report

1221 175th St

Homewood, IL 60430

Inspected by Robert Barcham, Cal Ramirez,
& Robert McNamara on Mon, Nov 22 2021 at 2:00 PM

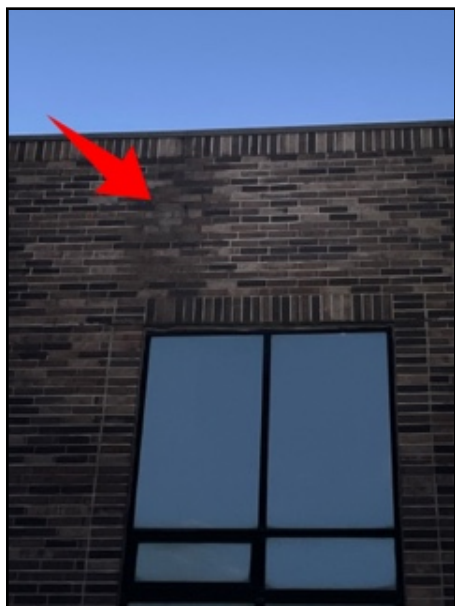
Figure 1-1

Observed at the time of inspection exterior wall facing west has a moisture issue at top need to tuck pointing.

Recommend licensed general contractor for repair and reevaluation as desired.

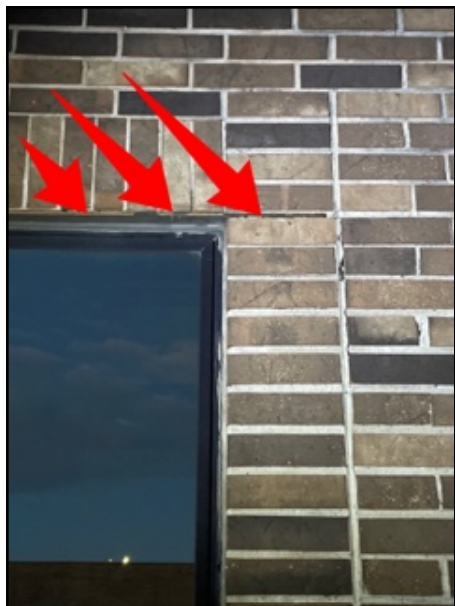
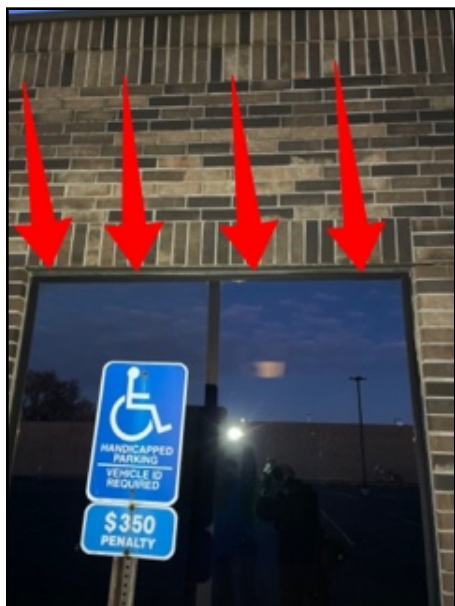
At the time of inspection, observed the East side exterior wall, window lenthil mortar has deteriorated also the window lintel needs to be looked at.

Recommend licensed general contractor for repair and reevaluation as desired.

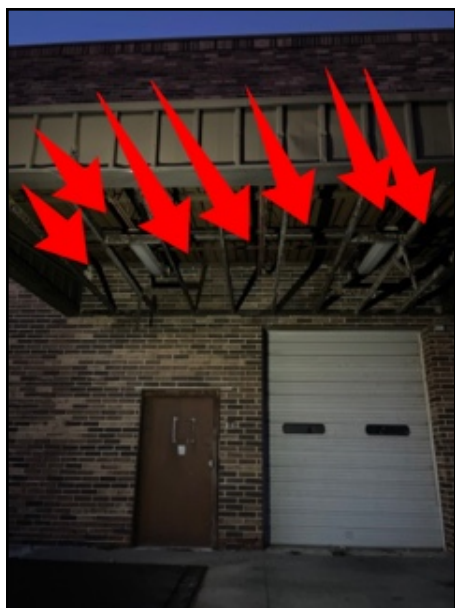
Figure 3-1

Observed at the time of inspection the exterior wall where are the dock is in the rear, The above canopy is missing force between joists.

Recommend licensed general contractor for repair and reevaluation as desired.

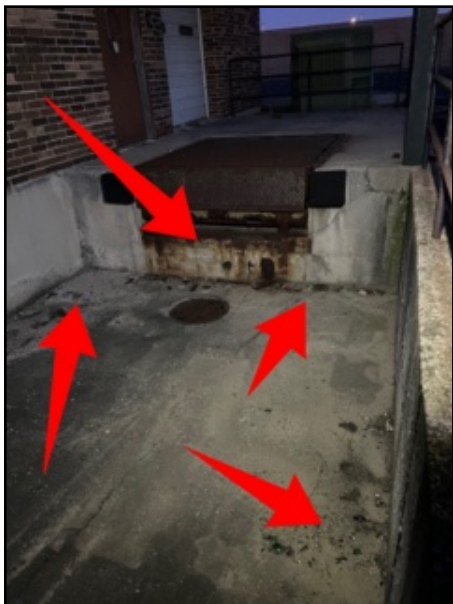
Figure 4-1

At the time of inspection, observed the retaining wall of the docking area, the slab how do erosion or perhaps mold like substance that needs to be repaired by a licensed general contractor as desired.

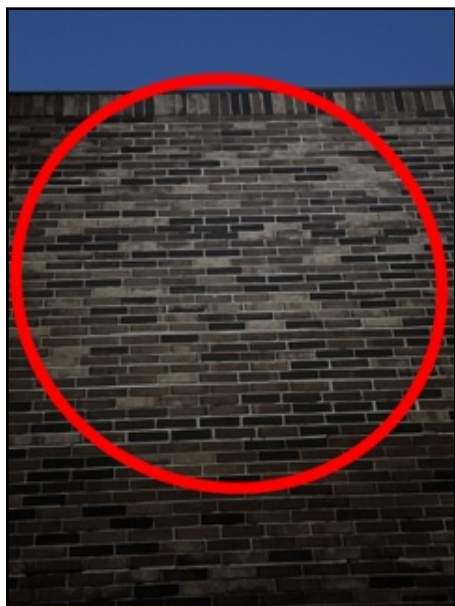
Figure 5-1

At the time of inspection observe the south side exterior wall needs tuck pointing. Recommend licensed general contractor for reevaluation and repair as desired.

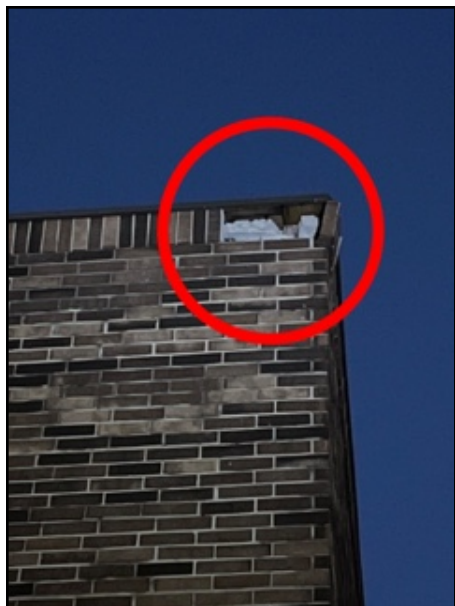
Figure 6-1

Observed at the time of inspection, The southwest corner top of the masonry wall is missing bricks.

Recommend replacement by a qualified masonry, or licensed general contractor as desired.

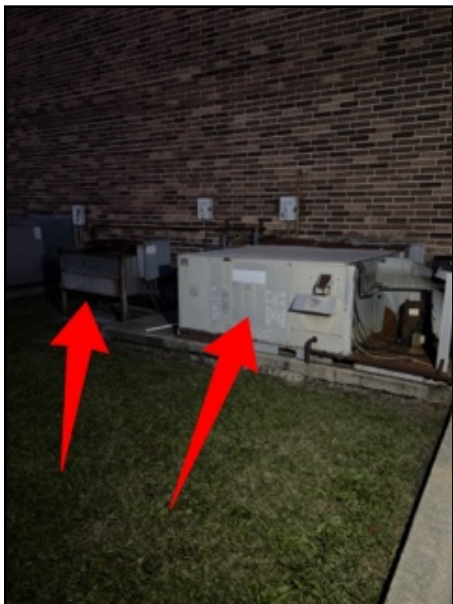
Figure 7-1

- Comment 7:
Observed at the time of inspection while facing west, these HVAC/power components were dismantled at the time of inspection.
Recommend a Licensed The HVACs for evaluation and repair as desired.

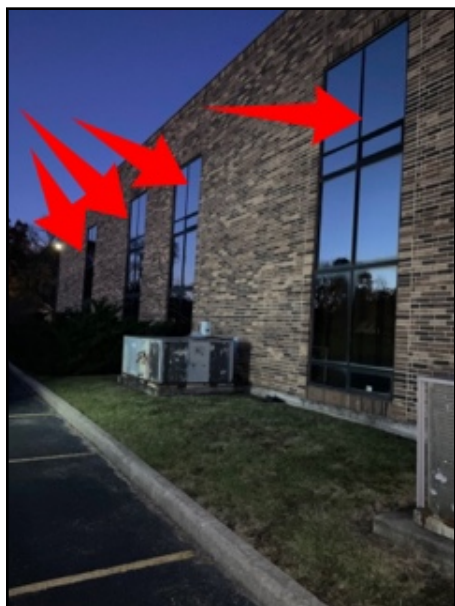
Figure 8-1

-
- Comment 8:
Observed The The time of inspection exterior wall facing west, these four windows seals need repair oh replace by qualified window and door specialist as desired.

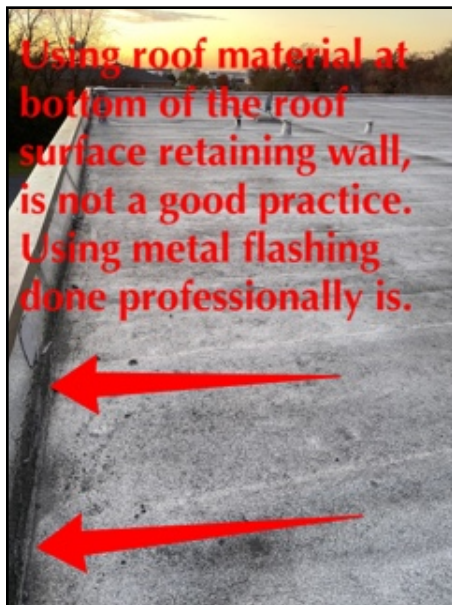
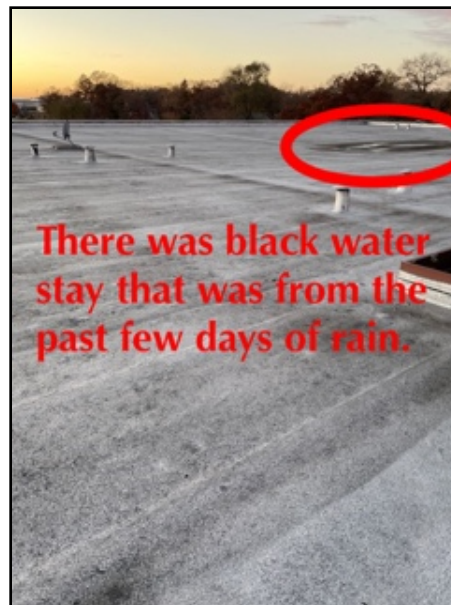
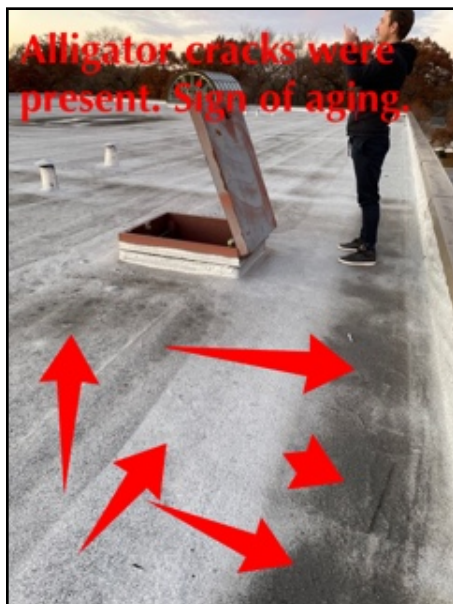
Observed roof at the time of inspection, a rolled walkable roof.

- Roof was wavy.
- Roof had water pulling/stray/puddles.
- Roof granular substance has almost faded away.
- The chimney flue was corroded, the one facing south.
- Also observed a noticeable amount of saturated erosion black substance in the center of the roof.

Recommend licensed roofing contractor or licensed general contractor for replace t and re-evaluation as as desired.

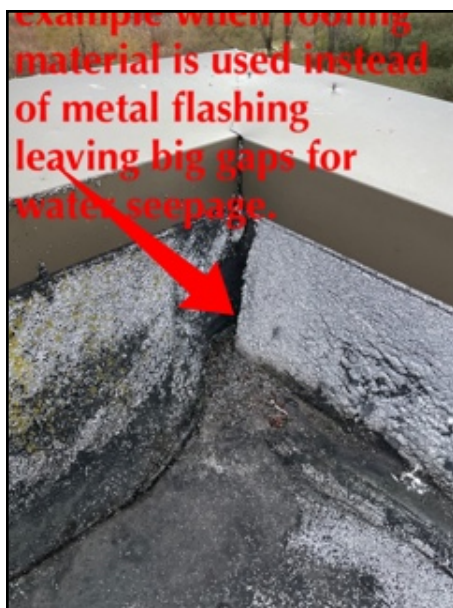
Figure 10-1

Observed at south west corner, big gap needs to be redone.

Recommend replacement of the entire roof by a roofing contractor or a licensed general contractor.

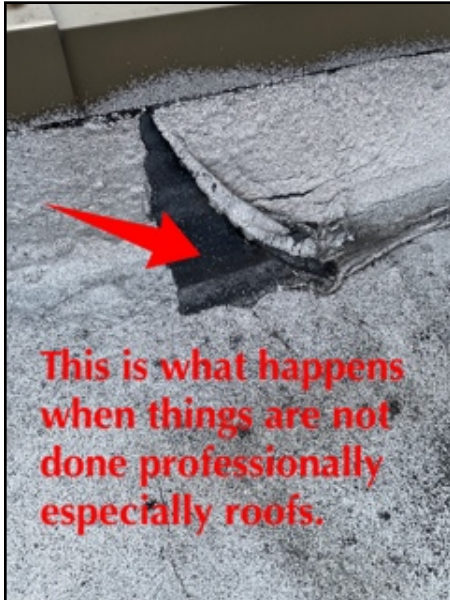
Figure 11-1

Observed towards the west side ceiling roof covering needs to be repaired and patched Brian roofing contractor license general contractor at the time of inspection.

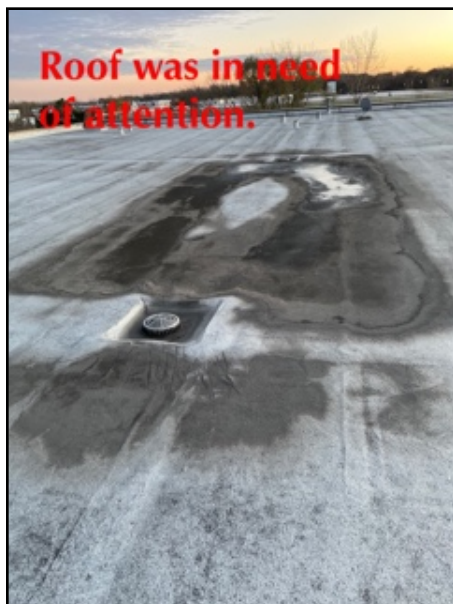
Figure 12-1

Observed in the middle of roof, huge puddle of water from few days ago that was rainy.

Recommend remove and replace by roofing contractor or licensed general contractor.

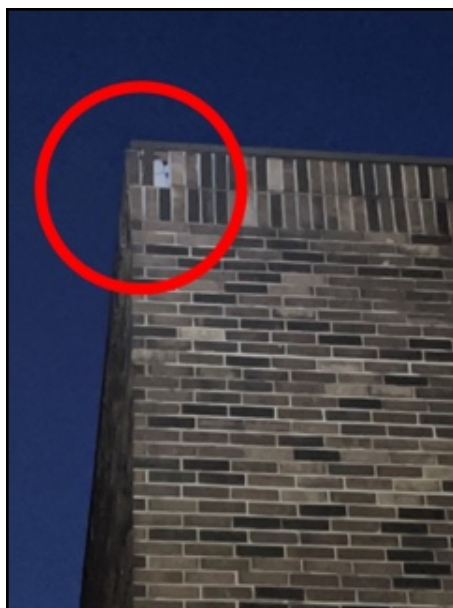
Figure 13-1

Observed at northwest corner of building at top brick/ masonry, bricks are starting to tilt/lean need tuck pointing need repair and re-evaluated by licensed contractor as desired.

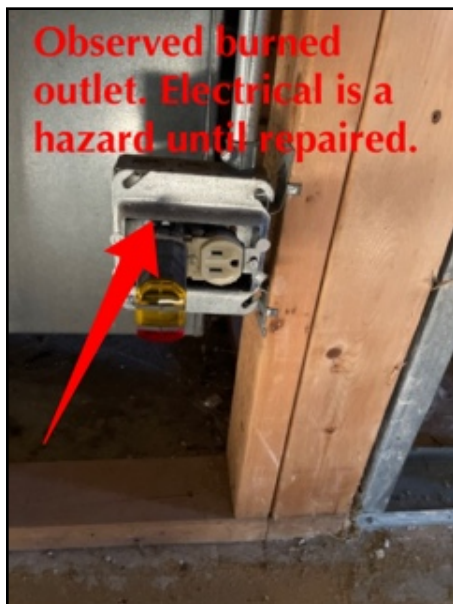
At the time of inspection observed quite a few electrical outlets missing cover as well as number representative of electrical outlets had no power or open hot. Recommend a Licensed The Electric in for repair and reevaluation of the entire electrical system in this commercial building as well as electrical panel as desired. Electrical outlet facing west side wall in the corner open heart no power. Recommend a licensed electrician for repair of the entire electrical service of this building as desired.

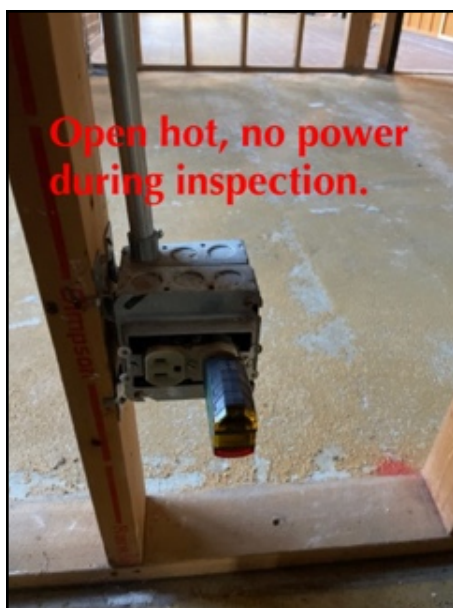
Figure 15-1

At the time of inspection observed partition wall across from the previous same issue open-heart recommend licensed electrician for evaluation and repair. The salad is facing east.

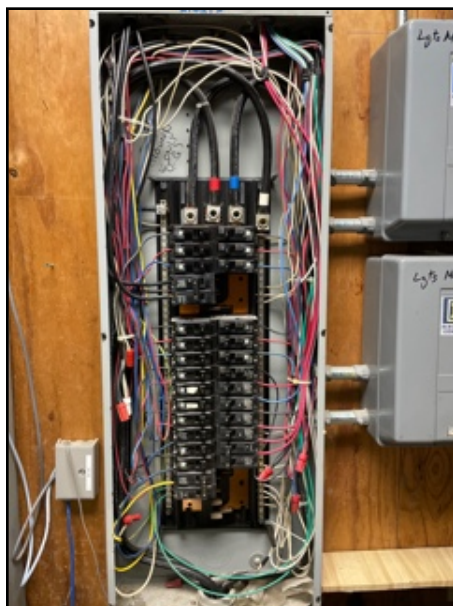
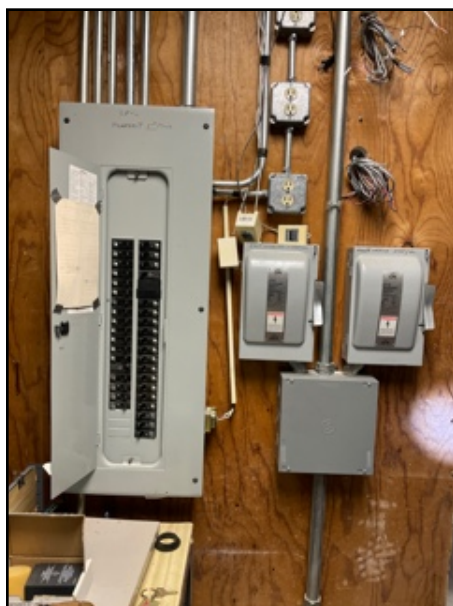
Observed at the time of inspection these electrical panel you see with the aero has a wrong size wire attached to a 20 amp breaker.

Also observes way too many that's could have been done a better job.

I am recommending a licensed electrician to look and inspect every single panel, every single outlet, for repair and reevaluation.

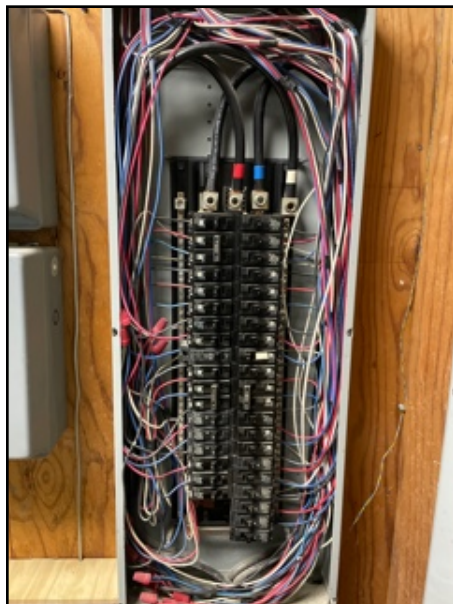
Observed at the time inspection number one outlet has a wrong wire size that does not match the 20 amp breaker.

I am recommending a licensed electrician to inspect every electrical panel, inspect every electrical outlet, for repair and re-evaluation as desired.

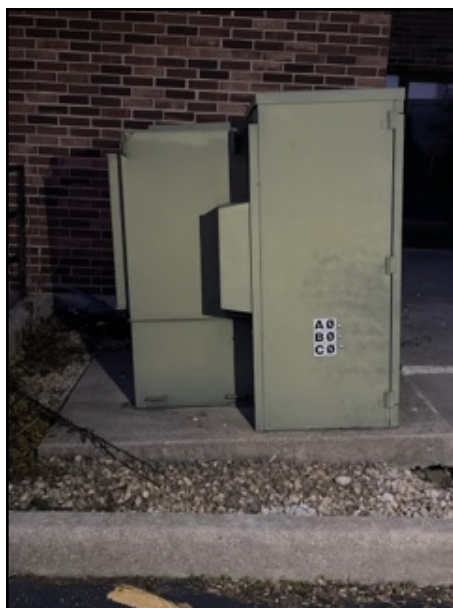
Figure 24-1

Observed transformers at south side exterior at the time of inspection that needs re-evaluation by qualified professionals for commercial property.

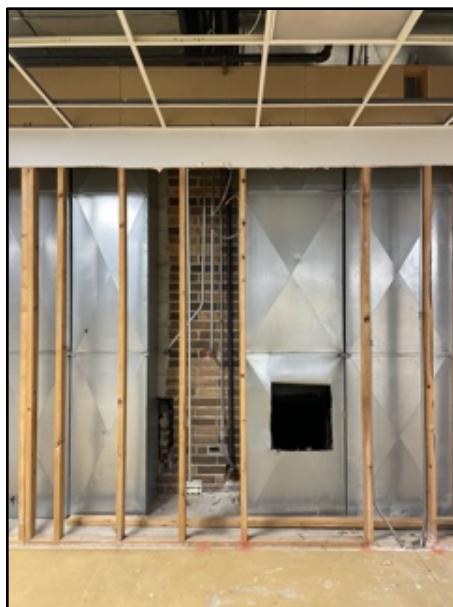
Figure 26-1

At the time of inspection did not installed/present. Therefore heating at the time of inspection was undetermined.

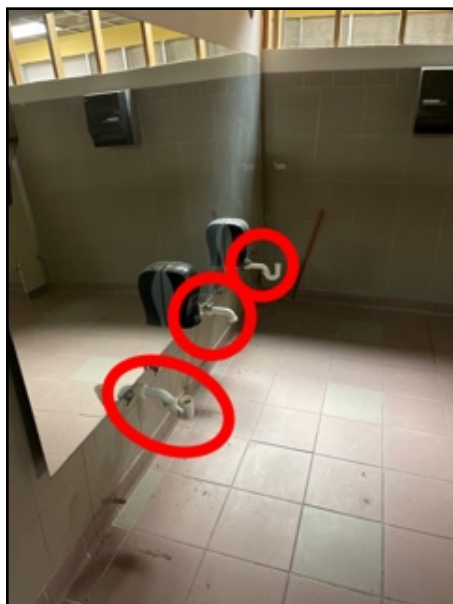
Figure 32-1

Again at the time when spec shin plumbing rough work was still not done as this is the other bathroom that was observed. Therefore, inspection of plumbing was undetermined due to the given above reason.

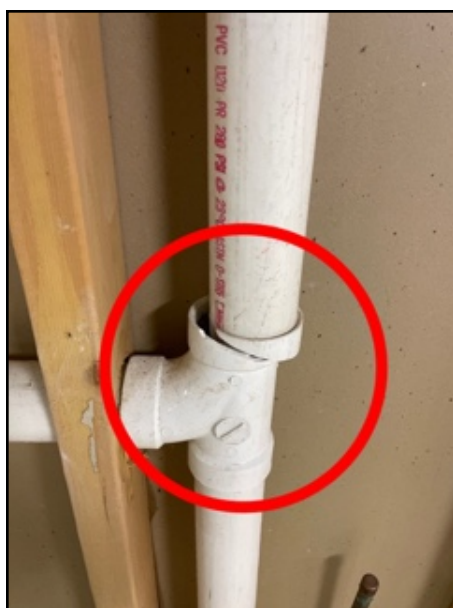
Figure 33-1

Recommend this unprofessional cut of PVC plumbing to be replaced. I mean the whole PVC pipe needs to be replaced not just a joint or have it patched. Recommend a License plumber for repair and reevaluation as desired.

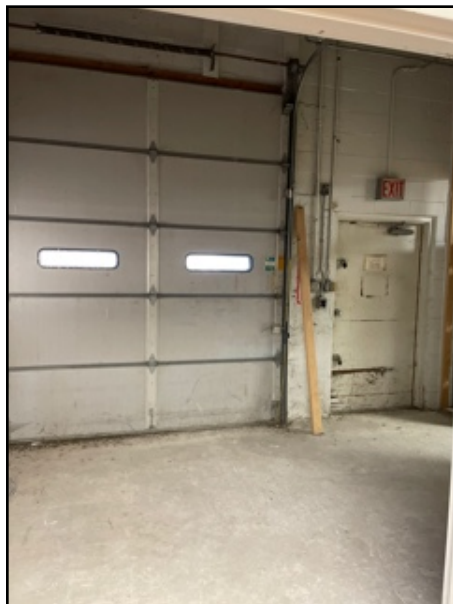
Figure 34-1

**Comment 34:**
At the time of inspection this docking door in the rear, did not function.
Recommend reevaluation by a qualified specialist.

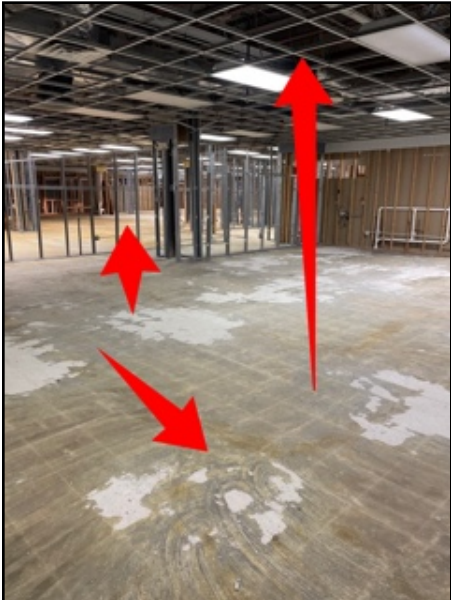
**Comment 35:**
At the time of inspection the interior of this entire commercial building, the floors were not done, the ceiling was not done, and the insulation between the studs and the wall was not covered.
Recommend licensed general contractor for reevaluation and repair as desired.

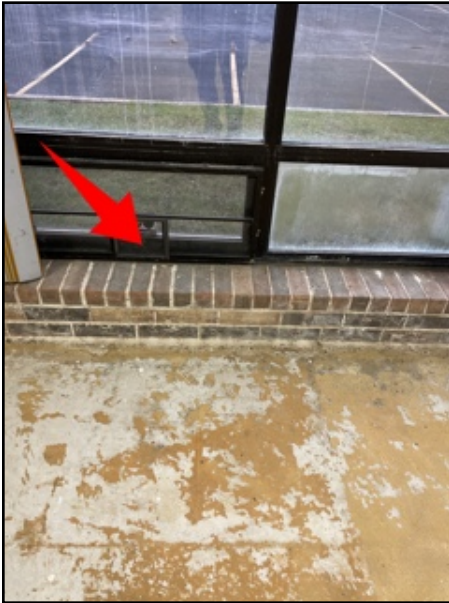
Figure 36-1

Observed at the time of inspection this bottom window that opens with the handle is stuck it does not open.

Recommend window and door specialist for repair and reevaluation.

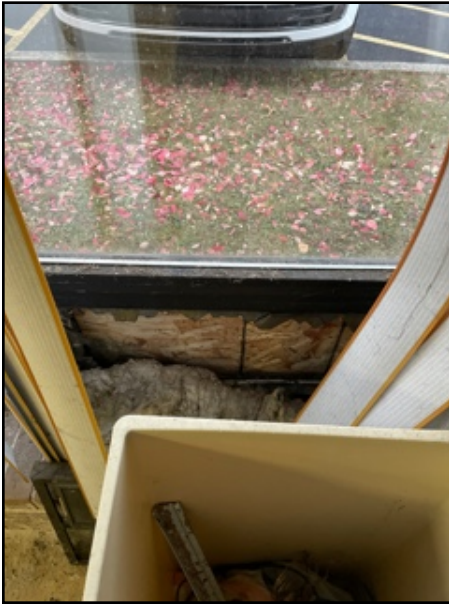
Figure 37-1

At the time of inspection observed this front window at bottom facing front property, missing glass.

Recommend window and door specialist for replacement as desired and further evaluation as desired.
