AmeriSpec Chicago - Xperience Home Inspections, LLC

1641 Harbor Ave Calumet City IL 60409

Doc #: Inspector: Ron Robins

Date: 5/26/2021

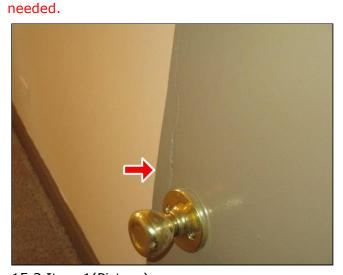
15.3 Item 1(Picture)

15.3 The second floor rear bedroom master bedroom door is damaged. Recommend repair/replacement as
