## SUMMARY REPORT

AmeriSpec Inspection Services  
License #450.011551; Expires, 11/30/22

Doc #: Client Name: Carl White Jr.  
Dwelling Address: 10 Hemlock St  
Park Forest IL 60466 Inspector: Cal Ramirez

INSPECTION REPORT  
10 Hemlock St  
Park Forest Illinois 60466

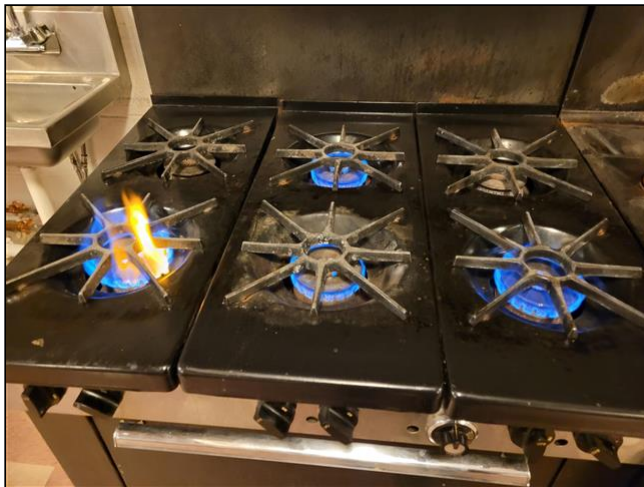
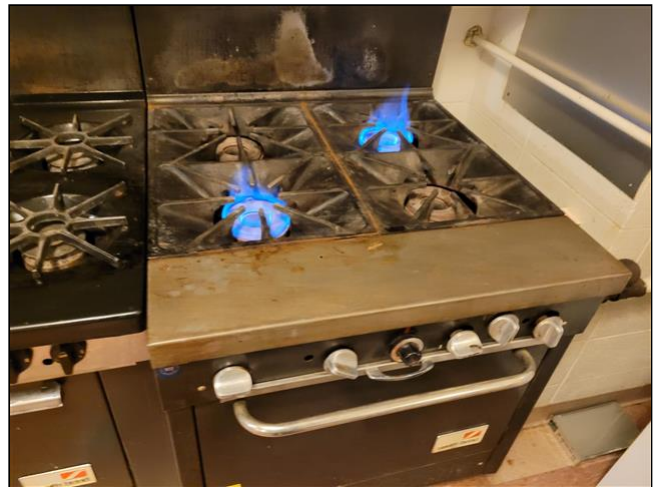
#### 1.4 Ranges/Ovens/Cooktops

**Multiple burners are inoperable. Recommend review by a qualified appliance technician for repair or replacement as necessary.**

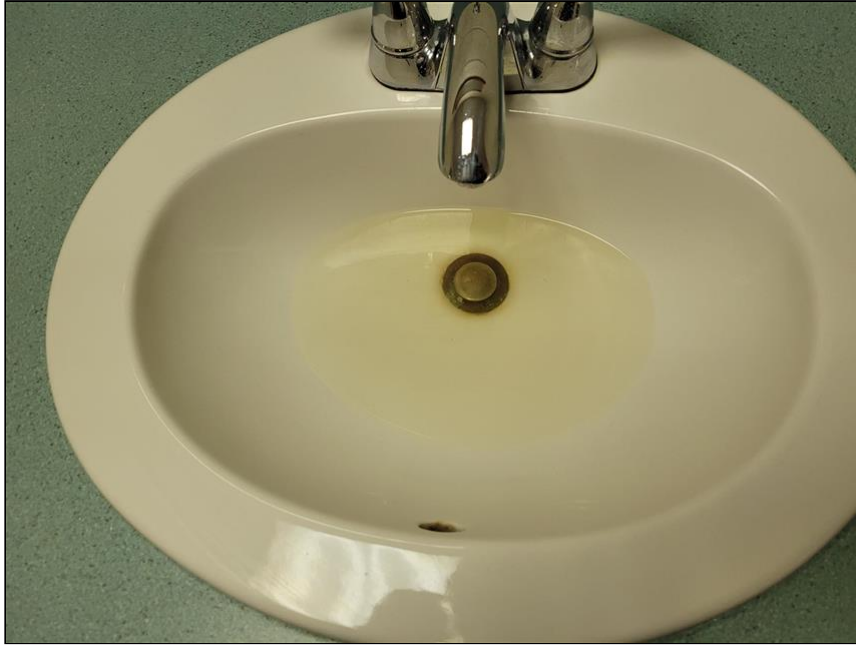
#### 2.4 Sinks

**(1) Low water flow observed in the multiple locations. Recommend review by Licensed/Qualified professional for repair or replacement as necessary.**

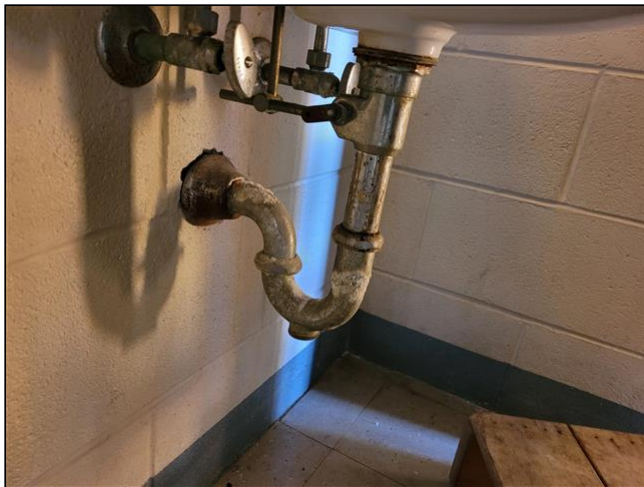
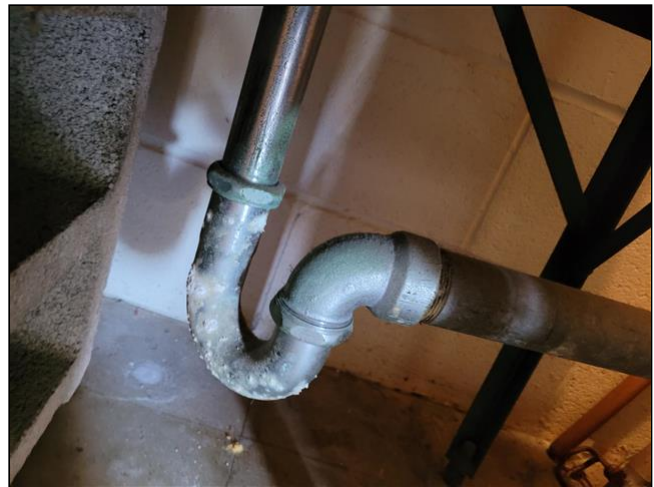
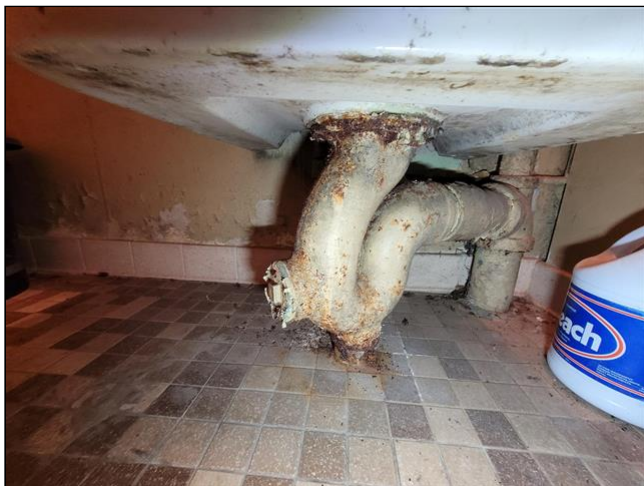
**(2) Corrosion observed at sink drain lines at multiple locations, no leaks at the time of inspection. Recommend corrections as needed.**

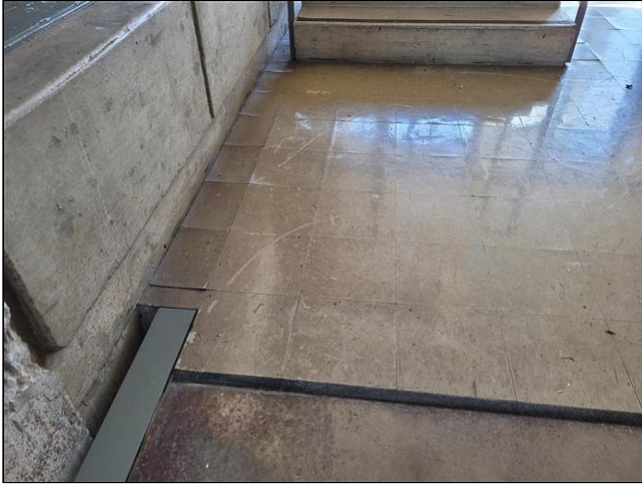
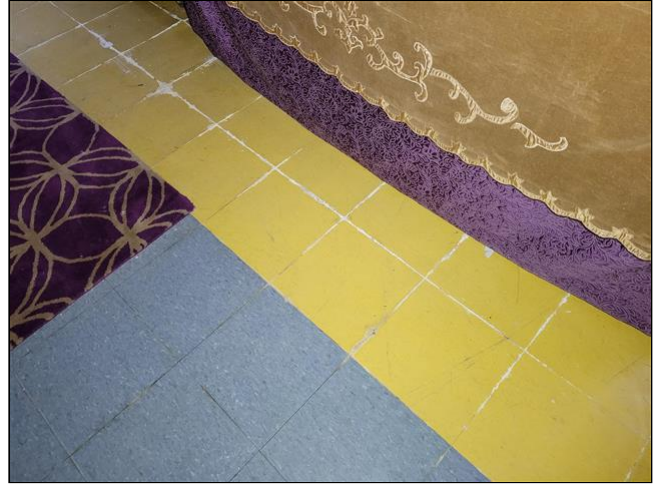
### 3.0 Floors

**(1) Popping floor tile observed in the various locations, suggest corrections to prevent further damage.**

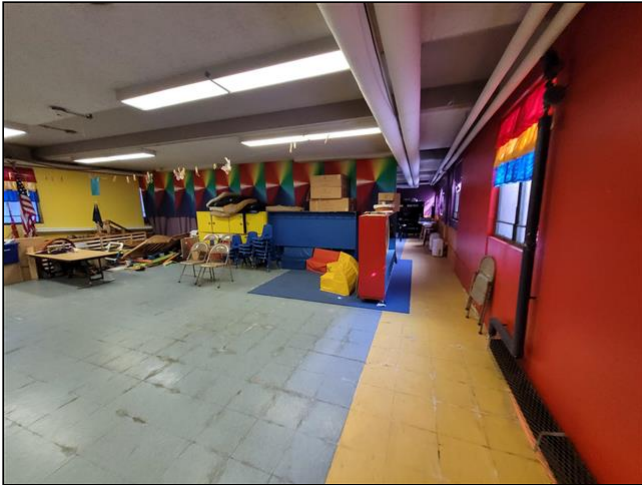
**(2) Water damage floor observed in the various locations. No moisture noted at time of inspection, client is advised to consult with sellers for additional information prior to close.**

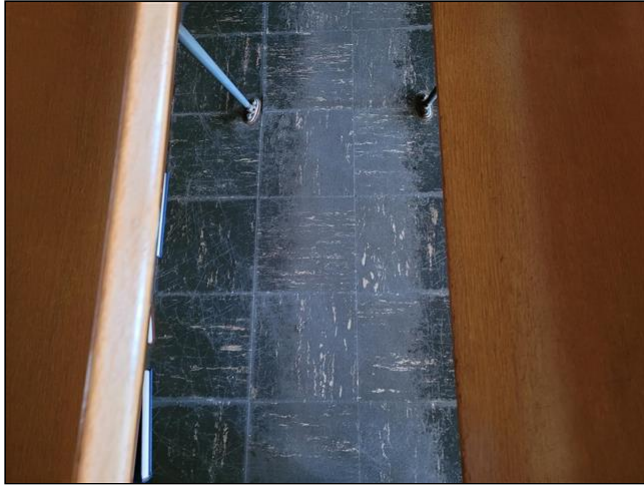
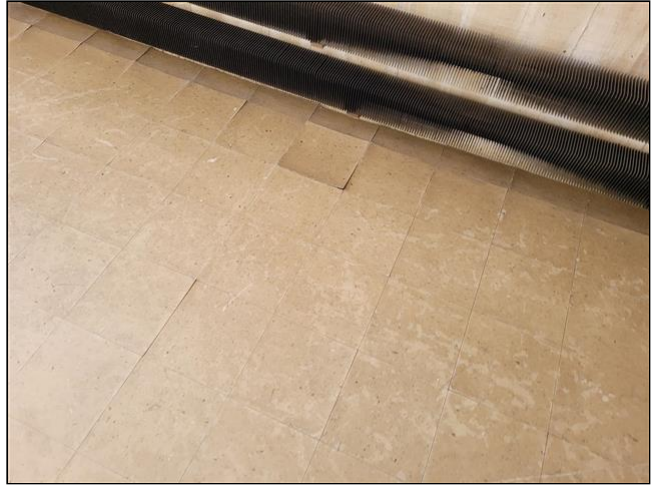
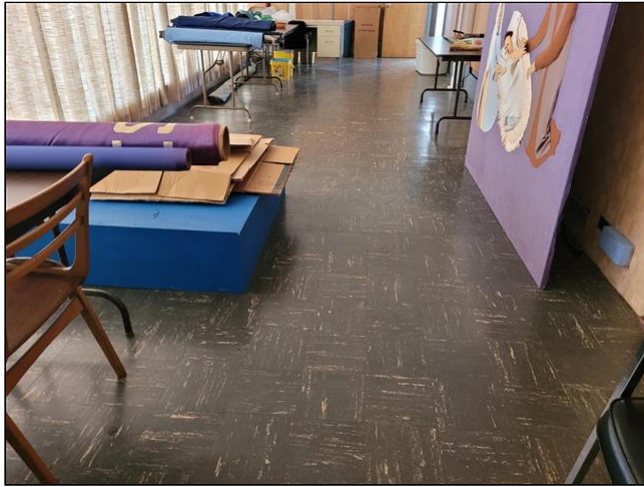
**(3) Asphalt Asbestos observed in the various locations, Plastic Asbestos, and Vinyl Asbestos floor tiles were sold in 6" x 6", 9" x 9" and in some years 12" x 12" sizes. Recommend review for possible removal if client is concerned.**

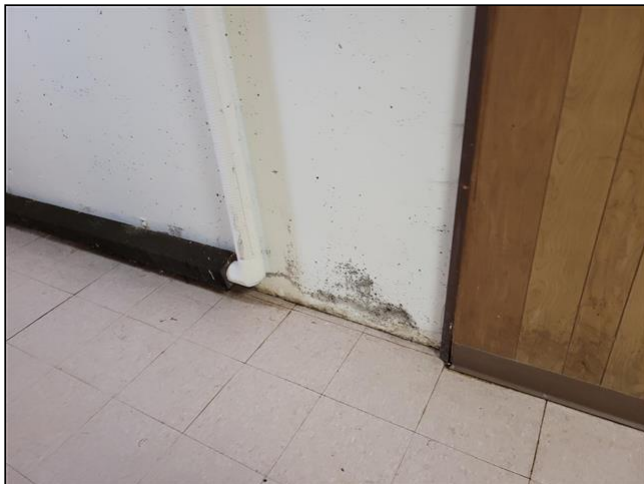
## 3.1 Walls

**(1) Stains, discoloration, growth and/or evidence of moisture observed in the basement. These conditions may indicate mold and/or fungus growth and were discovered during the home inspection. Because certain types of mold may be toxic and result in adverse health effects, it is strongly recommended that a mold inspection be performed by a qualified professional to determine the presence of, and types of, mold in the house and that corrective measures be taken to limit moisture inside the home.**

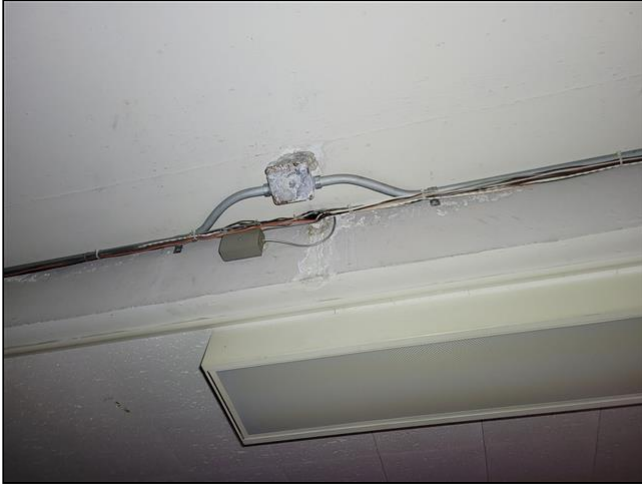
**(2) Efflorescence observed in the basement. Efflorescence is a crystalline deposit appearing on cement or brick surfaces due to the evaporation of water containing soluble salts. The salts left behind on wall surface have a crystal-like appearance. Recommend review by a Licensed/Qualified professional contractor for repair or replacement as necessary.**

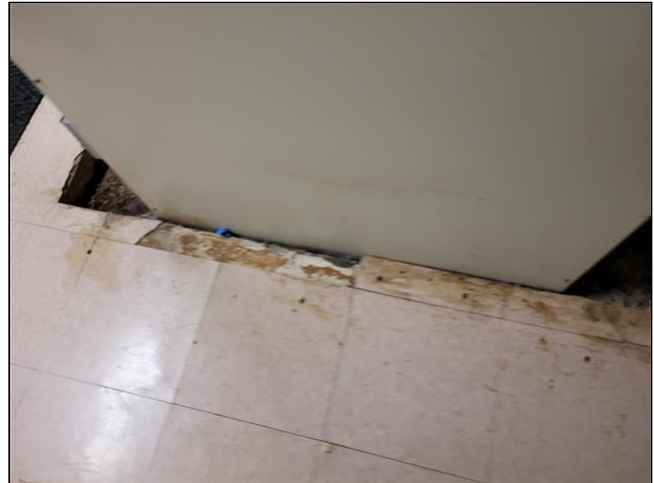
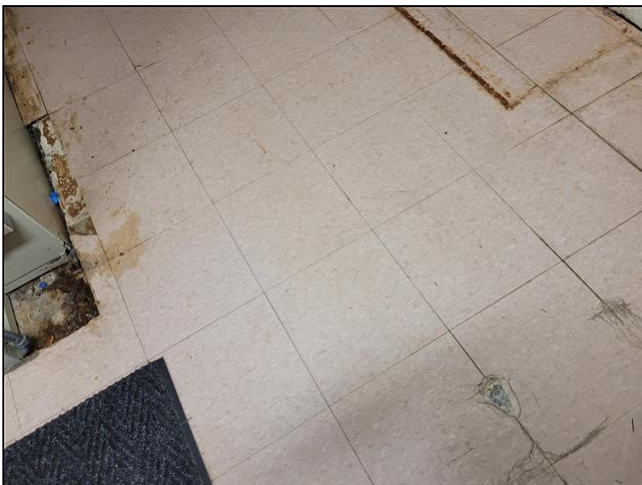
**(3) Evidence of water entry observed at lift, suggest consulting sellers for additional information.**

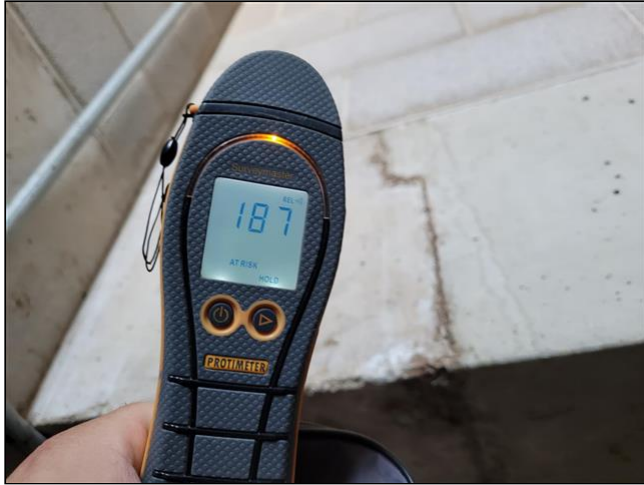
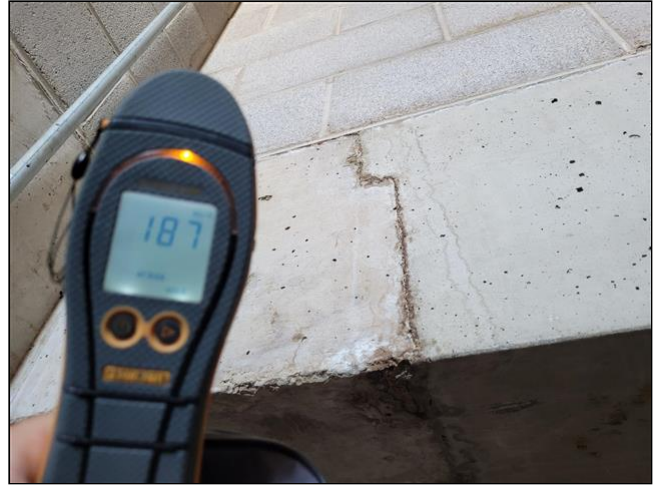
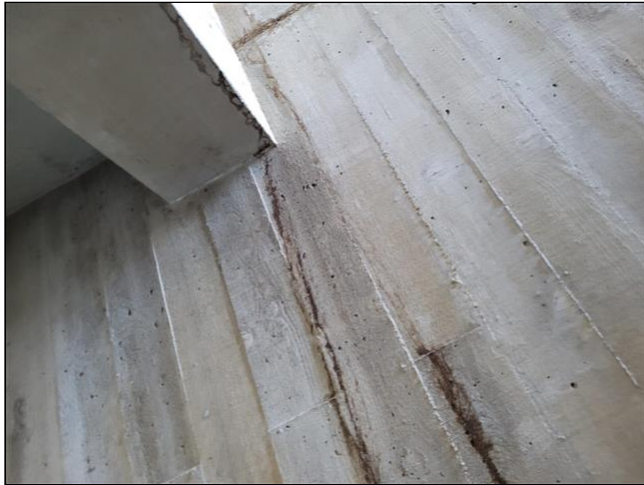
**(4) Stains observed on wall in the stairwell near main entry. An elevated level of moisture was detected using an electronic moisture meter. A qualified contractor is needed for further review and to perform necessary corrections prior to close.**

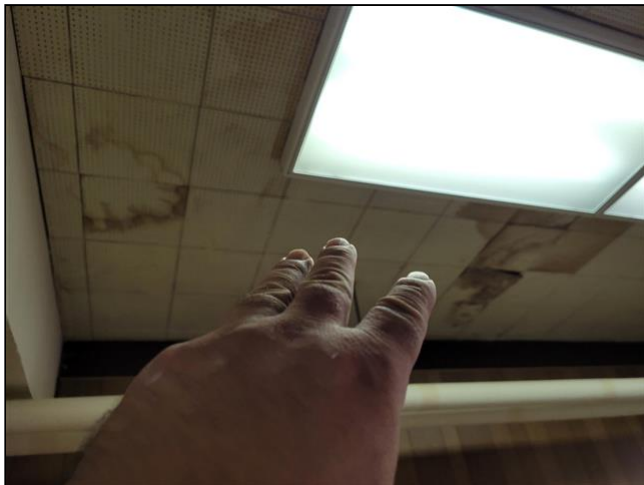
3.2 Ceilings

**(2) Evidence of past water penetration observed in the various locations. Recommend review sellers disclosure statement or have reviewed by licensed professional for repair or replacement as necessary.**

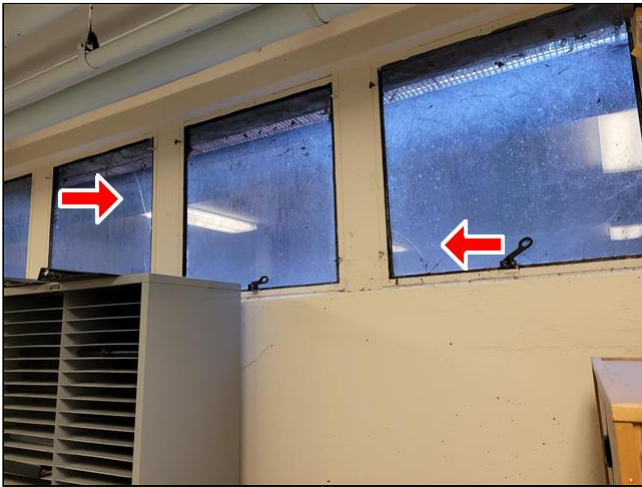
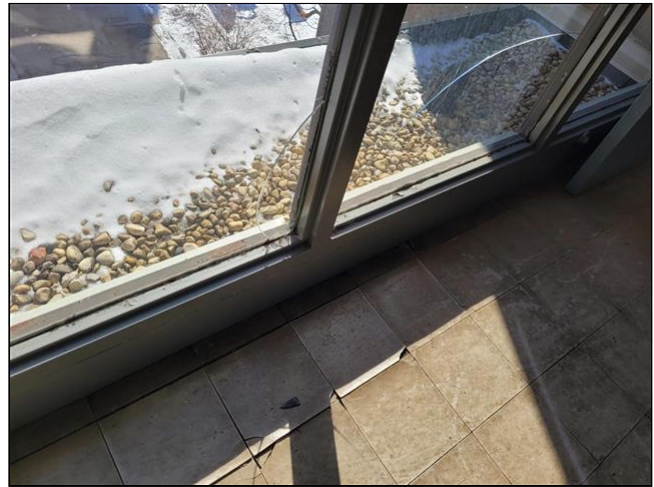
## 3.4 Windows (representative number)

**Windows at various locations are broken. Recommend corrections for proper operation.**

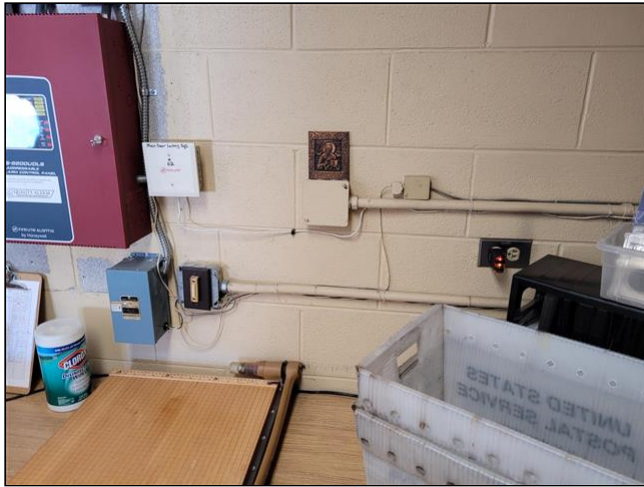
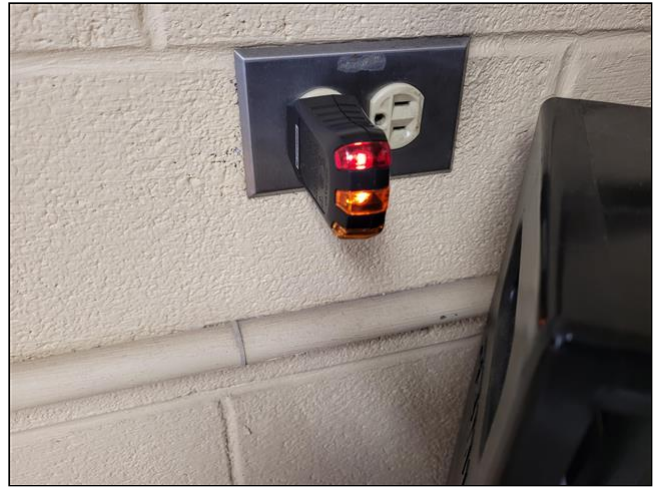
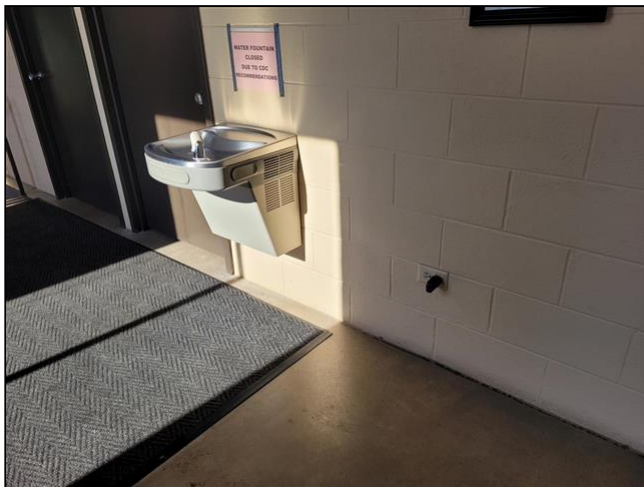
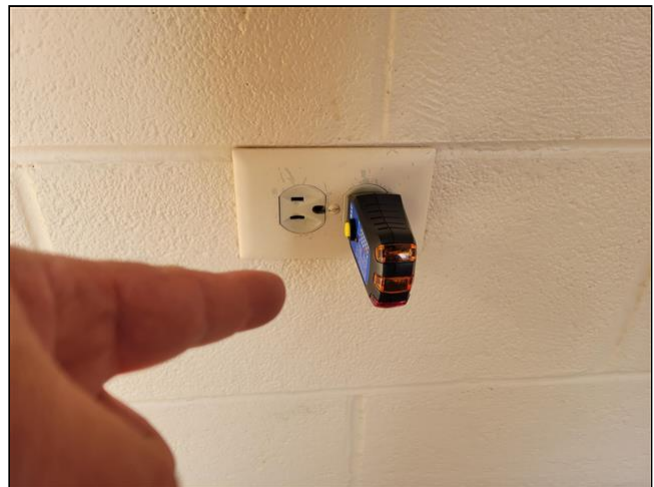
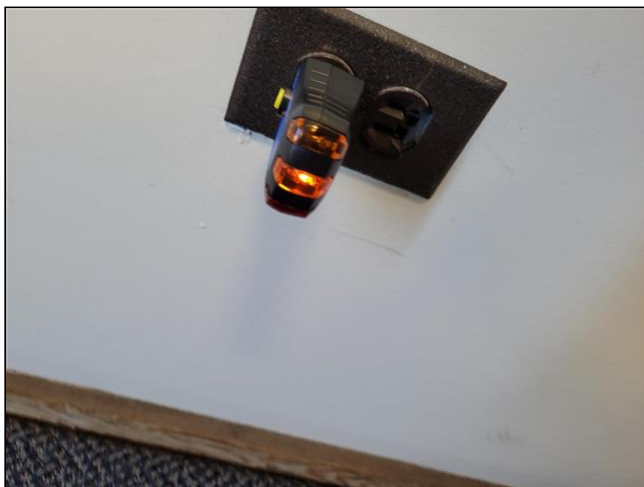
## 3.5 Receptacles, Switches and Fixtures

**(1) Multiple outlets are not wired correctly. Recommend review by a licensed/qualified electrician for repairs or replacements as needed prior to close.**

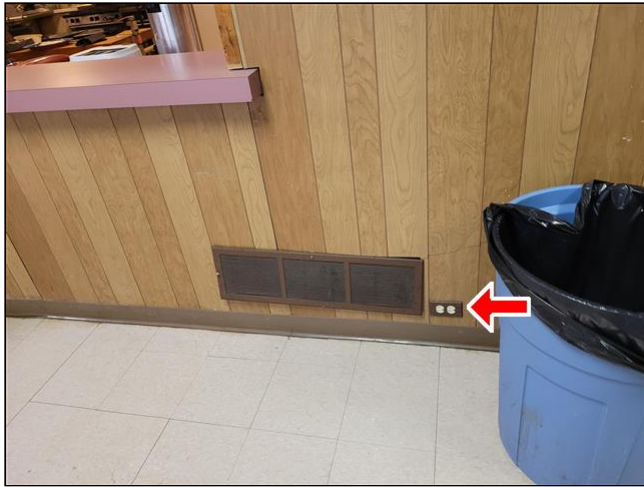
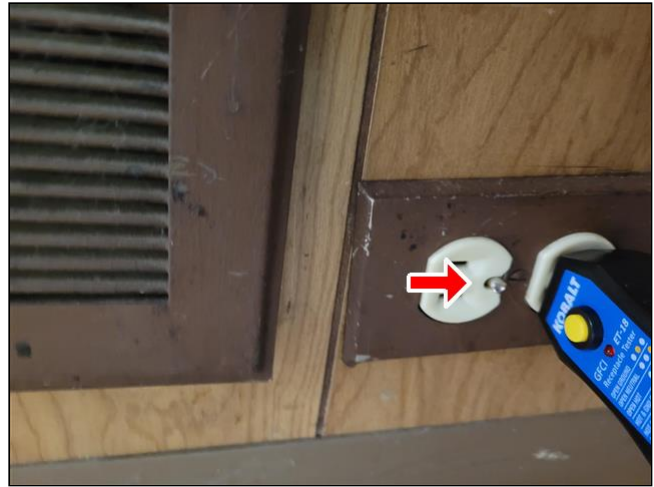
**(2) Broken prong left in wall outlet at basement, suggest corrections as needed.**

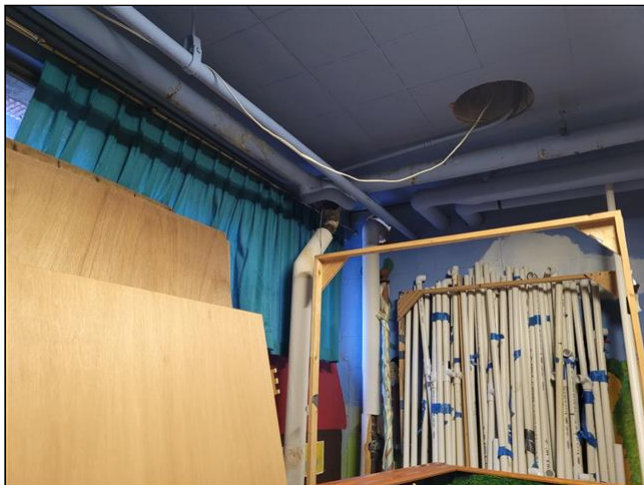
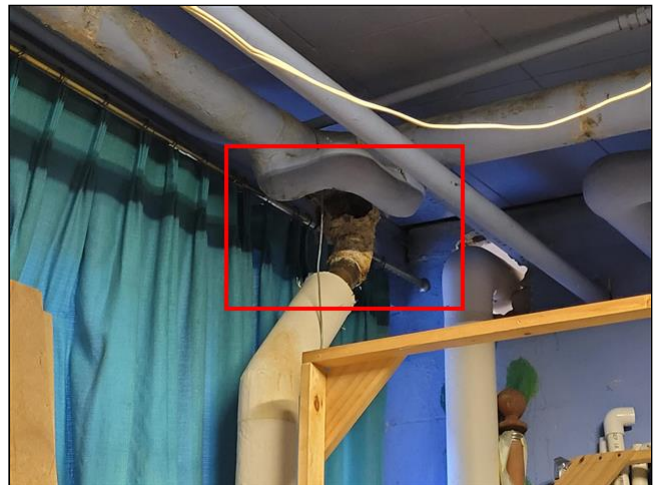
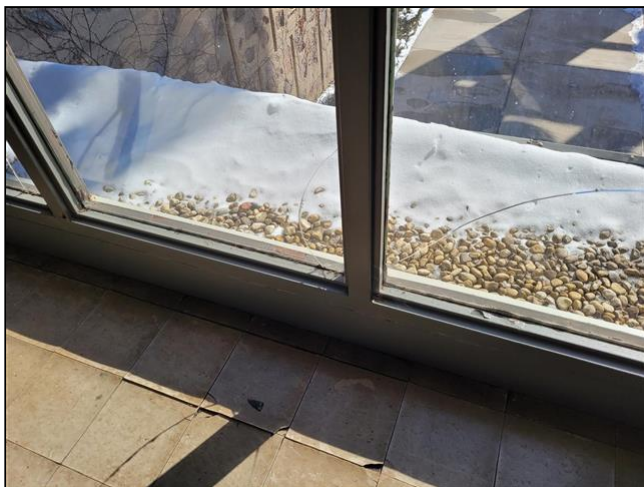
3.7 Interior Rooms and Areas Comments

**(1) Possible asbestos materials observed. The materials were torn, ripped, or damaged at the time of inspection. This is a possible safety hazard. Suggest further review by a licensed asbestos testing lab be performed prior to closing for repairs/replacement needed to ensure safety.**

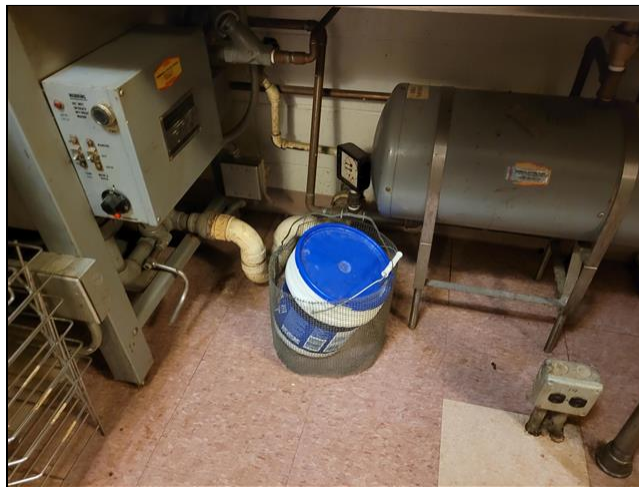
Step #	Component	Comment
1.0	Floors	<b>Serviceable.</b> Asphalt Asbestos observed in the kitchen, Plastic Asbestos, and Vinyl Asbestos floor tiles were sold in 6"x6", 9" x 9" and in some years 12" x 12" sizes. Recommend review for possible removal if client is concerned.

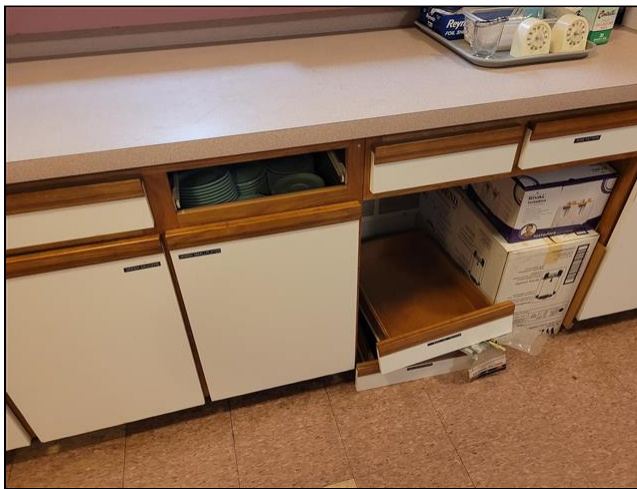
- 1.3 (1) Counters and Cabinets **Comment. Drawers are damaged; corrections needed for proper and smooth operation.**  
(representative number)

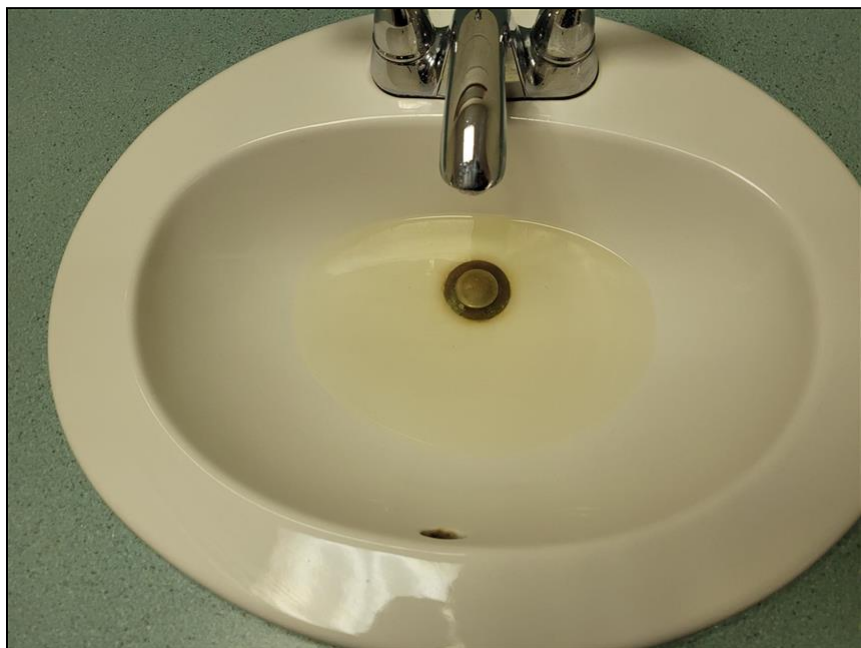
Step #	Component	Comment
2.0	Floors	Serviceable.
2.1	Walls	Serviceable.
2.2	Ceiling	Serviceable.
2.3	Doors	Serviceable.
2.4 (1)	Sinks	<b>Repair or Replace. Low water flow observed in the multiple locations. Recommend review by Licensed/Qualified professional for repair or replacement as necessary.</b>

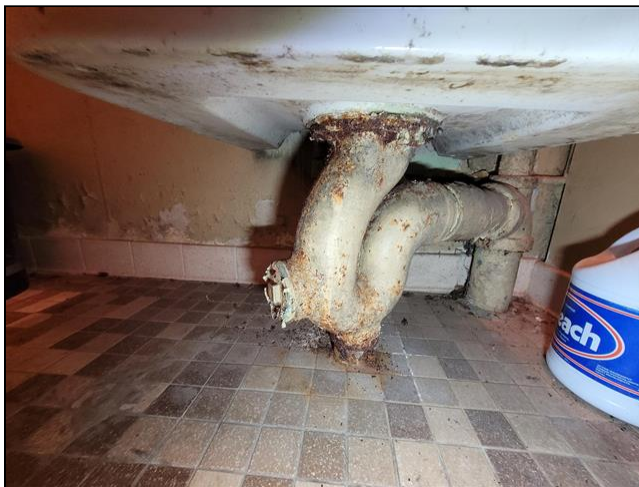
## 2.4 (2) Sinks

**Repair or Replace. Corrosion observed at sink drain lines at multiple locations, no leaks at the time of inspection. Recommend corrections as needed.**

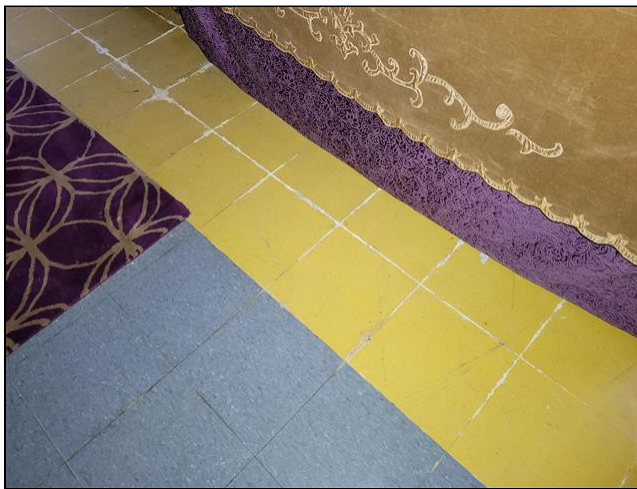
## 3.0 (1) Floors

**Repair or Replace. Popping floor tile observed in the various locations, suggest corrections to prevent further damage.**

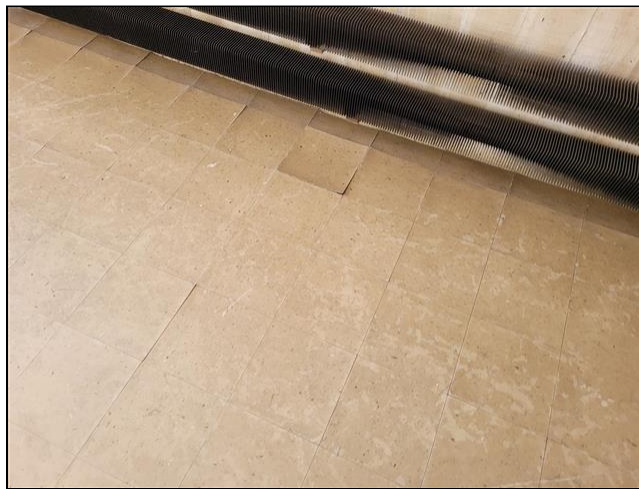
**Repair or Replace. Asphalt Asbestos observed in the various locations, Plastic Asbestos, and Vinyl Asbestos floor tiles were sold in**

**6"x6", 9" x 9" and in some years 12" x 12" sizes. Recommend review for possible removal if client is concerned.**

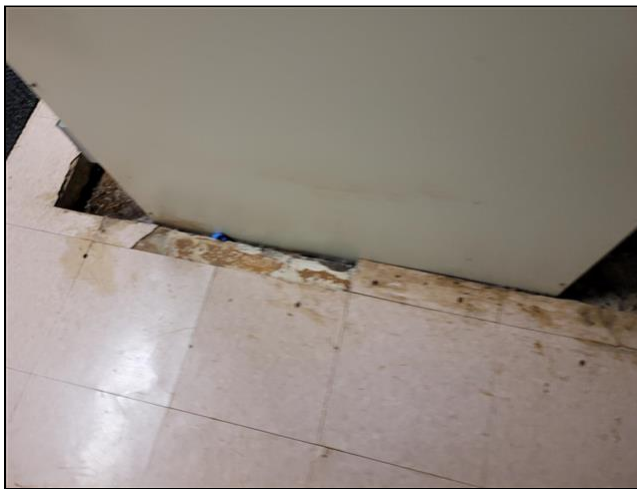
3.1 (3) Walls

**Repair or Replace. Evidence of water entry observed at lift, suggest consulting sellers for additional information.**

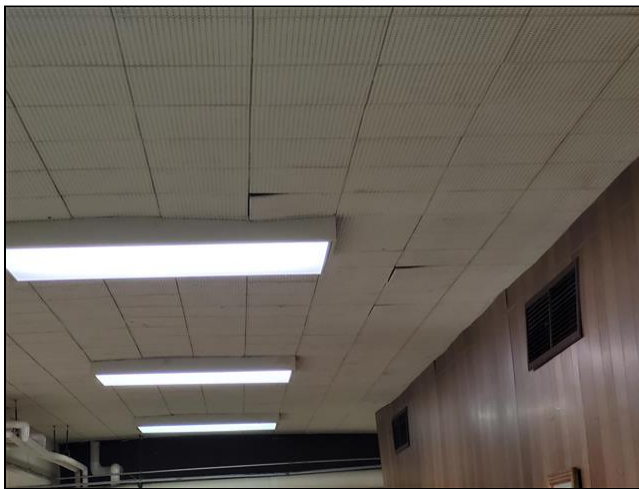
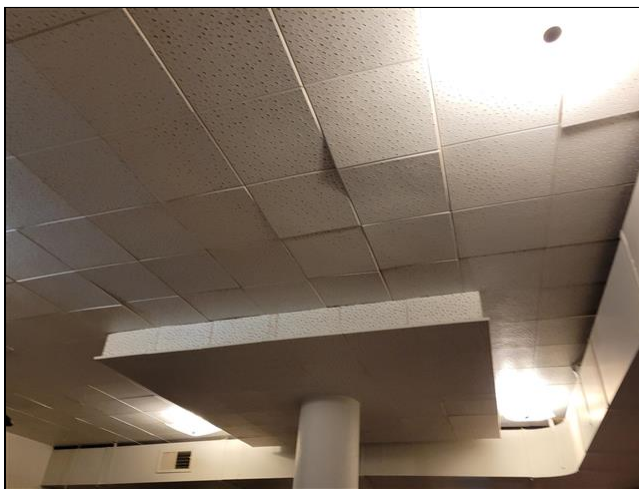
3.2 (1) Ceilings

**Repair or Replace. Loose/hanging ceiling tiles observed at multiple areas, suggest corrections as needed.**

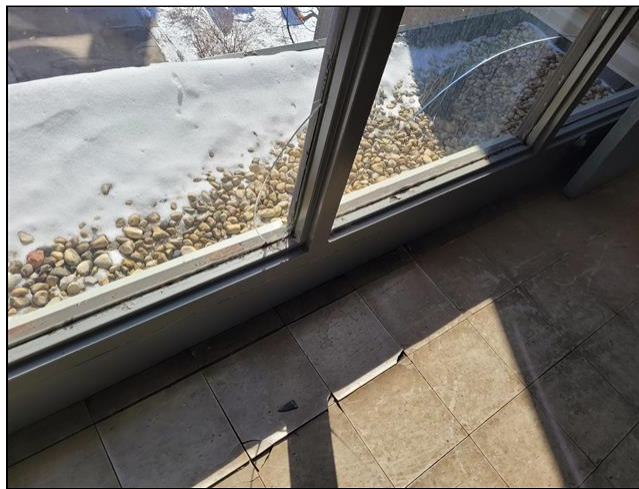
3.4 Windows  
(representative  
number)

**Repair or Replace. Windows at various locations are broken.  
Recommend corrections for proper operation.**

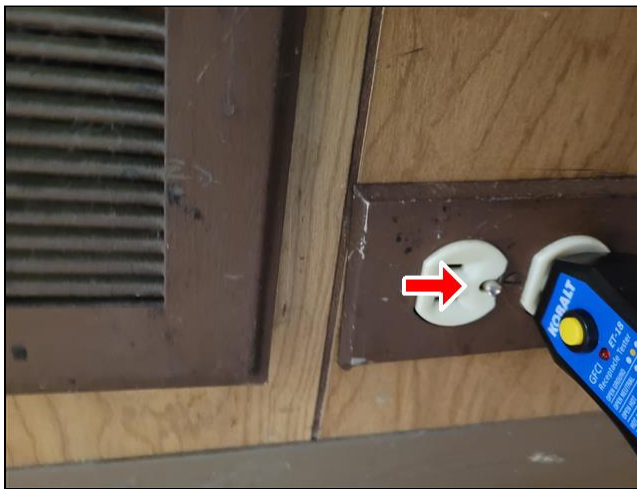
3.5 (2) Receptacles, Switches and Fixtures **Repair or Replace. Broken prong left in wall outlet at basement, suggest corrections as needed.**

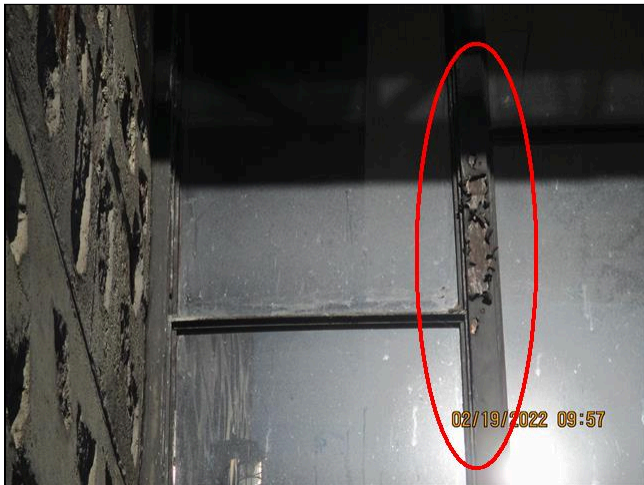
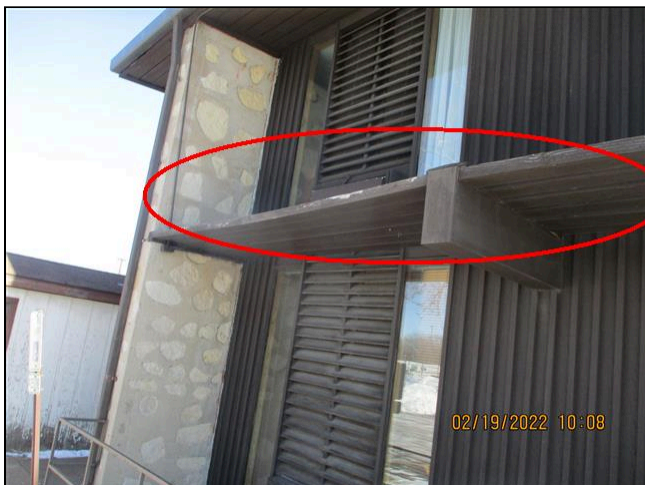
2.2 Item 1(Picture)

2.2 (1) The trim is peeling paint at most windows. Further deterioration may occur if not repaired. I recommend a qualified contractor inspect and repair as needed.

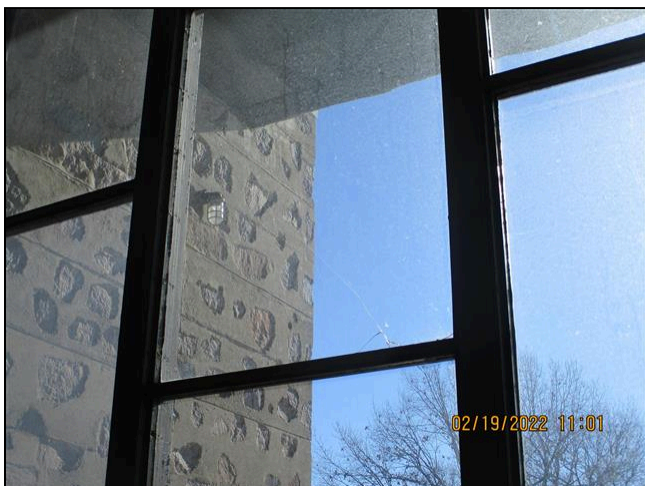
2.2 Item 8(Picture)

(2) Few windows cracked. A qualified person should repair or replace as needed.

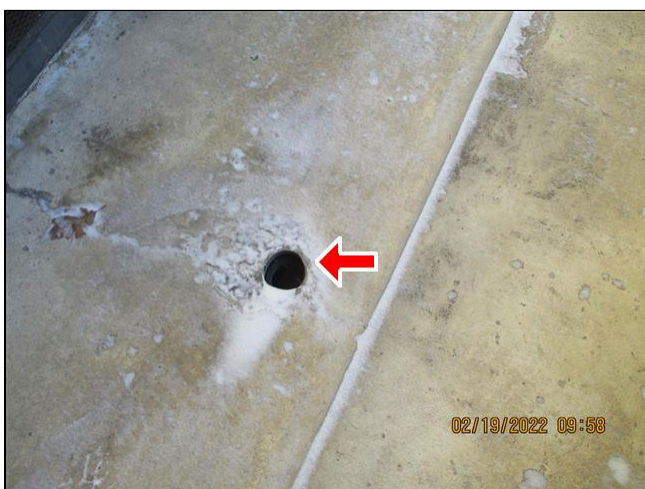
2.3 Item 1(Picture)

2.3 Missing ground drain cap

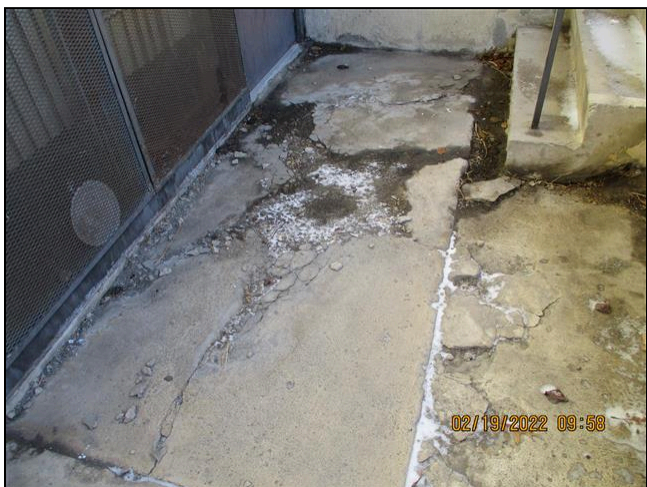
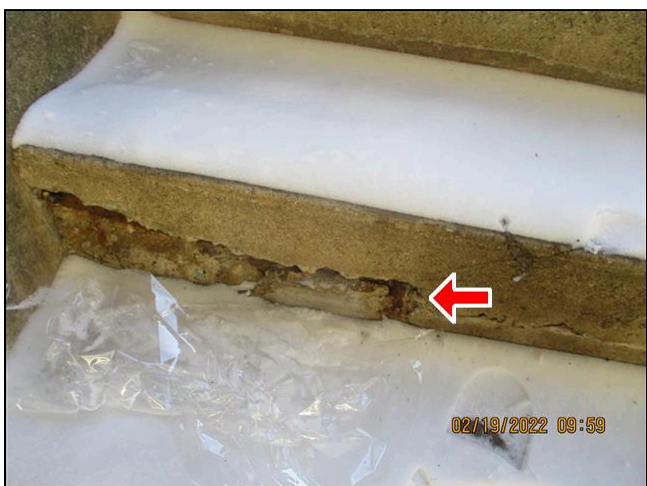
2.4 Item 1(Picture)

2.4 (1) The concrete walkway is deteriorated in areas and can be a tripping hazard. Further deterioration can occur if not

repaired. A qualified person should repair or replace as needed.

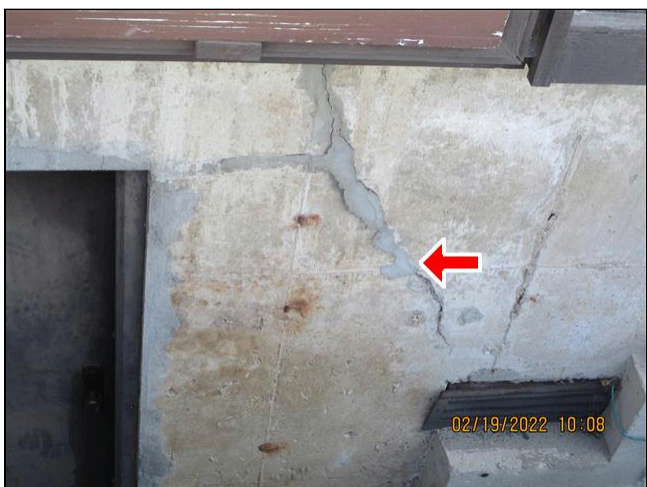
2.4 Item 4(Picture)

(2) The concrete foundation wall at the side has shifted somewhat, also water seepage from adjacent wall. Structural engineer required

2.4 Item 6(Video) WATER SEEPAGE

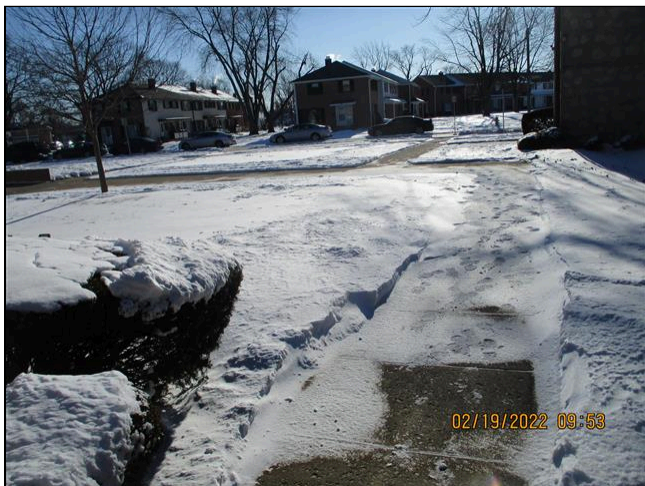
2.4 Item 7(Picture)

(3) Due to snow inspector unable to see negative slope that cause or contribute to water intrusion or deterioration.

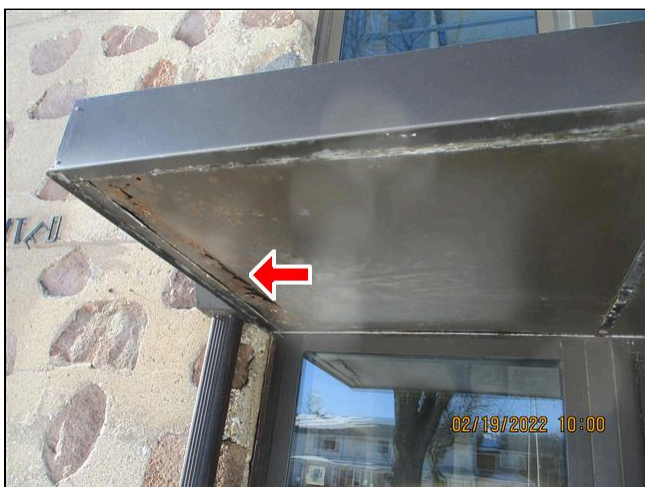
2.5 Item 1(Picture)

2.5 A gap between the fascia and roof sheathing exists which allows insects or bees to enter attic.

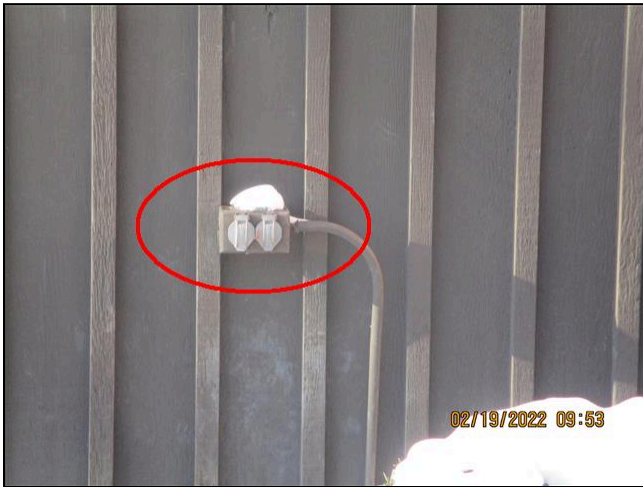
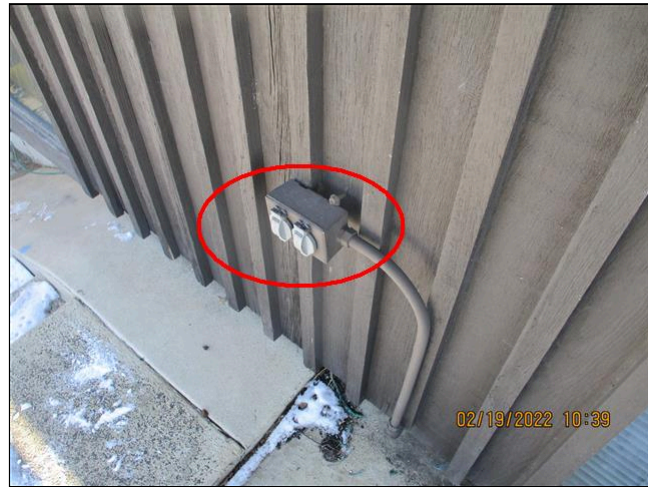
2.6 Item 1(Picture)

**2.6 (1) Exterior GFCI required, Electrical issues are considered a hazard until repaired.**

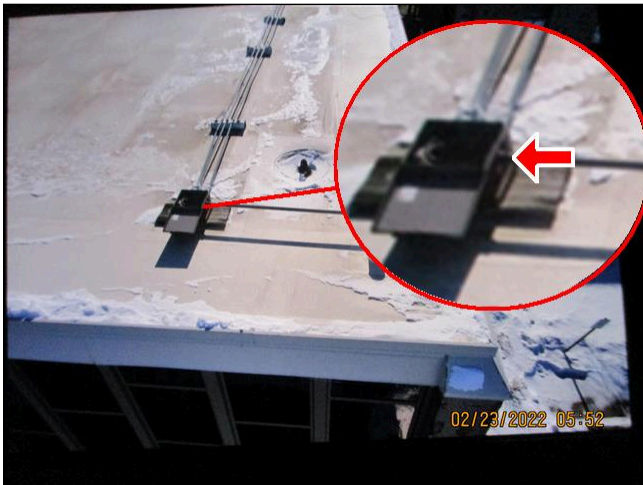
2.6 Item 3(Picture)

(2) The outside roof junction box cover is damaged and needs repair or replace. Electrical issues are considered a hazard until repaired.

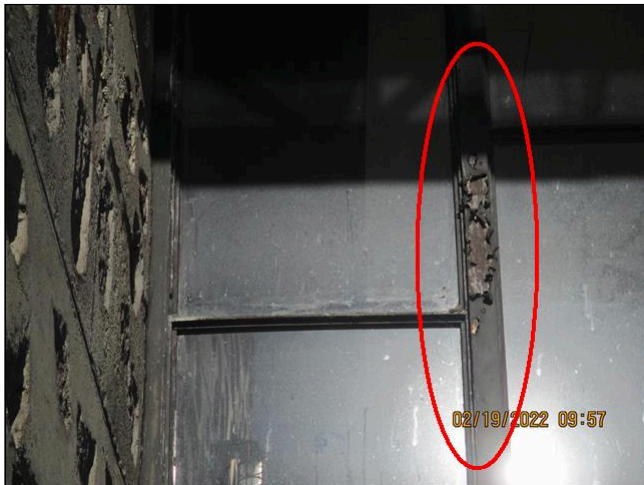
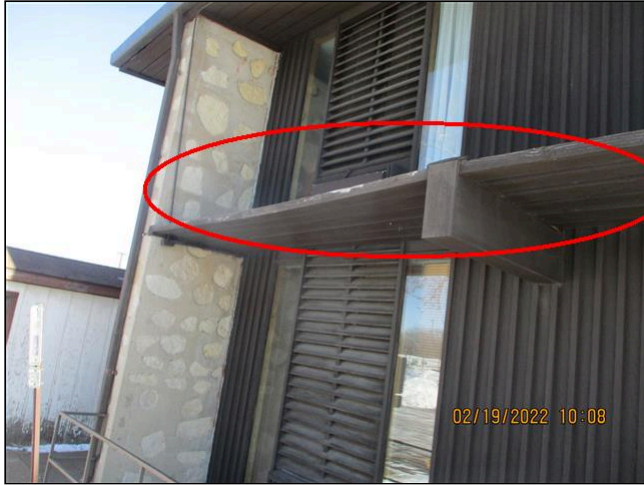
2.2 Item 1(Picture)

(1) The trim is peeling paint at most windows. Further deterioration may occur if not repaired. I recommend a qualified contractor inspect and repair as needed.

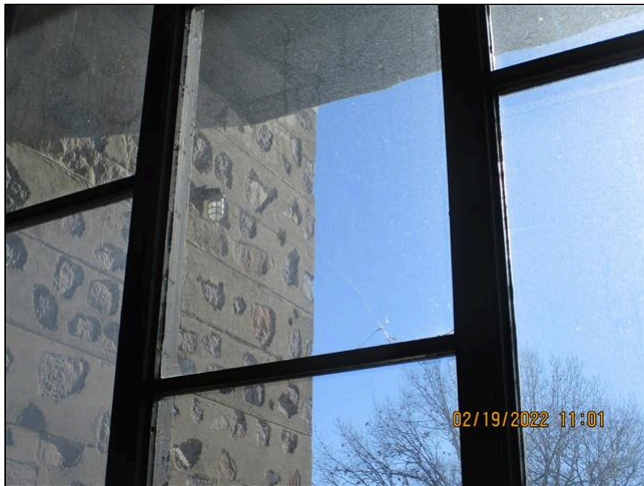
2.2 Item 8(Picture)

(2) Few windows cracked. A qualified person should repair or replace as needed.

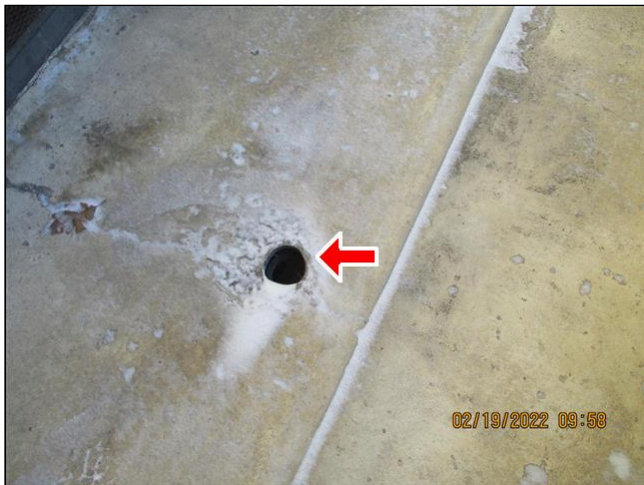
2.3 Item 1(Picture)

Missing ground drain cap

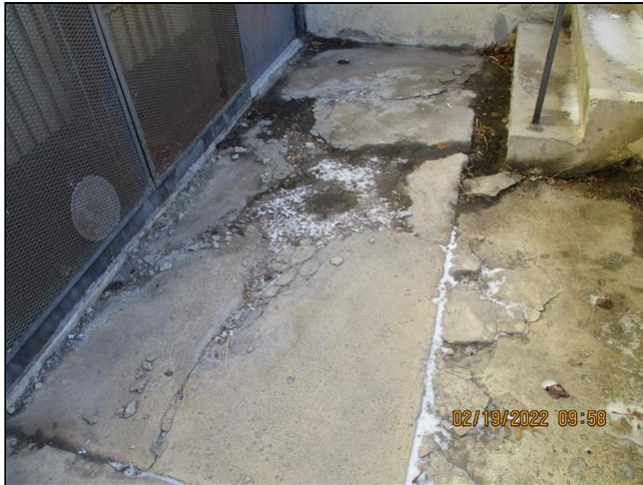
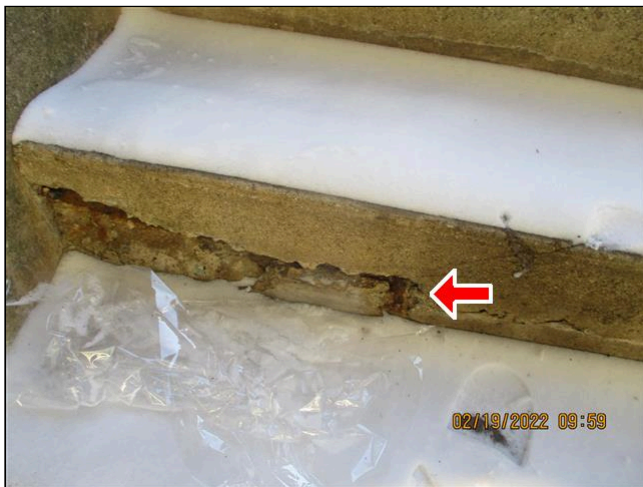
2.4 Item 1(Picture)

(1) The concrete walkway is deteriorated in areas and can be a tripping hazard. Further deterioration can occur if not repaired. A qualified person should repair or replace as needed.

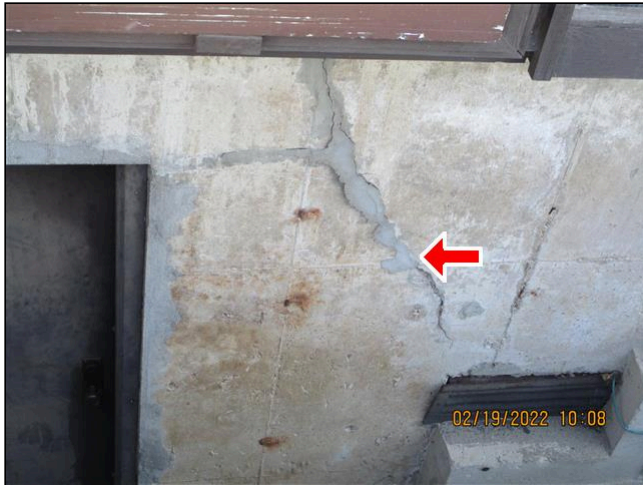
2.4 Item 4(Picture)

(2) The concrete foundation wall at the side has shifted somewhat, also water seepage from adjacent wall. Structural engineer required

2.4 Item 6(Video) WATER SEEPAGE

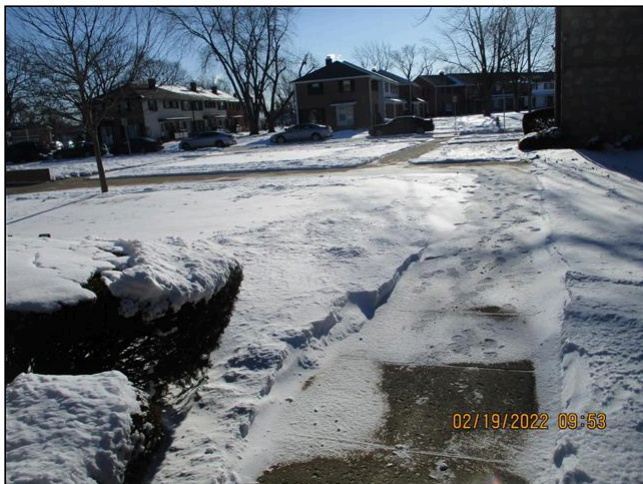
2.4 Item 7(Picture)

(3) Due to snow inspector unable to see negative slope that cause or contribute to water intrusion or deterioration.

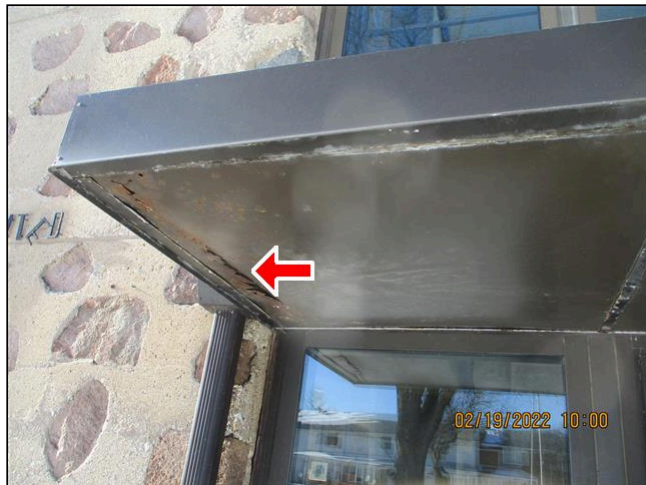
2.5 Item 1(Picture)

A gap between the fascia and roof sheathing exists which allows insects or bees to enter attic.

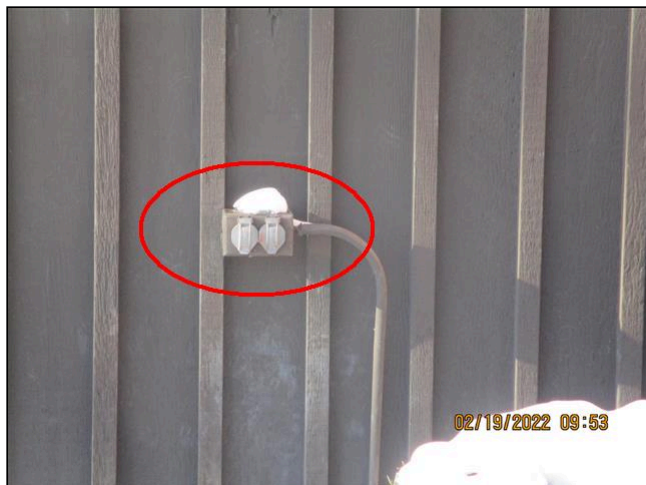
2.6 Item 1(Picture)

(1) Exterior GFCI required, Electrical issues are considered a hazard until repaired.
