## SUMMARY REPORT

AmeriSpec Inspection Services  
License #450.011551; Expires, 11/30/22

Doc #: Client Name: Carl White Jr.  
Dwelling Address: 10 Hemlock St  
Park Forest IL 60466 Inspector: Cal Ramirez

INSPECTION REPORT  
10 Hemlock St  
Park Forest Illinois 60466

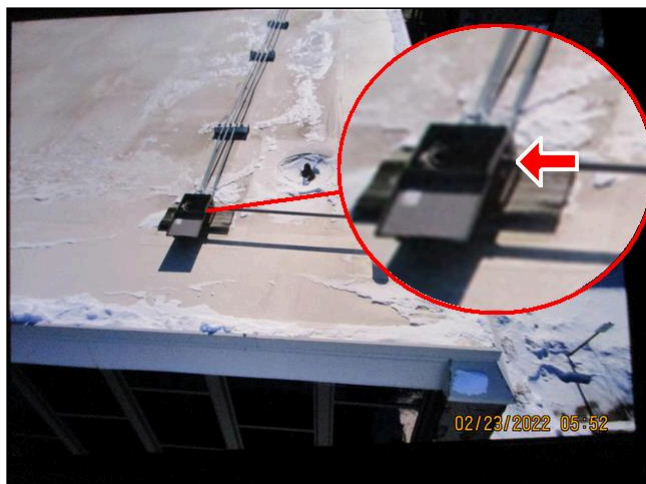
2.6 Item 3(Picture)

(2) The outside roof junction box cover is damaged and needs repair or replace. Electrical issues are considered a hazard until repaired.
