Inspection Report

Property Address:
24703 Ave Asoleada
Calabasas CA 91302

AmeriSpec Inspection Services

Date: 11/19/2022	Time: 09:00:00 AM	Report ID: 111922VM14VH
Property: 24703 Ave Asoleada Calabasas CA 91302	Customer: Ashghar Farhadi	Real Estate Professional: Courtney Van Cott Frontgate Real Estate

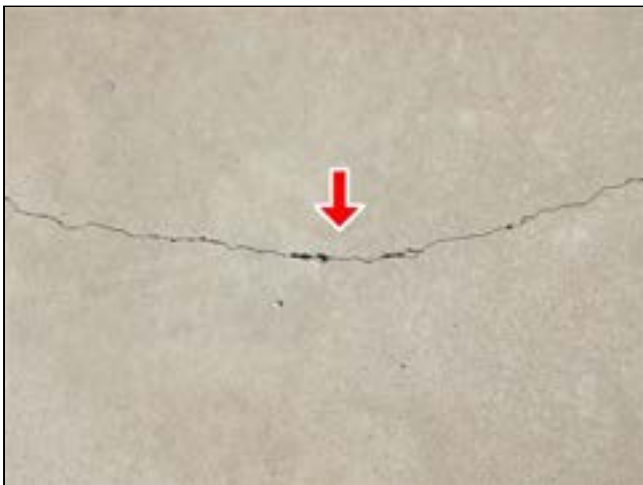
1.0 Item 1(Picture)

Cracks observed on driveway concrete. Recommend repair and seal all cracks in concrete surfaces to prevent water penetration as a routine maintenance effort.

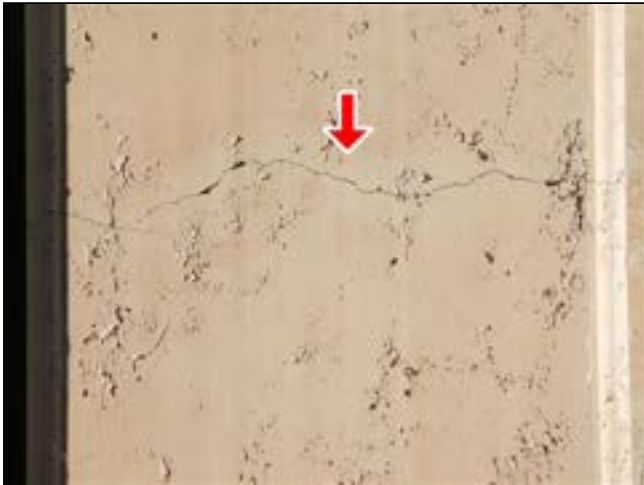
1.1 Item 1(Picture)

Cracks and missing/deteriorated grout observed on short decorative wall at the sides of the front walkway. Primarily a cosmetic concern. Recommend review for repairs, as needed.

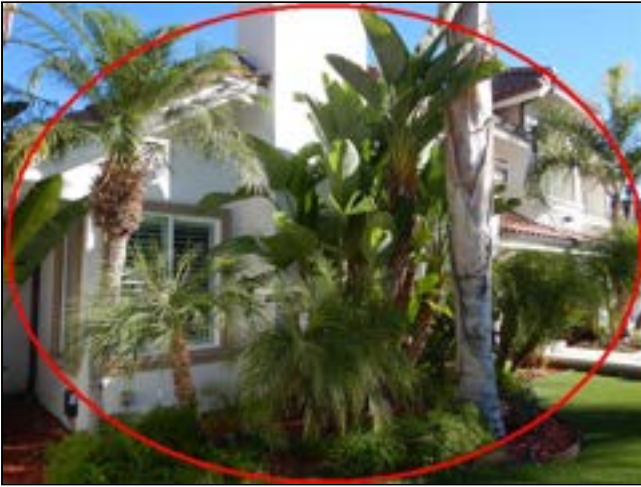
1.2 Item 1(Picture)

(1) Vegetation observed in direct contact with siding at front of home. This can promote moisture damage and wood deterioration to the siding and structure which is not always visible to the inspector. Suggest trimming/removal of vegetation to prevent damage to the home. This was a limited review of this area. Damage/deterioration can only be viewed after removal of vegetation/overgrowth.

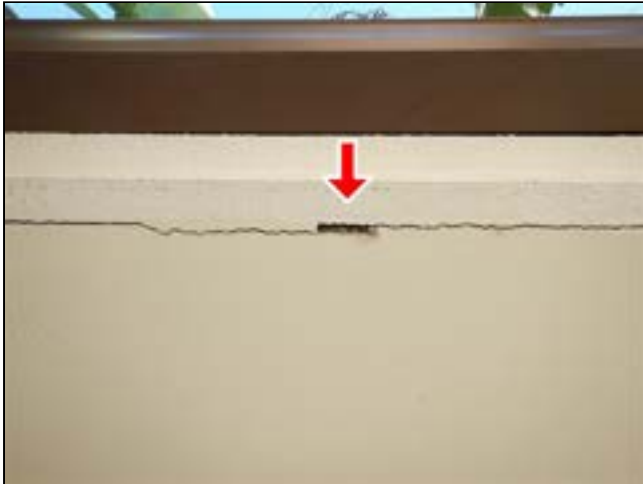
1.3 Item 1(Picture)

(1) Cracks/gaps observed between fascia boards and soffit area all around the home. This may allow pests, such as termites, to enter the home's structure. This may also allow moisture entry and lead to damage/deterioration. Recommend review by a licensed/qualified contractor for corrections to prevent damage.

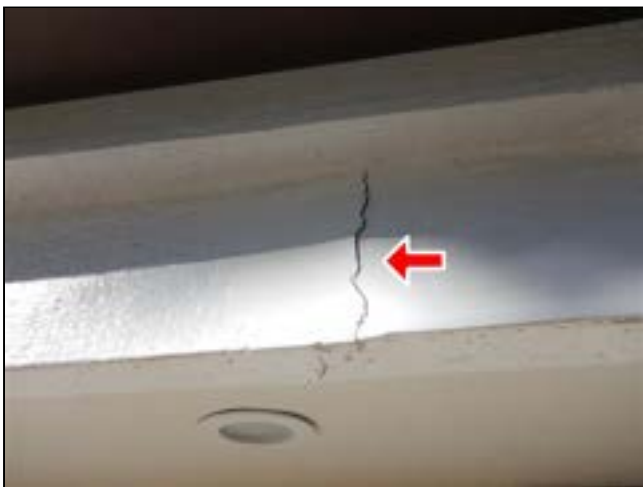
1.3 Item 5(Picture)

(2) Cracked fascia board observed at right side of home, near the pool equipment area. Recommend review by a licensed/qualified contractor for repairs.

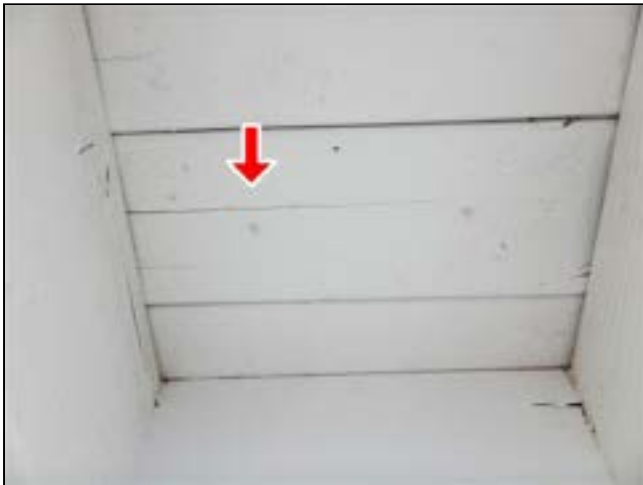
1.3 Item 6(Picture)

(3) Cracked soffit planks observed above the bedroom #2 balcony. Recommend review by a licensed/qualified contractor for repairs.

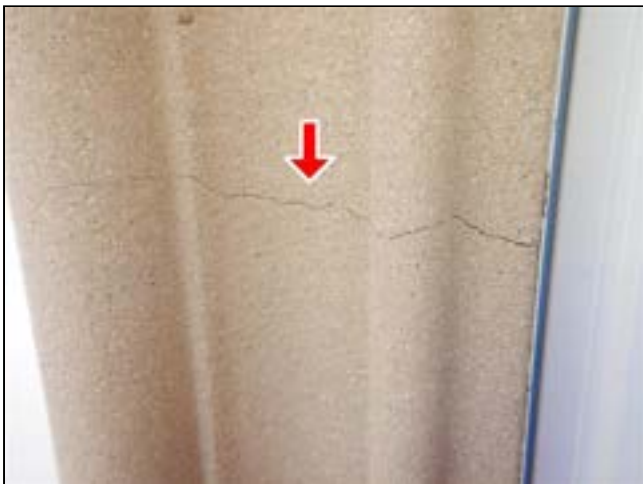
1.4 Item 1(Picture)

Cracks and deteriorated grout observed on decorative exterior moulding around the majority of the windows, as well as some of the doors. Suggest sealing all cracks to prevent moisture penetration.

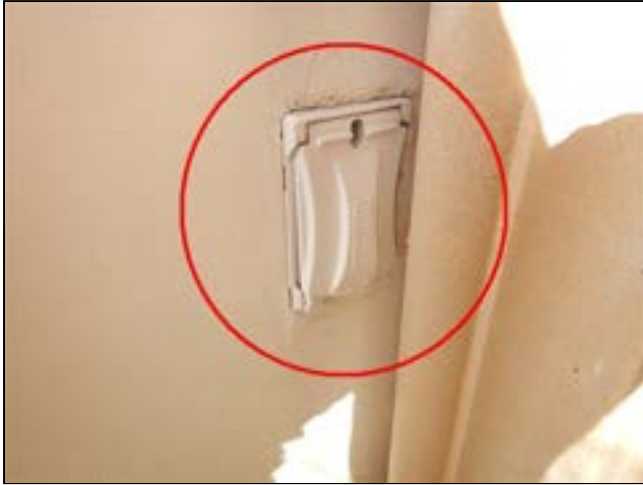
1.7 Item 1(Picture)

(1) The receptacle at the front of the home, immediately to the left of the main entry door, is blocked by the decorative moulding and as a consequence does not open. Recommend review by a licensed/qualified contractor for corrections if access to the outlet is desired.

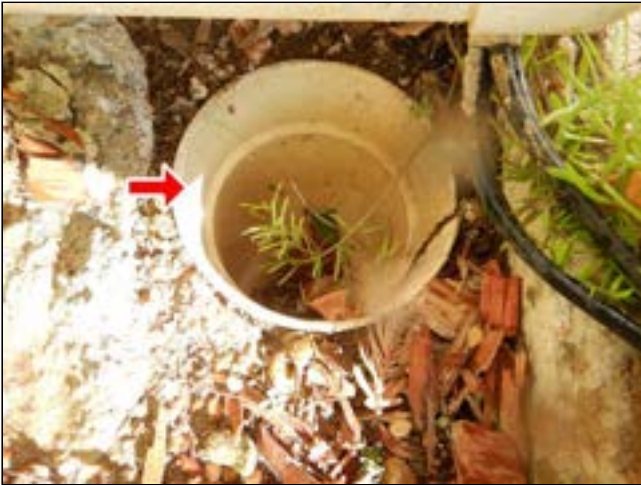
1.11 Item 1(Picture)

There is an underground drainage pipe at the front of the home, at the front/left corner of the garage, that does not have a screen/cover. Recommend replacing to prevent unwanted entry by pests or debris. It is beyond the scope of this inspection to inspect or perform tests on underground drainage systems. Suggest client obtain information from sellers or verify that the drainage system functions properly prior to closing.

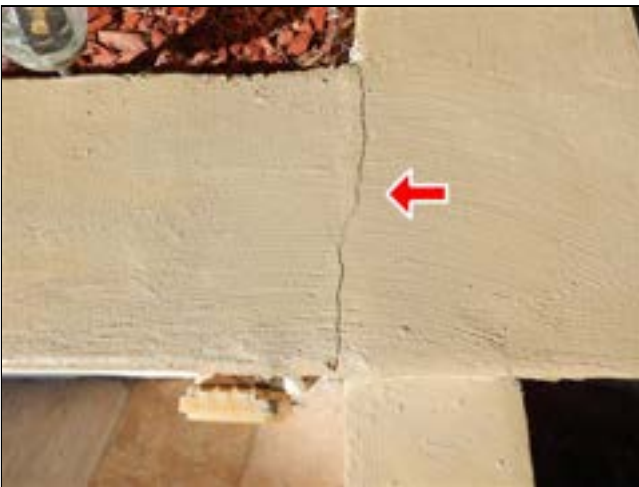
1.15 Item 1(Picture)

Hairline crack observed on top of the landscape retaining wall at the rear/left side of the home. Recommend review for repairs, as needed.

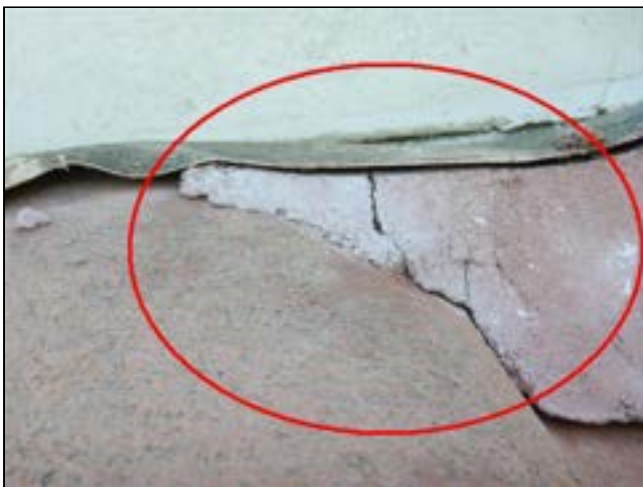
2.0 Item 4(Picture)

(2) The mortar that fills the gap between the flashings and roof tiles are deteriorated/cracked observed at rear. Recommend review for repairs/corrections as needed to prevent further future damages.

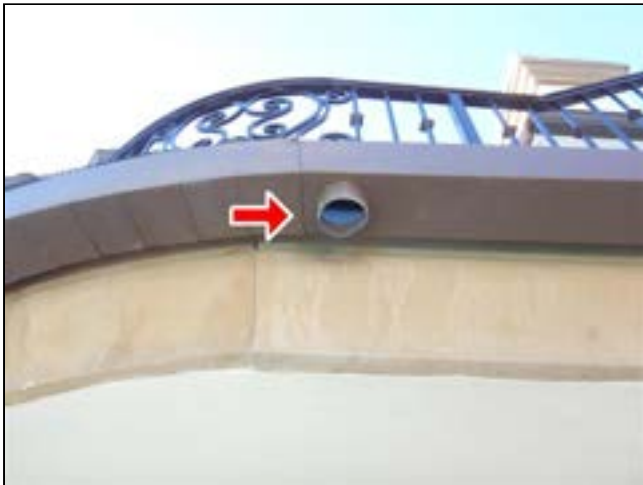
2.2 Item 1(Picture)

Missing downspouts observed at rear of home. Suggest downspouts be installed to ensure proper drainage away from the foundation.

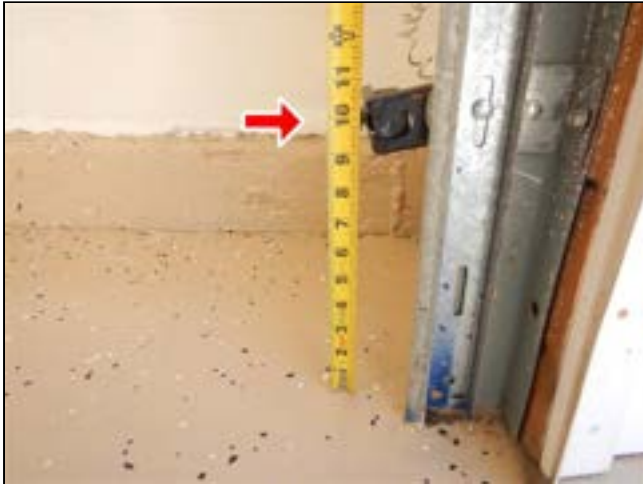
3.4 Item 1(Picture)

(1) The electric eyes are mounted (10" inches) too far above the floor, recommend lowering the eyes to within 6" inches of the floor or manufactures specifications in order to protect small children, pets, or property as intended by the manufacturer.

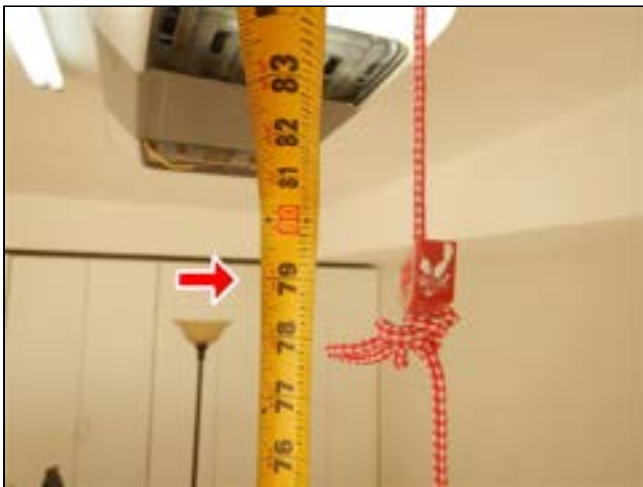
3.4 Item 3(Picture)

(2) The red emergency pull handle/rope for both garage doors are too high (79" for the small door and 76" for the large door). Should be maximum 72" high from the floor. Recommend corrections for proper operations at the time of emergency.

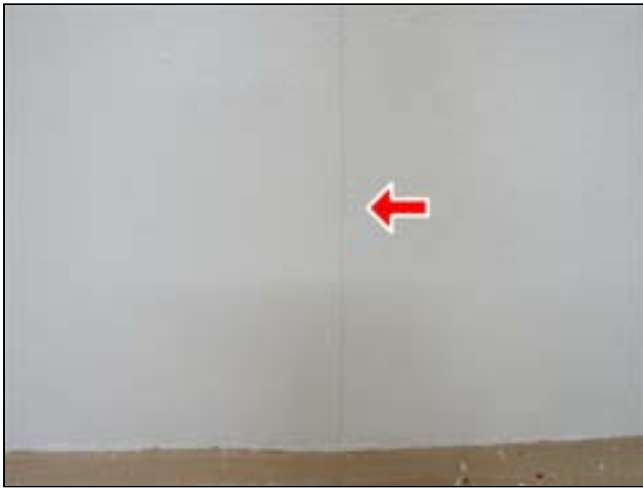
3.6 Item 1(Picture)

(1) Common cracks noted on garage walls. Appear to be primarily a cosmetic concern. Suggest repairs as needed.

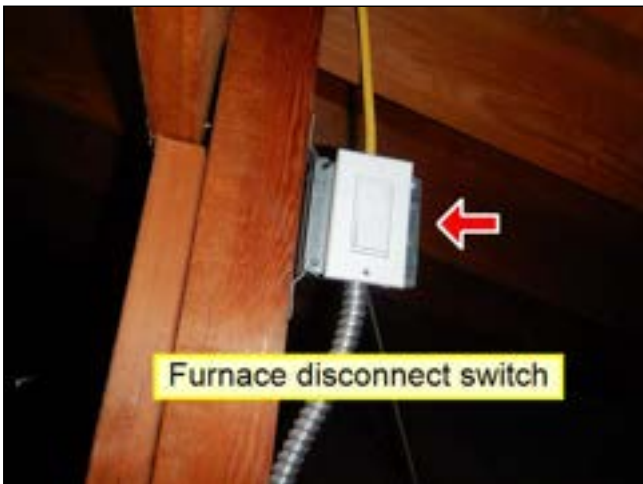
8.0 Item 9(Picture)

(3) The attic furnace shuts off after a few seconds of operation. Inspector was able to reset the furnace by switching it OFF and then back ON again using the disconnect switch above the furnace, however after a few seconds the furnace would shut itself off again. Unable to determine reason. Further evaluation is needed by a licensed/qualified HVAC contractor for repairs/corrections to ensure safe and proper operation.

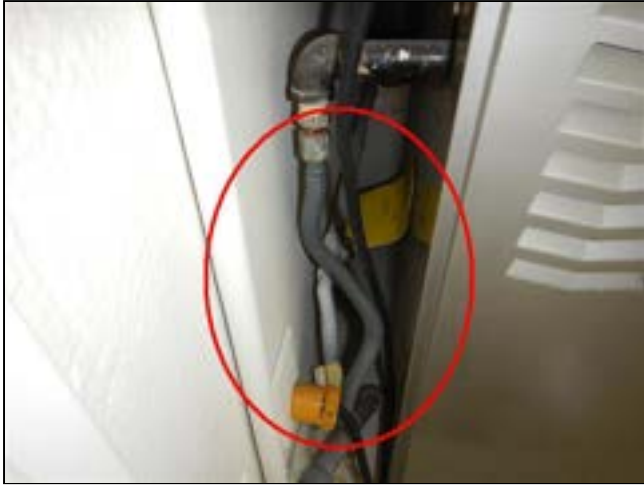
8.1 Item 1(Picture)

No sediment trap observed on either heating unit/furnace gas supply piping. Suggest upgrading/installing sediment trap to help prevent sediment in the gas piping from getting into the gas valve or burner area of an appliance and fouling things up.

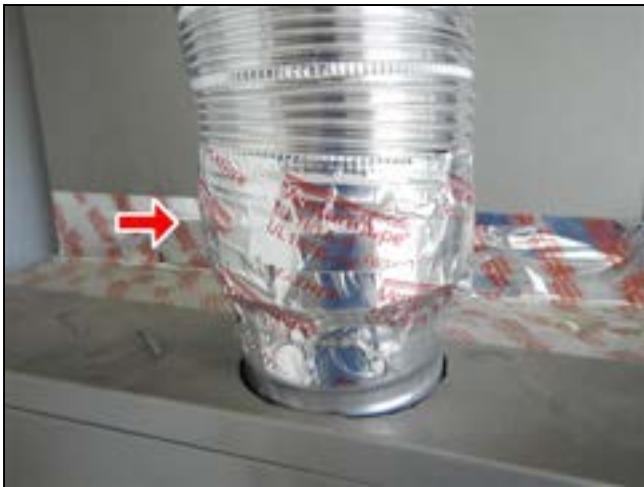
8.2 Item 1(Picture)

(1) Unable to determine if the flue pipe sections are connected using sheet metal screws. The screws will prevent separation of the flue pipe sections in the event of an earthquake. Sheet metal screws are required in each joint. Recommend review by a licensed/qualified plumber for repair or replacement, as necessary.

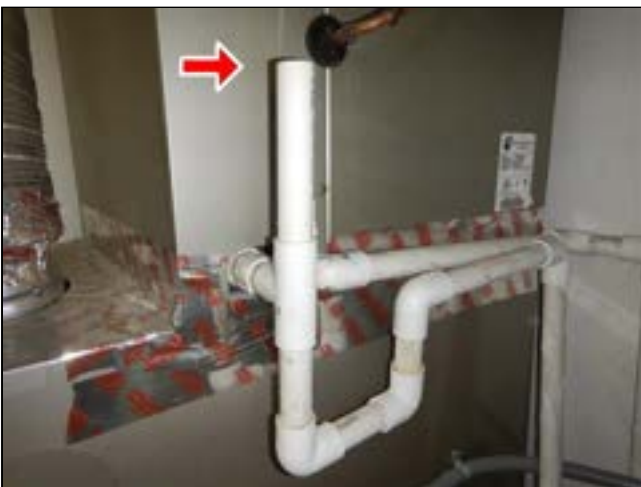
8.6 Item 1(Picture)

No emergency overflow safety switch observed on the condensate drain lines for either of the furnaces. The switch will shut the furnace off in the event of a condensation overflow. Suggest client consider upgrading as a safety enhancement.

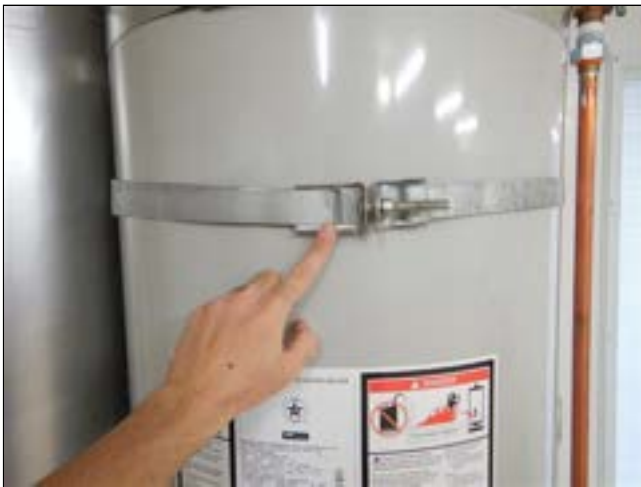
10.0 Item 1(Picture)

The middle earthquake strap on the water heater is loose. Suggest tightening strap to ensure safety.

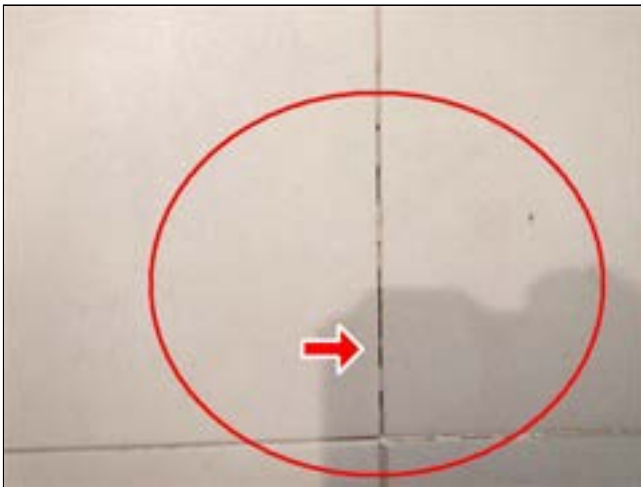
12.0 Item 1(Picture)

(1) Loose/missing grout at several areas observed in the upstairs hall bathroom #2; recommend re-grouting as necessary to prevent water intrusion.

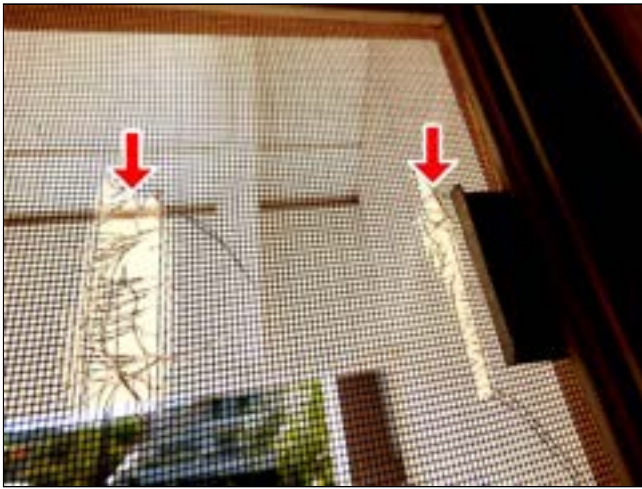
12.4 Item 1(Picture)

Damaged screen observed in the upstairs hall bathroom #2. Recommend corrections for proper operation.

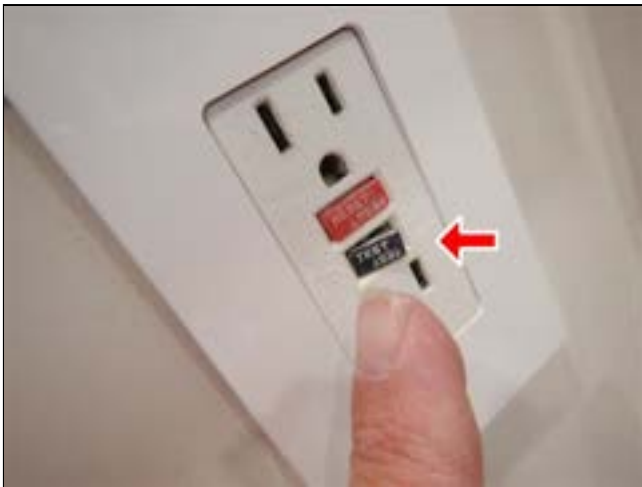
12.6 Item 1(Picture)

(1) The black push button marked test on GFCI outlet is loose/damaged observed in upstairs hall bathroom at left sink. Recommend review by a licensed electrician for repair/.replace as necessary to ensure safety.

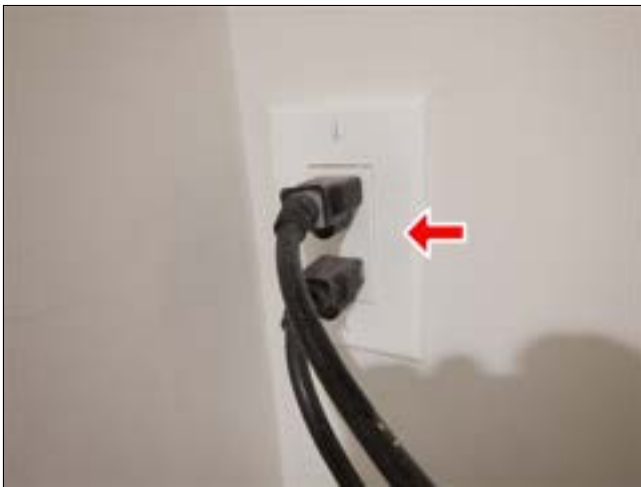
13.4 Item 1(Picture)

(1) A Ground Fault Circuit Interrupter (GFCI) is not present at the laundry room. Ground Fault Circuit Interrupters (GFCI) may not have been required at the laundry room when the home was built. Suggest client consider upgrading with ground fault circuit interrupters (GFCI's) at all receptacles near water sources. Upgrades should be performed by a licensed electrician.

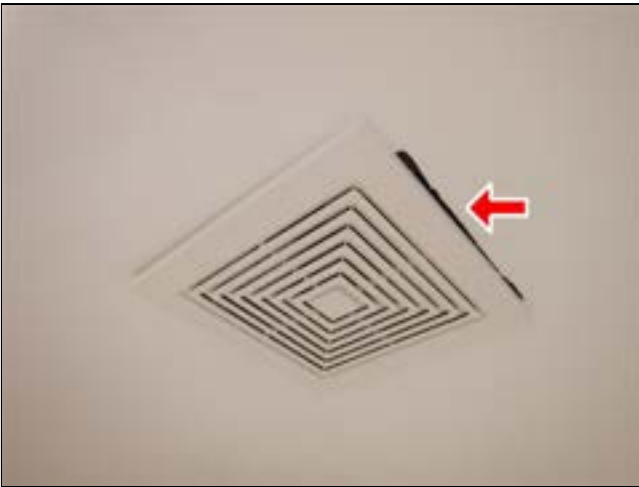
13.6 Item 1(Picture)

Exhaust fan cover is smaller than the opening observed in the laundry room. If this is a concern, recommend review for corrections as needed.

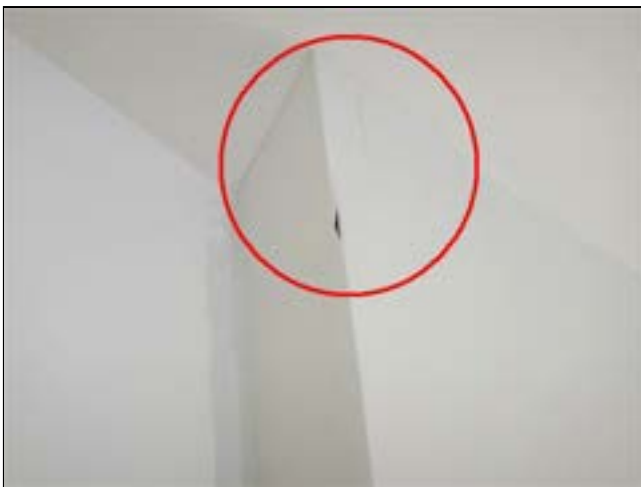
14.1 Item 1(Picture)

Crack and minor damage observed at the corner of the wall to the left of the family room (when facing the projector), near the ceiling. Recommend review by a licensed/qualified contractor for repairs.

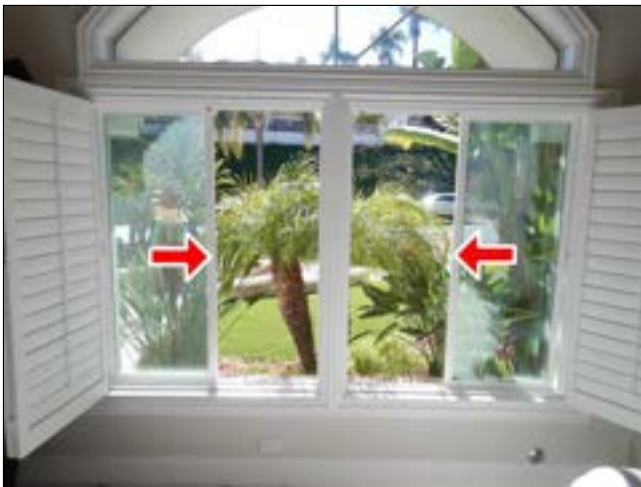
14.5 Item 1(Picture)

Missing screens observed at several windows in the living room. Recommend corrections for proper operation.

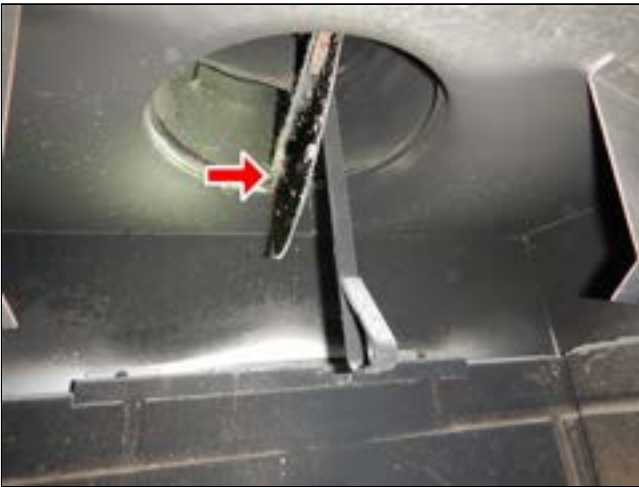
15.8 Item 3(Picture)

(2) Debris/Creosote build-up was observed in the fireplace located in the bedroom #1 (master). Creosote is a naturally produced flammable by-product of combustion. Its presence is a limiting factor on a visual review. We suggest having cleaned and inspected by a fireplace and chimney specialist to assure safe operation prior to close.

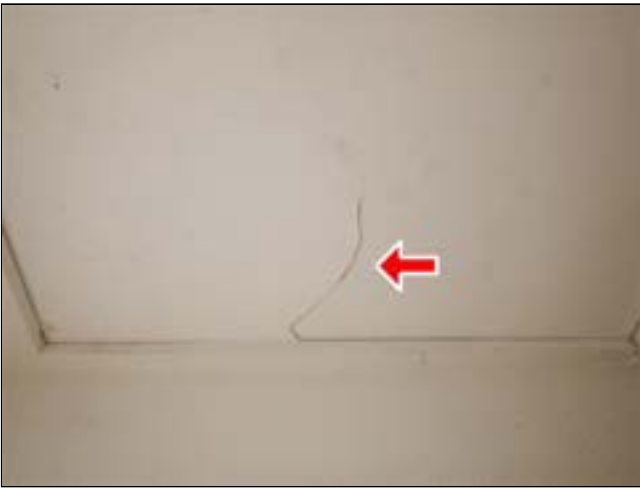
16.0 Item 1(Picture)

The attic access hatch is damaged. Recommend review for repair/replace, as needed.

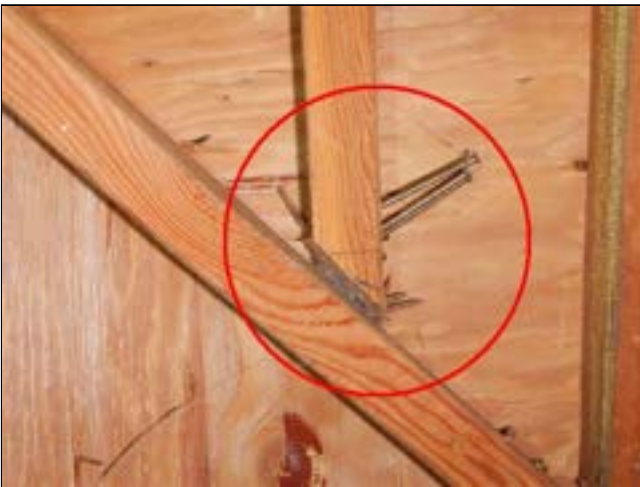
16.1 Item 1(Picture)

(1) One of the rafters in the attic does not appear to be secured properly; the nails don't penetrate all the way through. Recommend review by a licensed/qualified contractor for repairs/corrections.

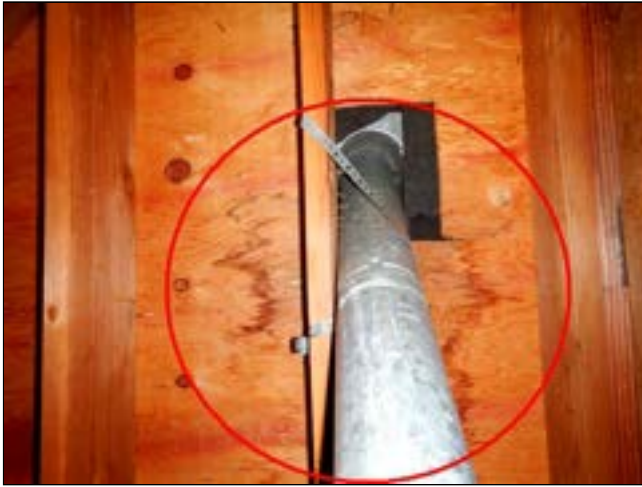
16.2 Item 1(Picture)

Dry stains observed on roof sheathing, noted around the garage furnace vent pipe where it passes through the attic at the roof line. This indicates that moisture may have been present in this area at some point in the past. Unable to determine how old the stains are. Recommend further evaluation by a licensed/qualified contractor for corrections, as necessary.

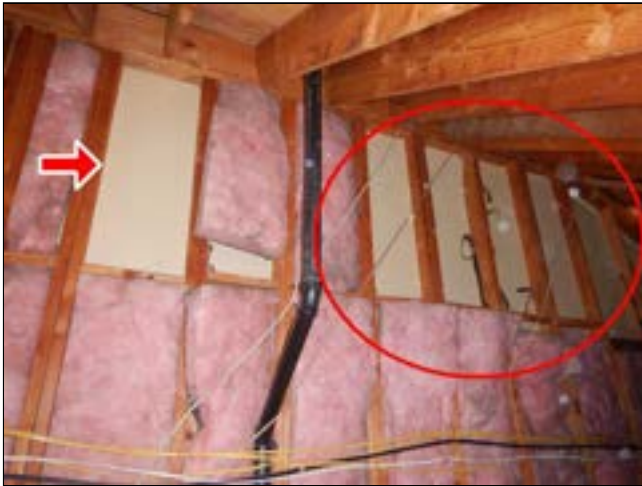
16.3 Item 1(Picture)

Insulation coverage of the attic walls is partial. Recommend adding additional insulation.

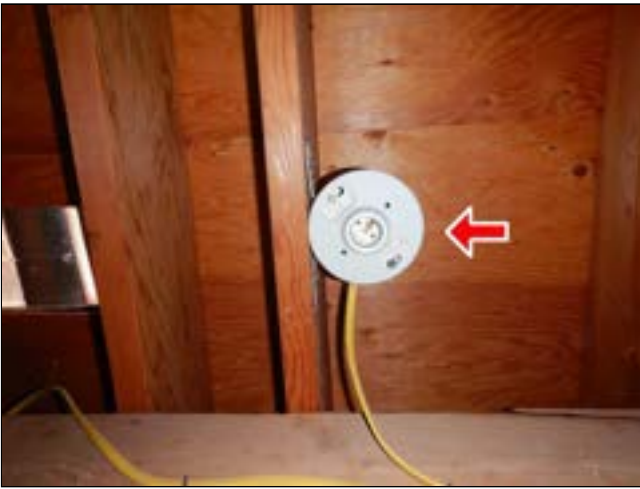
16.5 Item 1(Picture)

The bulb for the attic light is missing. Recommend replacing to ensure safety when entering the attic.

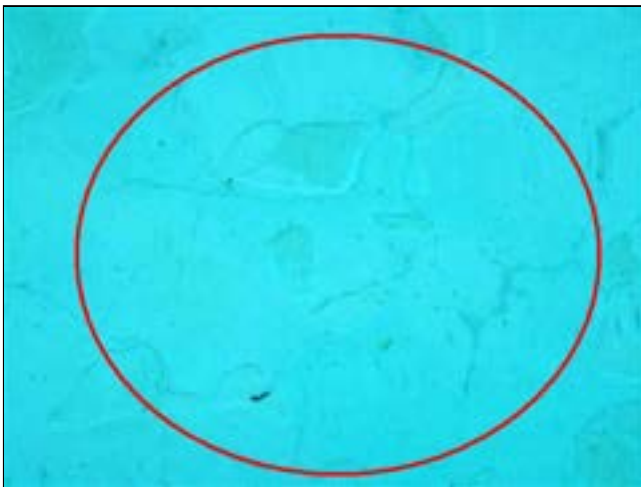
17.0 Item 1(Picture)

(1) Surface deterioration observed at several areas of the pool/spa. Recommend review by a licensed qualified professional for repair or replacement, as necessary.

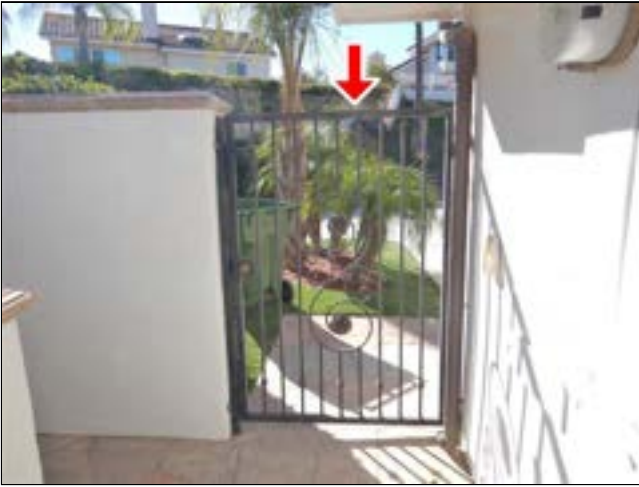
17.5 Item 1(Picture)

(1) The self-closing device or gate hardware needs adjustment or repair to properly close completely and maintain the intended safety enhancement to prevent pool access by small or unattended children.
