AmeriSpec Inspection Service
Temecula Valley
Ph#: (951) 303-1713

SUMMARY ITEMS

Murrieta, Ca.

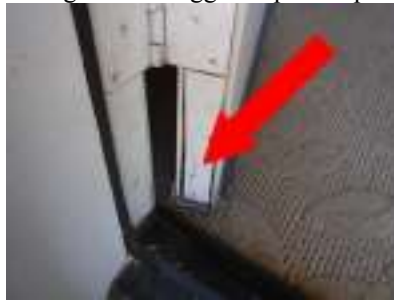
1106. Exterior Door(s) Review. (1) Wood deterioration observed at inside bottom of door off of Living Room. Suggest repairs/replacement as needed.

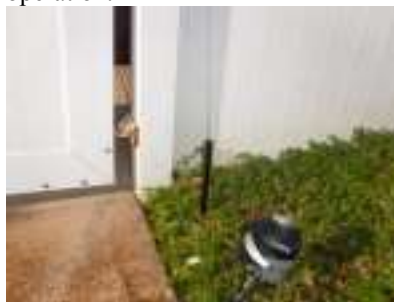
1113. Sprinkler System Review. (1) Broken head noted at front planter, suggest replacing for proper operation.

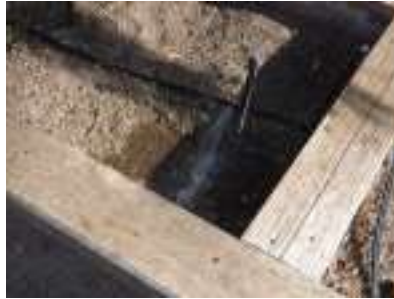
(2) Numerous missing drip heads noted at front and back yard, suggest repair as needed.

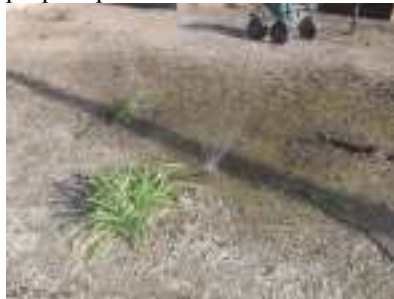
(4) A couple of broken drip lines noted at back yard, suggest replacing for proper operation.

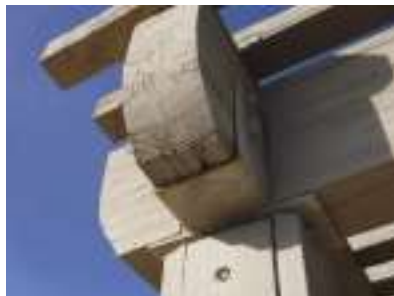
Wood deterioration observed at front cover . Suggest repairs/replacement as needed.

Suggest reviewing latest pest control report for a more detailed evaluation.

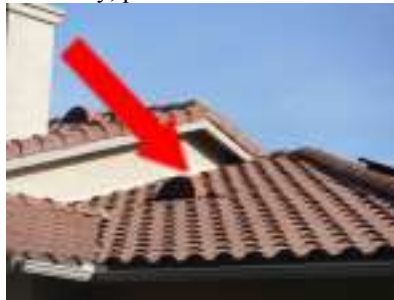
1205. Conditions Review. Loose tiles observed at roof to wall area at left rear side. To prolong the life of the roof repair the few areas where materials are loose should be performed. Recommend review by a roofing contractor for repair, as necessary, prior to close.

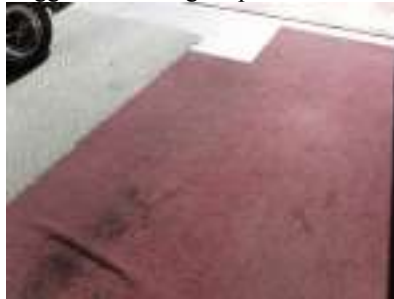
1307. Floor/Slab Suggest removing carpet as this is a fire safety concern.

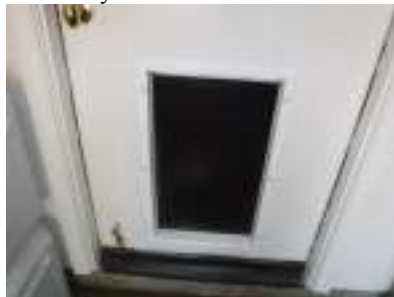
1311. Fire Door Review. Fire rating is compromised due to pet door. Suggest replacing for fire safety.

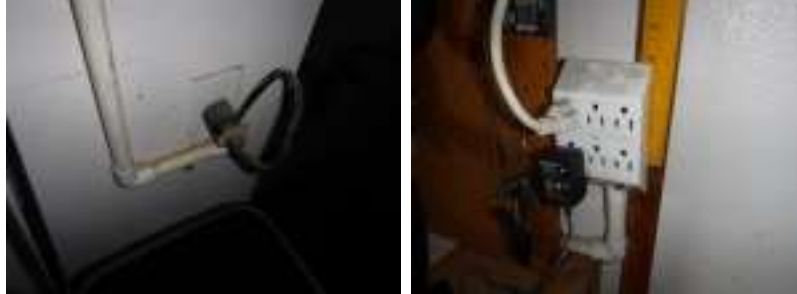
1317. Electrical Review. Extension cord at outlet by workbench improperly used as permanent wiring. Extension cords should not be used for permanent wiring due to fire safety concerns. Client should consider review by a licensed electrician prior to closing for installation of proper electrical wiring and receptacles to ensure safety.

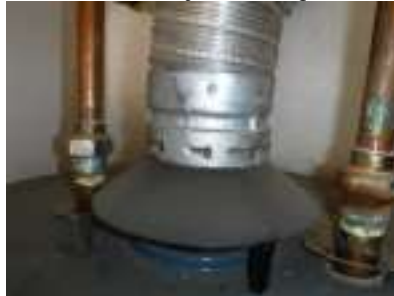
2109. Flue Venting Review. Loose bottom connection observed. Suggest properly securing with 3 screws in each joint as required. This is a safety concern.

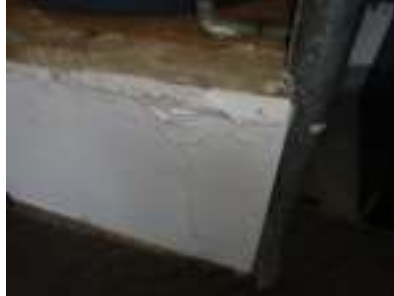
2112. Water Heater Water stains observed on floor/wall around unit. No leaks noted at the time of inspection. Client is advised to consult with sellers for additional information.

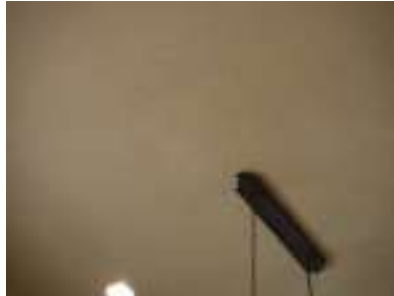
2203. Ceiling Patching observed at ceiling, suggest consult sellers for additional information.

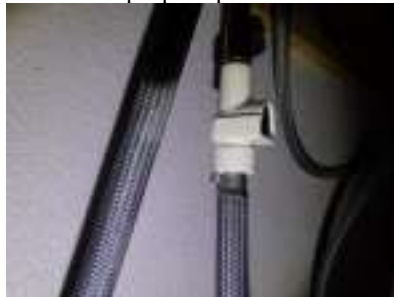
2212. Faucets Review. Sprayer line is leaking at connection below faucet. Corrections are needed for proper operation.

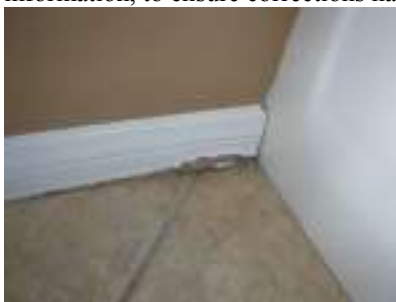
- 2302.3. Walls Evidence of past water penetration observed in the bottom of front side wall between tub and toilet. Client is advised to consult with sellers for additional information, to ensure corrections have been made.

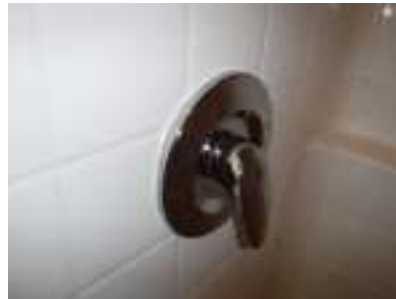
- 2317.4. Shower Faucet Faucet trim is not flush to the wall; which may result in water penetration to the interior structure and deterioration of the wall; corrections are needed to prevent wall damage.

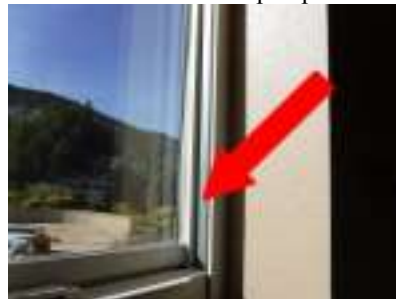
- 2306.6. Windows Review. Broken/loose sash rail observed at window frame on left side wall. Rail holds window in open position.

Suggest repairs/replacement as needed to ensure proper operation.

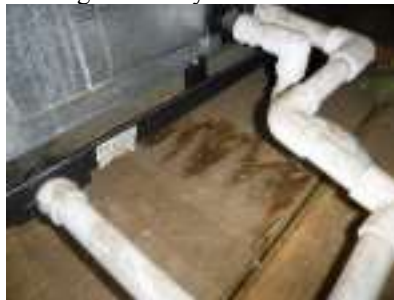
2704. Evidence of Leaking Stains observed on HVAC platform. No moisture present at time of inspection. Client is advised to consult seller to determine the source of staining and verify that corrections have been made.

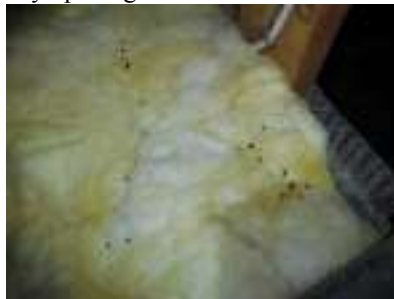
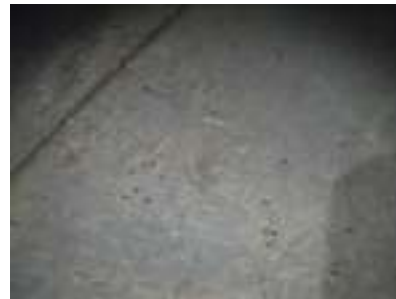
2712. Attic Comments Some rodent droppings noted. Recommend review by a specialist for sealing any openings to attic as needed.

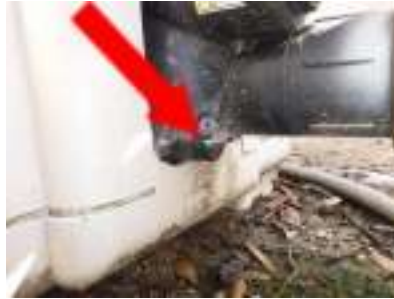
2860. Filter System Review. Leak at heater drain plug noted, suggest repairs as needed. In this filter, the water passes through a series of fabric-covered grids that are coated with DE. Filter was not accessed for inspection. Periodic backwashing is required for proper operation.
