## AmeriSpec Inspection Services

Doc #:	SAMPLE	Inspector:	Certified Inspector
Date:	1/2/2023		
Address:	123 S Main St Any City CA		
Client Name:	Mr. & Mrs. Buyer

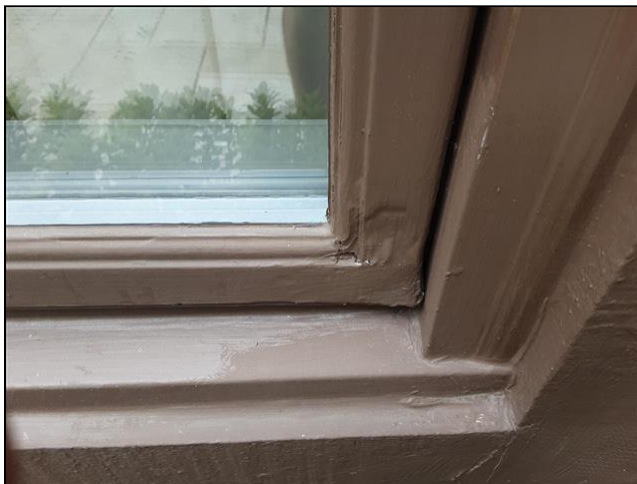
1.4 Trim **Condition: Deteriorated wood noted.**

1.5 Window Frames **Condition: Deteriorated wood noted.**

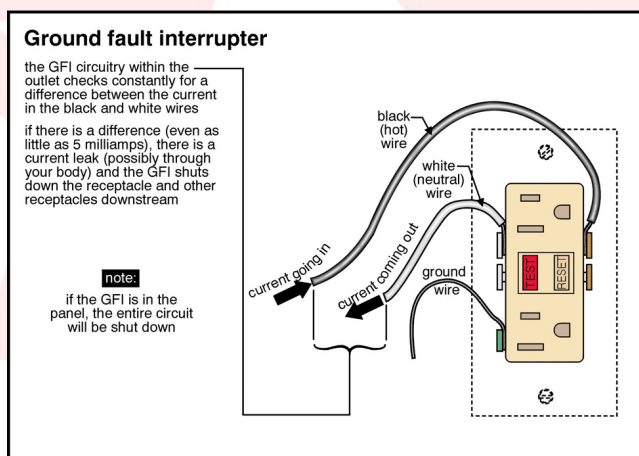
GFCI

1.6 Electrical **Serviceable. Ground fault circuit interrupters are provided for safety. We suggest periodic testing to ensure proper working order.**

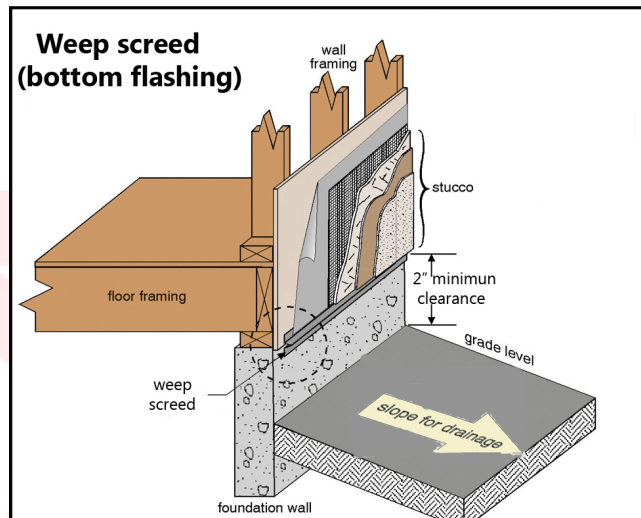
**WEEP SCREED**

**Home is built on a flat lot with a slope in the rear. Geological evaluations are beyond the scope of this report. We recommend consulting with a geotechnical engineer if concerned by conditions listed in this report or which you have observed. Grade at the foundation appears to be inadequate; Soil is above the weep screed (bottom flashing).**

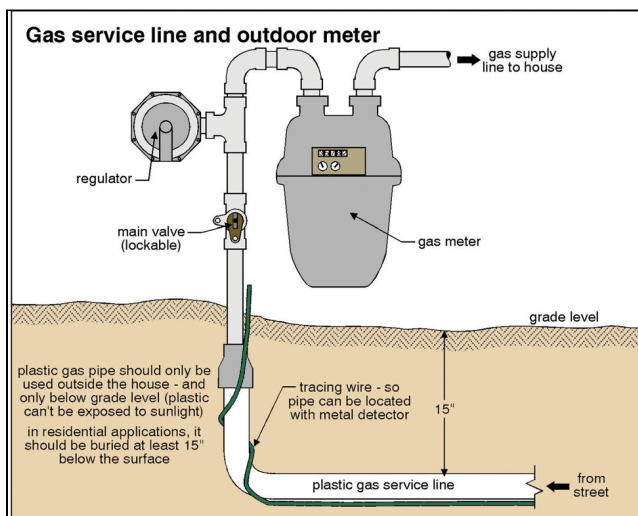
**TRACER WIRE**

**Condition: Rusted gas lines noted.**

**Gas meter is located on the left side.**

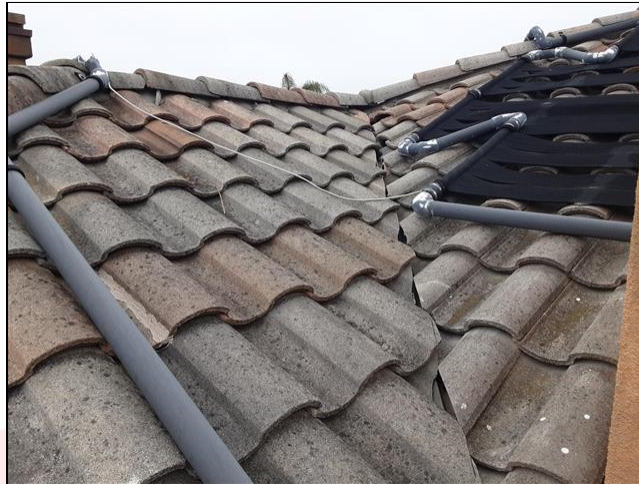
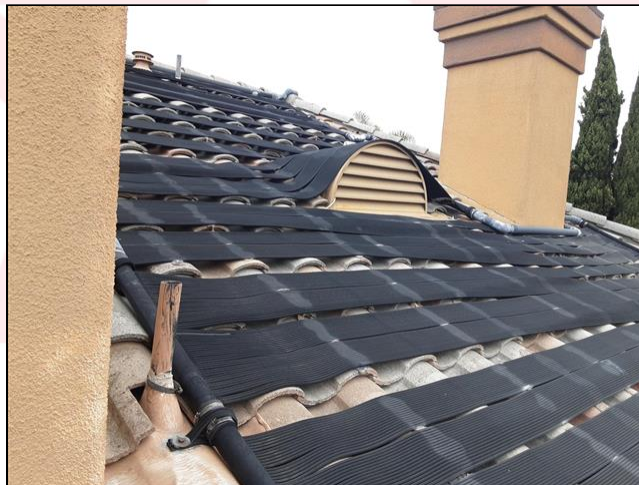
**Roof shows normal wear for its age and type; appears to be in serviceable condition. Roof was visually inspected from accessible points on the interior and/or exterior. If a roof is too high, is too steep, is wet, is part of an association or is composed of materials which can be damaged if walked upon, the roof is not mounted by inspector. Therefore, client is advised that this is a limited review and a licensed roofer should be contacted if a more detailed report is desired.**

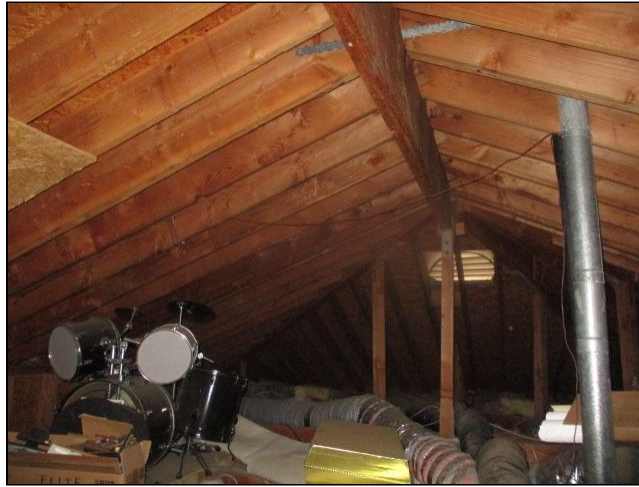
**Located in the master bedroom closet.****Limited inspection of the attic due to personal belongings.**

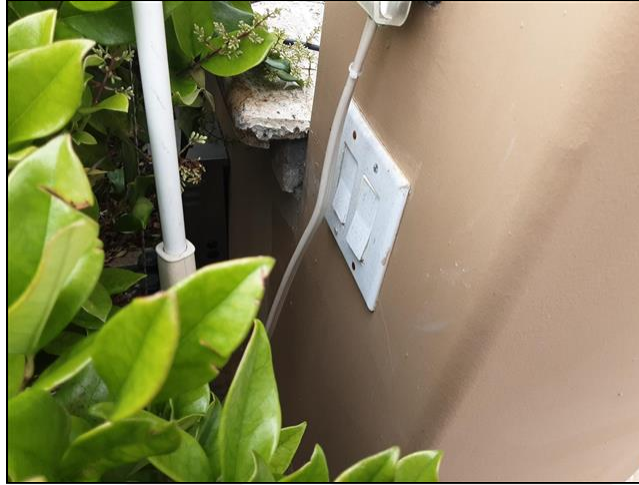
4.2 Electrical **Condition: Waterproof cover is not present at the switch, suggest replacing for safety.**

**Unable to test one outlet, weather cover is painted over.**

**Ground fault circuit interrupter is provided for safety. We suggest periodic testing to ensure proper working order.**

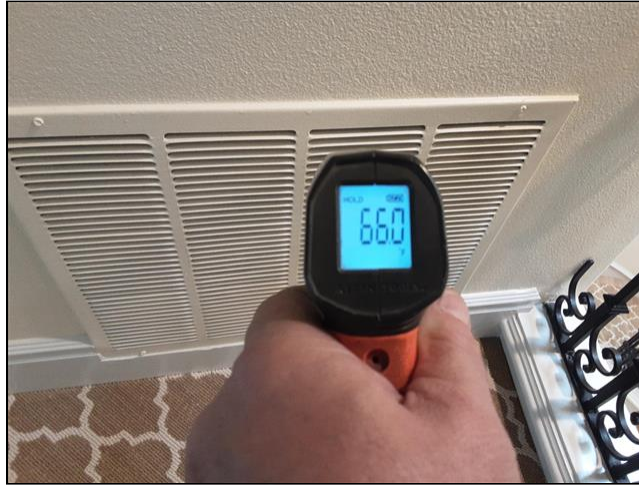
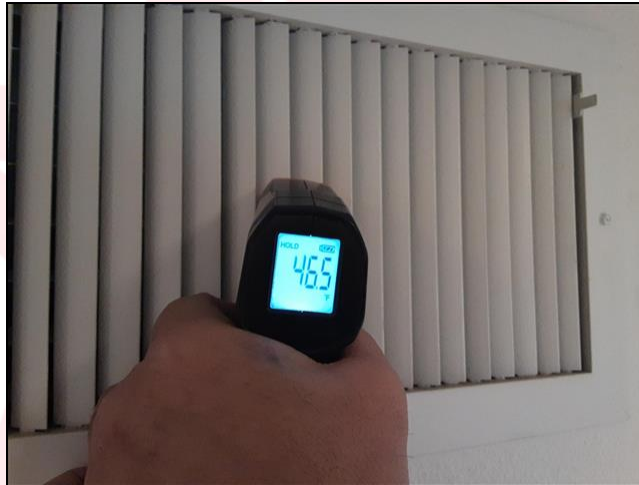
**Condition:.** Two compressors are located on the right side. Rust and deterioration noted on the compressor housing.

66 ° noted at the intake; 46 ° noted at the register, units are cooling within guidelines.

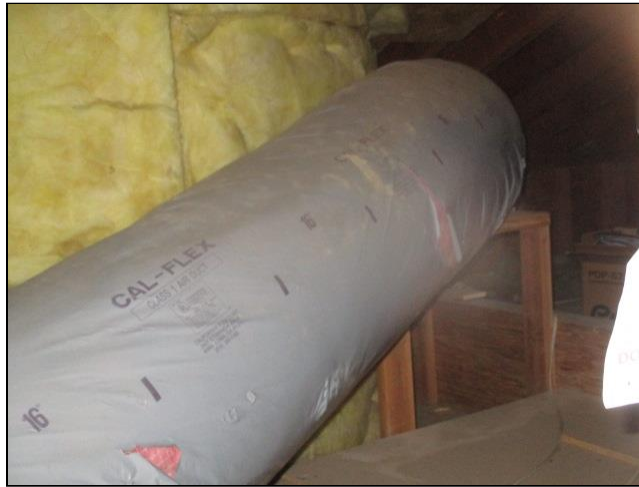
**Condition: Deteriorated plastic wrap noted.**

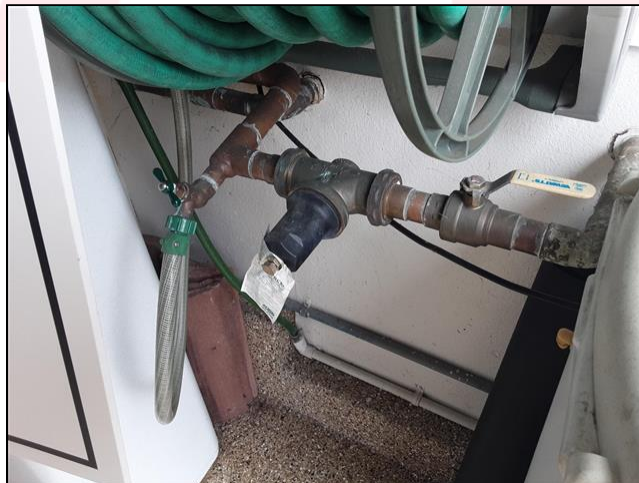
Step #	Component	Comment
8.0	Main Shut-off	<b>Main shut-off is located in the garage.</b>  <b>The main water shut-off was not tested. These can fail at any time due to non-use and corrosion.</b>

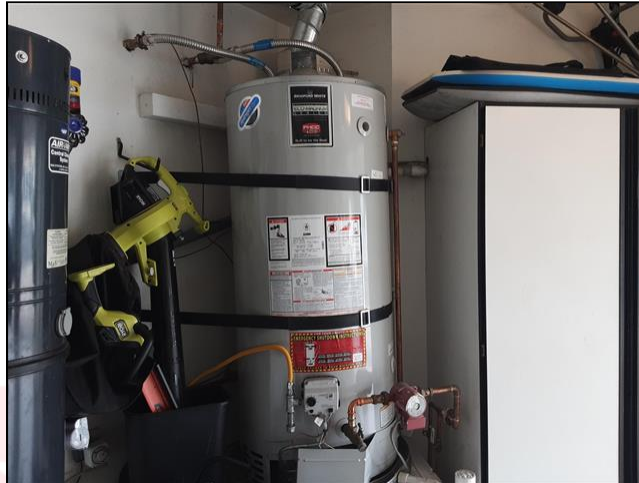
Step #	Component	Comment
9.0	Temperature Relief Valve	<b>Temperature pressure relief valve is installed as a safety measure.</b>
9.1	Condition	<b>Operable.</b>

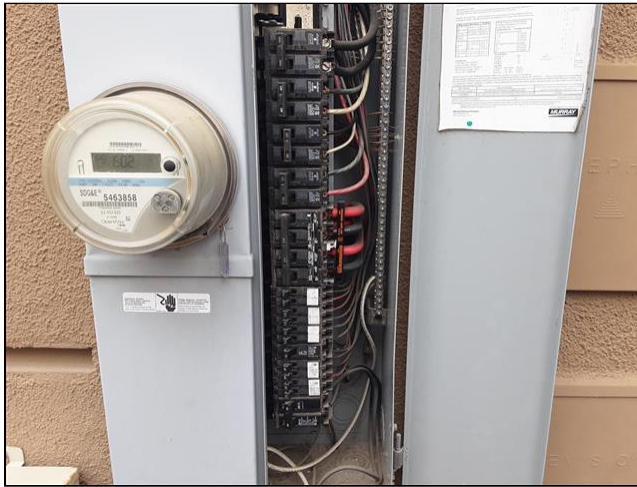
**Main panel is located on the left side.**

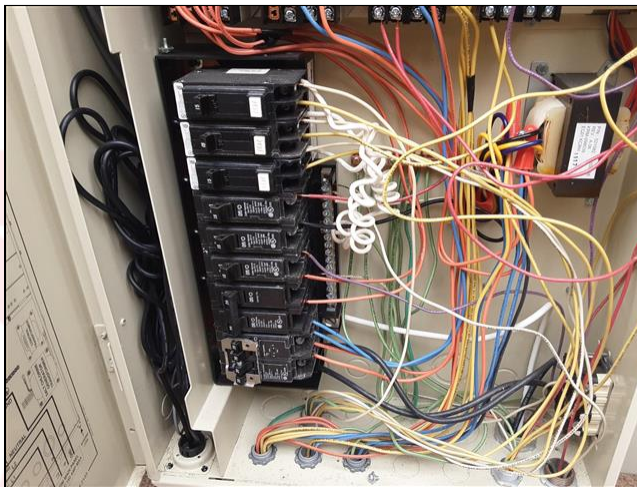
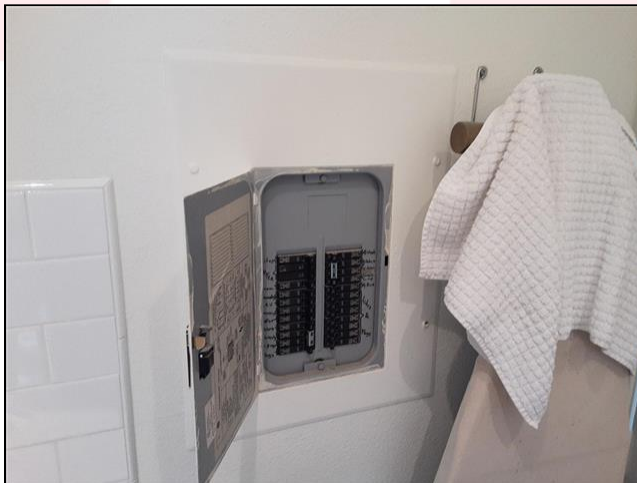
**Condition: Sub panel is located at the pool equipment and laundry room. Unable to access behind the sub panel cover, painted over.**

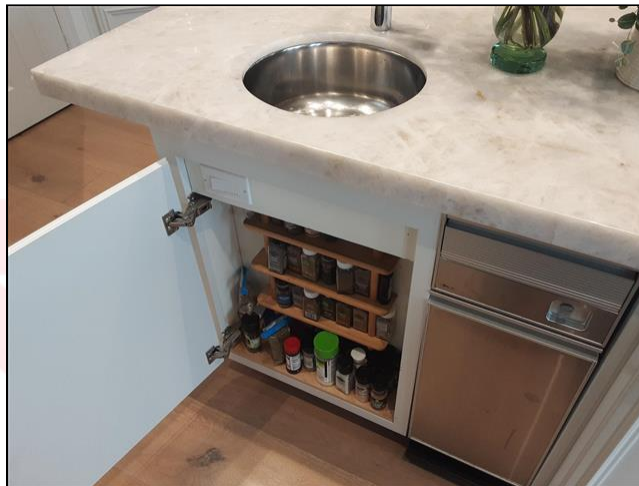
- 14.7 Countertops S.
- 14.8 Electrical **Condition:.** Some outlets are not GFCI protected, noted as a possible safety hazard, suggest further review with a licensed electrician.
- Ground fault circuit interrupter is provided for safety. We suggest periodic testing to ensure proper working order.**
- 14.9 Sinks **Serviceable. Two sinks noted.**
- Stainless steel.**
- 14.10 Faucets S.
- 14.11 Traps/Drains/Supply **Condition:.** Unable to inspect under island sink, no access to drain lines.

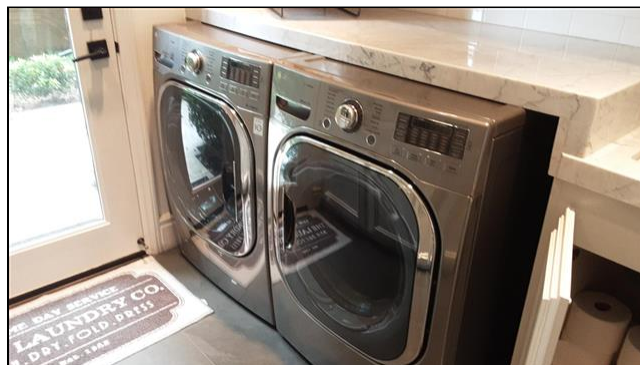
**Unable to fully inspect, blocked by machines.**

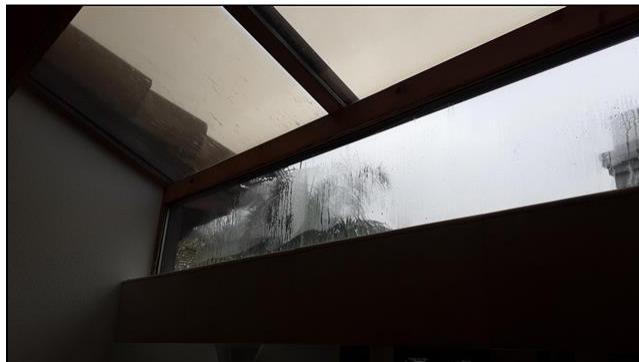
**Condensation was noted in the double insulated thermal windows, which will reduce visibility and the insulation capability of the window. To restore visibility and regain the insulating capability, replacement of the window may be required. Suggest further review with a window contractor.**

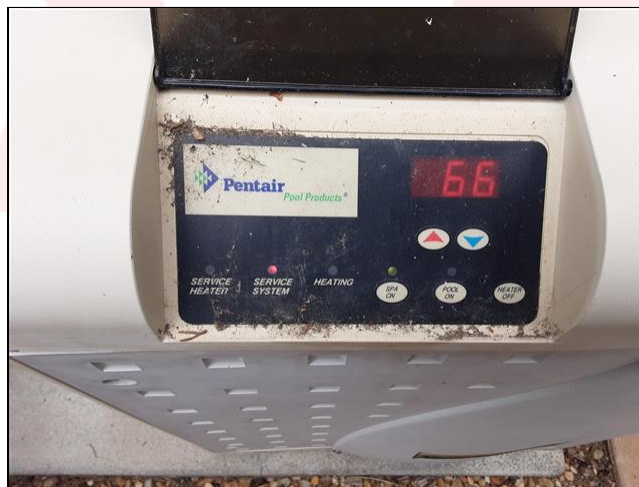
**Service indicator light is on, suggest further review with a pool/spa specialist.**

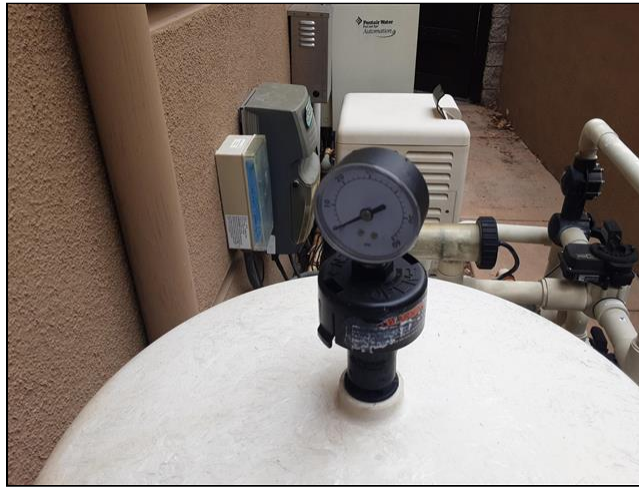
25.10 Pressure Gauge **Condition:. Inoperable.**

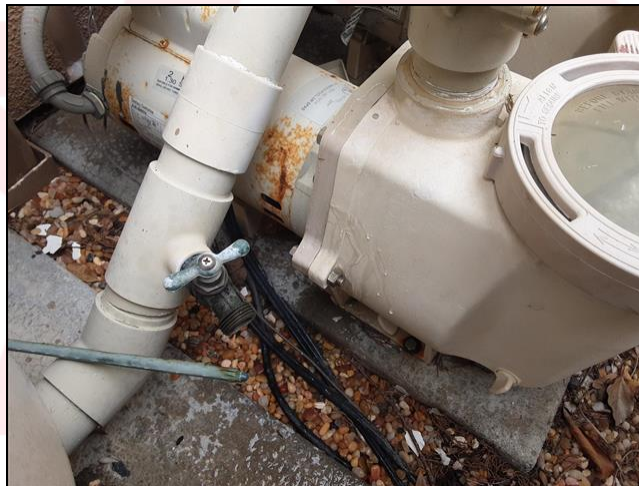
25.12 Pumps/Motors **Condition:. Leak noted, suggest further review with a specialist.**

**Rust noted at the housing.**
