Home Inspection Report for: John & Jane Smith

Property Address: 12345 Anywhere Street, Bend, OR

Date of Inspection: 10/10/2017

Inspected By: Clare Langford, OCHI #1965. CCB #213891

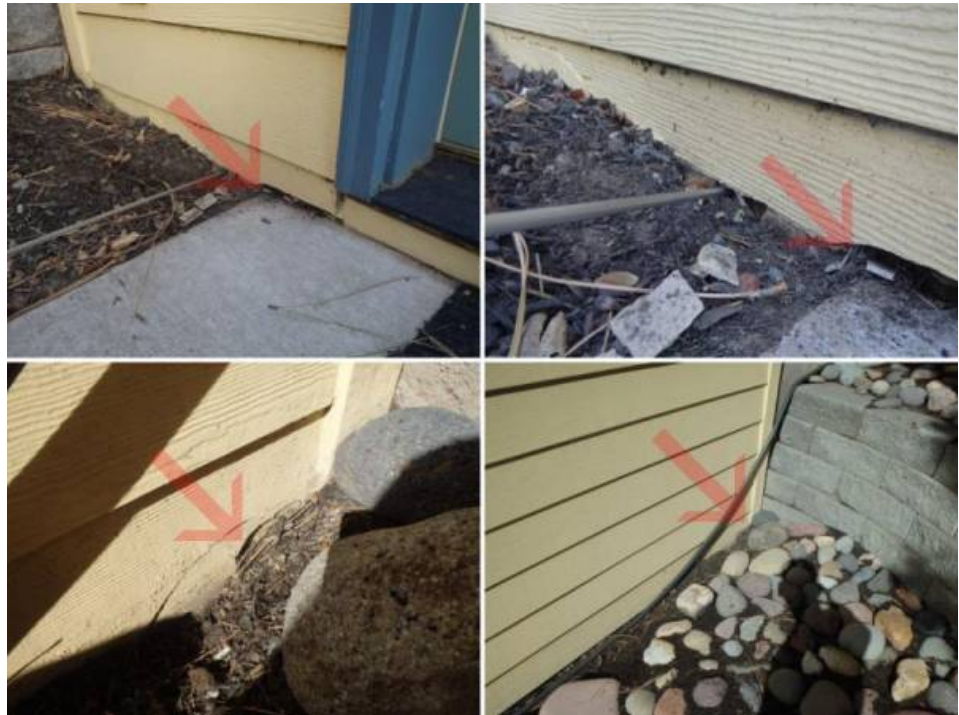
Some damaged material was noted that may have to be replaced. The most significant damage appeared to be located by the air conditioner unit and the entry to the downstairs office. We recommend further evaluation and appropriate corrections by a qualified licensed professional to prevent further damage or deterioration.

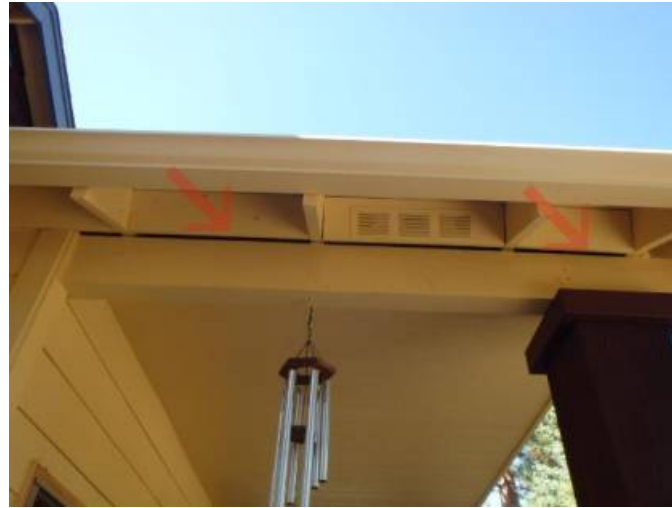
Trim

A gap was noted at the top of the siding at the entry roof which can allow insects access into the attic. We recommend that this gap be covered with trim. Appropriate corrective action recommended to address this condition.

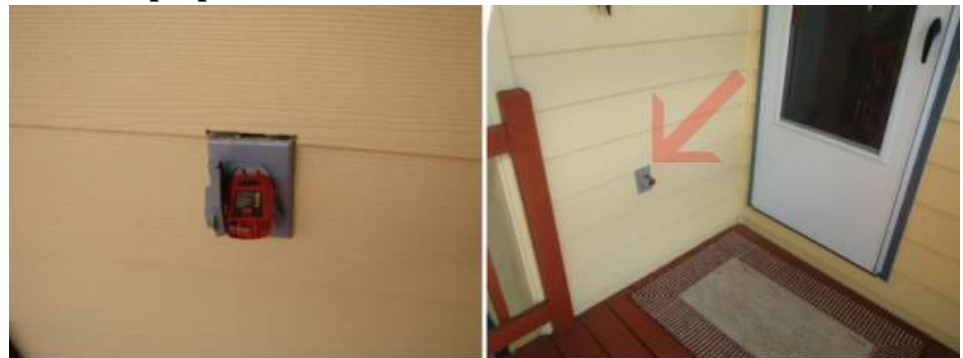
Notable Condition
Inoperable and loose receptacles noted at the back upper patio. This needs to be properly secured for safety. We recommend further evaluation and appropriate corrections by a qualified licensed electrician to restore proper function.

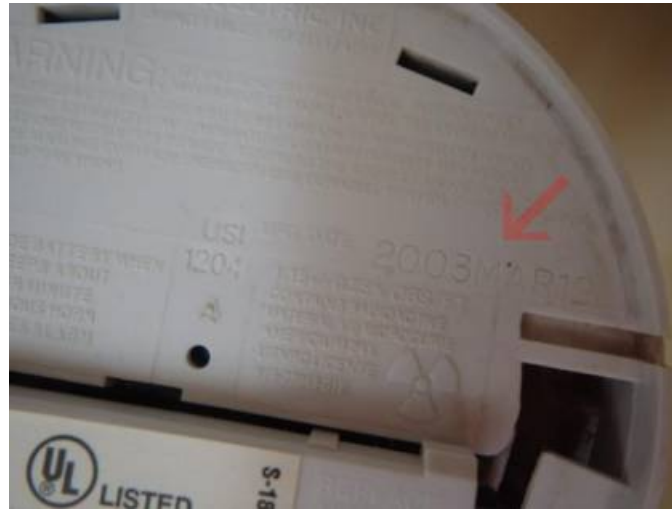
A carbon monoxide alarm was not observed downstairs. Correction recommended for occupant safety. Must be present at any level of the home with bedrooms and within 15' of any bedroom door. An alternate location option is to place them inside every bedroom. Location choice should be made logically, depending on possible sources of carbon monoxide.

Smoke alarms appear to be original equipment . Oregon fire code stipulates that smoke alarms should not remain in service longer than 10 years from their date of manufacture. The smoke alarms here appear to have exceeded the ten year limit, and should therefore be replaced.

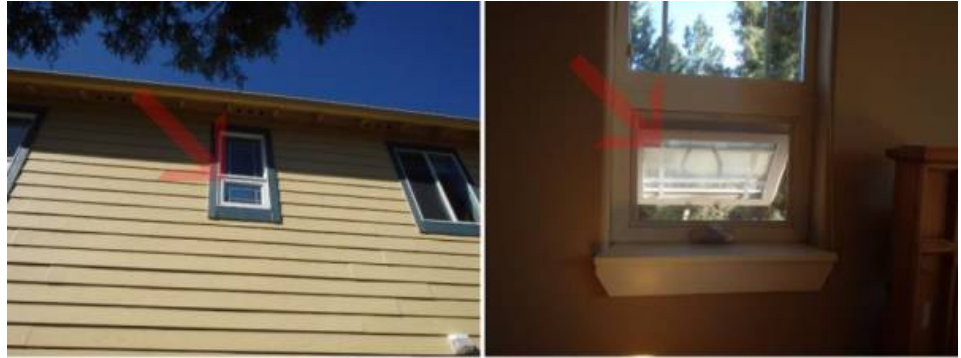
Evidence of condensation was noted in the dual glazed insulated window pane in the master bedroom. This indicates a broken seal; restoration of clarity and full thermal performance would require replacement of the affected panes. This has little significance in an obscure window such as this one.

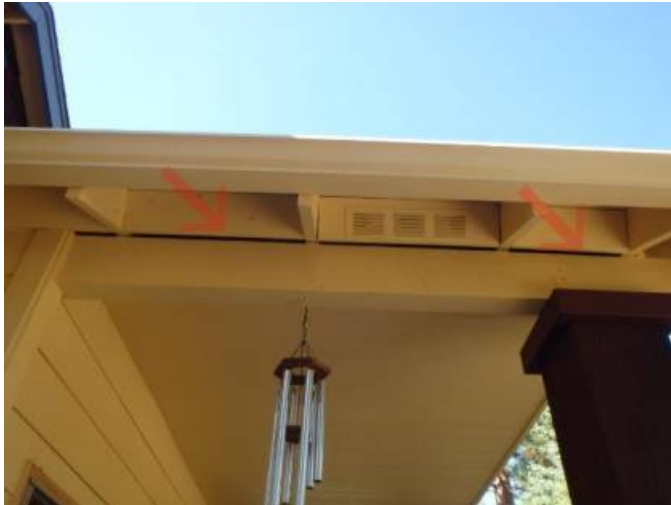
Trim

A gap was noted at the top of the siding at the entry roof which can allow insects access into the attic. We recommend that this gap be covered with trim. Appropriate corrective action recommended to address this condition.

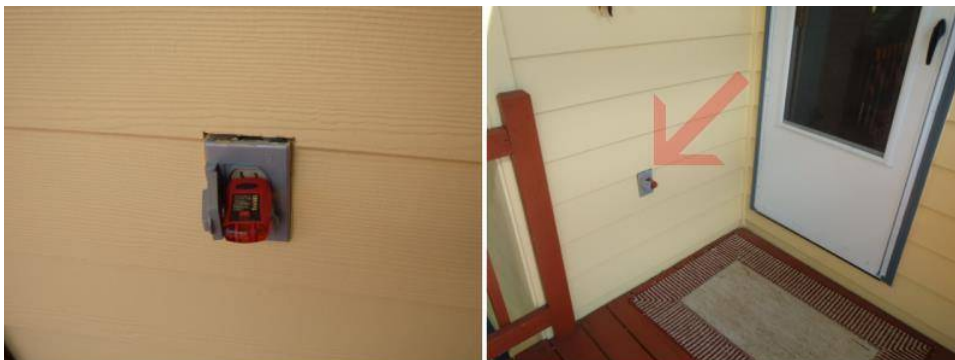
Electrical

Inoperable and loose receptacles noted at the back upper patio. This needs to be properly secured for safety. We recommend further evaluation and appropriate corrections by a qualified licensed electrician to restore proper function.

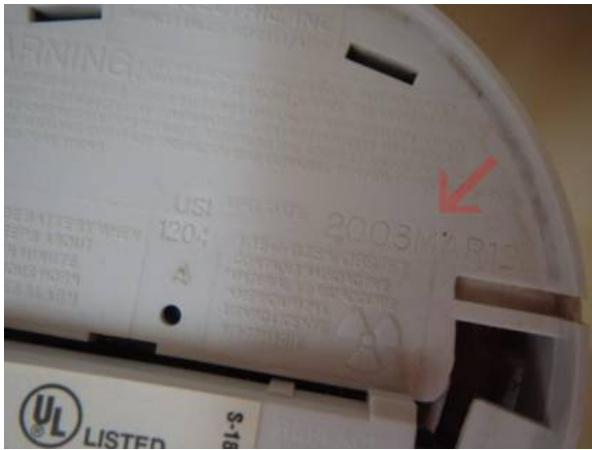
Smoke & CO Alarms

A carbon monoxide alarm was not observed downstairs. Correction recommended for occupant safety. Must be present at any level of the home with bedrooms and within 15' of any bedroom door. An alternate location option is to place them inside every bedroom. Location choice should be made logically, depending on possible sources of carbon monoxide.

Smoke alarms appear to be original equipment . Oregon fire code stipulates that smoke alarms should not remain in service longer than 10 years from their date of manufacture. The smoke alarms here appear to have exceeded the ten year limit, and should therefore be replaced.

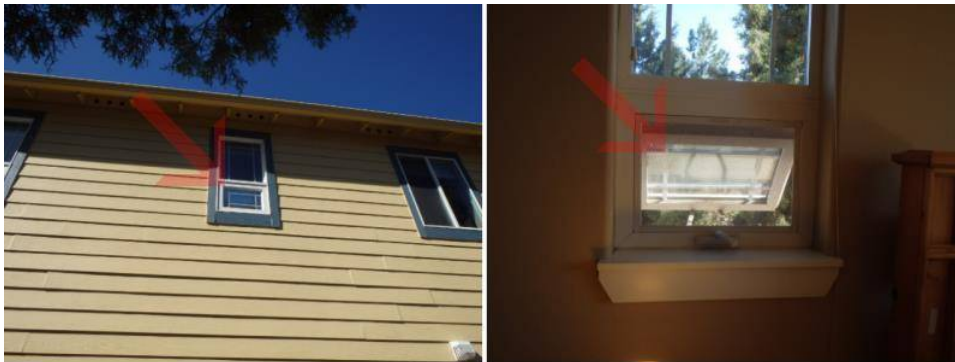
Windows/Screens

Evidence of condensation was noted in the dual glazed insulated window pane in the master bedroom. This indicates a broken seal; restoration of clarity and full thermal performance would require replacement of the affected panes. This has little significance in an obscure window such as this one.

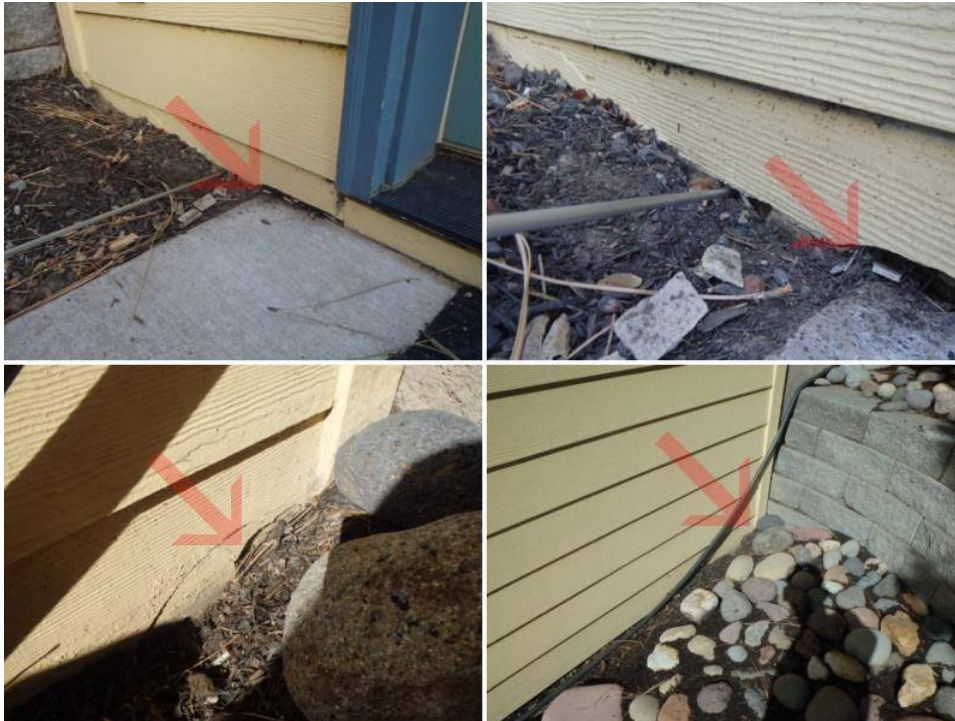
Some damaged material was noted that may have to be replaced. The most significant damage appeared to be located by the air conditioner unit and the entry to the downstairs office. We recommend further evaluation and appropriate corrections by a qualified licensed professional to prevent further damage or deterioration.
