AmeriSpec Inspection Services

Doc #:	M041119	Inspector:	Scott Raymond
Date:	4/11/2019		
Dwelling Address:	XXXXXXXXXXXX Mukwonago WI 53149		
Client Name:	XXXXX XXXXX		
Client's Agent:		Real Estate Company:

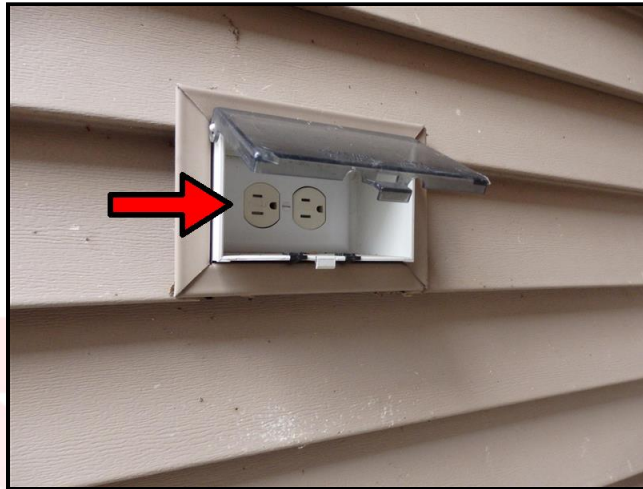
Review. GFCI located at front porch did not respond to test; this outlet appears to be on the garage circuit. Suggest review by licensed electrician for repairs/replacement as needed for safety.

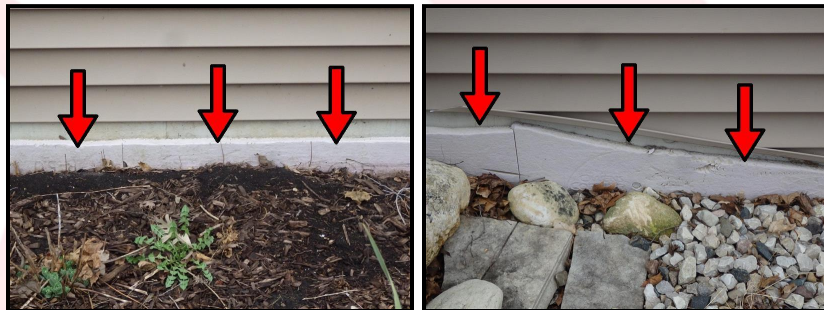
- 2.13 (1) Foundation Continued Deficient. The styrofoam sheathing on the foundation is settling at various areas around the home; this is not uncommon with styrofoam sheathing on a foundation. Recommend repairs for energy efficiency.

- 2.13 (2) Foundation Continued Deficient. **Industry standards at the time when this home was built did not allow any unprotected styrofoam insulation to be exposed to the light on the exterior of the home. There should be a coating/ plastic covering over any exposed sheathing at the top of the foundation to protect the styrofoam from deterioration caused by light. Recommend covering the exposed styrofoam before the material completely deteriorates.**

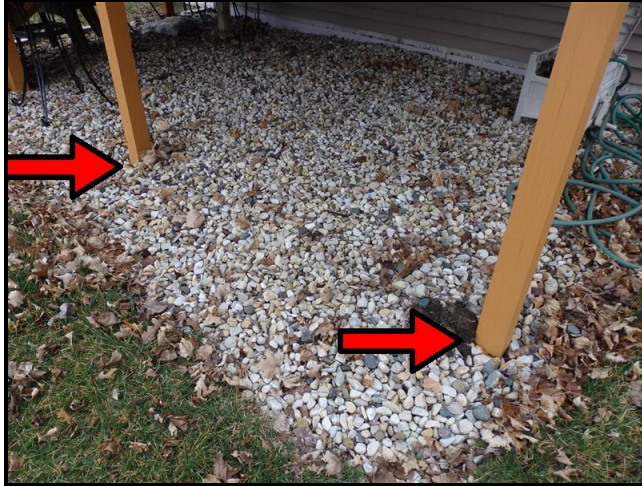
2.14 Deck

Comment. Limited inspection of the supports for the deck; today's industry standards require that any structure that is attached to the home have 4' deep frost pilings (foundation) to properly support the structure. The 4x4 supports are covered with earth and the support for the deck is not visible. Recommend that client consult the seller to confirm how the deck is supported, or consult the municipal building inspector to confirm that a permit was pulled for the deck.

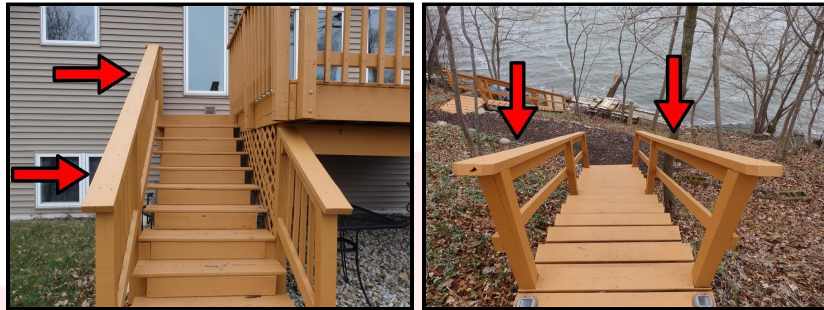
2.16 Stairs / Steps

+ **Review. Missing handrail(s) on the rear deck stairway and steps down to the lake. This is a "Safety Concern". Proper handrails were required when this stairway was built, we recommend installing handrails as was required. All stairways/steps with 4 or more rises are required by industry standards to have a handrail. Flat boards do not qualify as a handrail (a hand must be able to fit around the board). Industry standards at the time when this home was built required: Handrails with a rectangular cross sectional gripping surface shall have a maximum perimeter of 6 1/4" with a maximum cross sectional dimension of 2 7/8"; the top of these guardrails have 2x6's installed, which have a perimeter of 14" and a cross section of 5 1/2". Recommend review by a qualified carpenter for the installation of a handrail, as was required.**

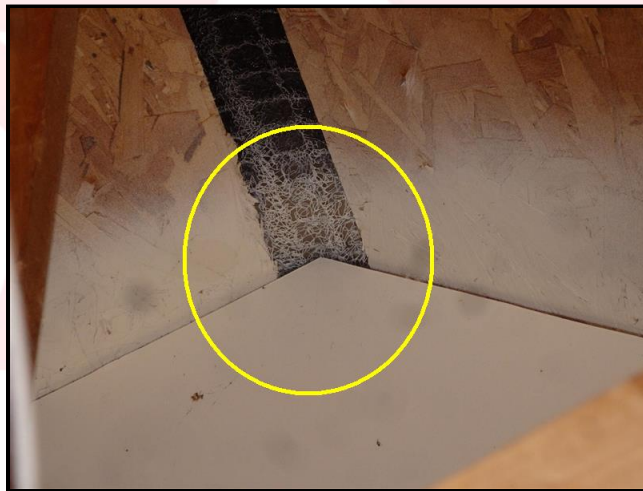
Review. Fire rating is compromised due to the ridge vent carrying through from the home to the garage. This is a safety concern. Industry standards allow no more than a 1/20" gap anywhere in a fire wall/ceiling. This ridge vent area should be filled (blocked off) as required. Recommend review by qualified professional drywaller for repairs as necessary.

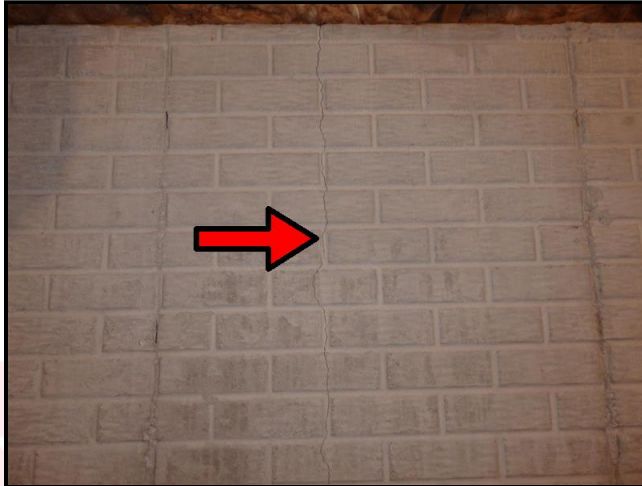
- 5.1 Basement Stairway Serviceable.
- 5.2 Floor Serviceable.
- 5.3 (1) Walls Review. Common cracks observed, primarily a cosmetic concern. We suggest monitoring all cracks in concrete surfaces for further movement, and sealing (never with caulking) to prevent water penetration as a routine maintenance effort. All poured concrete foundations have some cracks; industry standards allow for cracks provided they are no more than 1/8" separated or 1/8" deviated. All the cracks in this basement appear to be within industry standards. If client has concerns about these cracks I would recommend review by a poured wall professional.

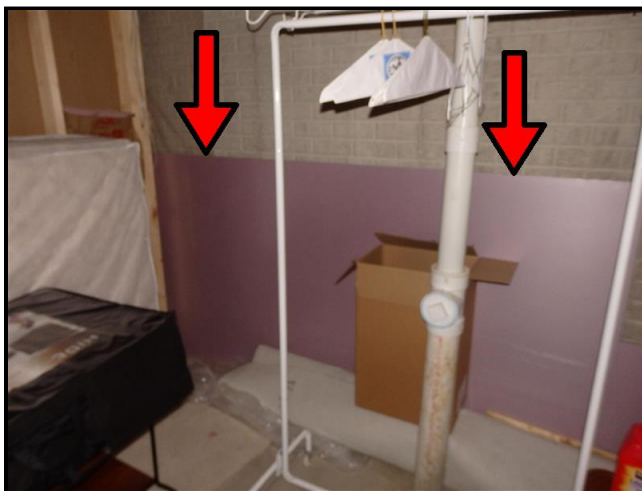
- 5.3 (2) Walls

Review. The exposed Styrofoam sheathing on the walls in the basement does not meet industry standards which require that all foam plastics MUST be covered with a 15 minute thermal barrier. Gypsum board, 1/2" thick is a common covering. The reason for this is that in the event of a fire foam board gives off toxic gases. Recommend covering the Styrofoam sheathing with a 15 minute thermal barrier, or removal, as required.

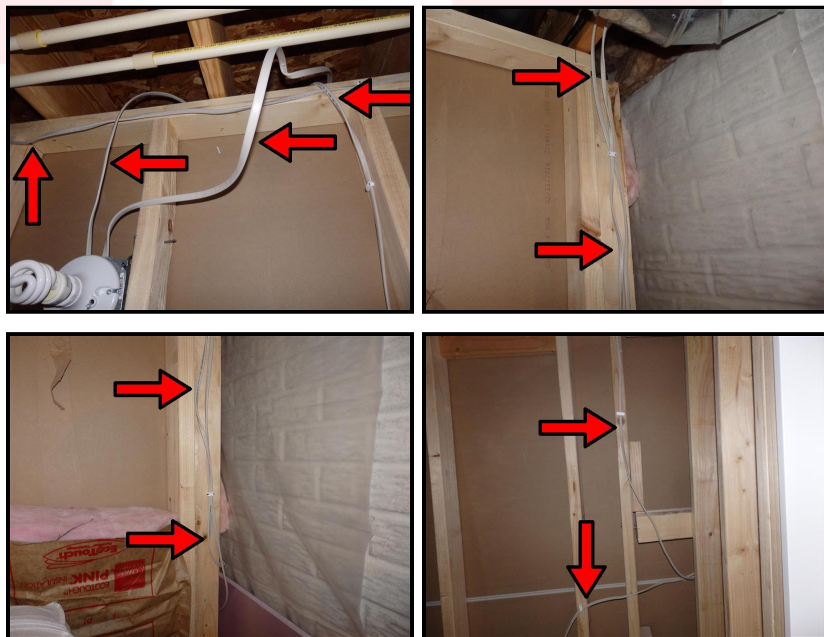
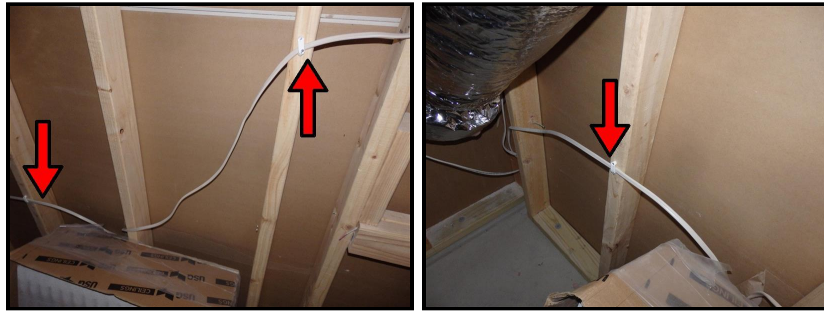
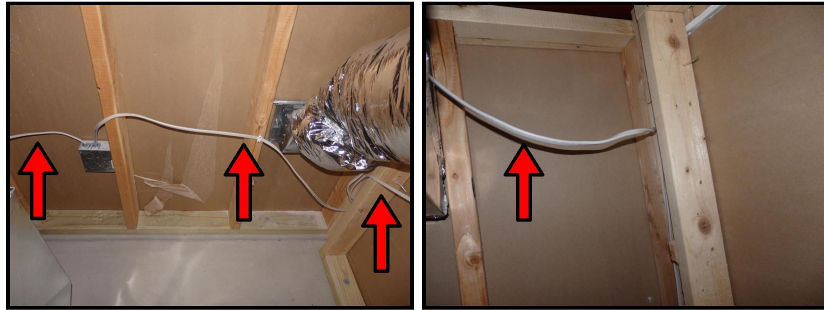
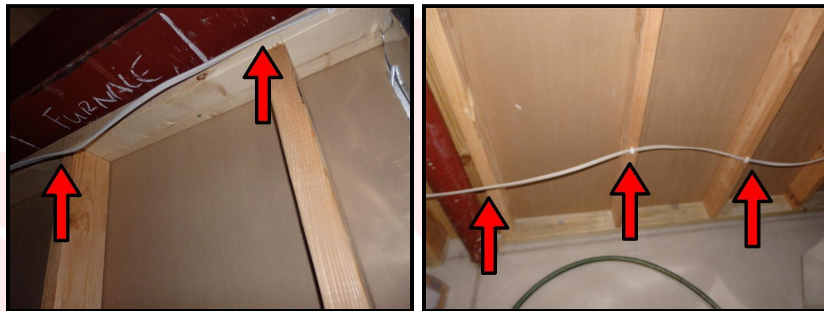
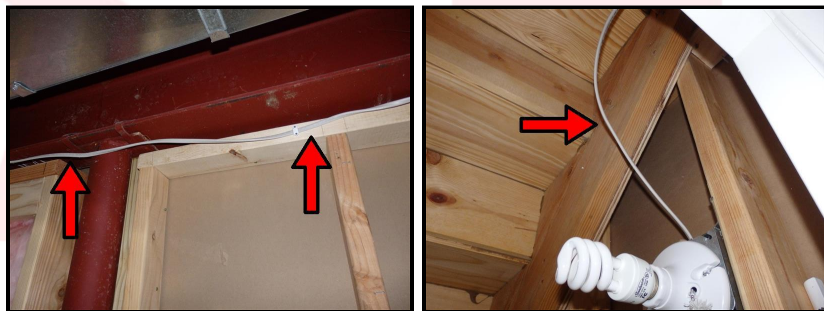
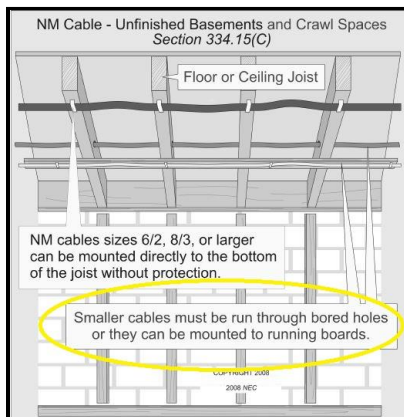
Review. Exposed/unprotected electrical wires (Romex/NM) observed at several locations in the unfinished basement. This is a safety concern because the wires could be subject to physical damage. The industry standard for Romex/NM wires is they are not allowed to be visible in a finished area, and in an unfinished area they are not allowed outside of framing unless they are covered/protected. These/this electrical wires were required to be protected at the time this wiring was performed. All romex wiring that drops below the sides of the joist spaces and/or is not inside a framed wall is required to be run through conduit or protected (Romex "NM" should not be run through conduit for long runs; long runs should use an alternative method of protection, or be separated and run on running boards), and is considered exposed/unprotected if it is not (Romex wire cannot exit the inside of a framed area unless mounted on Running Boards). On basement walls (outside of framing, if present) industry standards require: "NM cable installed on the wall shall be permitted to be installed in a listed conduit or tubing" (must be in conduit). Recommend review by a licensed electrician for removal/relocation or encasing in conduit for safety.

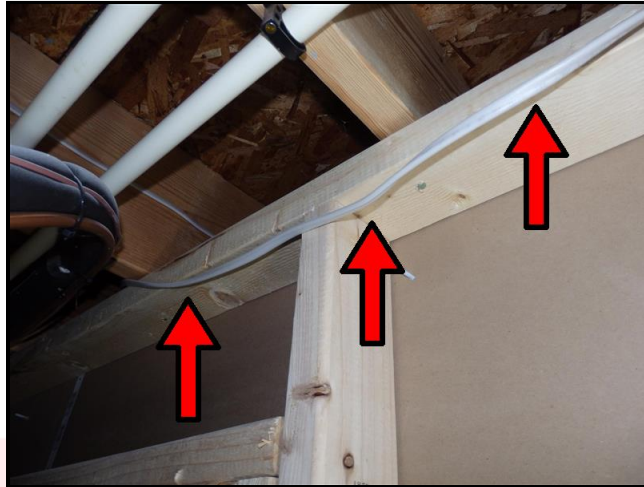
5.10 (2) Electrical Continued

Review. Improperly secured romex wiring (several) observed in the unfinished areas of the basement (wiring added for the finished areas of the basement). It appears that a lot of the wiring between the foundation and the finished walls is also not properly secured. It was required when this wiring was installed to secure the wiring with fasteners at least every 4 1/2' (and within 12" of each electrical box), and where necessary to keep the wiring taunt. Hanging wiring observed. Recommend review by licensed electrician for repairs/ corrections as necessary.

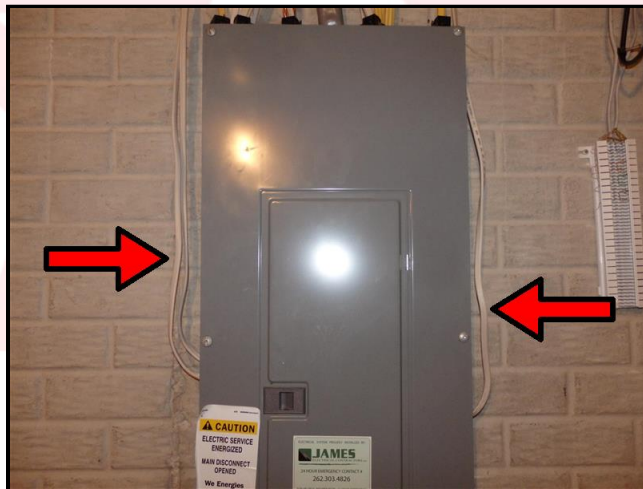
Review. Exposed electrical wires observed at the right side and left side of the main service box. This is a safety concern because the wires could be subject to physical damage. Exposed electrical wires are required to be encased in a conduit (or otherwise protected) to prevent damage. All romex wiring that drops below the joist spaces and is not INSIDE a framed wall is required to be run through conduit. The only exception to this is any wiring exiting the main service box at the top of the box and running straight up into the joist space, where protection is not required; any wiring exiting the main service box at the sides, bottom or top (not running straight up) must be encased in conduit. Recommend review by licensed electrician for removal or encasing in conduit for safety.

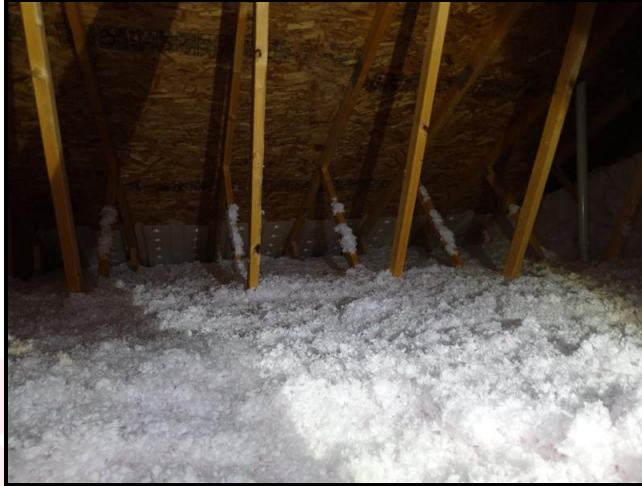
- 18.2 Framing Serviceable. Wood truss construction noted. Trusses are often used to provide additional headroom and wider spans than is common with wood rafter/joist systems. This is a specialized system which is intended for site-specific engineering. The integrity of a truss system depends on the builder following a truss engineer's instructions, which we do not have. Verifying appropriate installation is beyond the scope of this inspection. Trusses should not be cut or notched as this will damage their structural integrity.
- 18.3 Sheathing Serviceable.
- 18.4 Insulation Serviceable. 14"+ of insulation present.
