AmeriSpec Inspection Services

Doc #:	202201-00001	Inspector:	Justin Spinks
Date:	1/13/2022		
Dwelling Address:	898 SampleTrail SW Loganville GA 30052		
Client Name:	Bob Sample		
Client's Agent:		Real Estate Company:

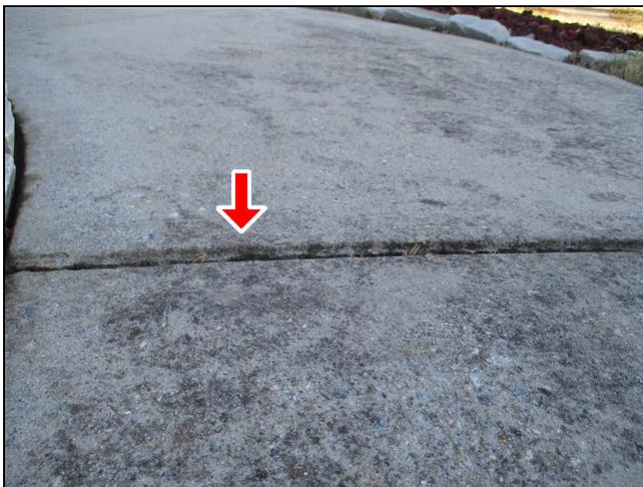
Heaving observed at the front walkway. Possible trip hazard noted. We recommend further evaluation by a licensed contractor for repairs or replacement prior to close.

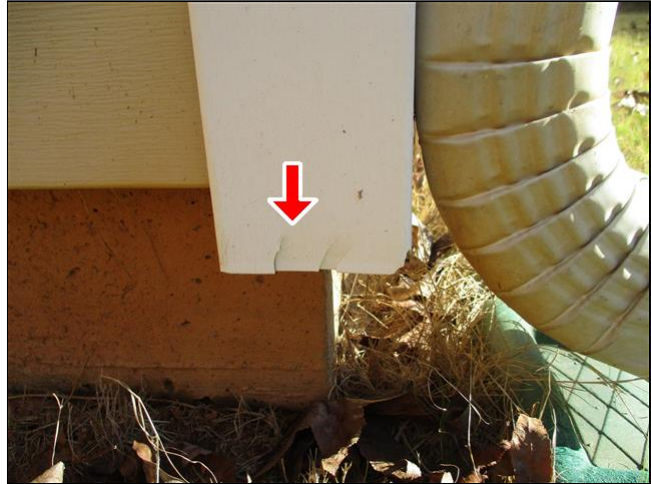
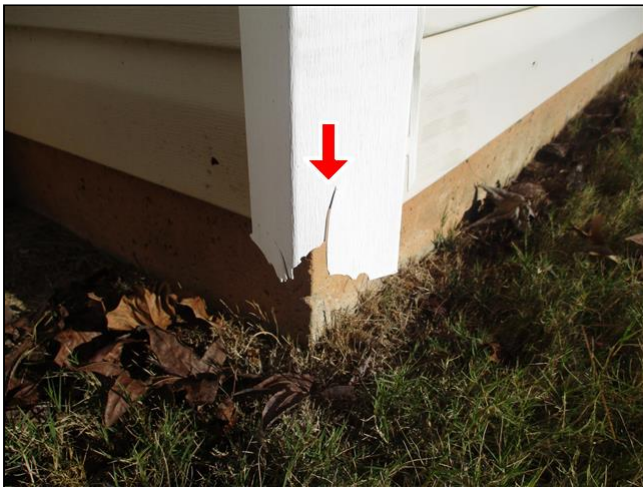
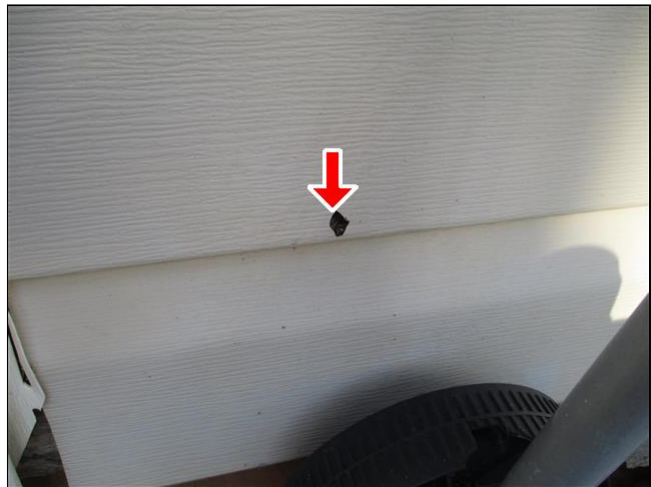
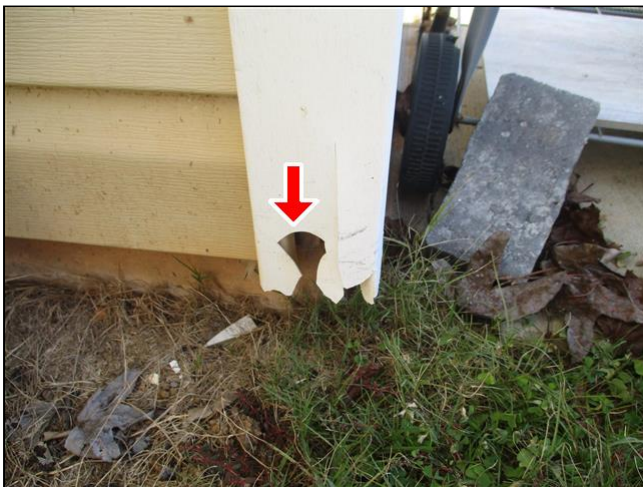
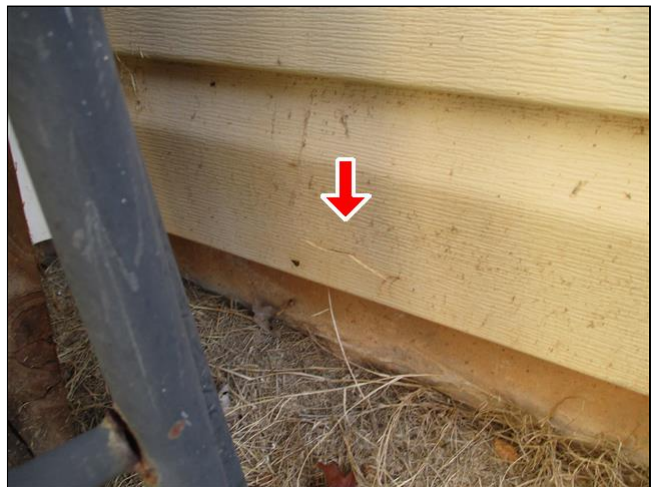
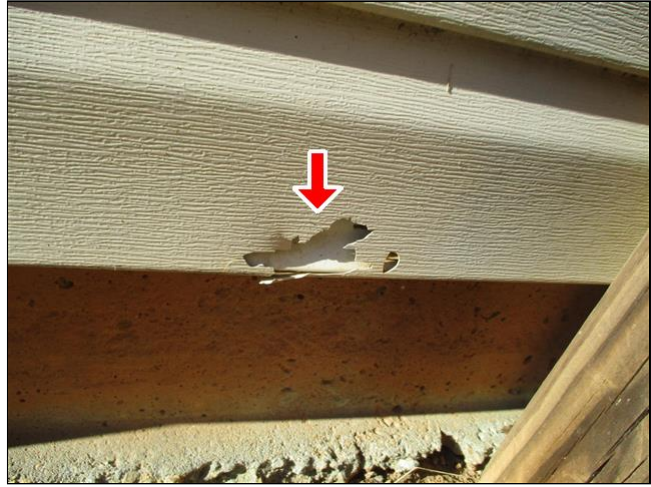
1.3 Exterior Wall Cladding

(2) Minor damage to the vinyl siding and trim observed at multiple locations. Damage appears to be primarily cosmetic. Suggest review by a qualified contractor for repairs or replacement as needed.

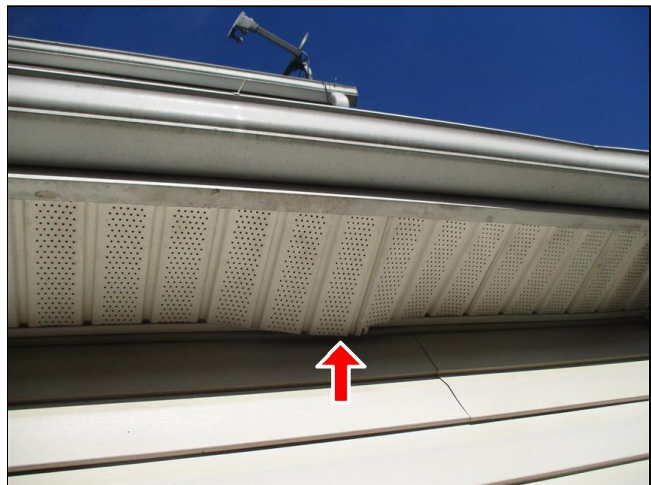
1.4 Trim, Eaves, Soffits and Fascias

(2) Damaged/loose vinyl soffit sheathing observed at the front of home and rear of home. Recommend review by a qualified contractor for repairs or replacement as needed.

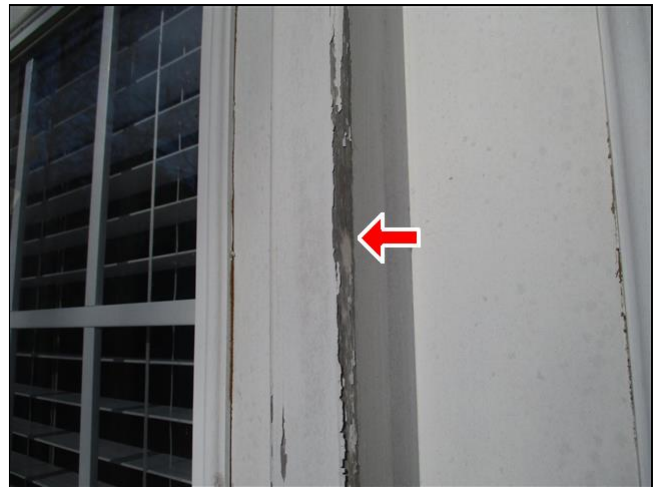
Peeling paint observed at the rear entry door; suggest scraping and painting as necessary as part of normal maintenance.

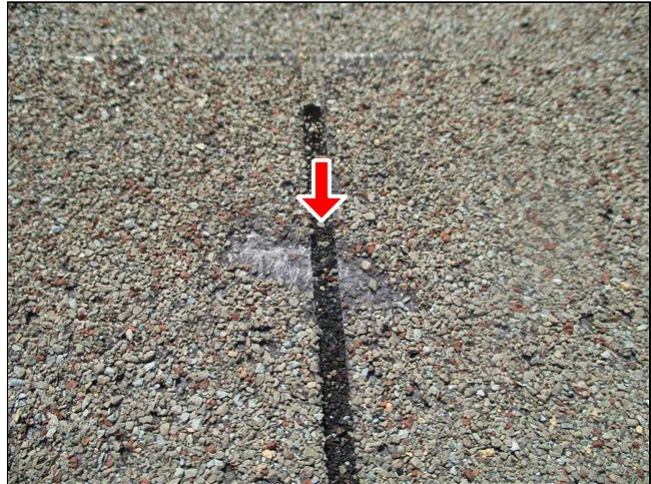
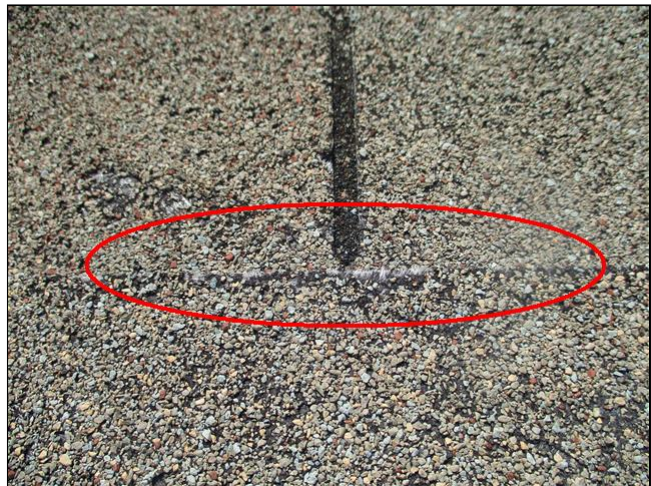
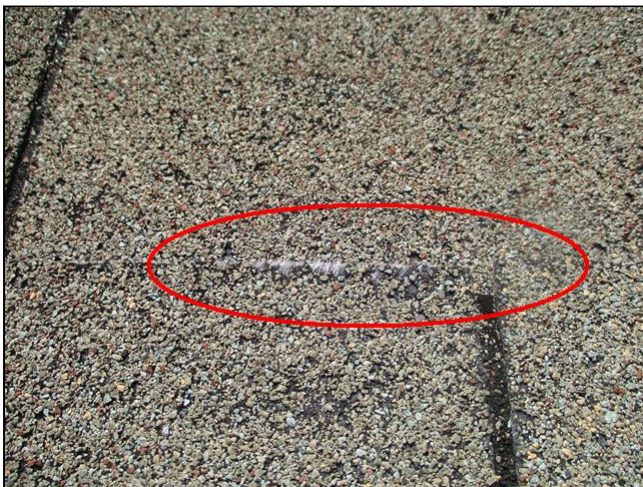
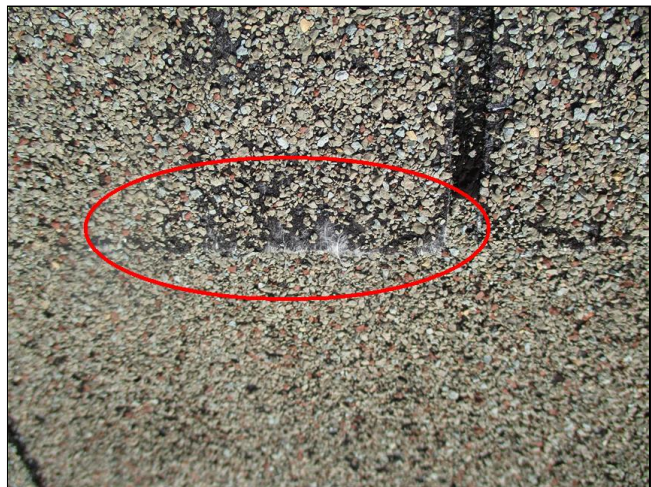
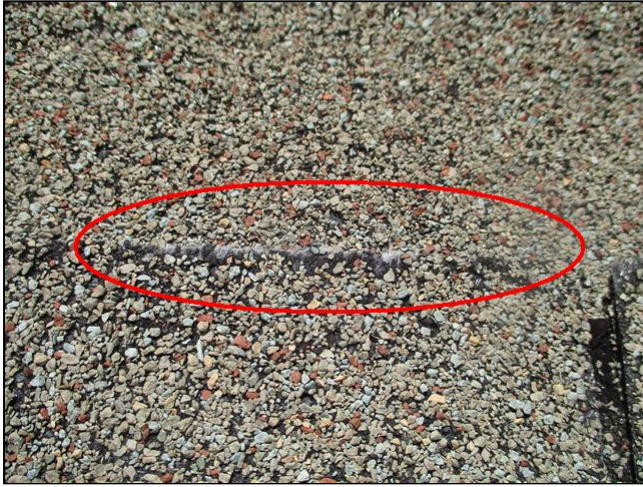
2.2 Roof Conditions

Loose shingles, deterioration and granular loss observed at multiple sides of the roof. Recommend further evaluation by a licensed roofer prior to close to determine the serviceability of the roof, estimate the remaining life of the shingles, and for repairs or replacement as needed.

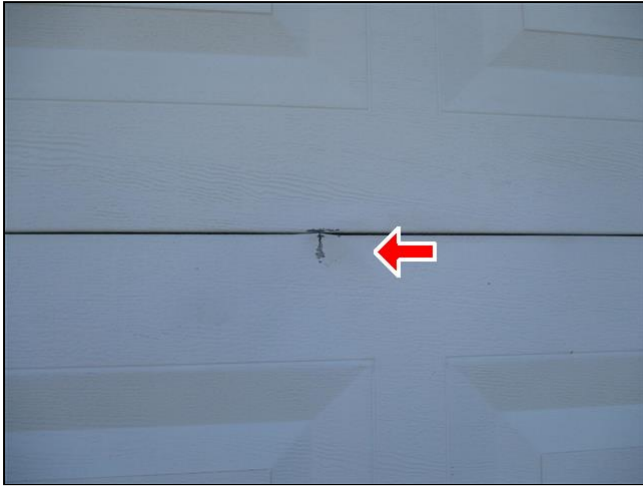
(1) Panels of the garage door are slightly bent or damaged. This does not appear to be affecting the serviceability of the door. Recommend review for repairs as needed.

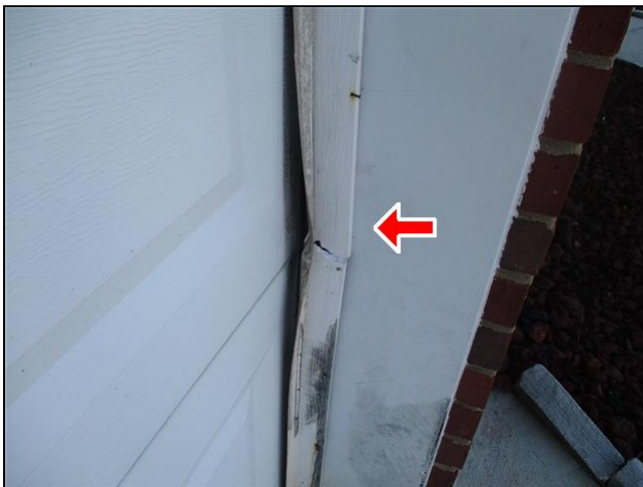
(2) Damaged weather stripping observed at the garage door. Recommend review by a qualified contractor for corrections as needed.

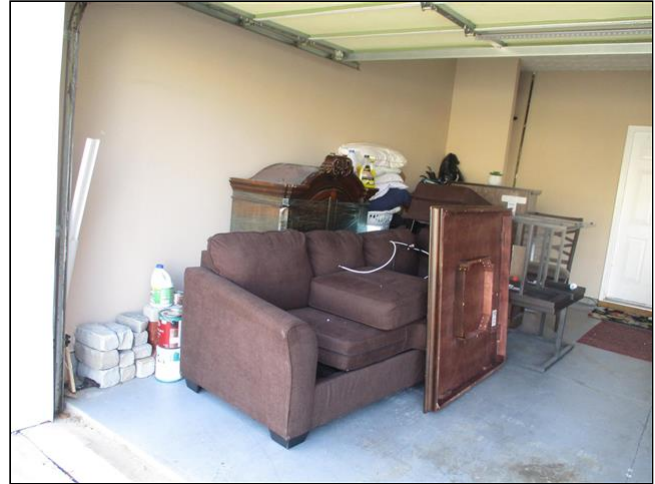
(1) Limited review of the garage due to personal property. Client is advised to verify the condition of all unobserved areas prior to close.

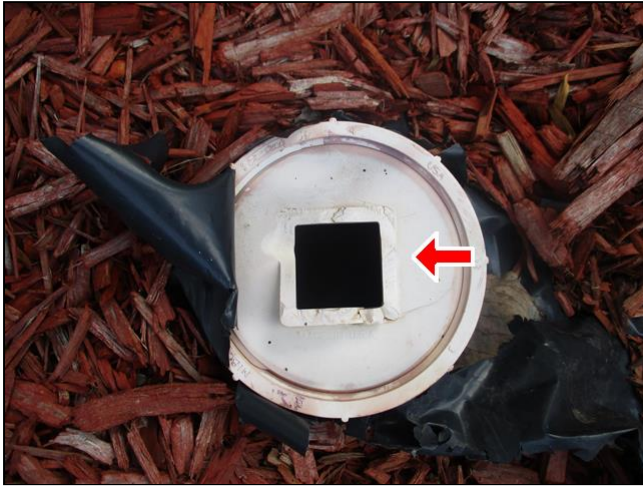
Damaged cap observed at the drain line clean out. Recommend review by a qualified contractor for replacement.

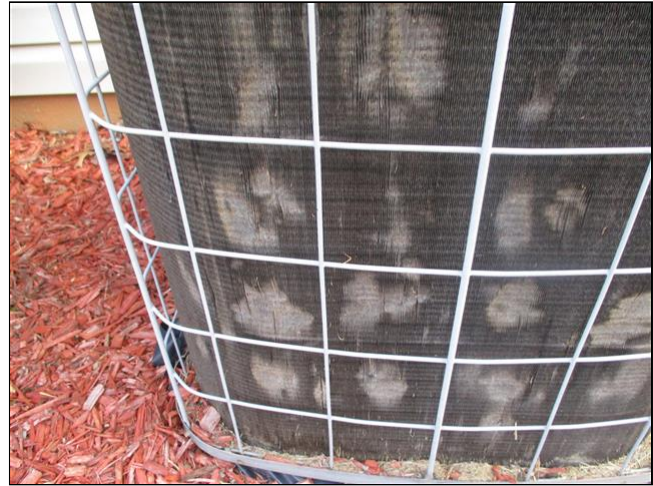
(3) The condenser fins at the outside compressor are bent or damaged. Recommend repairs the outside condenser cooling fins on the exterior condenser to help assure adequate airflow and operation or have HVAC contractor review for replacement as needed.

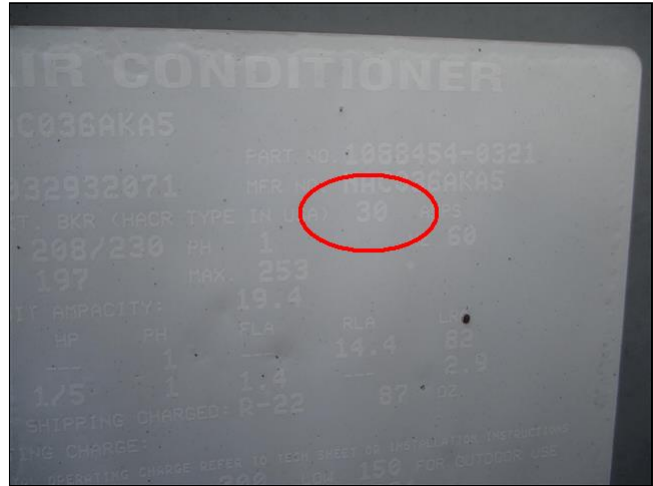
9.3 Energy Source

According to the air-conditioning units' specification label, the breaker protecting the condenser is not properly sized. A 40 amp breaker has been installed with a labeled demand that calls for a maximum breaker size of 30 amps. We recommend a licensed heating and air contractor perform any corrections necessary to assure proper protection.

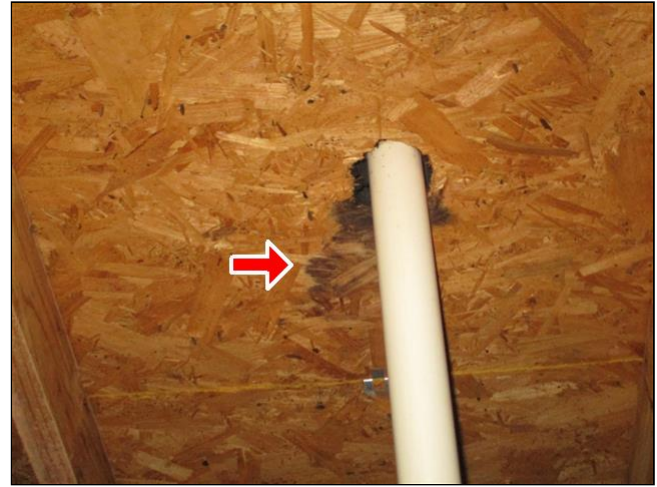
Stains observed on roof decking in the attic at the left rear plumbing vents. Inspector is unable to determine if the stains are active due to the height or location of the stain. Client is advised to consult seller to determine the source of staining and verify that corrections have been made or have reviewed by a qualified contractor for corrections prior to close.

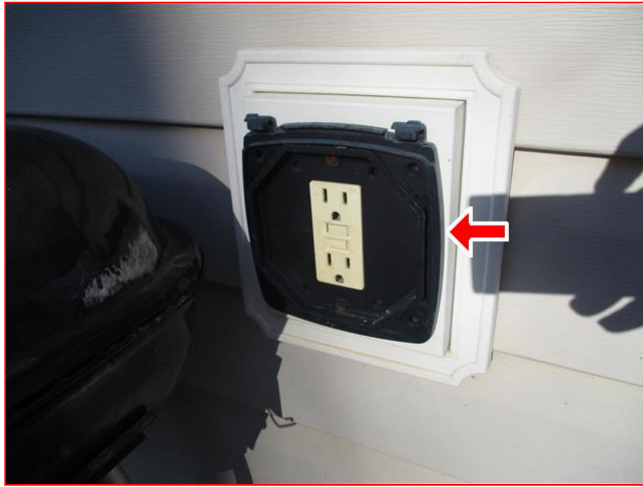
(2) Weatherproof cover at rear of home (at patio) is missing. Suggest repairs/replacement of weatherproof cover as needed to ensure safety.

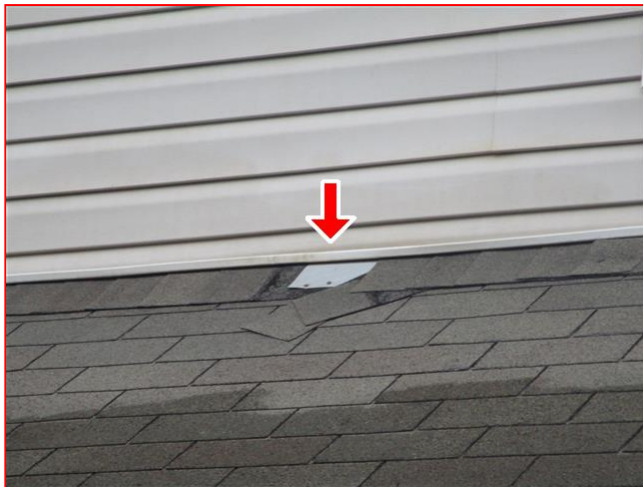
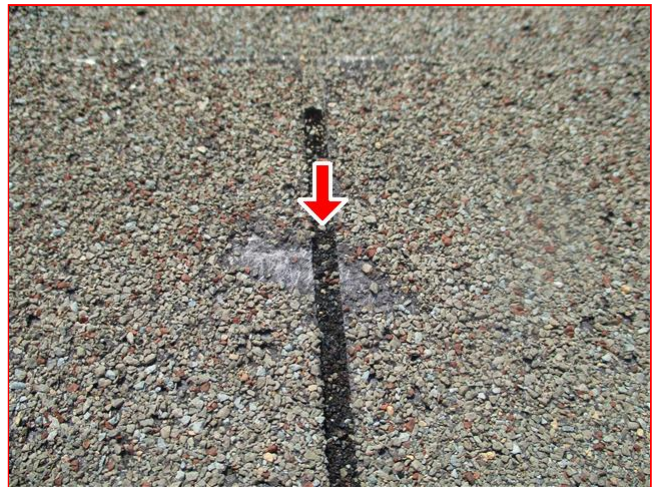
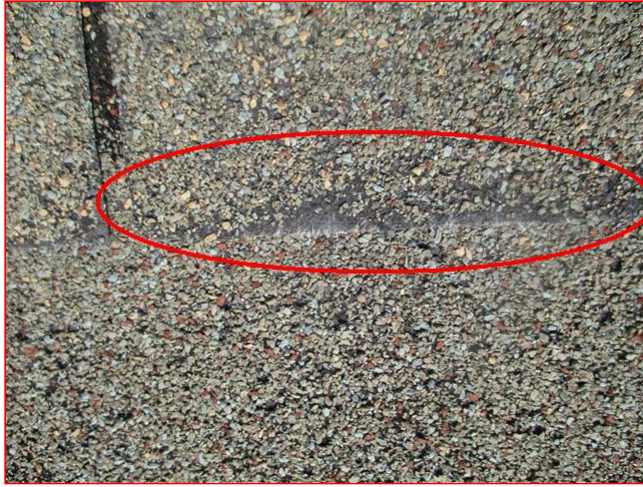
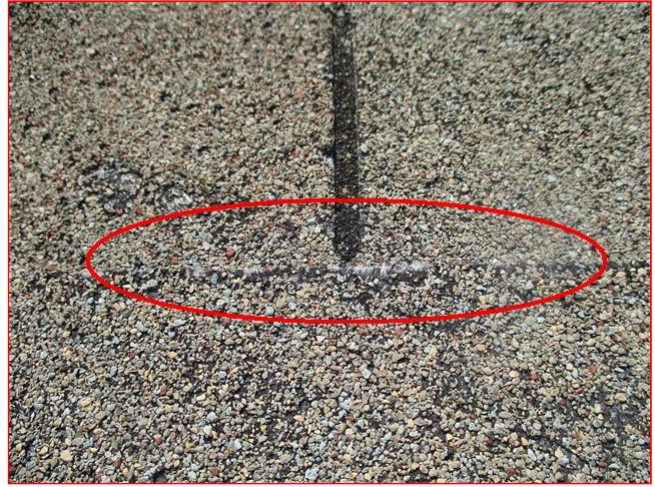
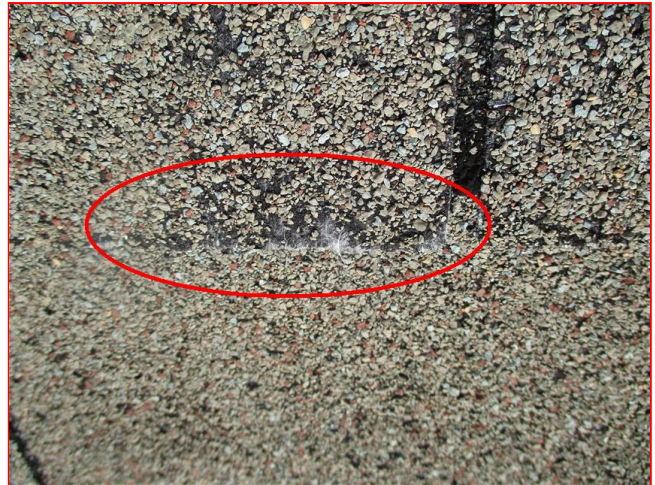
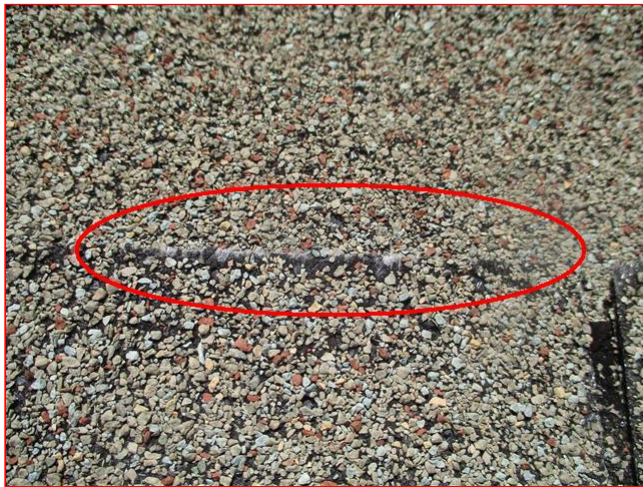
Loose shingles, deterioration and granular loss observed at multiple sides of the roof. Recommend further evaluation by a licensed roofer prior to close to determine the serviceability of the roof, estimate the remaining life of the shingles, and for repairs or replacement as needed.

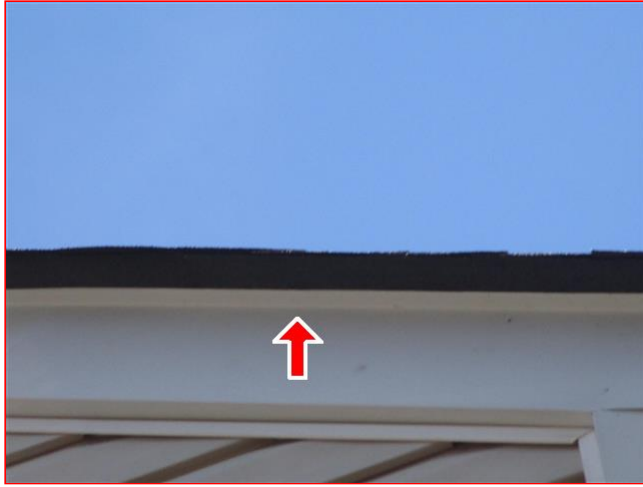
2.3 Roof Penetrations and Exposed Flashings

No drip edge flashing present. Drip edge is a piece of metal flashing installed to cover the gap between the roof deck and the fascia board. Drip edge flashing is required to prevent potential damage the trim, soffit, and roof sheathing. Recommend further evaluation by a licensed roofer for the installation of drip edge flashing prior to close.

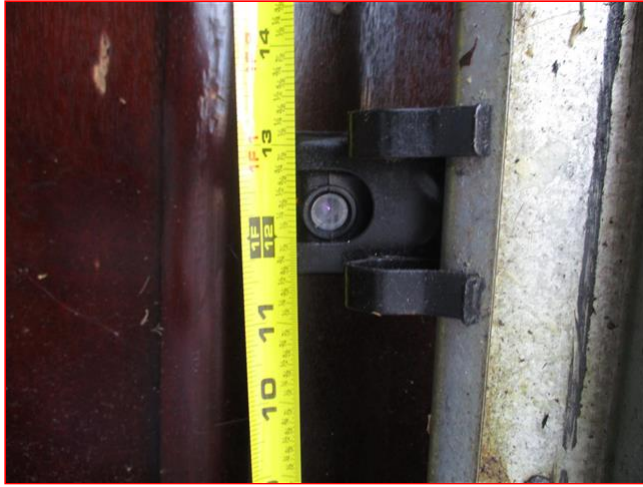
(2) The electric eyes are mounted too far above the floor to protect small children, pets, or property as intended by the manufacturer. We recommend lowering the eyes to within 6 inches of the floor or manufactures specifications.

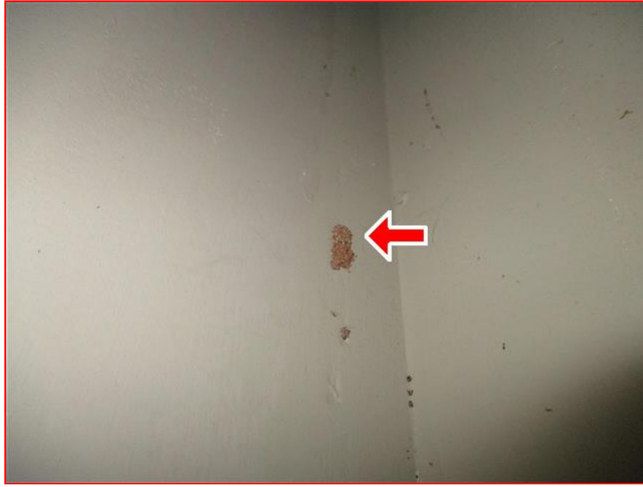
(2) Although identification of termites is beyond the scope of a general home inspection, mud tubes or damaged areas indicative of possible termite activity were observed at right side of garage (near garage door). We are unable to determine if it is currently active or the extent of any potential damage. We suggest consulting with homeowner regarding any past history of treatment. We recommend arranging for further review by a licensed pest control specialist prior to close and review by a qualified contractor for repairs of any potential damage.

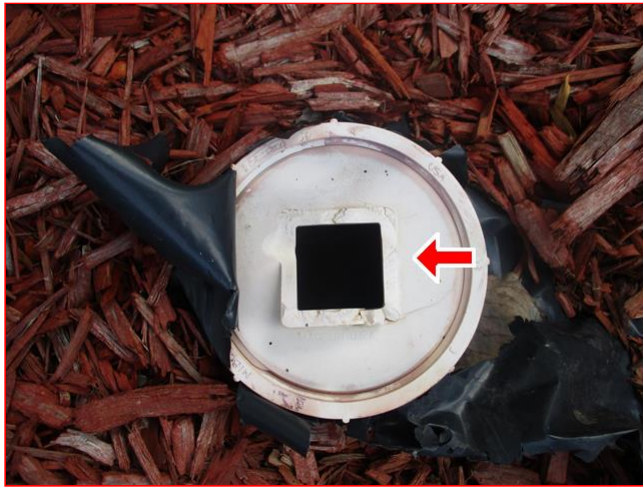
Damaged cap observed at the drain line clean out. Recommend review by a qualified contractor for replacement.

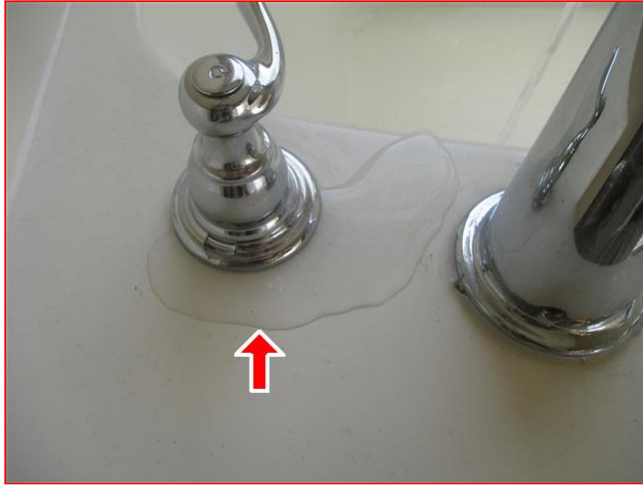
(2) The master bathroom cold water faucet handle leaks. Recommend review prior to close by a licensed plumber for repair or replacement.

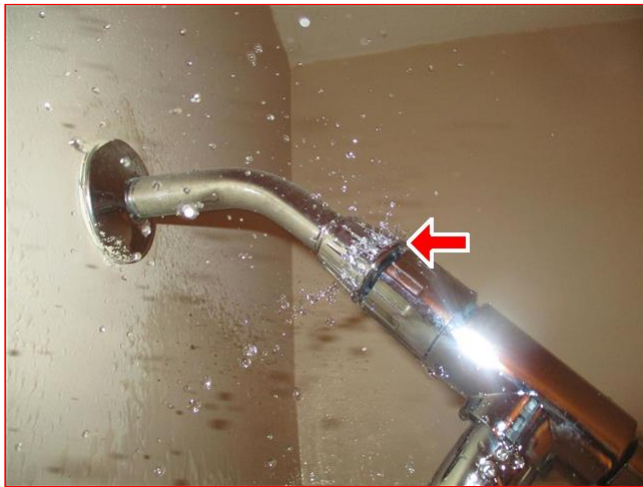
12.11 Shower

(2) Shower head in the shared bathroom leaks severely. Corrections are needed to prevent potential wall damage. Recommend review by a qualified plumber for repairs prior to close.

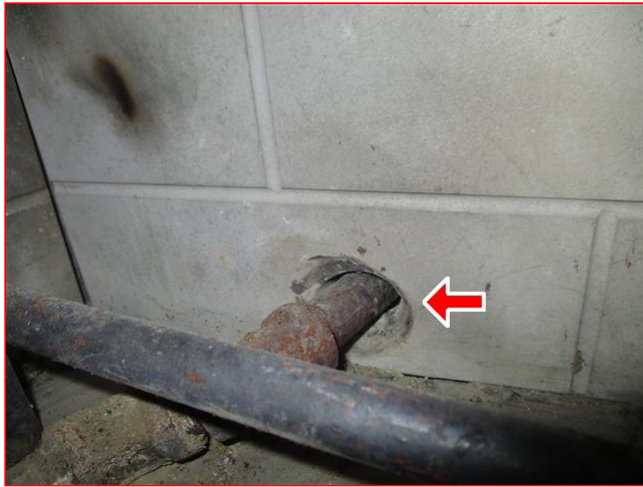
Minor gaps observed around the gas line where it penetrates the fire brick. Suggest sealing with a fire rated sealant prior to use. Suggest review by a qualified contractor for corrections.

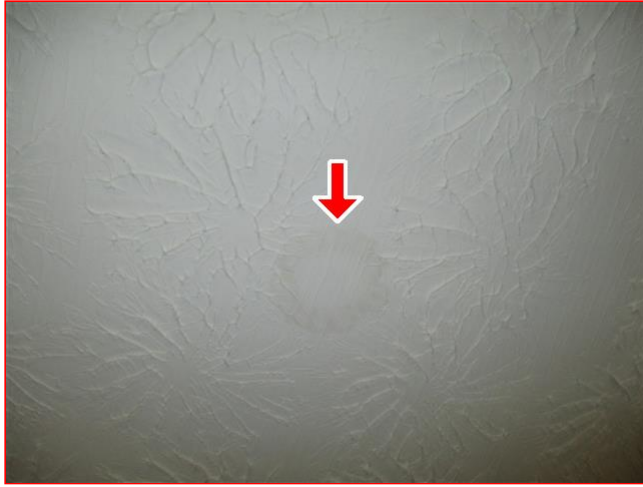
Stains observed on ceiling in the upper left rear bedroom. The inspector probed stains with a moisture detector, which showed no moisture present at time of inspection. Client is advised to consult seller to determine the source of staining and verify that corrections have been made or have reviewed by a qualified contractor for corrections as needed.

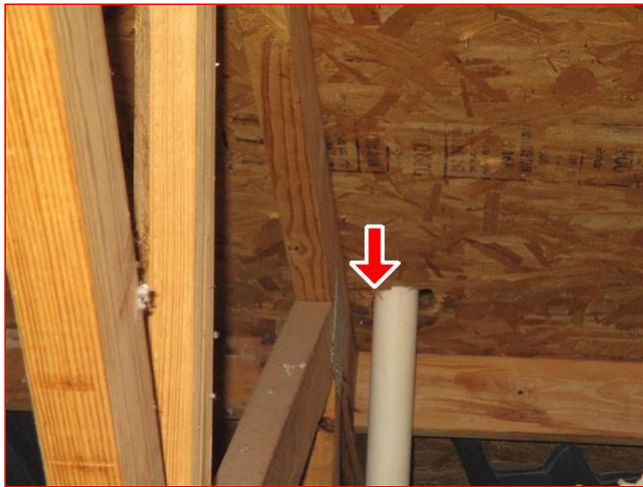
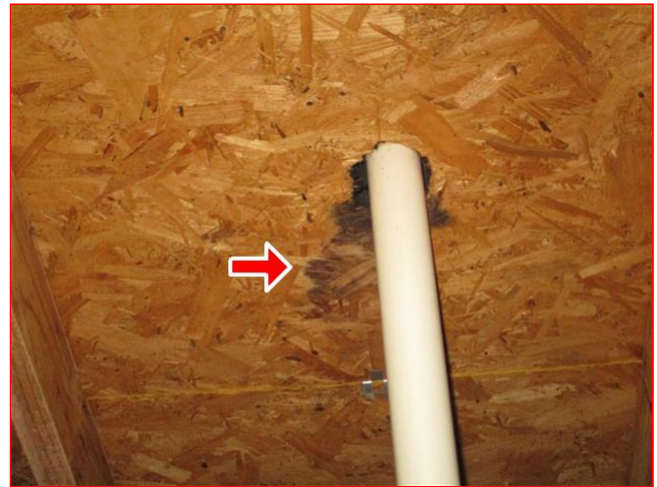
Stains observed on roof decking in the attic at the left rear plumbing vents. Inspector is unable to determine if the stains are active due to the height or location of the stain. Client is advised to consult seller to determine the source of staining and verify that corrections have been made or have reviewed by a qualified contractor for corrections prior to close.

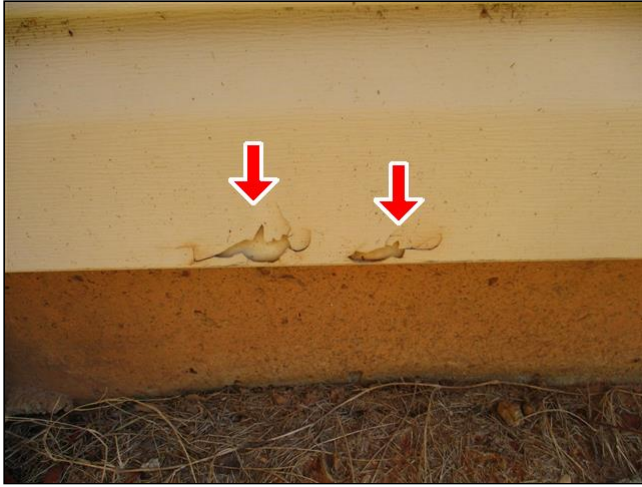
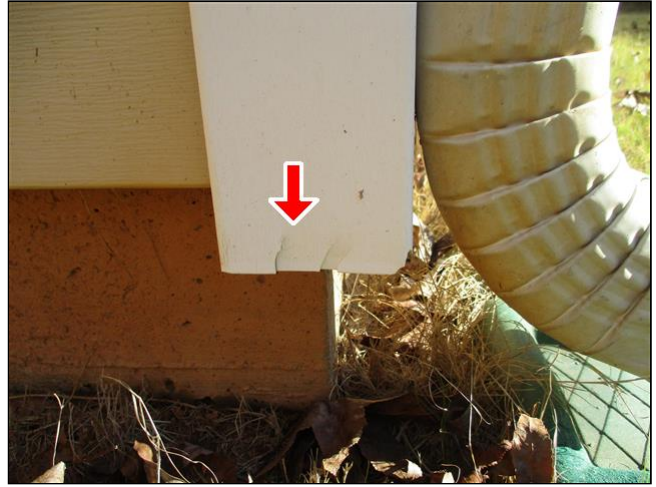
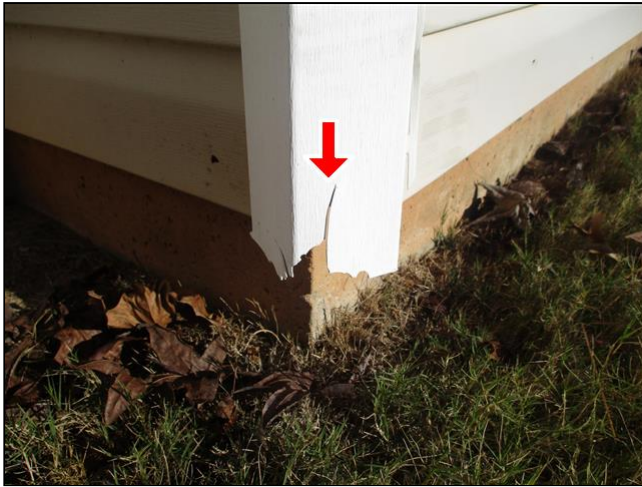
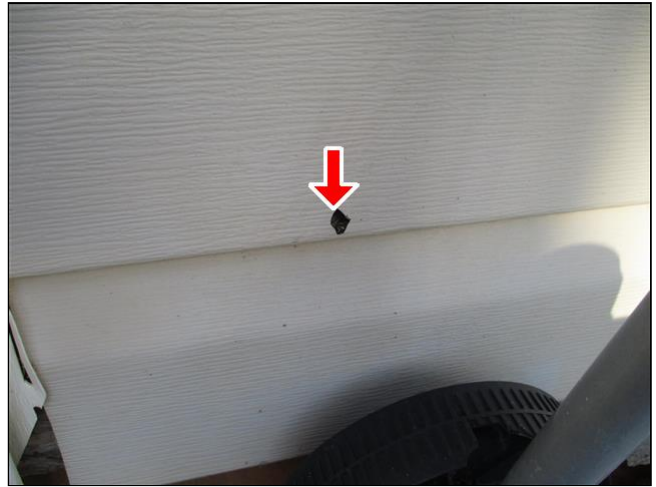
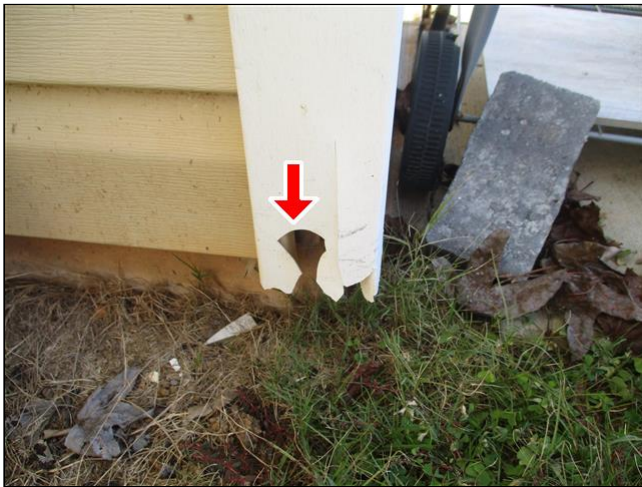
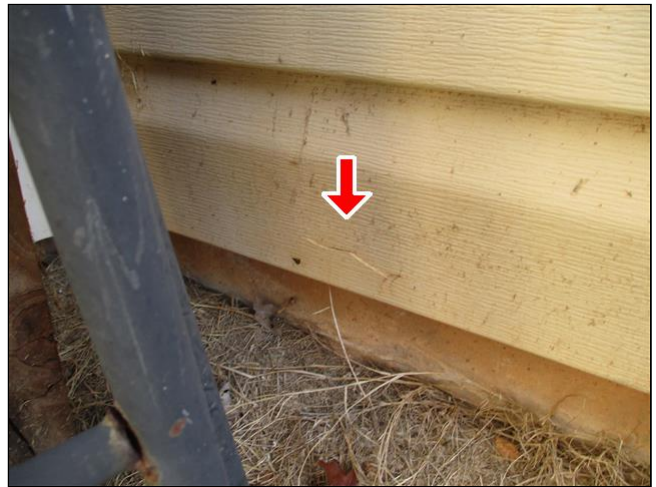
(2) Minor damage to the vinyl siding and trim observed at multiple locations. Damage appears to be primarily cosmetic. Suggest review by a qualified contractor for repairs or replacement as needed.

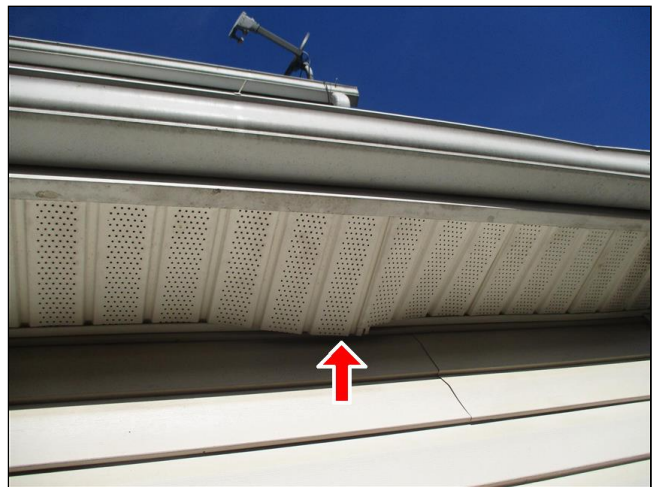
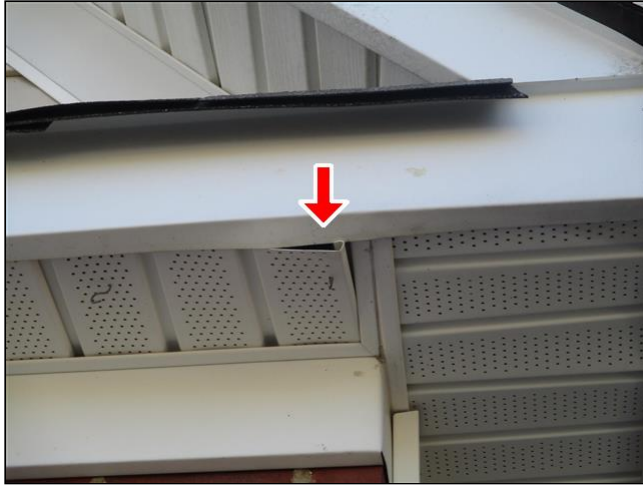
1.4 Trim, Eaves, Soffits and Fascias

(2) Damaged/loose vinyl soffit sheathing observed at the front of home and rear of home. Recommend review by a qualified contractor for repairs or replacement as needed.

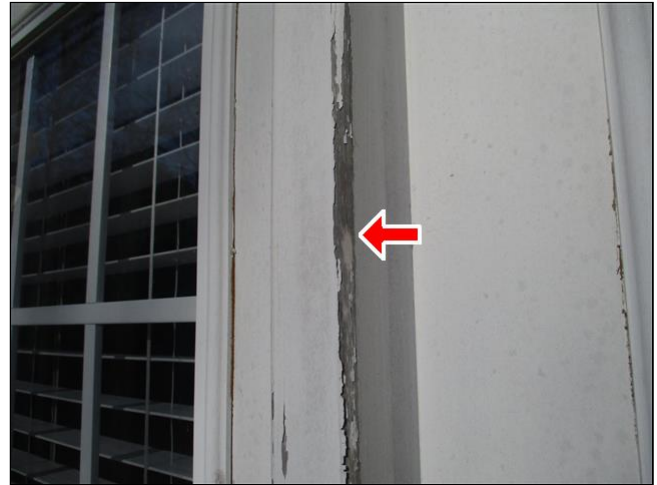
1.6 Doors (Exterior)

Peeling paint observed at the rear entry door; suggest scraping and painting as necessary as part of normal maintenance.

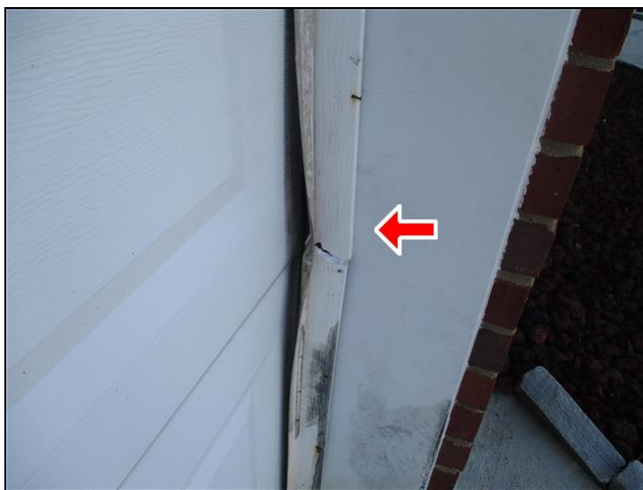
(2) Damaged weather stripping observed at the garage door. Recommend review by a qualified contractor for corrections as needed.

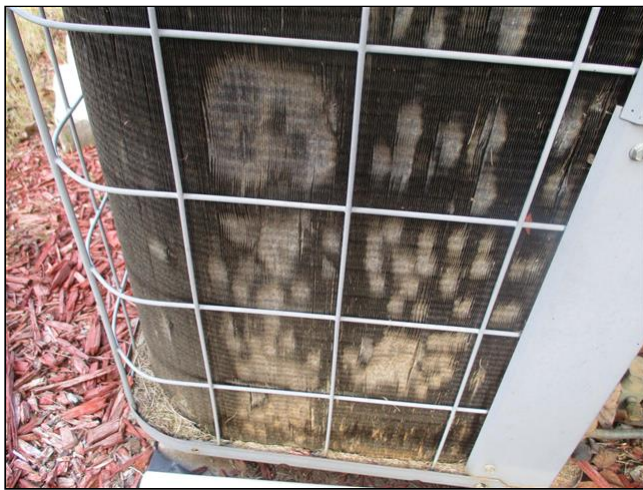
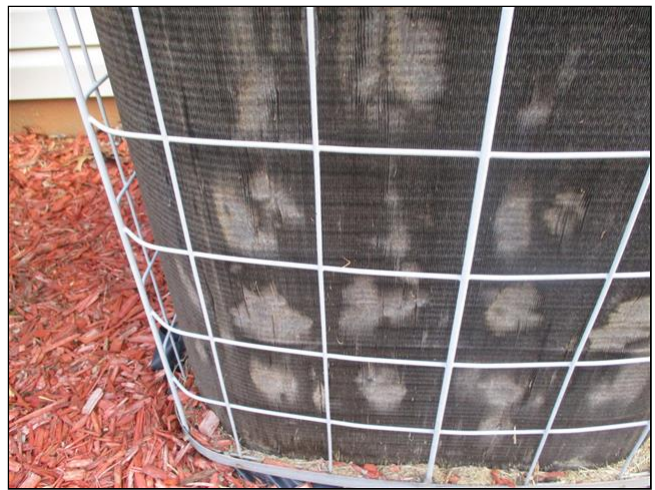
(3) The condenser fins at the outside compressor are bent or damaged. Recommend repairs the outside condenser cooling fins on the exterior condenser to help assure adequate airflow and operation or have HVAC contractor review for replacement as needed.

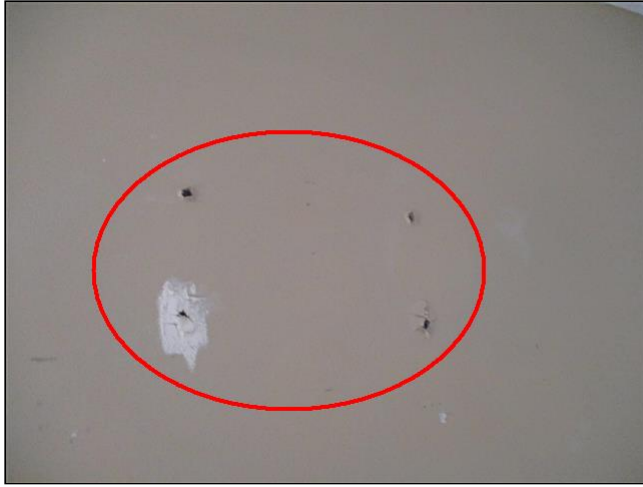
Large holes observed on the wall in the family room. Recommend review by a qualified contractor for corrections as needed.

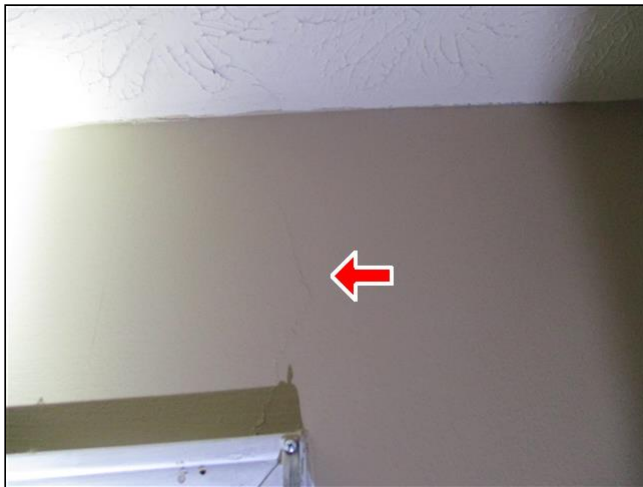
Common cracks noted in the upper left rear bedroom. Appear to be primarily a cosmetic concern Suggest repairs as needed.
