## AmeriSpec Inspection Services

Doc #:	Sample Report	Inspector:	AmeriSpec
Date:	6/14/2018		
Dwelling Address:	1234 Main St. Any Town MN		
Client Name:	Joe Homebuyer Julie HomeBuyer		
Client's Agent:		Real Estate Company:

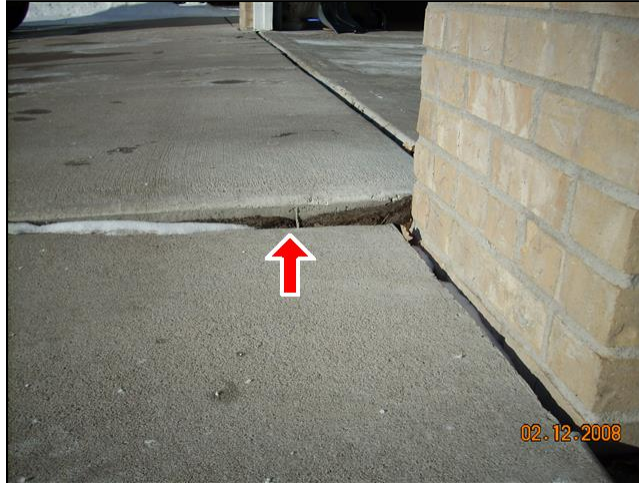
## 2.1 Walkways

**Maintenance Needed.** Settling noted. Possible trip hazard. This is a safety concern. Suggest repairs/replacement as needed to ensure safety.

front right corner

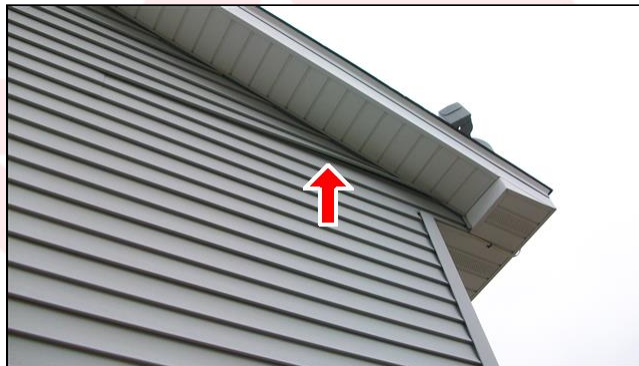
## 2.2 (1) Exterior Siding

**Maintenance Needed.** Loose siding at the following areas. Suggest repairs/replacement as needed to prevent damage/deterioration.

rear left corner

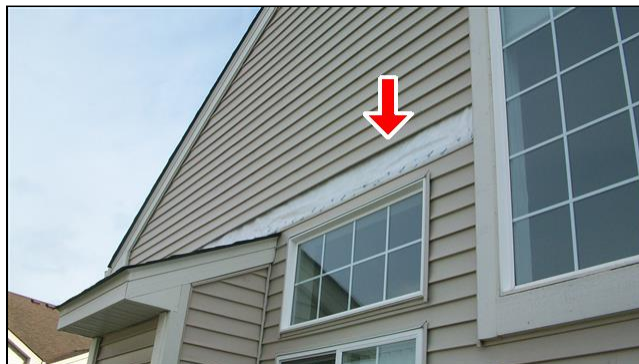
## 2.2 (2) Exterior Siding

**Maintenance Needed.** Missing siding at the following. Suggest repairs/replacement as needed to prevent damage/deterioration.

right side

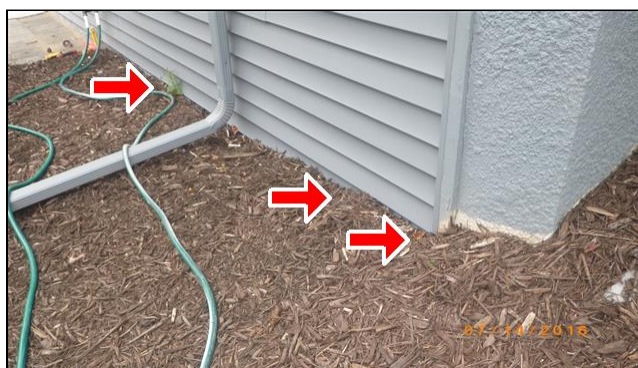
## 2.2 (3) Exterior Siding

**Maintenance Needed.** Siding to earth contact at the following areas. This can cause damage to the siding and to the structure. Suggest maintaining adequate clearance between the siding and the earth.

left side

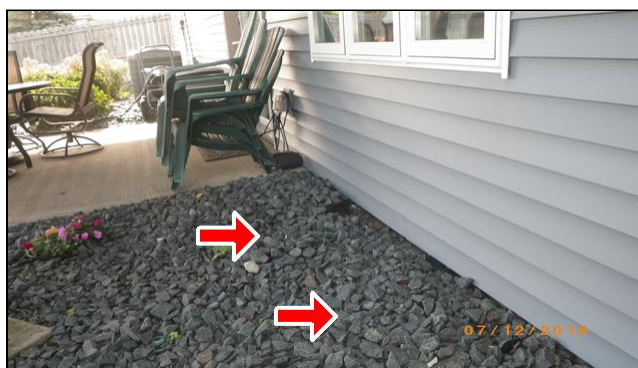
2.12 Lot/Grade Drainage

**Maintenance Needed.** Inadequate drainage noted at the following areas.  
**Recommend regrading or adding dirt backfill to any low lying areas adjacent to the foundation to ensure proper drainage away from the foundation at all times.**

rear

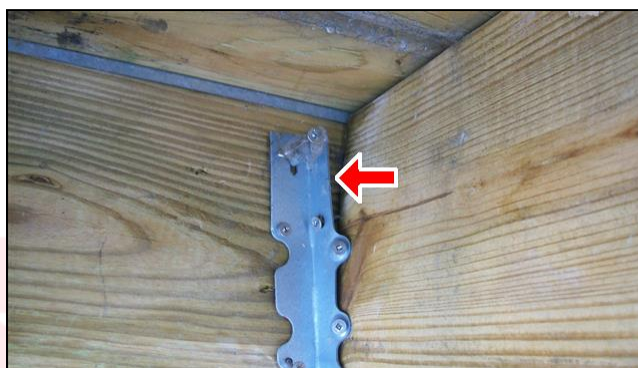
Step #	Component	Comment
4.0	Decking	<b>Maintenance Needed.</b> Joist not properly nailed in joist hangers. Suggest further review prior to closing by a qualified licensed contractor for repairs/replacement as needed.

third from right side

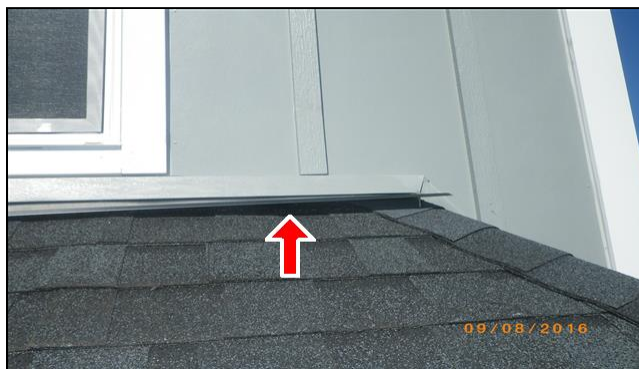
## 5.1 Visible Flashings

**Maintenance Needed.** Loose wall flashing at the following. Suggest review/repair by a licensed roofer.

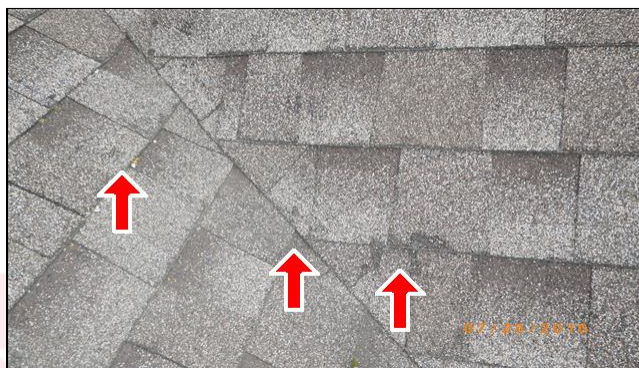
## 5.2 Conditions

**Comment.** Minor deterioration noted. Possibly during installation

front valley

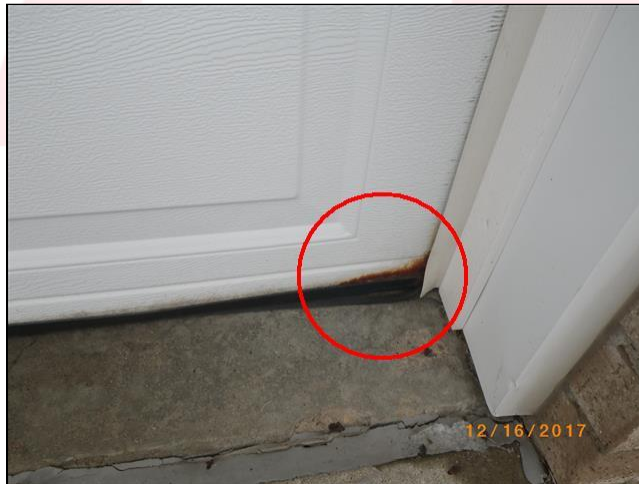
Step #	Component	Comment
7.0	Exterior Siding	<b>Serviceable.</b> Garage is attached. See EXTERIOR section for more information.
7.1	Trim	<b>Serviceable.</b>
7.2	Roof	<b>Serviceable.</b> Garage is attached. See ROOF section for more information.
7.3	Floor/Slab	<b>Serviceable.</b>
7.4	Garage Door	<b>Comment.</b> Rusted at bottom Suggest repairs/replacement as needed.

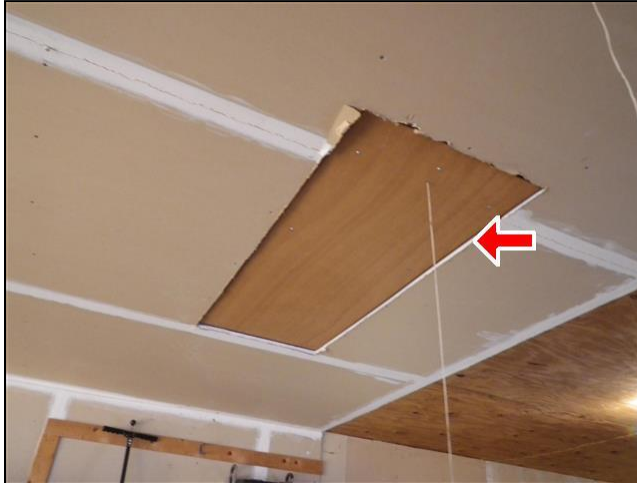
- 7.9 Fire Wall/Ceiling **Maintenance Needed.** Compromised due to attic ladder. Ladder is not a fire rated material and should be removed. Suggest repairs/replacement as needed.

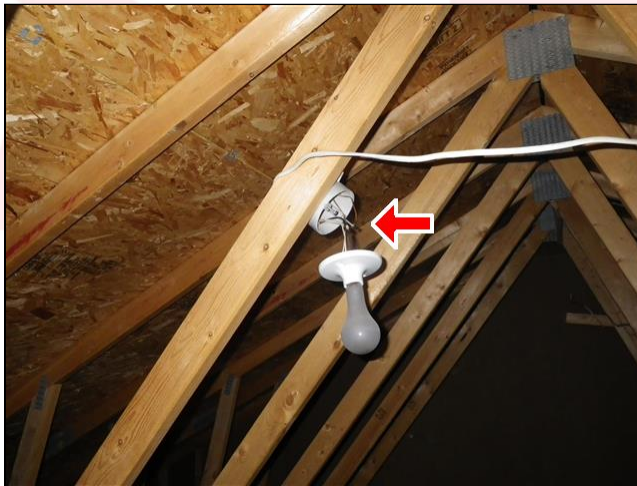
- 7.10 Garage Framing & Supports **Serviceable.**
- 7.11 Walls **Serviceable.**
- 7.12 Ceiling **Serviceable.**
- 7.13 Electrical **Maintenance Needed.** Loose hanging light noted. This is a safety concern if used where it could be subject to physical damage. Client should consult with a qualified licensed electrician prior to closing for repairs/replacement as needed to ensure safety.

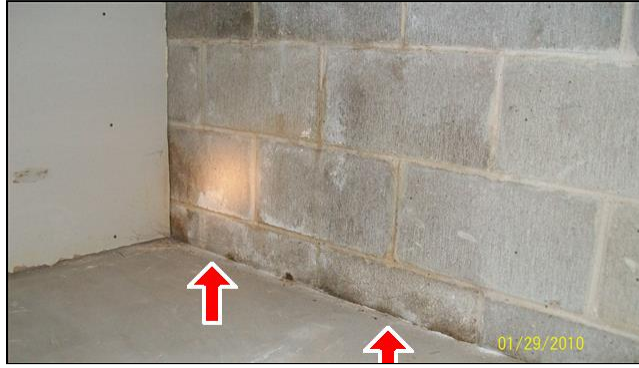
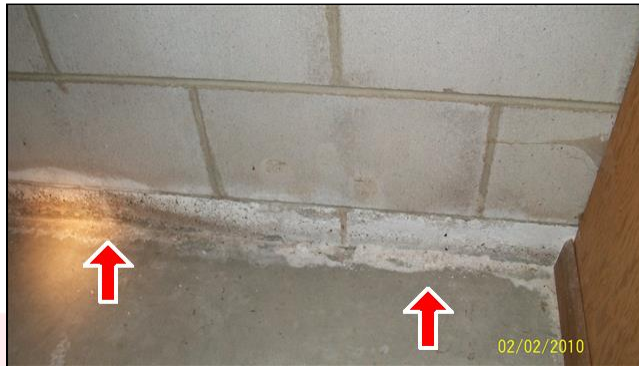
## 9.4 Walls

**Maintenance Needed.** Walls show evidence of water penetration at the following. Regrading at the exterior of the home may be needed.

left side

front

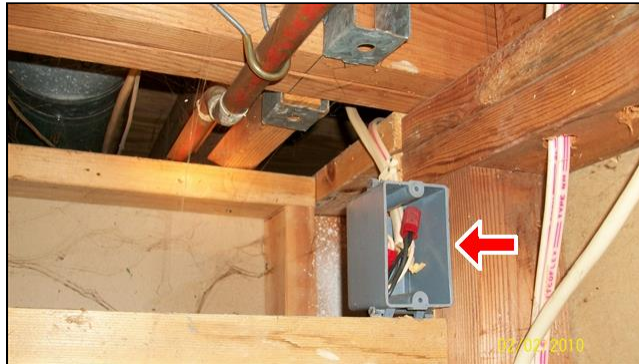
## 9.8 Electrical

**Maintenance Needed.** Open junction boxes were noted. This is a safety concern. Whenever an electrical wire is cut and reconnected, the 'splice' should be encased in a covered 'junction box' to prevent shocks and separation of the splice. Client is advised to consult with a qualified licensed electrician prior to closing for repairs/replacement as needed to ensure safety.

furnace room above water heater

left wall furnace room

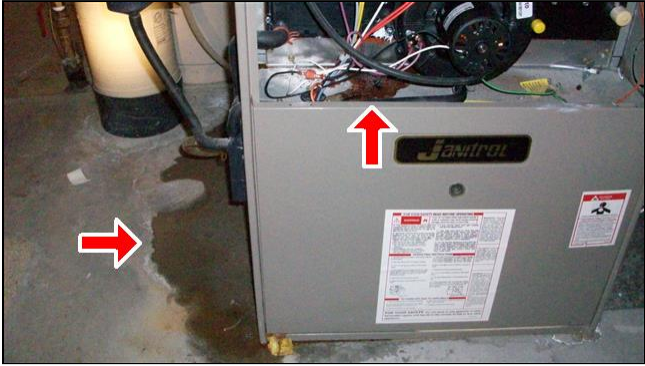
| 10.1 | Conditions | <b>Maintenance Needed.</b> Condensation leaking from the furnace, suggest further review by an HVAC contractor prior to close. |

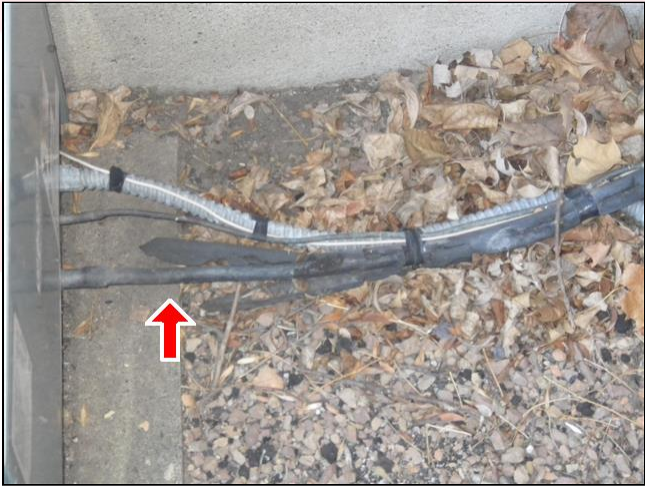
| 10.7 | Air Conditioning System | <b>Maintenance Needed.</b> Insulation damaged/missing. Suggest replacing for energy efficiency. |

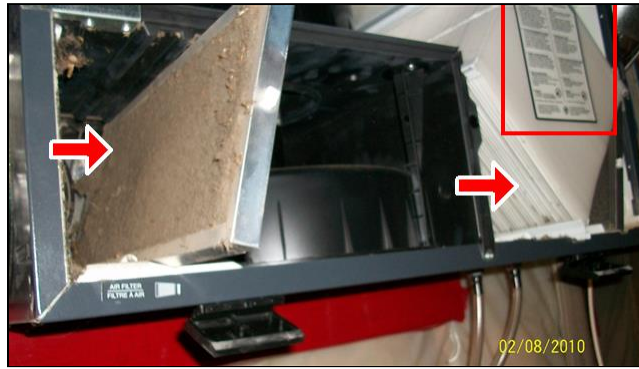
## 10.9 Air Exchanger

**Maintenance Needed.** Filters are dirty, see cleaning instruction inside of the front door of the unit.

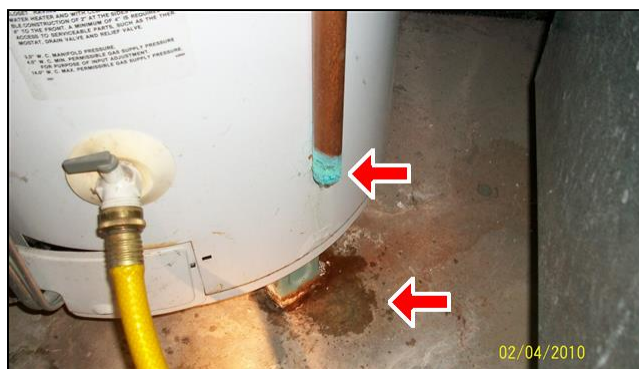
## 11.5 Water Heater

**Maintenance Needed.** Leaking noted at TPR valve over flow pipe. Suggest repair/replacement by a licensed plumber.

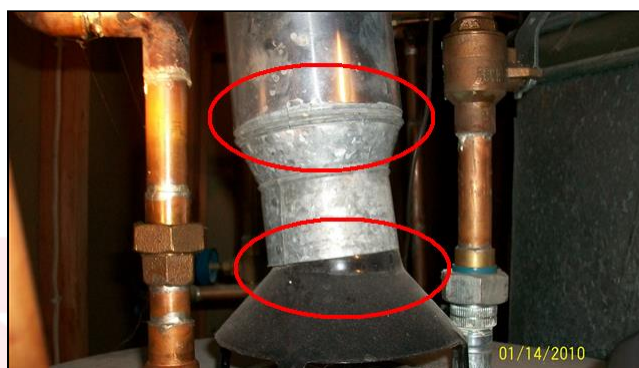
## 11.6 Exhaust Venting System

**Maintenance Needed.** Disconnected/poorly fitted joints on vent pipes will allow product of combustion to escape, suggest repair.

missing screws at connections

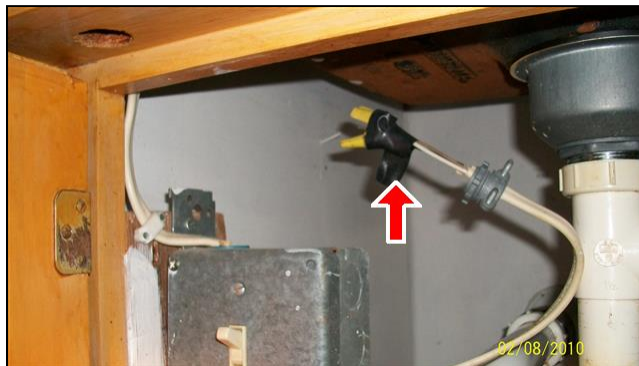
Step #	Component	Comment
13.0	Floor	<b>Serviceable.</b>
13.1	Walls	<b>Serviceable.</b>
13.2	Ceiling	<b>Serviceable.</b>
13.3	Doors	<b>Serviceable.</b>
13.4	Windows	<b>Serviceable.</b>
13.5	Cabinets	<b>Serviceable.</b>
13.6	Counter Tops	<b>Serviceable.</b>
13.7	Electrical	<b>Maintenance Needed.</b> Exposed/loose/hanging wires noted. Open splices noted. This is a safety concern if used where it could be subject to physical damage. Client should consult with a qualified licensed electrician prior to closing for repairs/ replacement as needed to ensure safety.

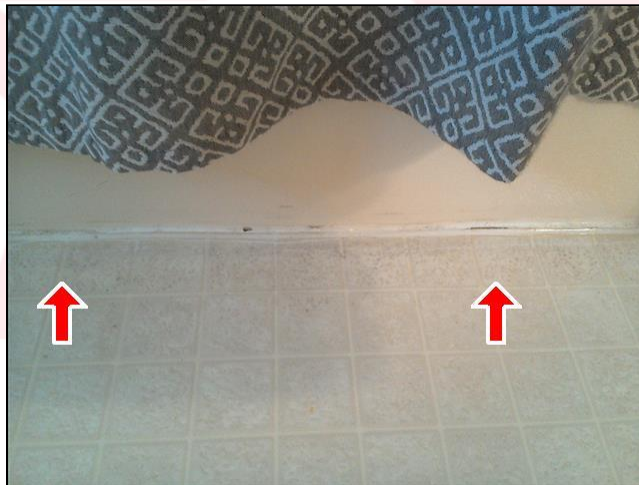
Step #	Component	Comment
19.0.C	Floor	Serviceable.
19.1.C	Walls	Serviceable.
19.2.C	Ceiling	Serviceable.
19.3.C	Doors	Serviceable.
19.4.C	Windows	Serviceable.
19.5.C	Electrical	Serviceable.
19.6.C	Exhaust Fan	Serviceable.
19.7.C	Heat Source	Serviceable.
19.8.C	Tub/Surround	<b>Maintenance Needed.</b> Suggest caulking at the floor outside the tub to prevent future/further moisture penetration and damage/deterioration to interior walls and surrounding sub-flooring. This damage is not always visible or accessible to the inspector at the time of inspection.
