# Inspection Report

**Property Address:**  
1234 Sample Lane Ln  
Germantown TN 38139

**AmeriSpec MidSouth**

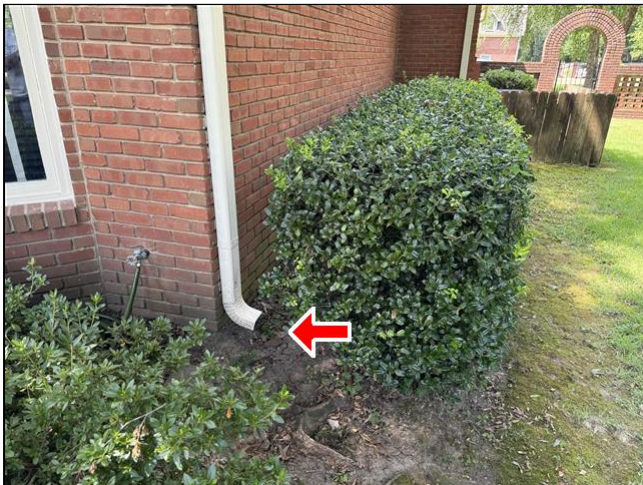
1.3 Item 1(Picture)

(1) Downspout extensions missing at several locations. Recommend installing downspout extensions where missing to move water away from foundation of home.

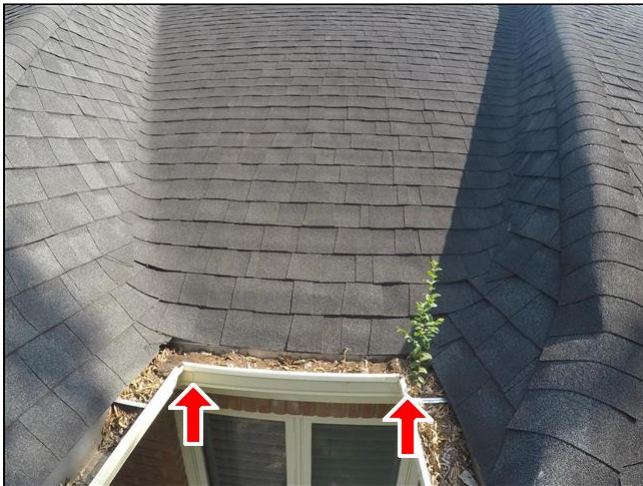
1.3 Item 5(Picture)

(2) Gutters need to be cleaned out at multiple locations. Recommend contractor clean gutters to ensure proper operation.

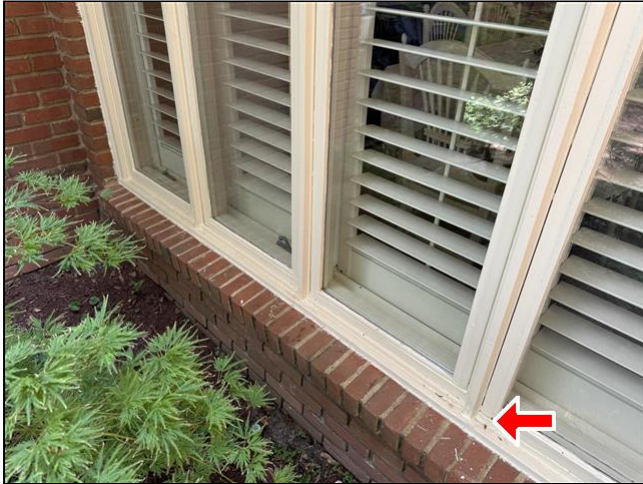
2.0 Item 1(Picture)

(1) Water damaged window trim at rear of home. Recommend contractor repairs as needed.

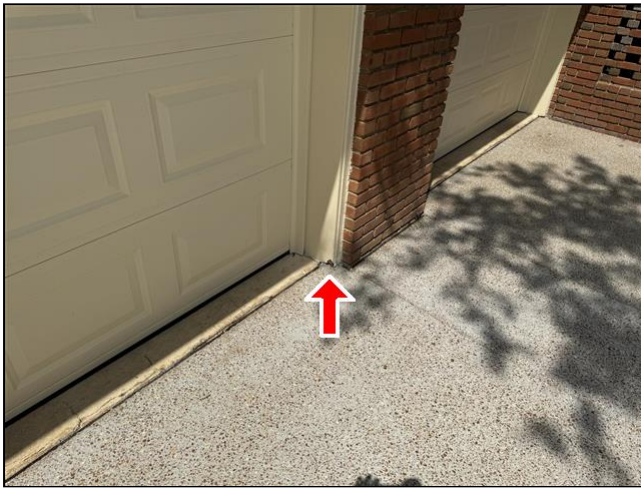
2.0 Item 3(Picture)

(2) Water damaged wood trim at garage door. Recommend contractor repairs.

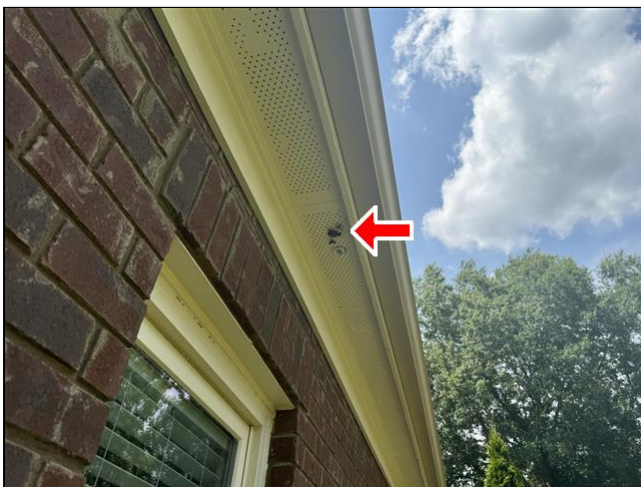
2.5 Item 1(Picture)

(1) Hole in vented soffit at side of homes where wasps are currently nesting. Recommend contractor review and repair hole.

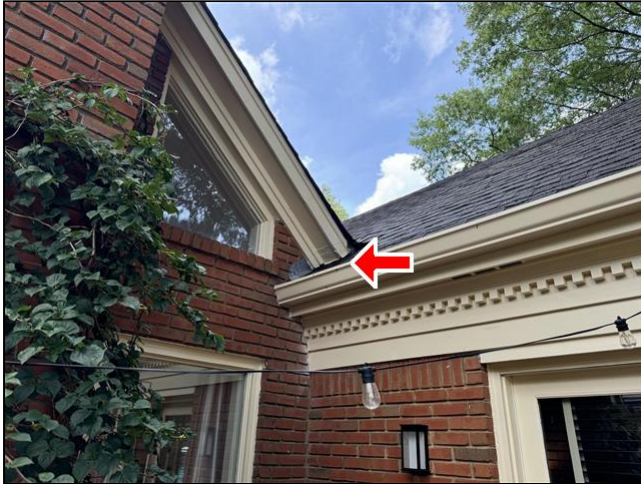
2.5 Item 3(Picture)

(2) Water damaged trim and unprofessional repair at rear of home. Recommend qualified contractor review and repair as necessary.

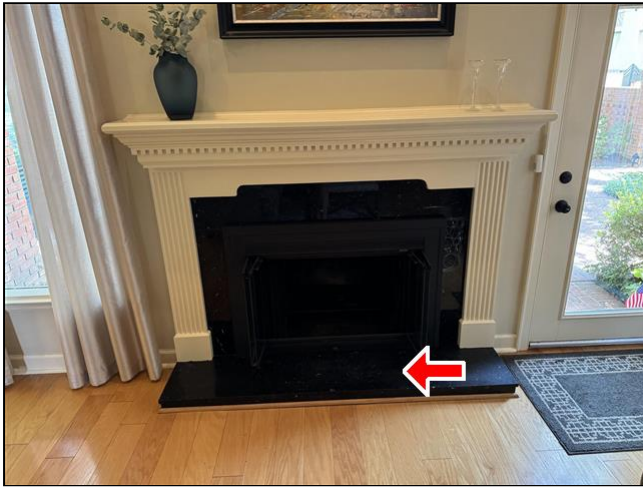
4.2 Item 1(Picture)

Crack in stone hearth at fireplace. Recommend having hearth repaired or replaced as needed.

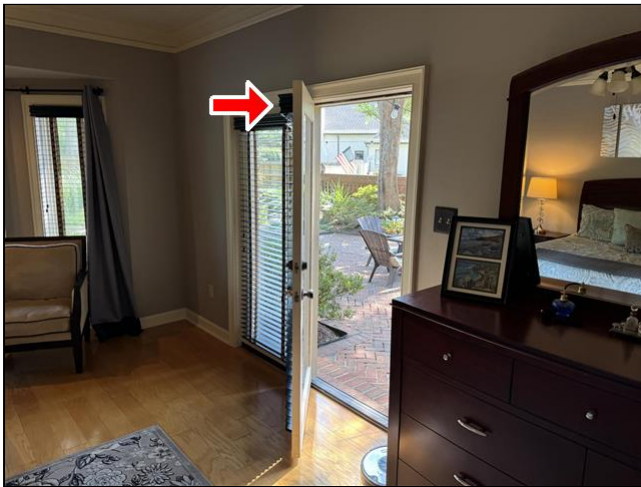
4.5 Item 1(Picture)

Trim on blinds at exterior door in master bedroom prohibit door from opening fully. This is noted for client information.

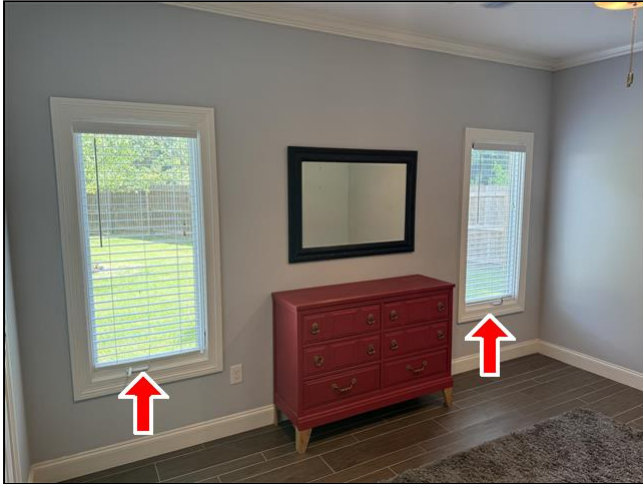
4.6 Item 1(Picture)

(1) The majority of the homes windows do not open, likely due to being painted shut. Recommend contractor review and "free" all windows in order to ensure proper operation and means of egress in case of emergency.

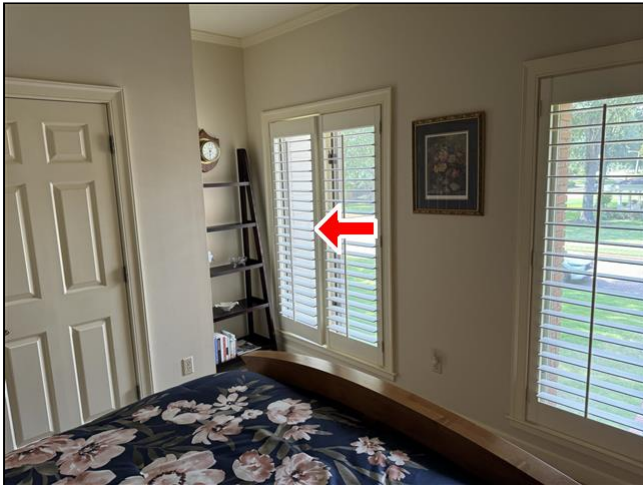
4.6 Item 6(Picture)

(2) Fog and condensation was noted in the double glazed insulated window panes multiple locations (living room, kitchen, upstairs bedroom, master bedroom, etc.). This indicates a broken seal which will reduce visibility and the insulating capability of this window. To restore visibility and regain the insulating capability, replacement of this window pane is required. Conditions such as temperature, humidity, and even cleanliness can limit the inspectors ability to locate all broken seals. Recommend qualified contractor review all windows and replace as needed.

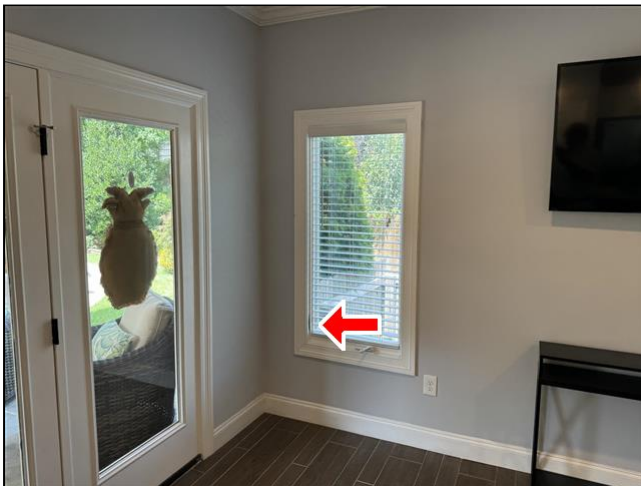
4.6 Item 13(Picture)

(3) Broken/missing locking mechanism handle on casement window in pool house. Recommend qualified contractor review and repair.

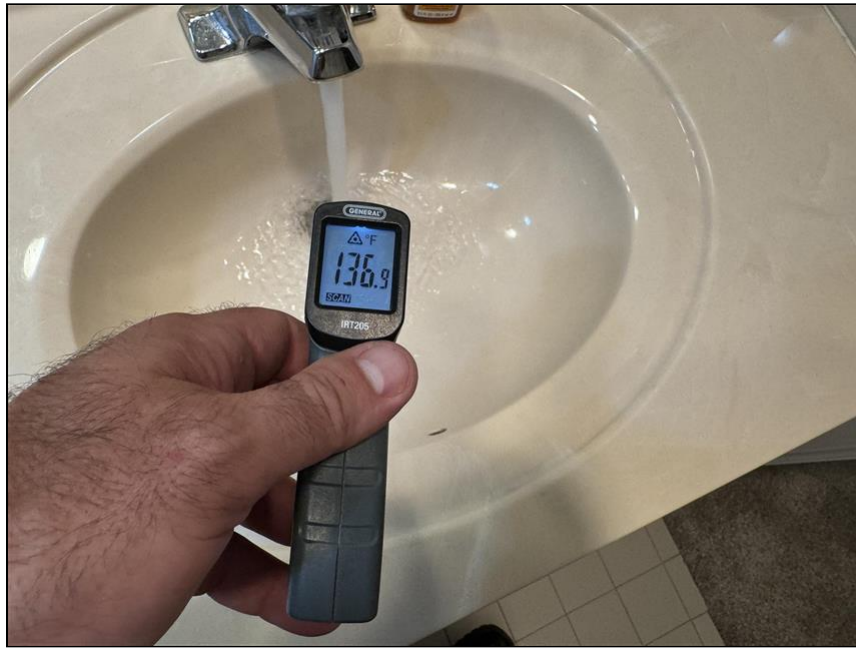
Hot water temperature main house

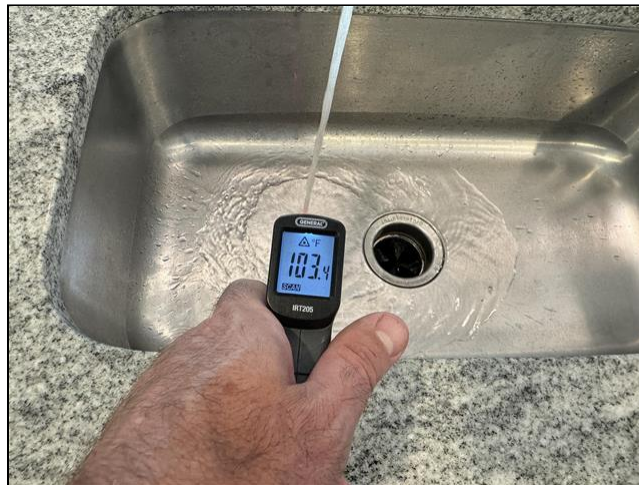
Hot water temp pool hose is a bit low. Recommend contractor increase temperature at water heater as needed.

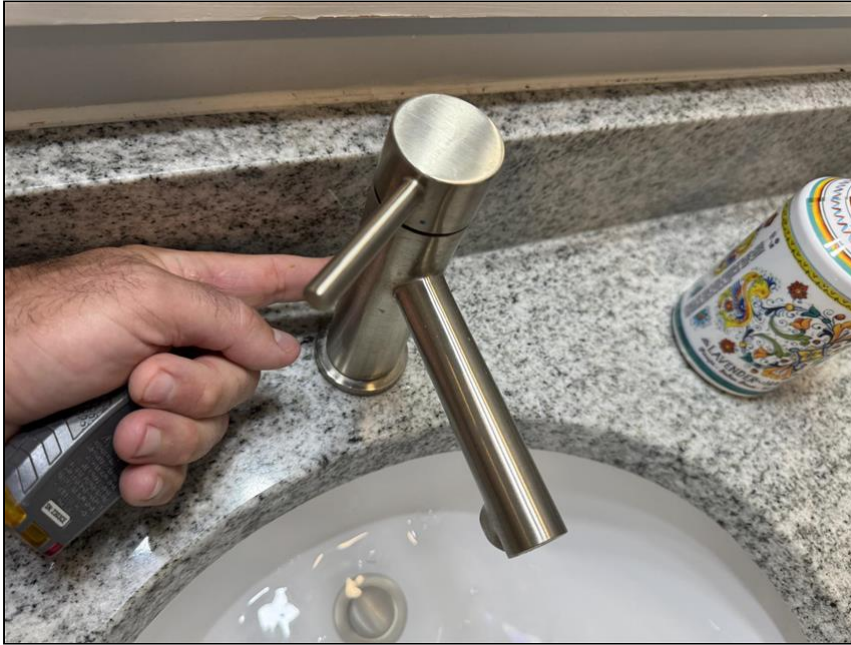
6.0 Item 1(Picture)

(1) Drain stop not opening in pool house bathroom. Recommend contractor review and repair.

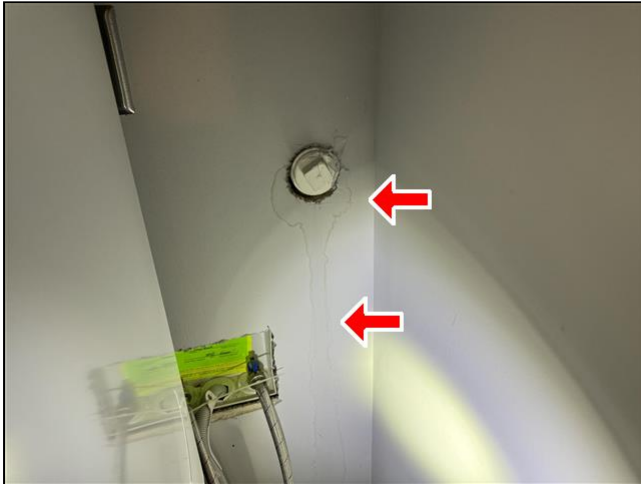
6.0 Item 3(Picture)

(2) Water staining noted at clean-out in laundry closet of pool house. This area was dry at the time of inspection. Recommend consulting seller as to cause of staining, additionally, recommend monitoring of this area to ensure no issue exists.

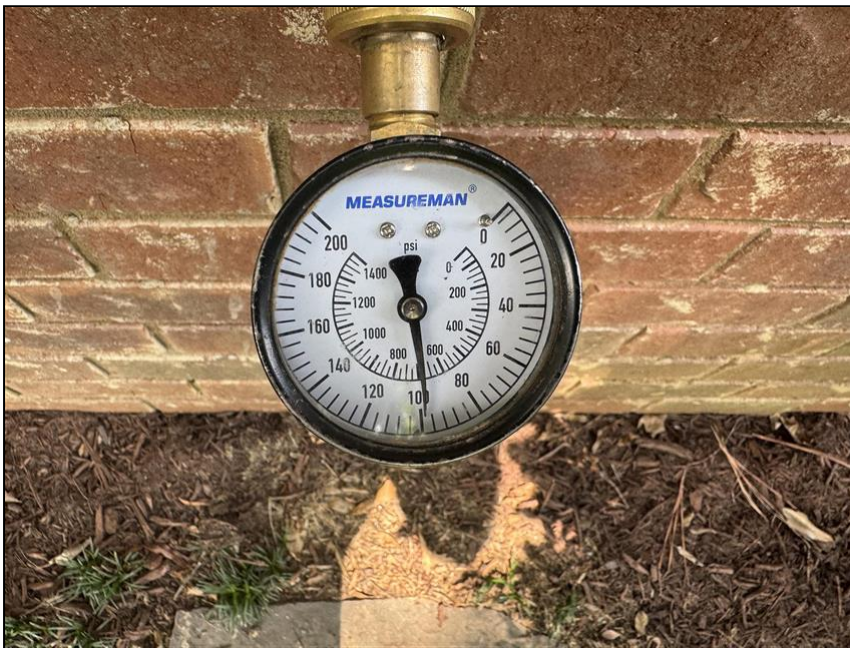
6.1 Item 1(Picture)

(1) Water pressure to the home is high at 100 psi. High water pressure can put undue stress on plumbing system and fixtures, however, no deleterious effects were noted at the time of inspection. Recommend licensed plumber review and repair as necessary.

Water pressure high at 100 psi. See Section 6.1 for more details.

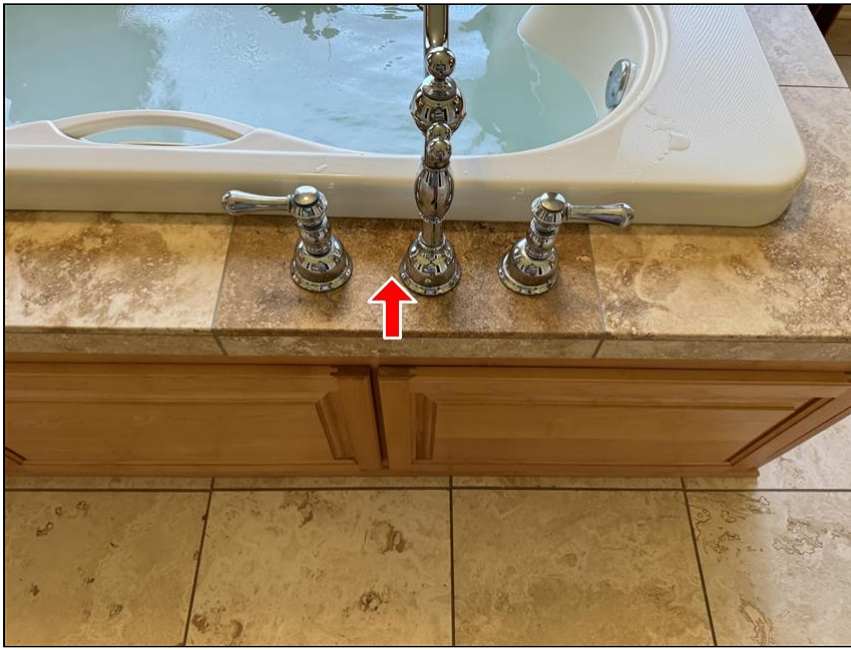
6.1 Item 2(Picture)

(2) Small leak noted at faucet of tub in master bathroom. Recommend licensed plumber repair as needed.

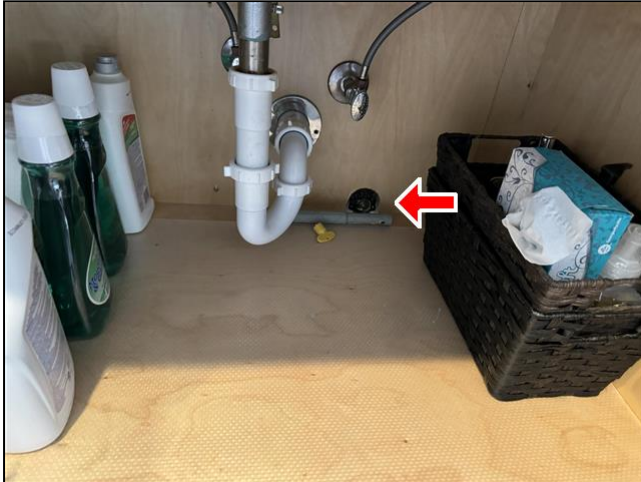
6.3 Item 1(Picture)

Main water shutoff in pool hose is located under sink in bathroom. Main water shut-off was not located in main house and may only exist on water meter at street. This is noted for client information.

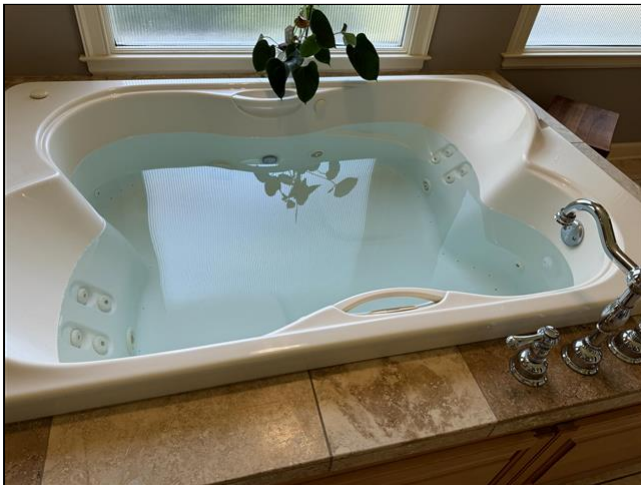
6.7 Item 1(Picture)

Remote for whirlpool tub not working at the time of inspection, likely due to a bad battery. Recommend seller replace battery and ensure proper operation.

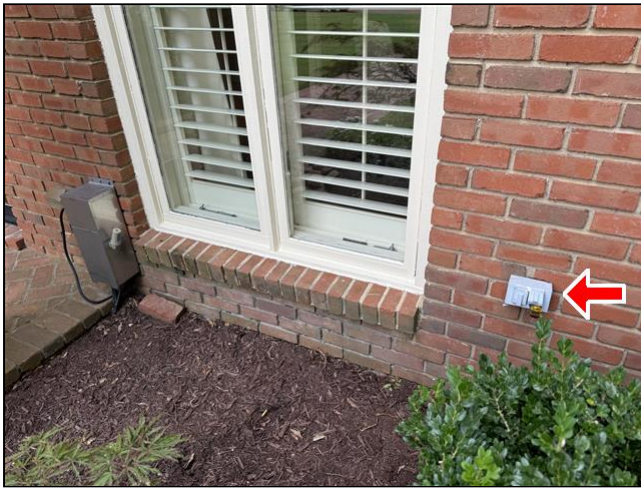
7.3 Item 1(Picture)

Outlet at front of home is not GFCI protected. Recommend licensed electrician replace with a GFCI protected outlet.

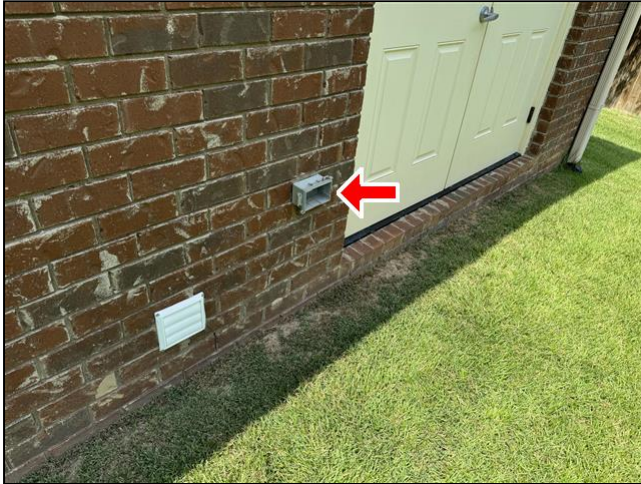
7.7 Item 1(Picture)

GFCI receptacle at rear of pool house will not reset and has a broken cover. Recommend licensed electrician repair as necessary.

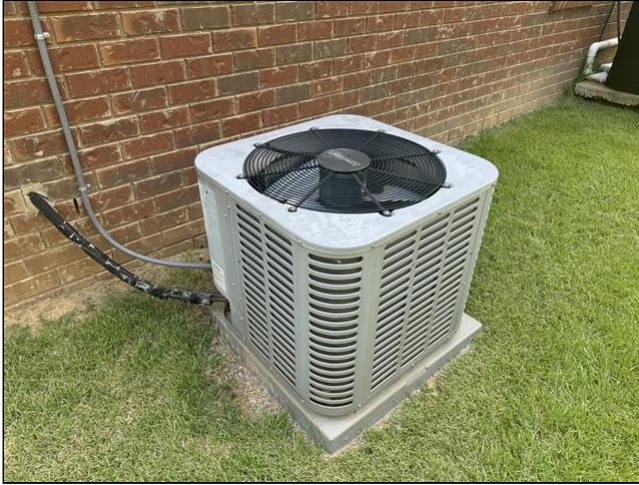
Pool house AC

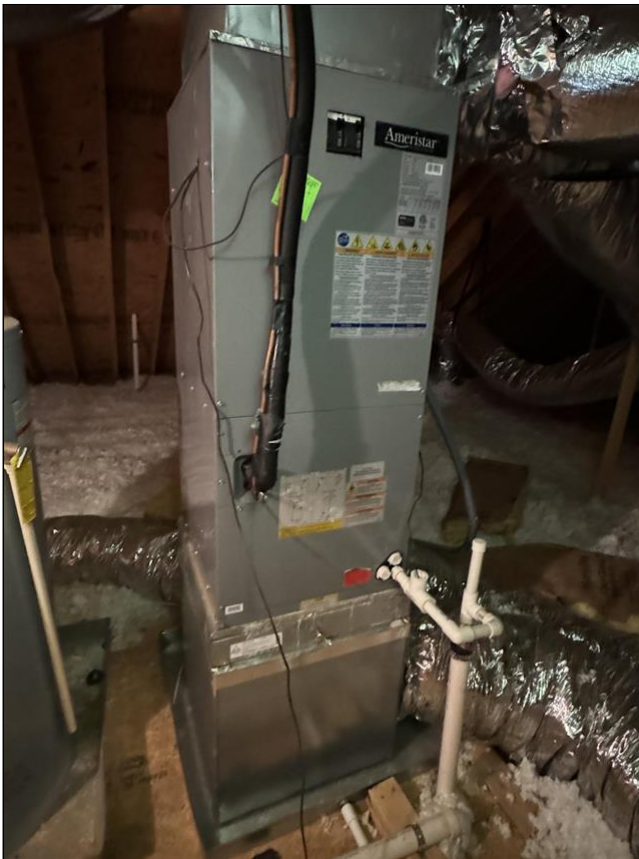
Pool house furnace

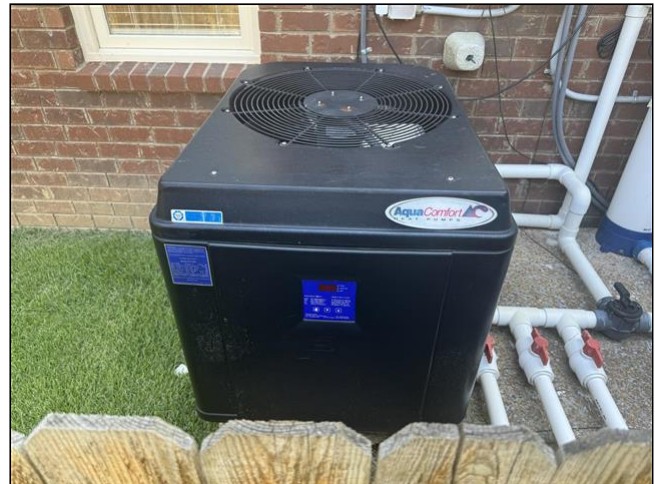
Pool heater

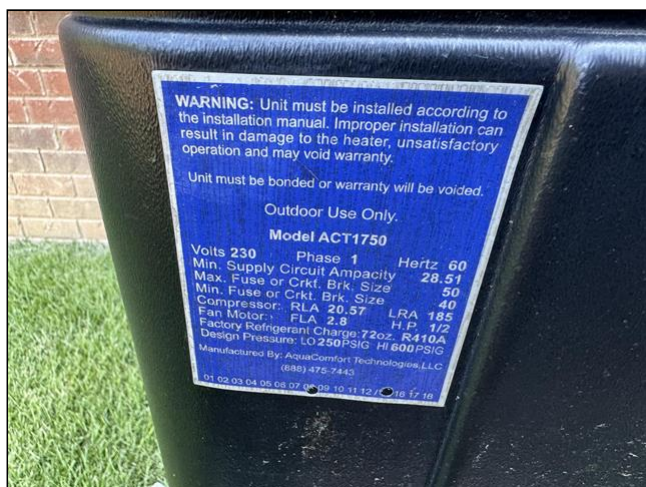
Pool heater data plate

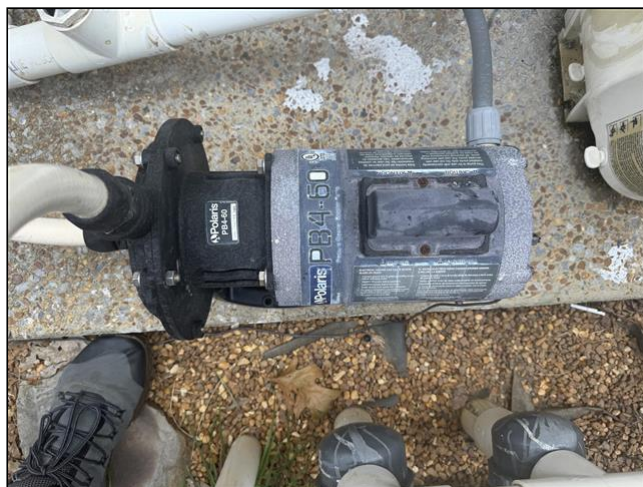
Polaris pump

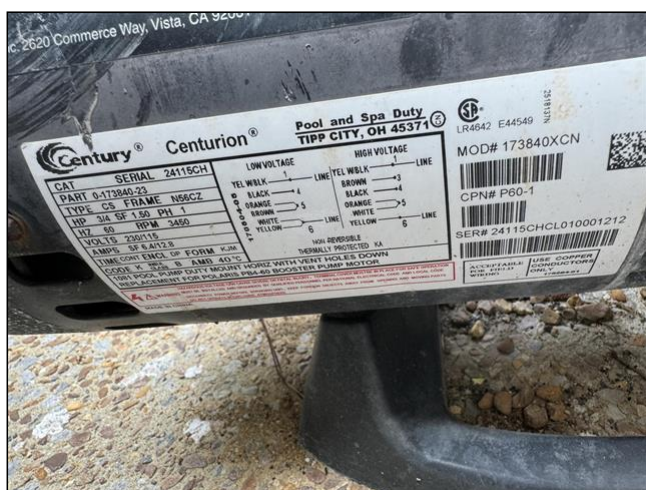
Polaris pump data plate

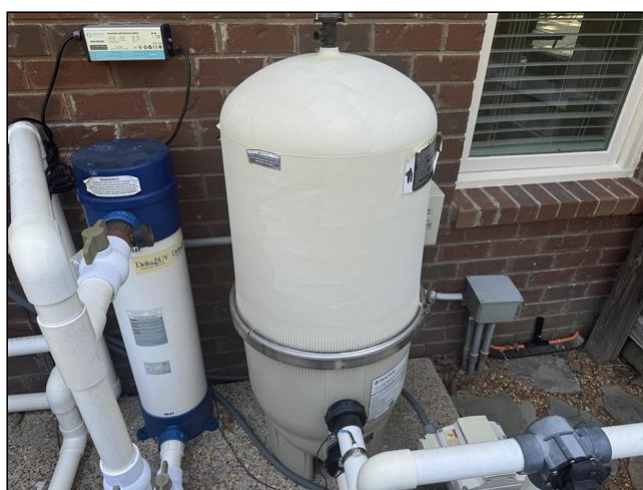
Pool filter

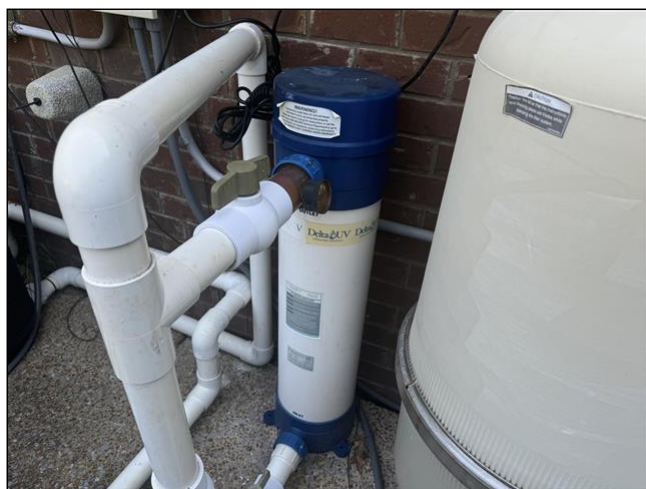
UV water sanitizer

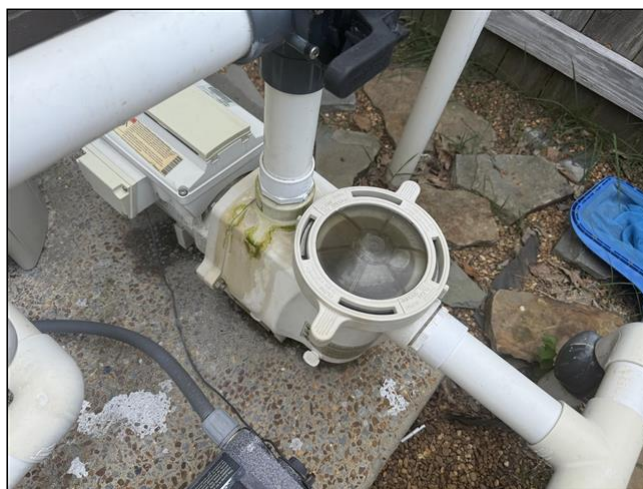
Pool pump

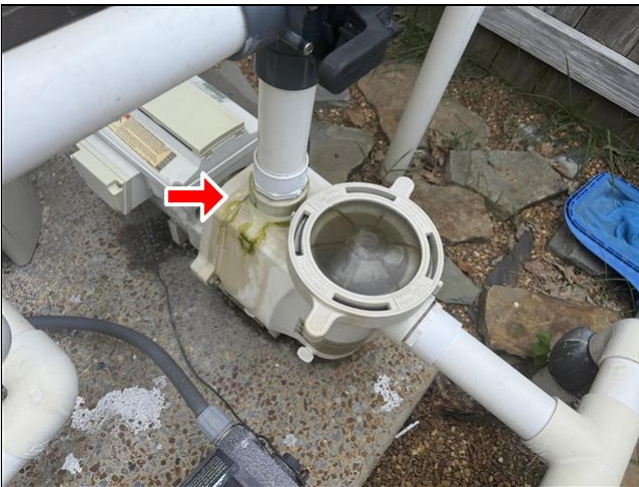
12.4 Item 1(Picture)

Leak noted on PVC pipe above pool pump. Recommend pool specialist review and repair as necessary.

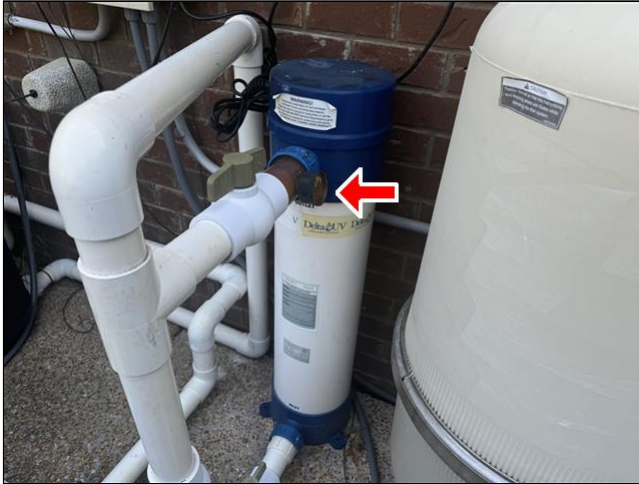
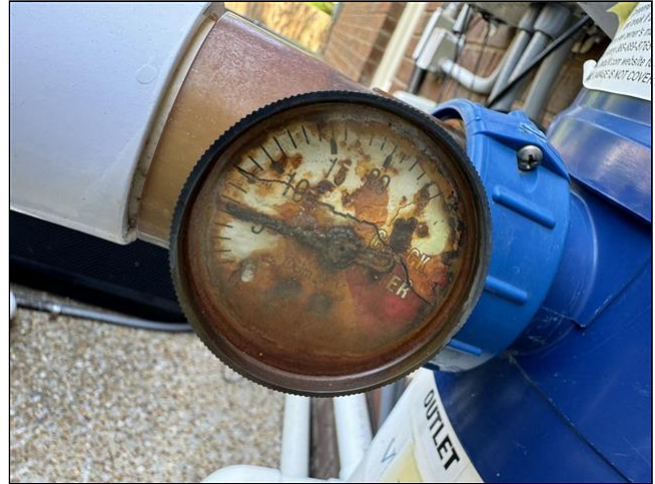
12.5 Item 1(Picture)

Gauge for UV sanitizer has a compromised seal and is difficult to read. Recommend pool specialist review and repair as needed.

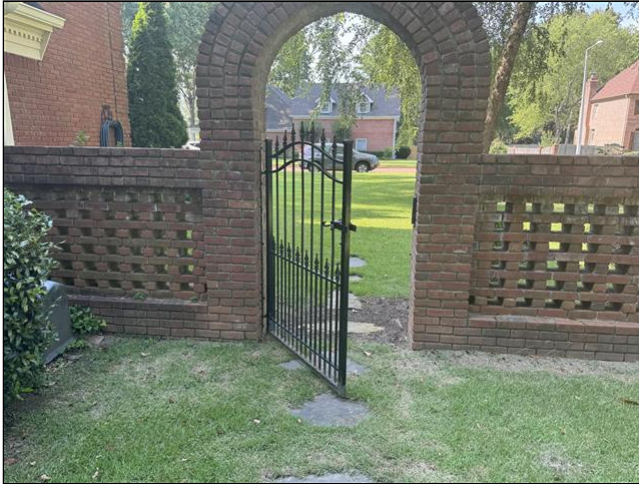
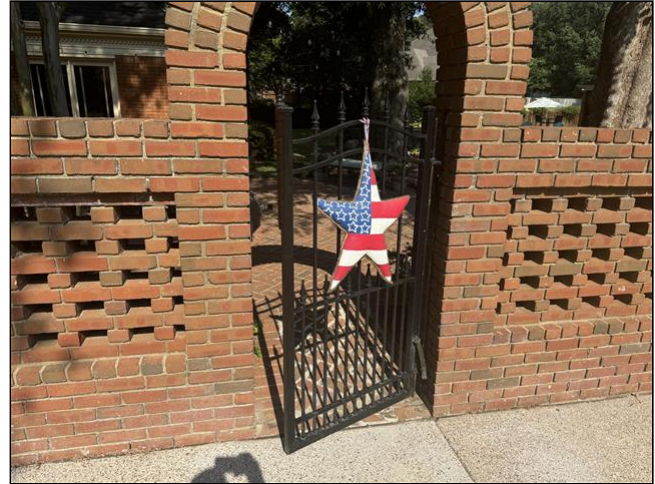
12.16 Item 1(Picture)

Main gate off driveway is self closing and self latching, however, self closing spring is not functioning properly. Secondary gate at side of home has no self closing or self latching mechanisms.
