RESIDENTIAL REPORT

1234 Main Street
Loganville, GA 30052

Buyer Name
03/26/2025 9:00AM

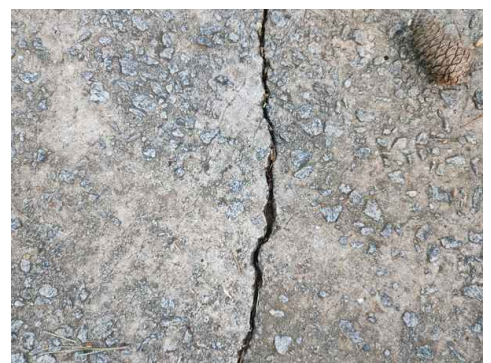
2.2.1 Walkways & Driveways

COMMON CRACKING DRIVEWAY/WALKWAY

Minor shrinkage or settlement cracking was observed in one or more locations at the driveway/walkway. We suggest sealing all cracks to prevent water penetration which can make cracking more significant over time.

Recommendation

Contact a qualified concrete contractor.

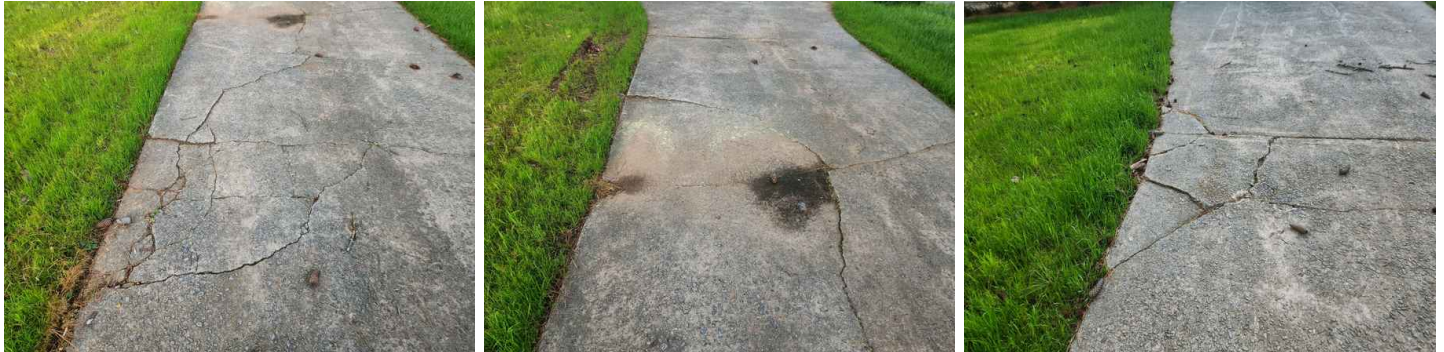
2.2.2 Walkways & Driveways

DRIVEWAY CRACKING/HEAVING - MAJOR

Advanced settlement with cracking and/or heaving noted at one or more areas of the driveway. Possible trip hazards observed. Recommend concrete contractor evaluate and correct as needed.

Recommendation

Contact a qualified concrete contractor.

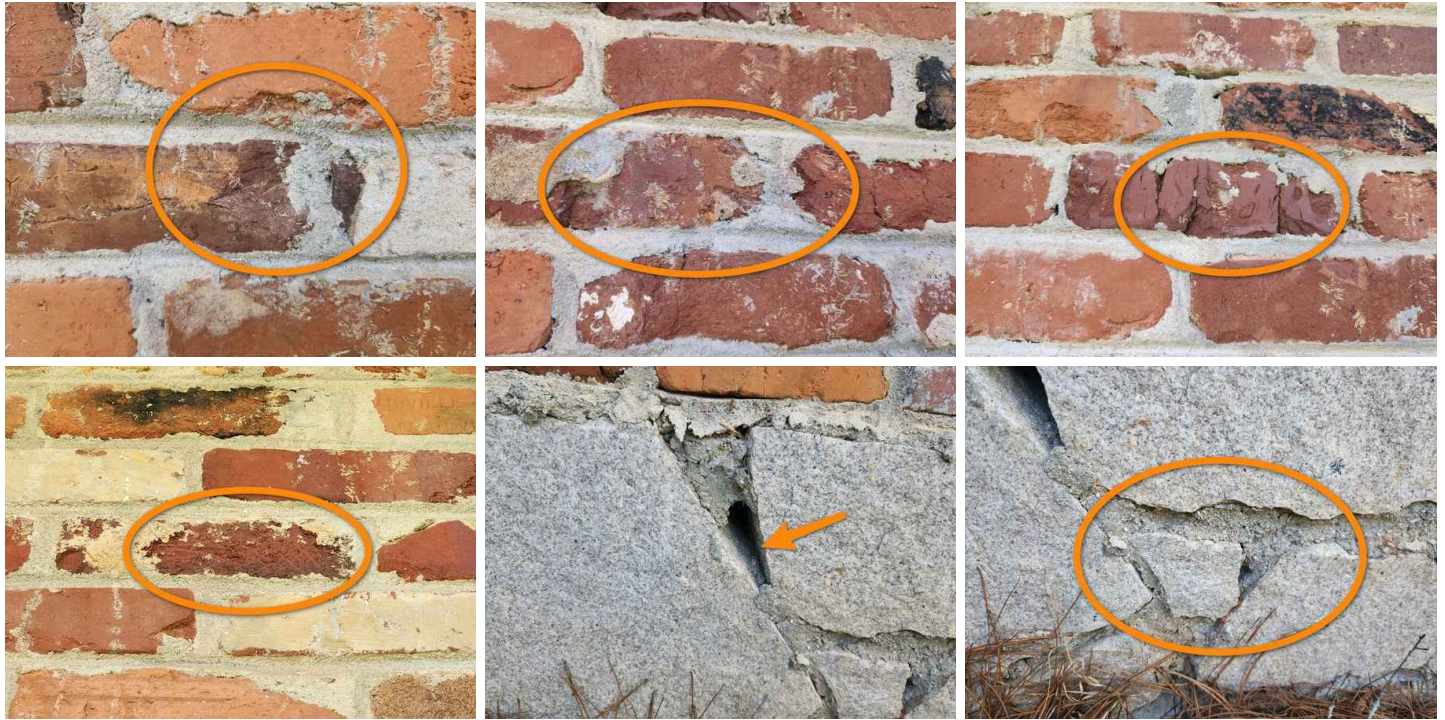
2.3.3 Siding

DAMAGED/DETERIORATED MASONRY

One or more areas of slightly damaged/deteriorated masonry (brick, stone or mortar) were observed around the structure. We recommend having these damaged/deteriorated areas repaired or replaced by a qualified masonry contractor as needed.

Recommendation

Contact a qualified masonry professional.

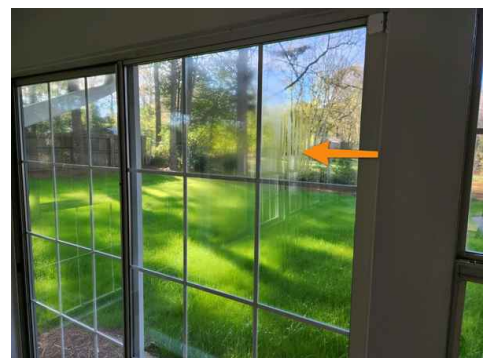
2.5.1 Exterior Windows/Doors

BREACHED SEAL(S) AND/OR FAILED UV COATINGS

REAR SLIDING DOOR

Condensation, mineral deposits and/or discoloration were observed at one or more thermopane windows or doors. This indicates that the insulated glass window seal(s) or UV coatings have failed and/or are breached. This condition allows condensation stains to develop on the inside of the glass or colored streaking to occur at the glass. While this will not have a significant effect on the ability to insulate, it will increasingly hamper visibility and appearance. We are not required to inspect thermopane units in doors, windows, and/or skylights for breached seals or failed UV coatings but it is done as a courtesy only. If concerned, we recommend review and corrections by a qualified professional.

Recommendation

Contact a qualified window repair/installation contractor.

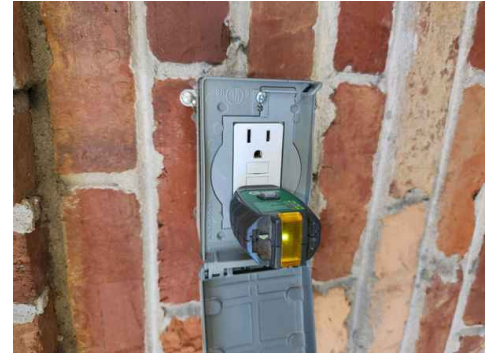
One or more outlets at the exterior of the home tested as ungrounded/open ground, hot/neutral reversed, open neutral or otherwise improperly wired. This condition is a potential safety concern. Evaluation by a licensed electrician is recommended for corrections or replacement as needed.

Recommendation

Contact a qualified electrical contractor.

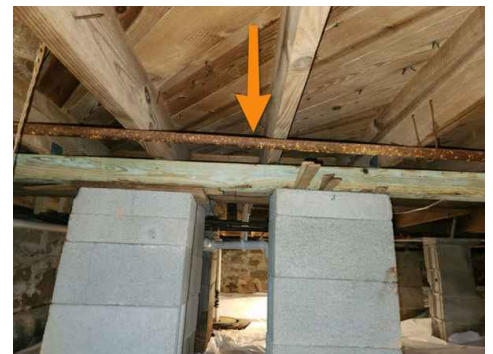
**CORROSION/RUST**

One or more exposed metal gas lines in the crawlspace are corroded/rusted. Further corrosion can lead to deterioration and potential leaks. Recommend further evaluation by a licensed contractor for corrections to prevent further rusting or replacement as needed.

Recommendation

Contact a qualified professional.

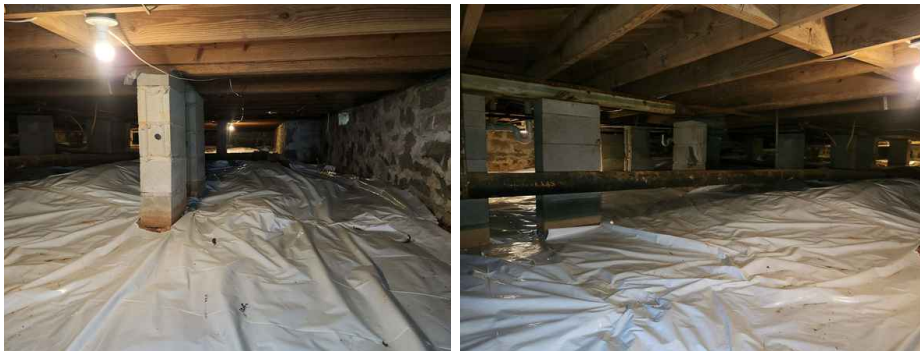
General: Photo/Video Views

Basement Slab/Substructure Floor(s): Crawlspace Floor Dry

Crawl floor was dry where visible, at the time of inspection. Due to changing conditions, we recommended monitoring the condition through the rainy season.

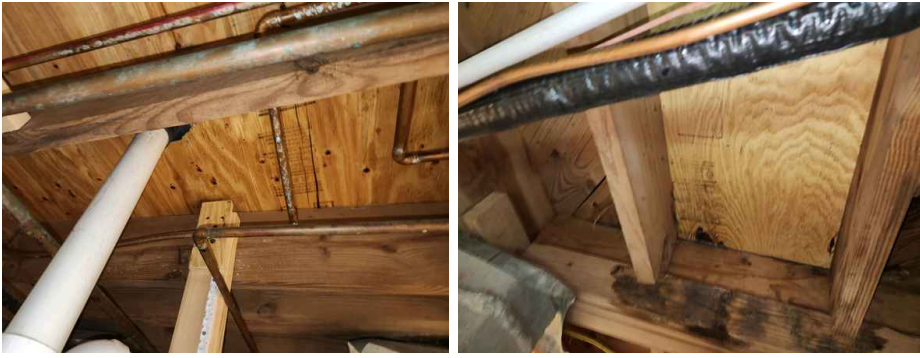
Joists & Sub-Floor: Repairs Noted

Repaired/replaced sub-flooring or framing was observed in one or more areas. We recommend obtaining repair information from the seller as needed.

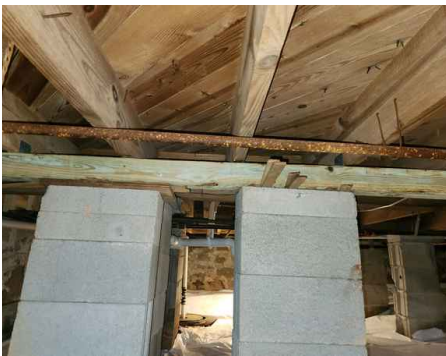
Joists & Sub-Floor: Evidence of Leveling or Additional Structural Supports

Evidence was observed in the sub-structure of past leveling or structural re-supporting efforts at the floor support structure. Unable to determine the adequacy of these components. We suggest verifying past conditions with the seller as needed and obtaining any contractor information. If client has further concerns we suggest consulting a licensed structural engineer or qualified contractor for further review.

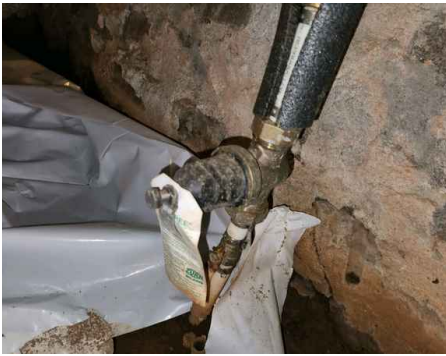
A pressure regulator device was observed for this structure. We recommend verifying the operation and proper setting for this device with a licensed plumber if concerned. It is beyond the scope of our inspection to operate these

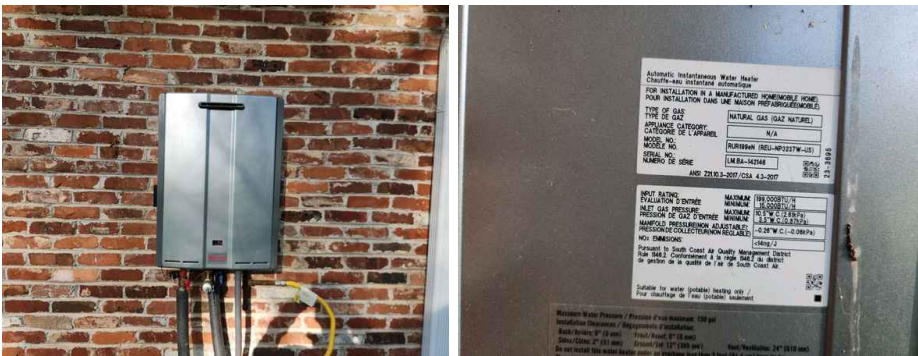
Water Heaters: Photo/Video Views

Water Heaters: Water Heater(s) Functional

Hot water was obtained at all tested wet locations, indicating these units were operational at the time of inspection. Determining the future condition and remaining life of the water heaters is beyond the scope of this inspection. No visible leaks were observed at time of inspection.

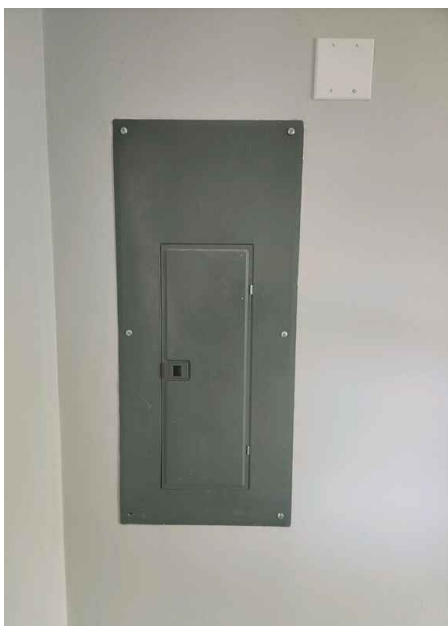
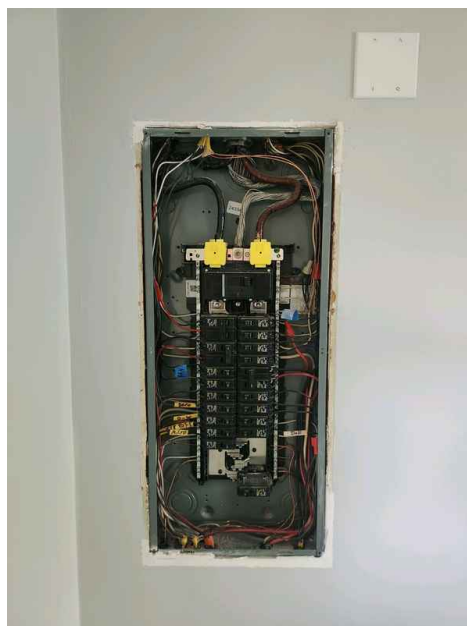
Branch Wiring Circuits, Breakers & Fuses: Thermal Scan

All the breakers were scanned with an infrared laser thermometer or thermal imaging camera and no abnormal temperatures were detected (no more than 10 degrees + or - the temperature of the metal panel itself).

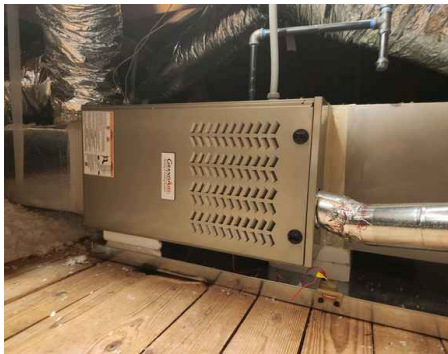
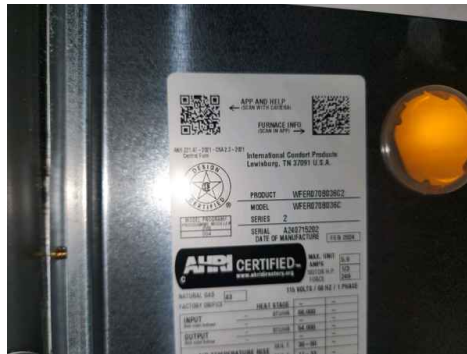
Equipment: Photo/Video Views

Equipment: Serviceable/Operational

Units were operated by thermostats. Units functioned properly when tested and appeared to be serviceable at the time of inspection. As with all mechanical equipment, they can fail at anytime without warning. Inspectors cannot determine future failures.

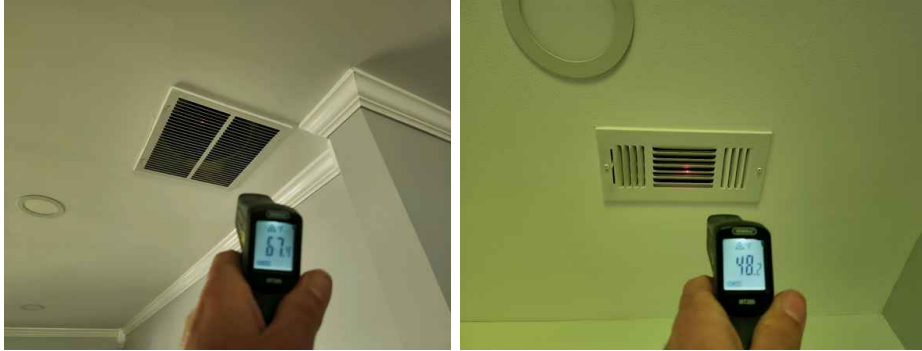
Cooling Equipment: Adequate Temperature Drop

19 (F)

A temperature drop was performed across the evaporator coil of this unit. When testing, the temperature difference between the return register and the supply registers are considered normal if within an operating range of 14-22 degrees. Units operating above or below the 14-22 degree range should be evaluated for maintenance by a qualified HVAC contractor.

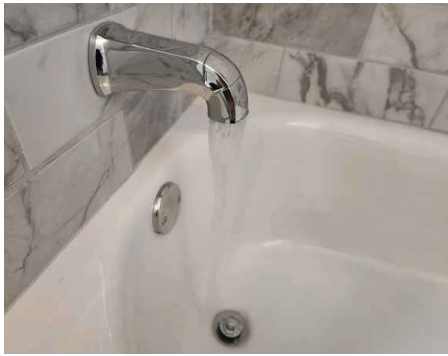
Shower(s): Faucets/Drains Operational

Operational. Functional water flow observed and no leaks noted at the time of inspection.

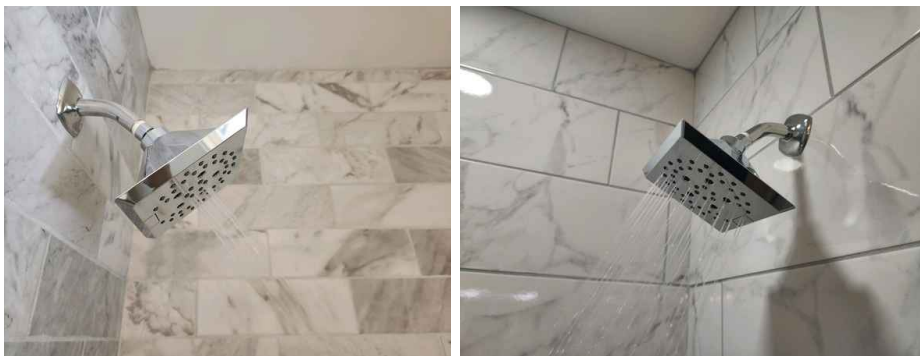
Shower(s): Keep Caulked

The seams/edges of the tub/shower surround should be caulked or sealed to prevent moisture penetration. Failure to keep walls sealed can cause moisture damage to the interior walls, which is not always visible at the time of the inspection.

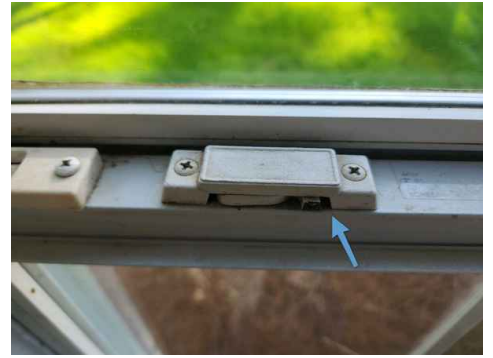
One or more window latches/locks were inoperable, damaged or missing. We recommend corrections for safety.

Recommendation

Contact a qualified professional.

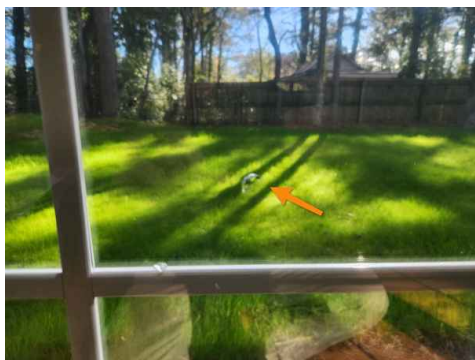
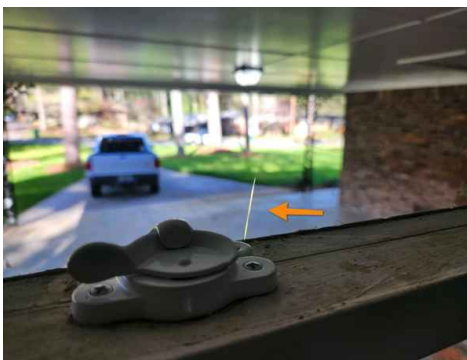
One or more cracked panes were observed. Repairs/corrections as needed by a licensed window specialist are recommended.

Recommendation

Contact a qualified window repair/installation contractor.

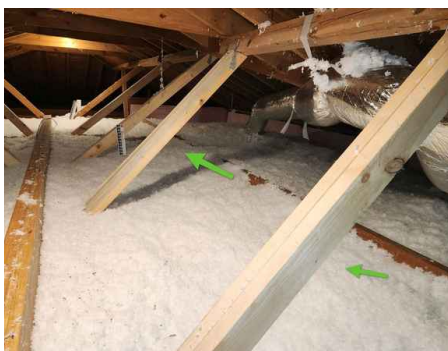
One or more roof supports appear to have been added after construction. We recommend verifying the history/reason for these supports with the seller or a licensed contractor prior to close.
