PROPERTY INSPECTION REPORT

Property Information- This is a single family home. Levels- 2 story structure, Estimated age- This structure is approximately 12 years of age. Weather Conditions Cloudy. Temperature at the time of the inspection was in the mid 60's.

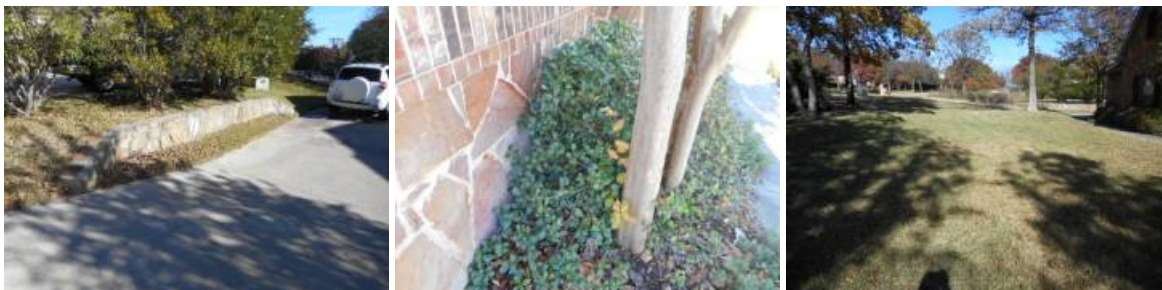
Grade appears to slope toward the foundation on the Front side(s). Reshaping the area around the foundation to move water away from the structure would help to minimize movement of the foundation system which can be caused by poor drainage.

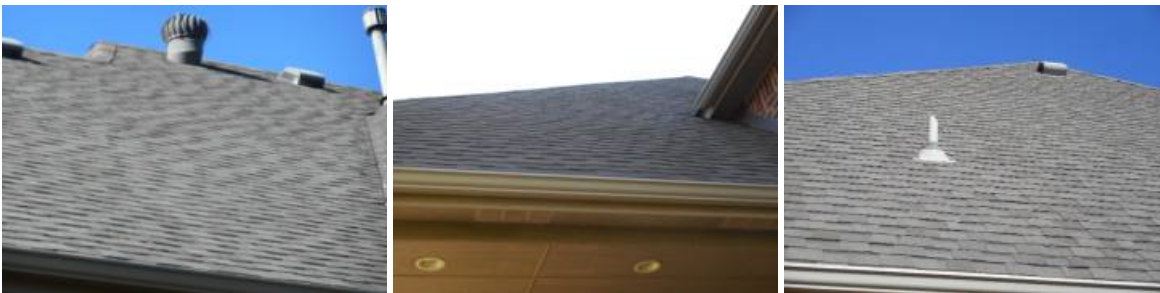
Tree limb(s) observed in contact and rubbing surface of roof. Trim to avoid excessive wear.

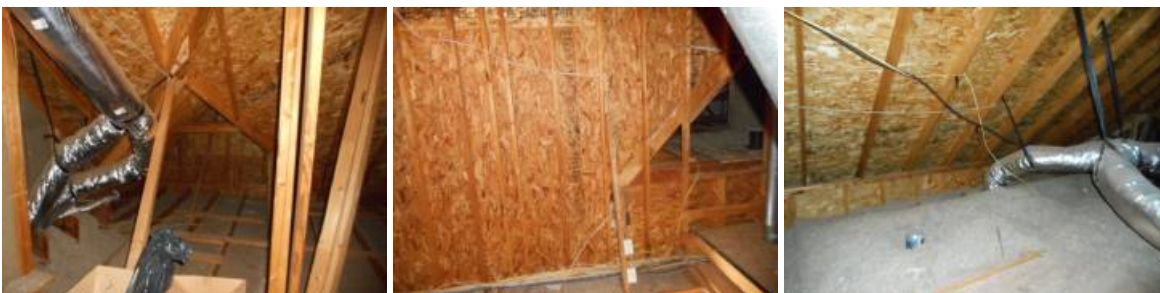
ATTIC OBSERVATIONS- Conventional framing Plywood sheathing was noted. ROOF STRUCTURE OBSERVATIONS- All visible components were in serviceable condition at the time of our inspection, ATTIC VENTILATION IS PROVIDED BY: Eave Vents. turbine Vents

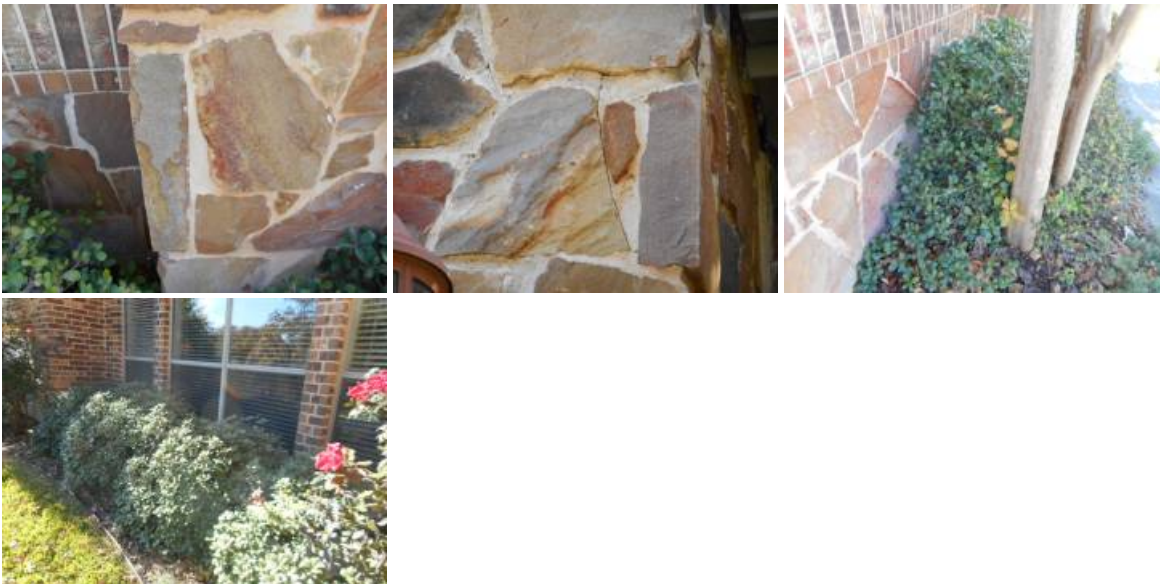
Common cracks observed, primarily a cosmetic concern. Suggest sealing all brick and mortar cracks to prevent water penetration as a routine maintenance effort.

We recommend sealing the fireplace vent at rear wall to prevent water intrusion.

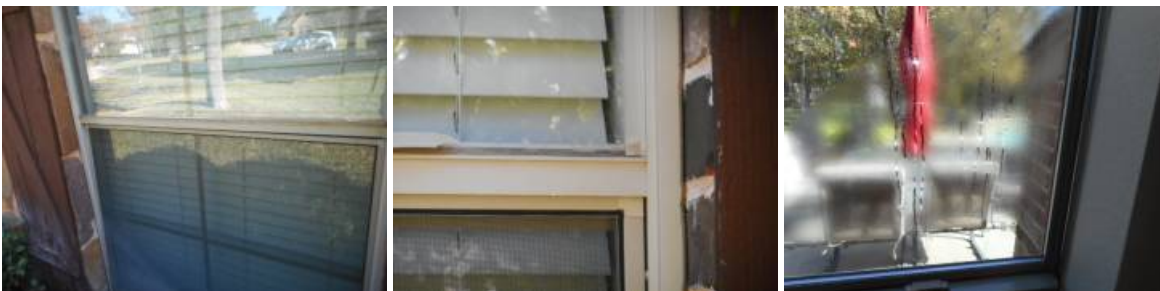
Thermal pane window(s) deficiencies- **Condensation stains were noted in the thermal pane windows located in the following areas: 1ea living room, 1ea right upstairs bedroom. Repair or replacement will be required if the visibility of the windows is to be restored.**

Area(s) of window glazing is cracked and/or missing.

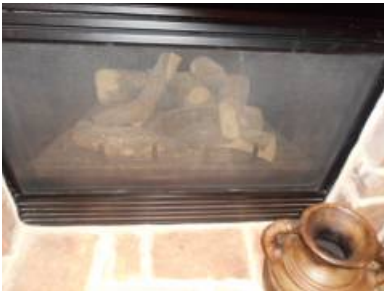
Examination of concealed or inaccessible portions of the chimney is beyond the scope of our inspection. We do not perform draft or smoke tests. If further review is desired, we recommend consulting with a qualified contractor. FIRE PLACE LOCATION- First Floor, Living Room. FIREPLACE TYPE- The fireplace is a prefabricated metal type. Gas logs were noted, The gas logs operated, FIRE PLACE OBSERVATIONS- All visible components were in serviceable condition at the time of our inspection.

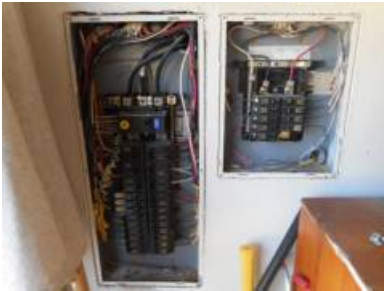
electrician. Service is underground. MAIN PANEL COMMENTS: The main service was approximately 200 amps, 240 volts. A grounding system was present. A main disconnect was not present. Overload protection provided by breakers. Main panel is located in the Garage Arc- Fault Circuit Interrupters (AFCI) were providing protection to all bedroom outlets. AFCIs use unique current sensing circuitry to discriminate between normal and unwanted arcing conditions. Once an unwanted arcing condition is detected, the control circuitry in the AFCI trips the internal contacts, thus de-energizing the circuit and reducing the potential for a fire to occur. Circuit breakers are provided. All visible components were in serviceable condition at the time of our inspection.

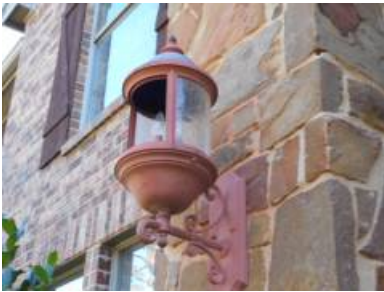
We noted the front porch light is missing a globe recommend repair.

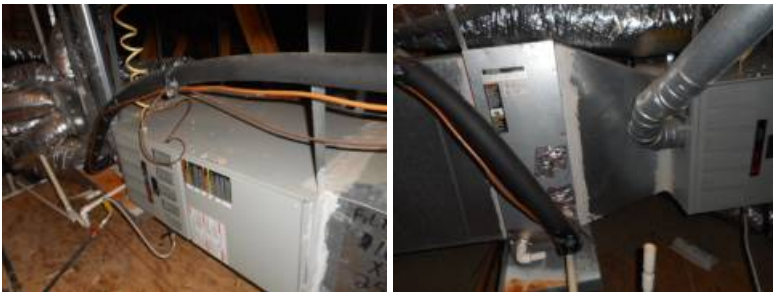
The evaluation of the HVAC system is an operational test of the equipment. The equipment is not disassembled, which means that in most cases, evaporator coils are not viewed and heat exchangers are not fully accessed (most newer units prevent any visibility of the exchanger/burner compartment). Regular maintenance of the hvac system can greatly extend it's useable life. We recommend contracting with a licensed professional on a yearly basis to help ensure safe and proper operation of the furnace and air-conditioning system. Heating System- The heating system operated correctly at the time of the inspection.

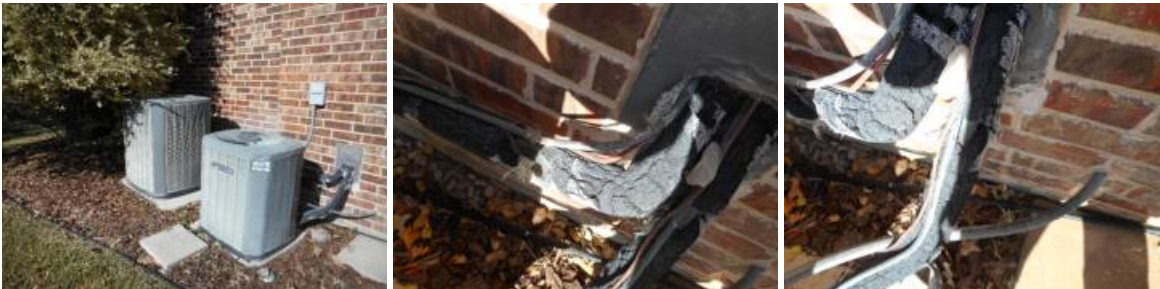
CONDENSER (EXTERIOR UNIT) OBSERVATIONS- Condenser Deficiencies- Insulation is damaged and/or not present on refrigerant line, recommend repair.

EVAPORATOR OBSERVATIONS- Evaporator Deficiencies- Rust was present in the secondary drain pan. This is an indication that the primary drain line is or has been clogged at some point in time, recommend review/repair by qualified HVAC contractor.

Insulation is damaged and/or not present on primary drain line recommend repair.

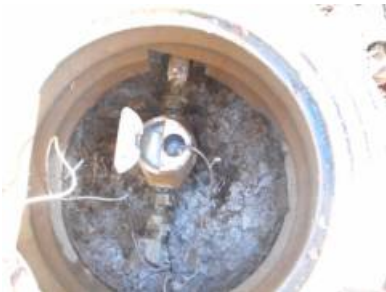
Location of water meter: The water meter is located at the street.

Location of main water supply valve: Valve is located at the water meter.

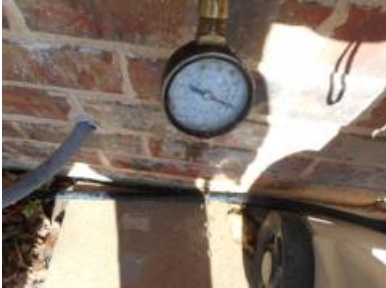
The water meter drip indicator showed no signs of flow to the structure when no demand was called for at the structure. Kitchen, bathroom, and exterior fixtures were operated. Municipal service is primary water source. SUPPLY PIPING TYPE- Piping, where visible, is copper.

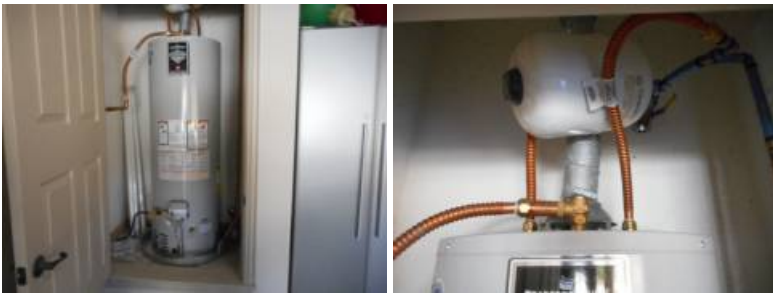
The water heater(s) operated as intended and all visible components were in serviceable condition at the time of our inspection.

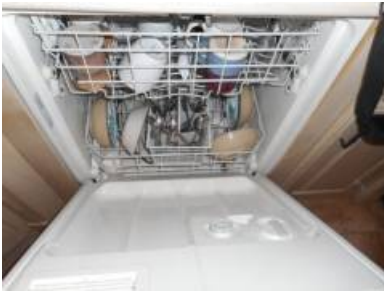
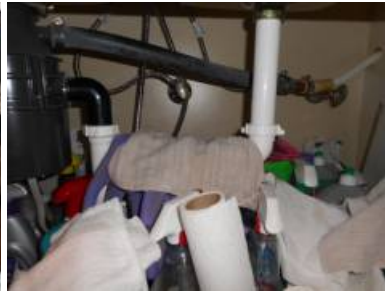
We noted the soap cup did not stay closed recommend repair.

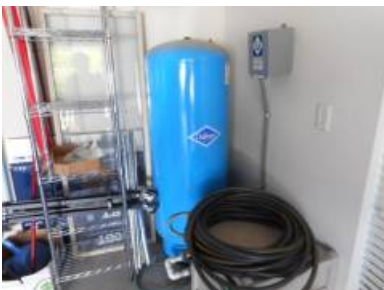
D. Private Water Wells (A coliform analysis is recommended.)

Type of Pump Submersible.

Type of Storage Equipment: Pressure Tank (with membrane)
