**AmeriSpec Inspection Services**

Doc #: Sample #12345  
Date: 8/1/2019  
Dwelling Address: 123 Main St.  
Anytown OH 43333  
Client Name: John Doe  
Client's Agent: Jane Smith                      Real Estate Company: Real Estate Pro

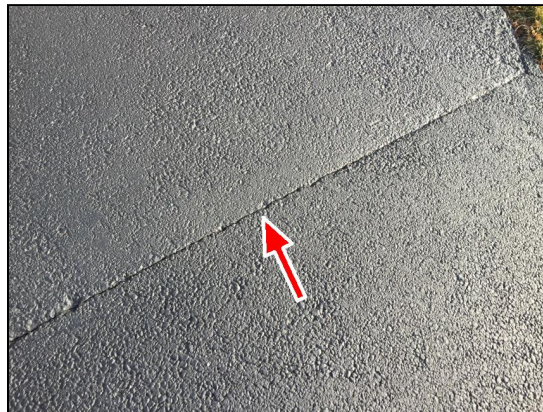
Step #	Component	Comment
2.0	Driveway	<b>Maintenance. Cracks observed, we recommend sealing cracks to prevent water infiltration and further cracking.</b>

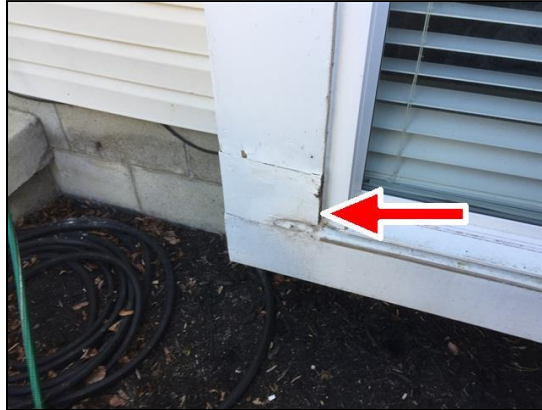
2.3 Trim **Maintenance. Moisture damaged trim observed at the front. Recommend repairs to prevent further damage.**

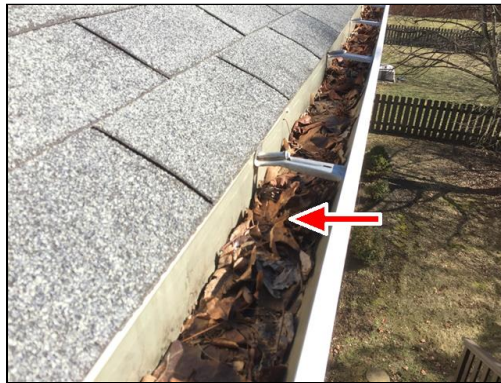
2.4 Gutters / Downspouts **Maintenance. Recommend cleaning leaves and debris from gutters and downspouts as a part of a normal maintenance routine to ensure proper drainage.**

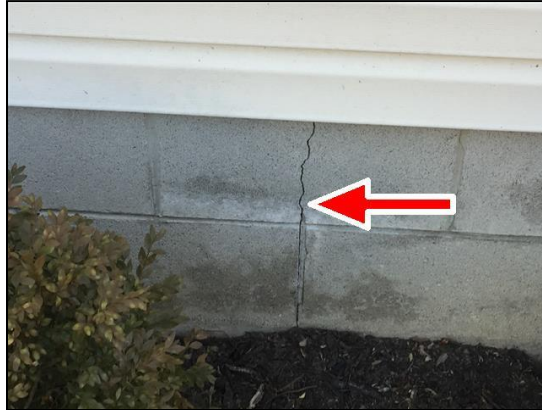
2.13 Foundation **Maintenance. As viewed from the exterior, the dwelling appears to have experienced a common degree of settlement for its age. At the time of the inspection, the cracks do not appear to be affecting the**

serviceability of the structure. Recommend sealing cracks to prevent water and pest penetration.

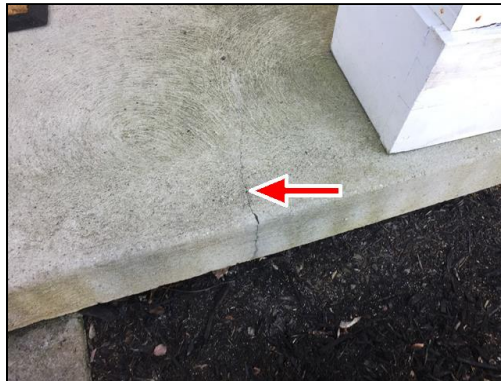
2.15 Porch

Maintenance. Common cracks observed, primarily a cosmetic concern. We recommend sealing all cracks to prevent water penetration as a routine maintenance effort.

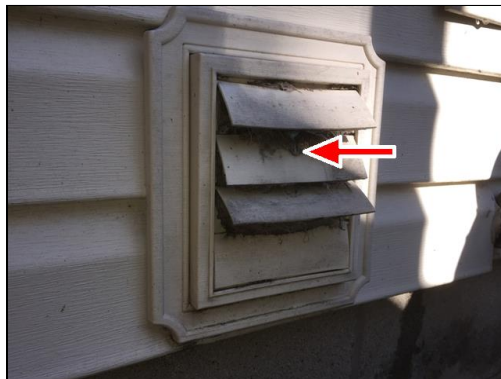
2.17 Dryer Vent

Safety. Dryer vent is dirty and needs cleaned for proper air flow and safety.

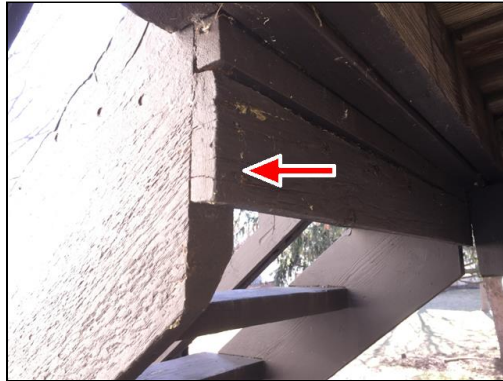
2.18 Stairs / Steps

**Safety. Stair stringers at deck are not properly attached with hangers, deterioration observed. Recommend review by a licensed contractor for corrections as necessary.**

**Stair stringers at deck are not properly attached with hangers, deterioration observed. Recommend review by a licensed contractor for corrections as necessary.**

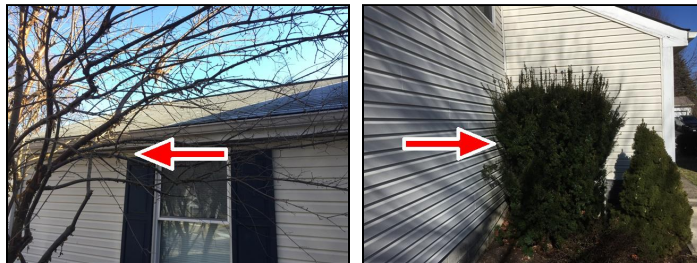
2.19 Exterior Comments

**Maintenance. Recommend trimming vegetation away from structure to enhance air flow, reduce moisture build-up and help prevent accelerated deterioration.**

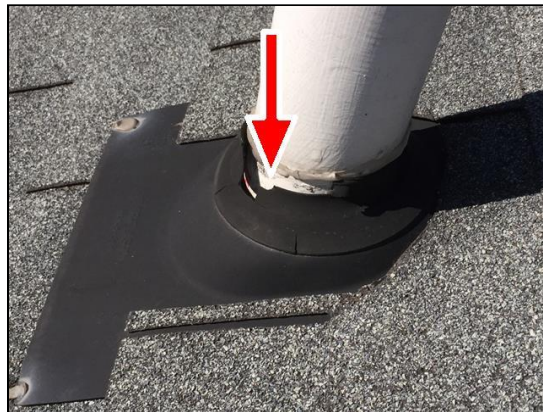
3.0	Exposed Flashings	<b>Review. Plumbing vent collar is deteriorated; recommend replacing by a licensed roofing contractor to prevent leaks.</b>
-----	-------------------	---

**Plumbing vent collar is deteriorated; recommend replacing by a licensed roofing contractor to prevent leaks.**

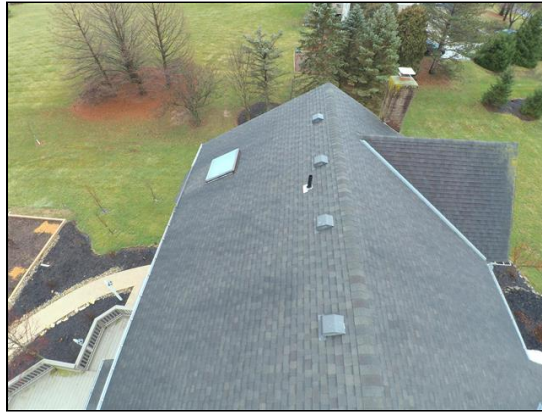
3.1 Roof Conditions

**Serviceable. Roof shows normal wear for its age and type. No damaged, deteriorated, or missing roofing materials were observed; it appears to be in serviceable condition at time of inspection.**

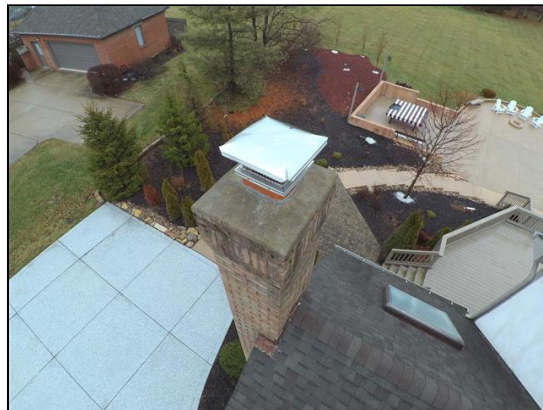
**Serviceable. Visible masonry is intact and appears to be in serviceable condition.**

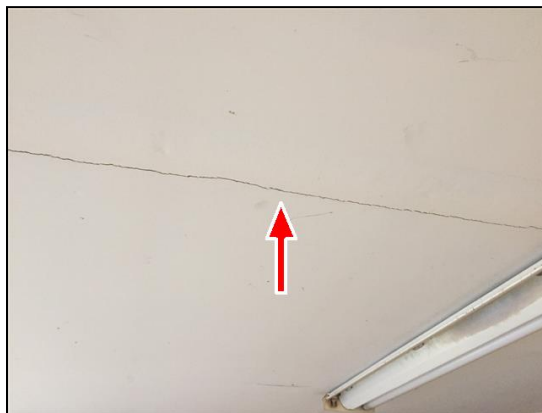
Step #	Component	Comment
5.0	Floor/Slab	<b>Serviceable.</b>
5.1	Walls	<b>Serviceable.</b>
5.2	Ceiling	<b>Maintenance. Visible cracks do not appear to be affecting the serviceability of the structure. Recommend repairs as needed for appearance.</b>

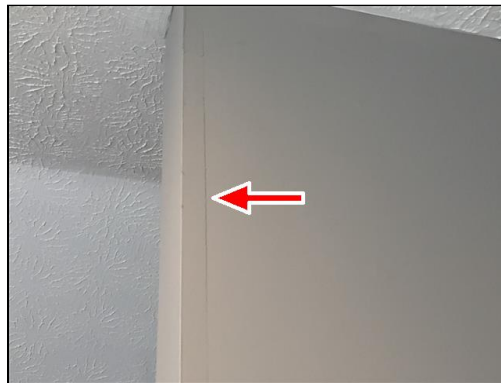
Step #	Component	Comment
6.0	Floor	Serviceable.
6.1	Walls	<b>Maintenance. Visible cracks do not appear to be affecting the serviceability of the structure. Recommend repairs as needed for appearance.</b>

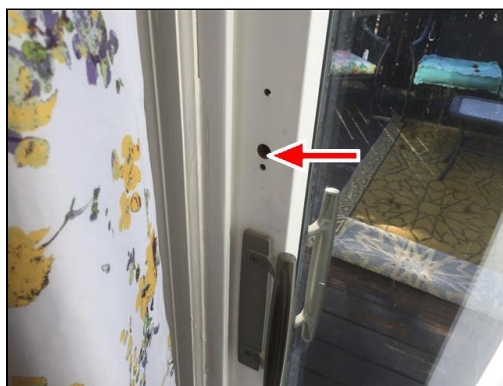
<b>Step #</b>	<b>Component</b>	<b>Comment</b>
7.0	Floors	<b>Serviceable.</b>
7.1	Walls	<b>Serviceable.</b>
7.2	Ceiling	<b>Serviceable.</b>
7.3	Doors	<b>Safety. Door lock is missing, replace as needed to ensure security.</b>

**Door lock is missing, replace as needed to ensure security.**

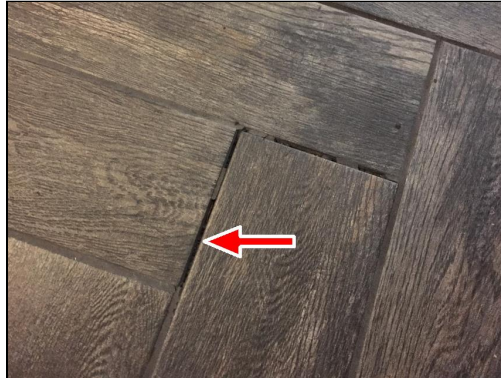
Step #	Component	Comment
9.0	Floors	<b>Maintenance. Deteriorated grout / loose tiles observed; recommend re-grouting as necessary, to prevent further damage.</b>

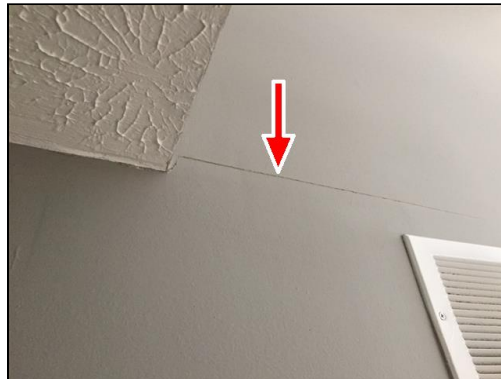
Step #	Component	Comment
10.0	Floors	<b>Serviceable.</b>
10.1	Walls	<b>Maintenance. Visible cracks do not appear to be affecting the serviceability of the structure. Recommend repairs as needed for appearance.</b>

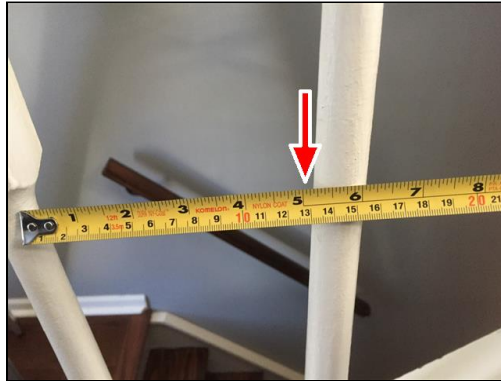
10.5 Stairs

**Safety. Spacing between spindles is larger than 4 inches which may allow small children to crawl through the space. Recommend reducing spacing as a child safety enhancement.**

**Spacing between spindles is larger than 4 inches which may allow small children to crawl through the space. Recommend reducing spacing as a child safety enhancement.**

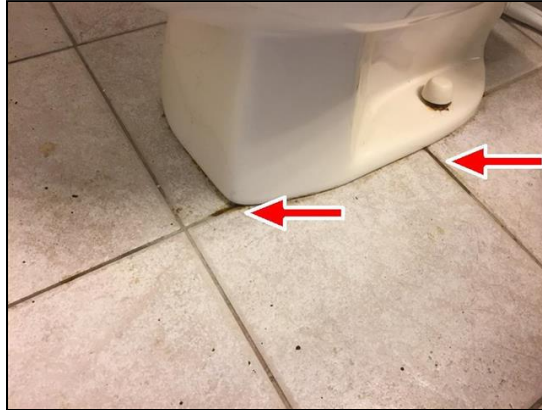
- 11.13 Sinks **Serviceable.**
- 11.14 Sink Faucets **Serviceable.**
- 11.15 Traps / Drains / Supply **Serviceable. Flow and drainage appeared to be serviceable at the time of inspection.**
- 11.16 Toilet **Review. Moisture detected at the base of the toilet using an electronic moisture detector. A licensed plumbing contractor is needed to make necessary repairs to prevent further damage.**

**Moisture detected at the base of the toilet using an electronic moisture detector. A licensed plumbing contractor is needed to make necessary repairs to prevent further damage.**

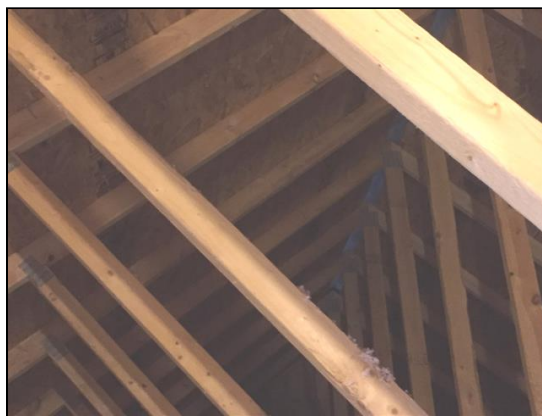
Step #	Component	Comment
15.0	Framing	<b>Serviceable. Wood truss construction noted. A visual inspection of trusses that were visible from the attic hatch was completed looking for damage, cuts, notches and gusset plate installation. Trusses should not be cut or notched as this will damage their structural integrity.</b>

15.1	Sheathing	<b>Serviceable.</b>
------	-----------	---------------------

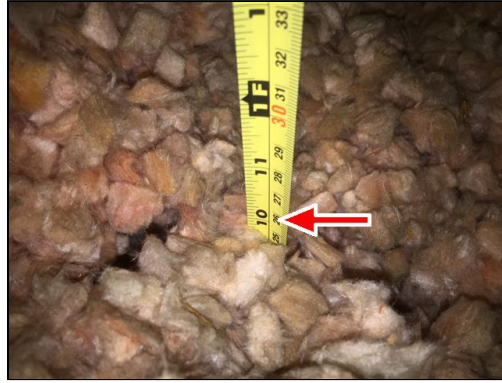
15.3 Insulation

**Serviceable. Approximately 10 inches of insulation was present in the attic. This equates to an R-value of approximately R-25.**

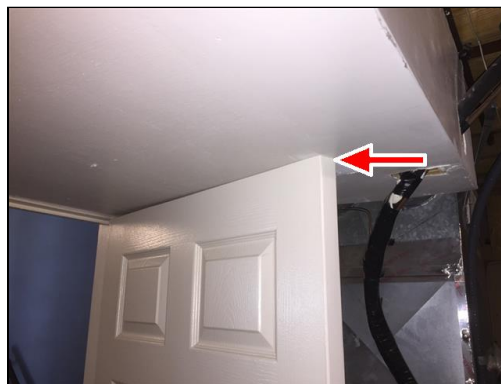
Step #	Component	Comment
16.0	Doors	<b>Maintenance. Door rubs ceiling, adjustments are needed for smooth operation.</b>

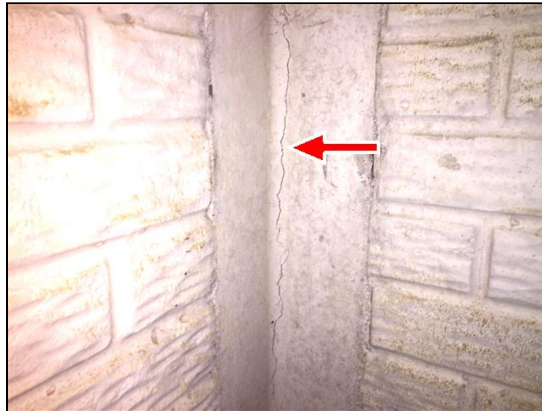
- 16.2 Walls **Maintenance. Cracks were visible on the exterior walls. At the time of the inspection, they do not appear to be affecting the serviceability of the structure. Recommend sealing cracks to prevent water penetration and monitoring the applicable areas for worsening condition.**

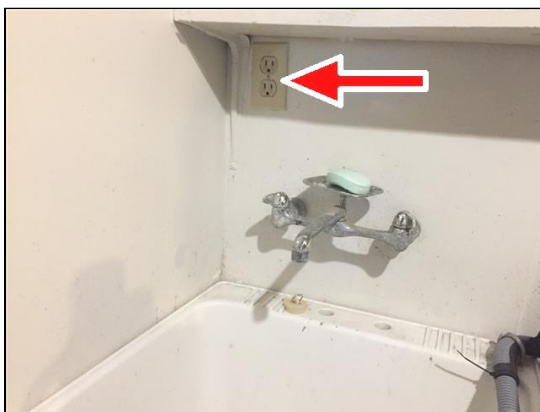
Step #	Component	Comment
17.0	Laundry Tub / Sink	<b>Serviceable.</b>
17.1	Faucets	<b>Serviceable.</b>
17.2	Electrical	<b>Safety. No Ground Fault Circuit Interrupter (GFCI) protection is present at washing machine and sink receptacles. Recommend installation of GFCI protected receptacles by a licensed electrician for safety.</b>

**No Ground Fault Circuit Interrupter (GFCI) protection is present at washing machine and sink receptacles. Recommend installation of GFCI protected receptacles by a licensed electrician for safety.**

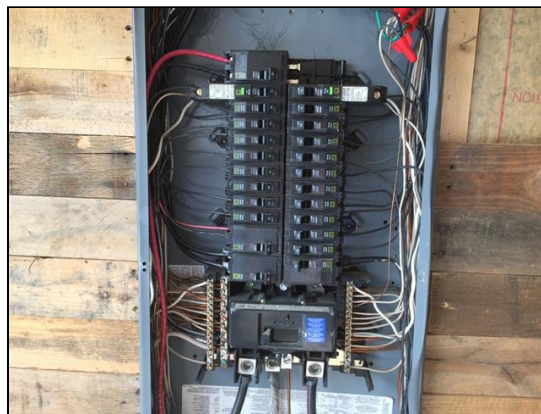
Step #	Component	Comment
19.0	Main Electrical Panel	Serviceable.

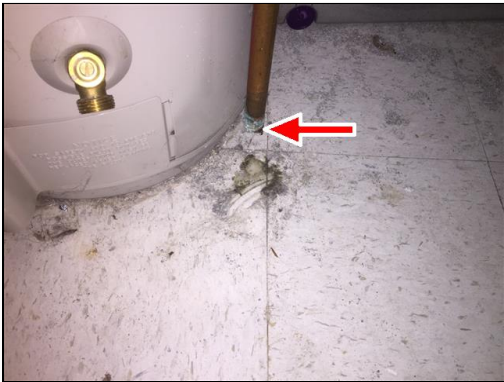
Step #	Component	Comment
22.0	Supply Lines	<b>Serviceable.</b>
22.1	Energy Source	<b>Serviceable.</b>
22.2	Temperature / Pressure Release Valve	<b>Review. TPR valve is leaking, which usually indicates a defective valve or the need for an expansion tank. Recommend review by a licensed plumber for corrections as needed.</b>

**TPR valve is leaking, which usually indicates a defective valve or the need for an expansion tank. Recommend review by a licensed plumber for corrections as needed.**
