SUMMARY REPORT

AmeriSpec Inspection Services
P.O. Box 5541
Vacaville, CA 95696
707-624-6133

Doc #: 070119DF3

Doc #: 070119DF3 Inspector: David Ferguson
Date: 7/1/2019
Dwelling Address:
Client Name:
Client's Agent: Real Estate Company:

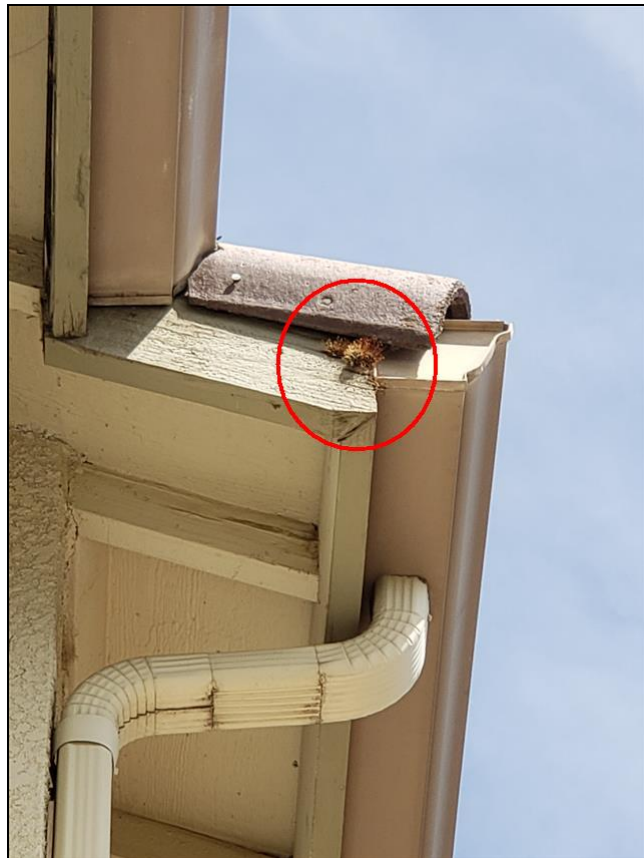
1.0 Item 1(Picture)

1.0 (1) Moss growth observed at front of home. Recommend corrections as needed.

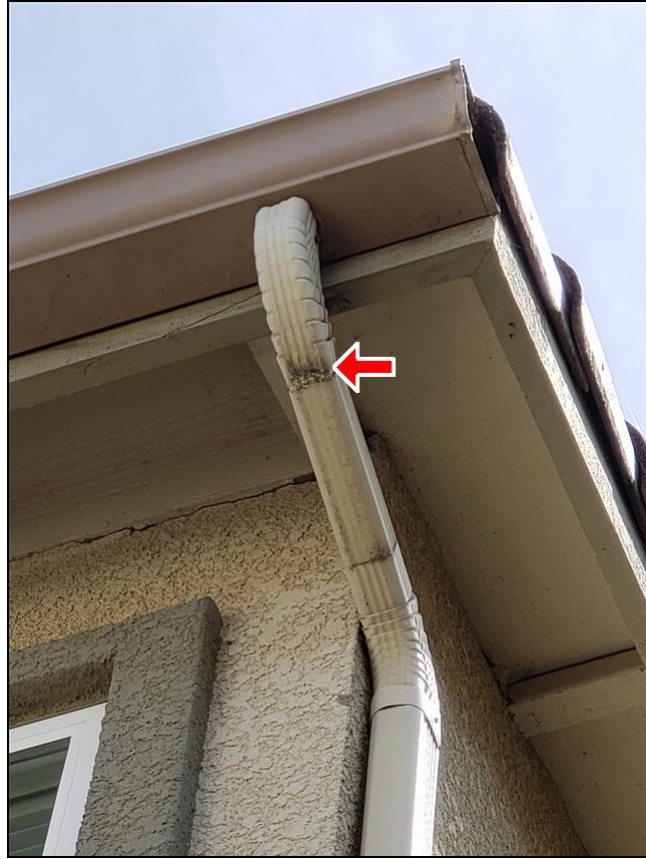
1.2 Item 1(Picture)

1.2 Recommend cleaning and apply sealant or epoxy as needed.

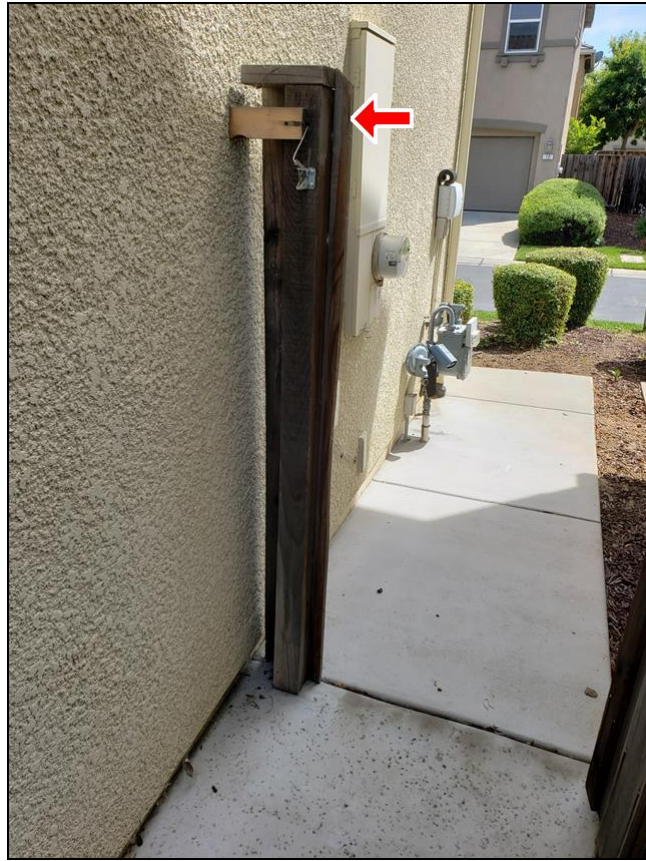
2.6 Item 1(Picture)

2.6 Loose fence sections observed at left side . Recommend review for repair or replacement as necessary.

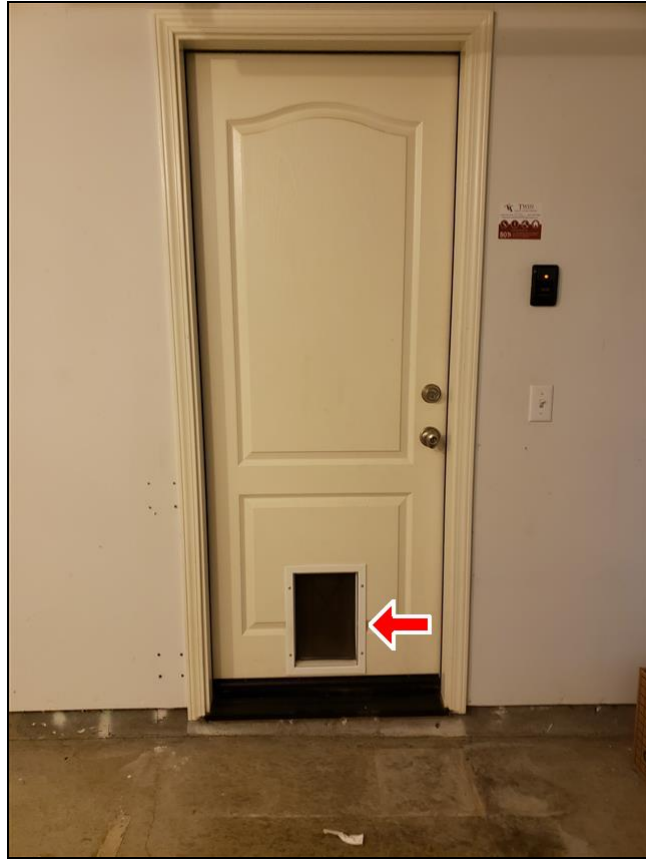
3.6 Item 1(Picture)

3.6 Fire rating of the garage wall is compromised due to installation of a dog door. This is a safety concern. Recommend corrections as needed.

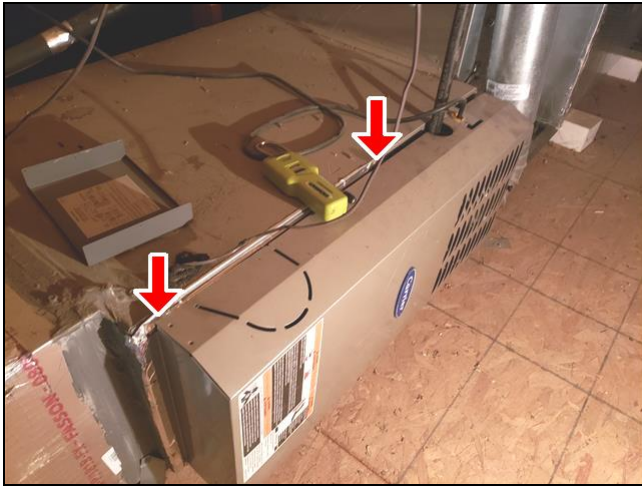
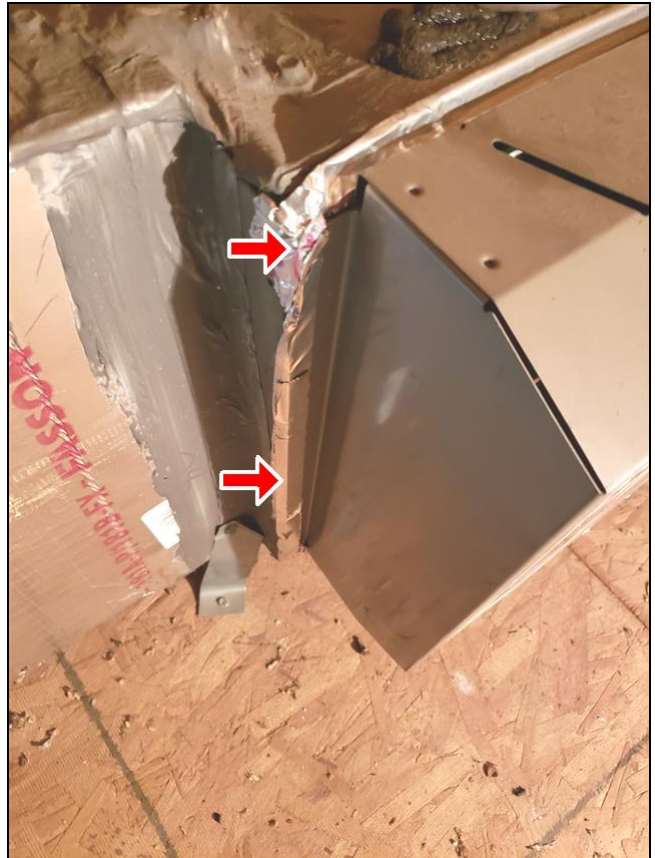
8.0 Item 1(Picture)

8.0 Due to excessive foil tape, the appliance cover does not fit properly. Recommend corrections as needed.

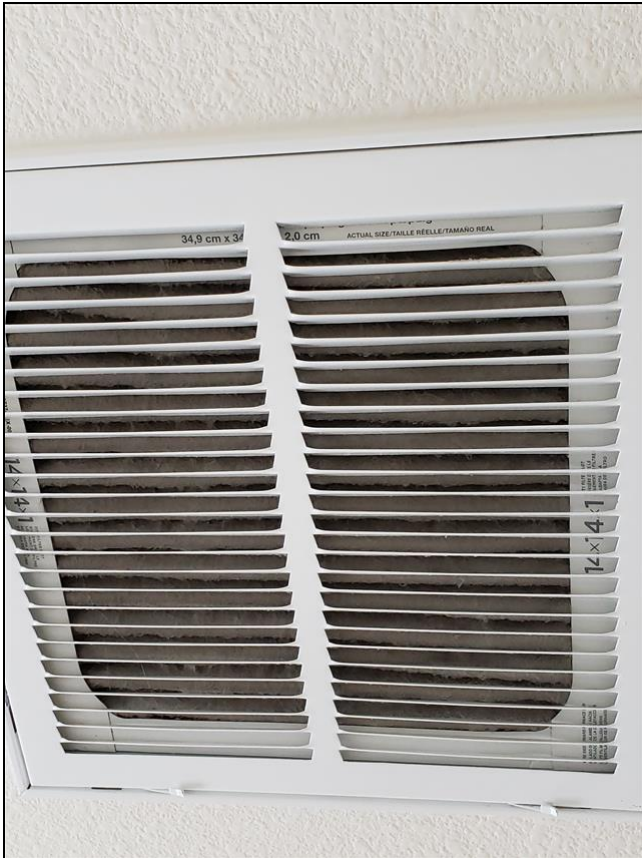
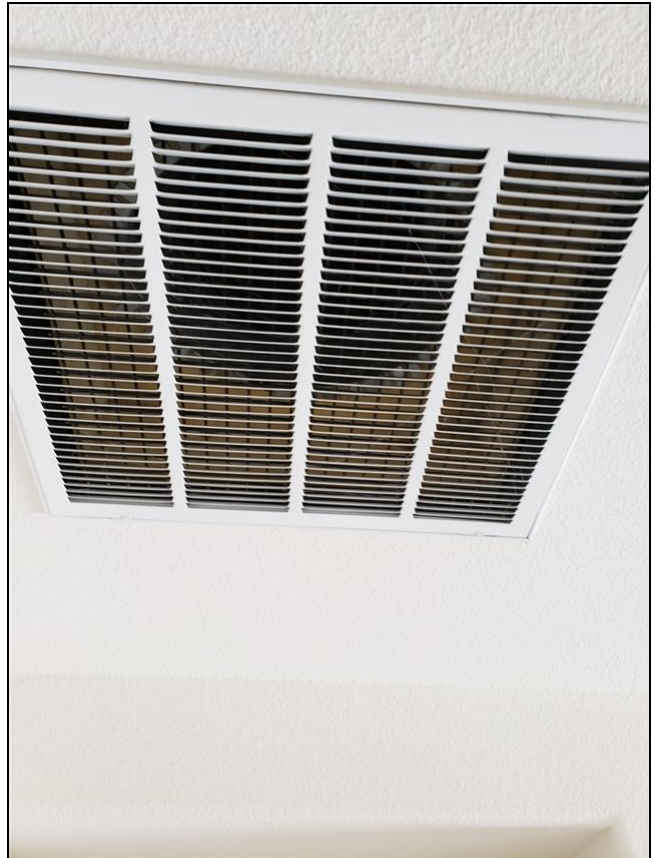
8.4 Item 1(Picture)

8.4 Filter is dirty; recommend replacement for proper operation of the system.

Filters are missing; suggest installing filters for proper operation. Recommend servicing/cleaning filters on a regular basis to ensure proper operation and air flow.

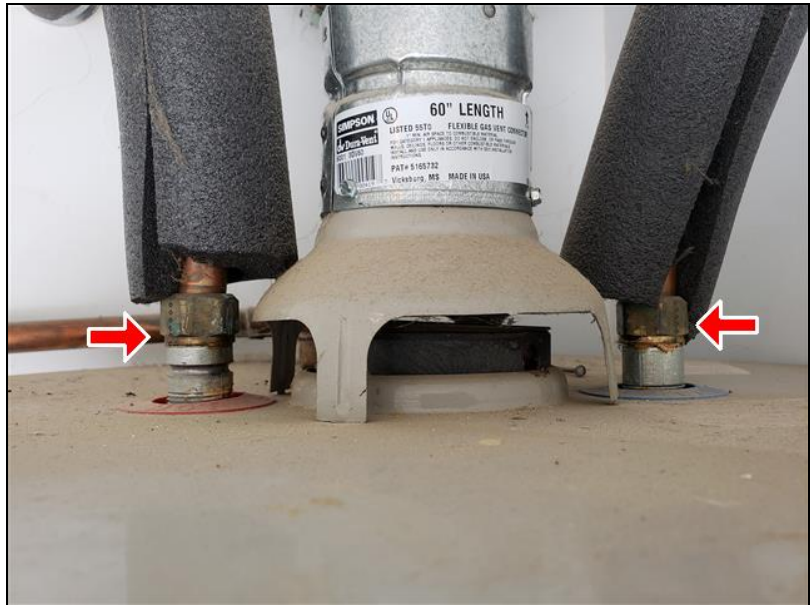
10.1 Item 1(Picture)

10.1 Copper and galvanized water lines connected without di-electric fittings. This causes electrolysis, which leads to rust, corrosion, and eventually leaks. Ideally, where copper and galvanized water lines are connected, they should be separated by a di-electric fitting. Suggest review by a licensed plumber prior to closing for repairs/replacement as needed.

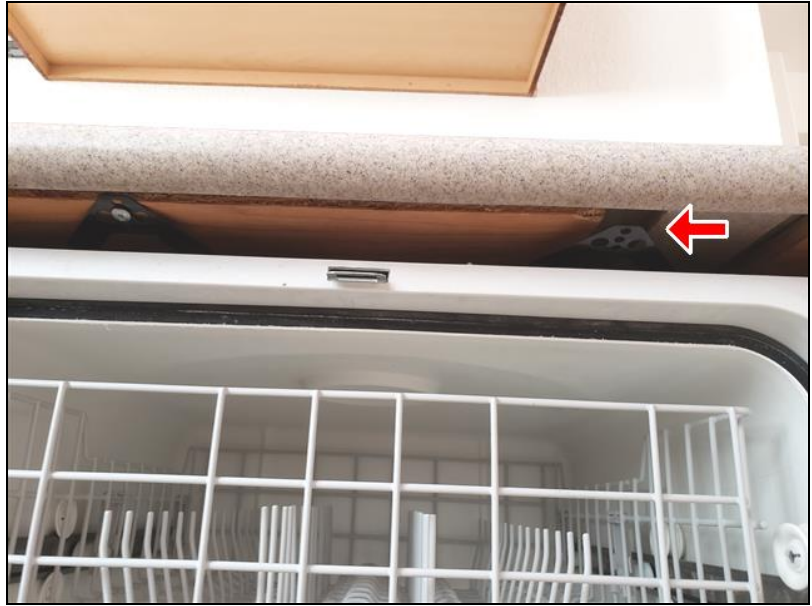
11.10 Item 1(Picture)

11.10 The dishwasher is loose and needs securing to underside of countertop (using a proper length screw). Recommend repair as necessary.

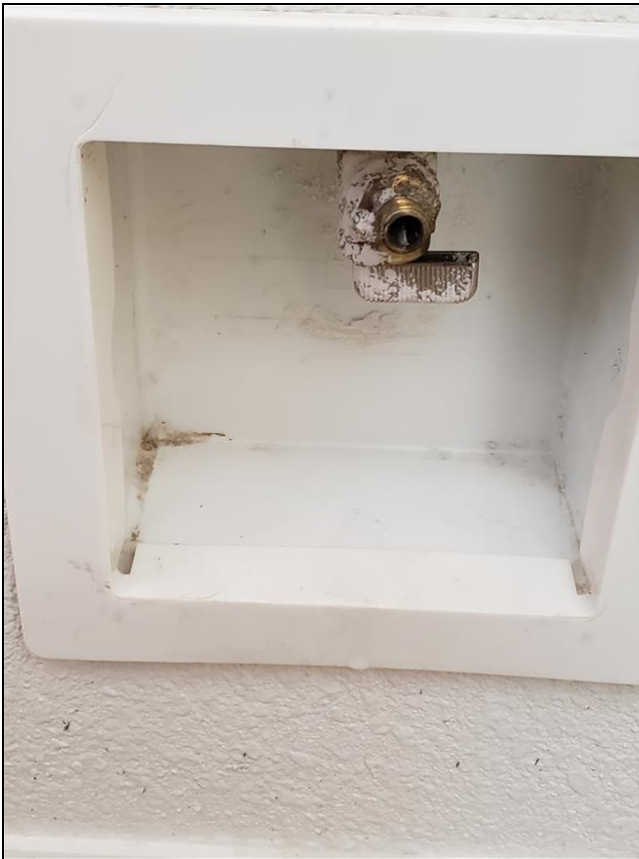
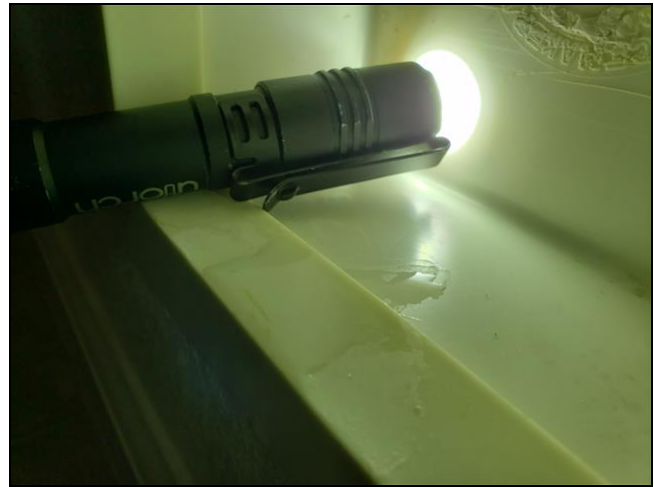
11.14 Item 1(Picture)

11.14 Although a shut off valve has been installed at the refrigerator water supply line. It was leaking at time of inspection. Recommend corrections to prevent moisture damage.

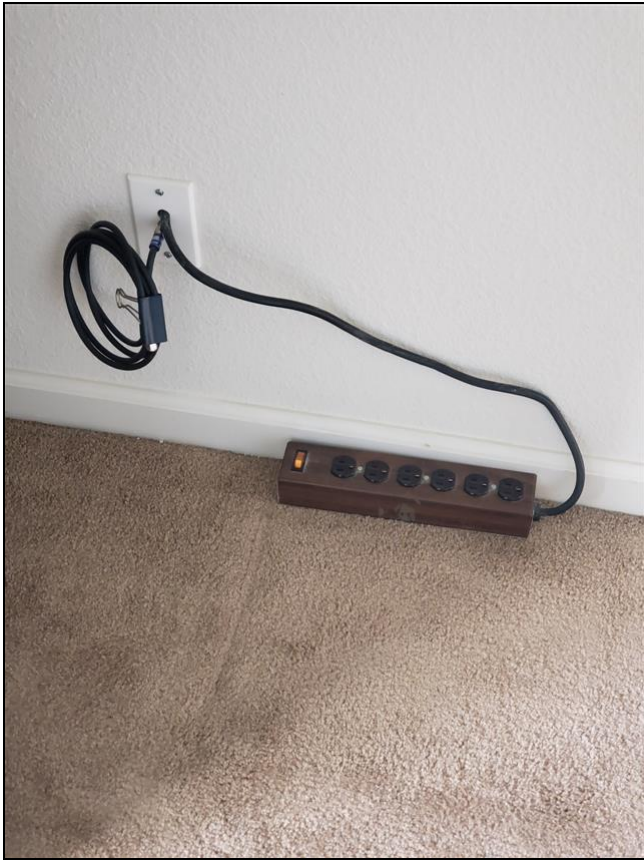
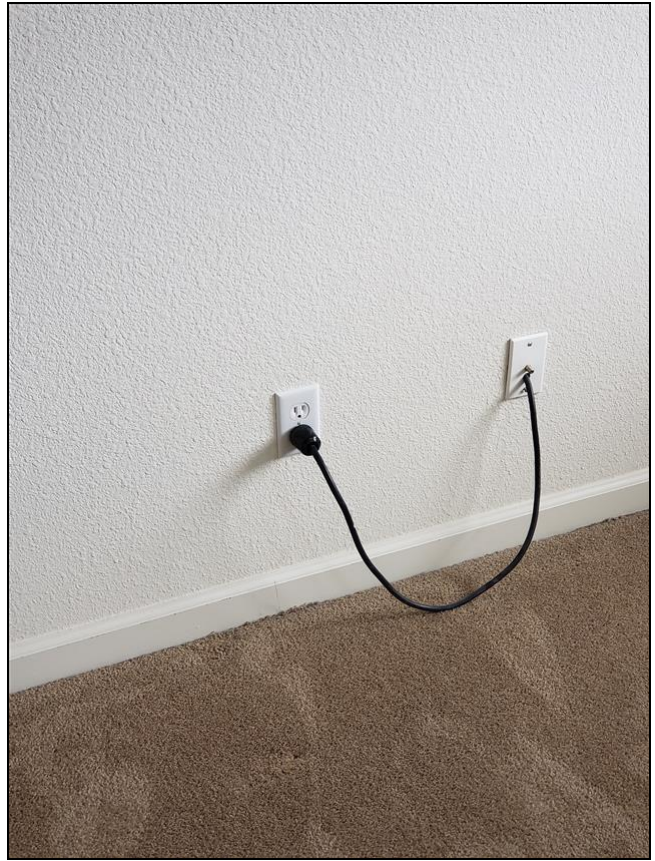
12.6 Item 1(Picture)

12.6 An extension cord is being used as permanent wiring. Recommend corrections to ensure safety.

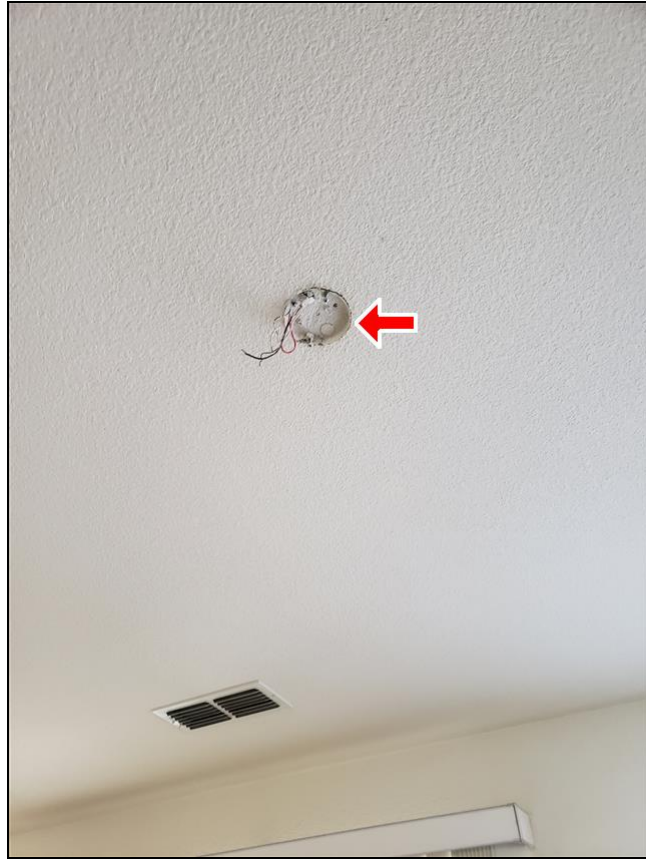
15.6 Item 1(Picture)

15.6 Exposed electrical wiring observed in the living room. It appears that the seller removed a ceiling fan. Recommend replacement.
