Property Inspection Report

N La Jolla Ave
Los Angeles, CA

Sample Client
Tuesday, August 6, 2019

Colleen Brand, Master CREIA Inspector #0155413

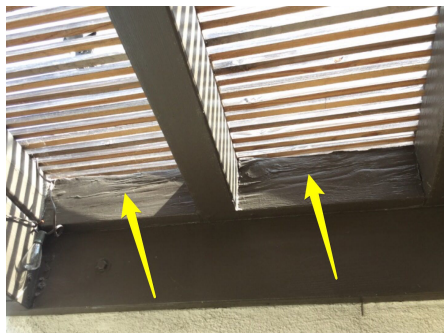
Wood deterioration observed at the rear deck cover framing. Suggest repairs/replacement as needed. Refer to the latest Structural Pest Control report for more information.

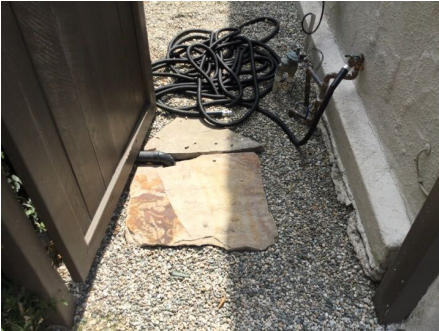
Underground lot drainage system with area drain(s) and sump pump observed. It is beyond the scope of this inspection to inspect or perform tests on underground drainage systems. Suggest client obtain information from sellers or verify that the drainage system functions properly prior to close of this transaction.

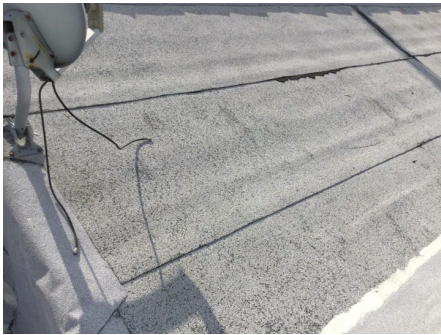
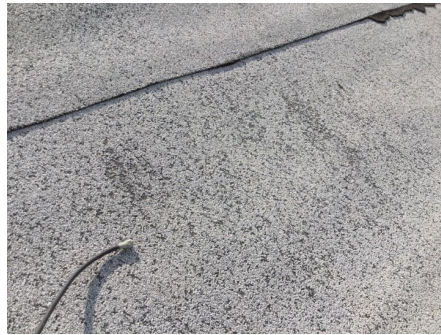
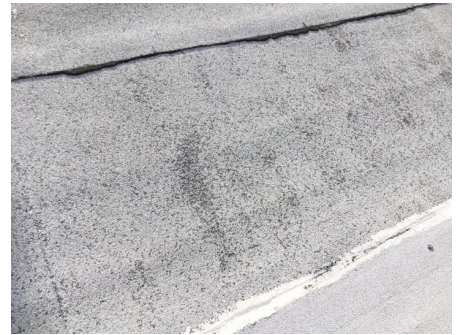
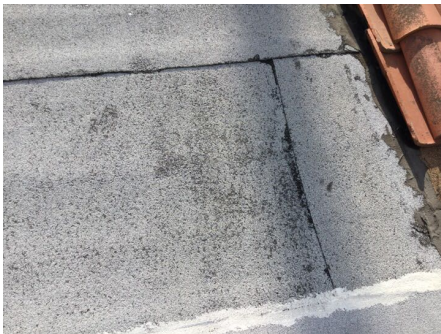
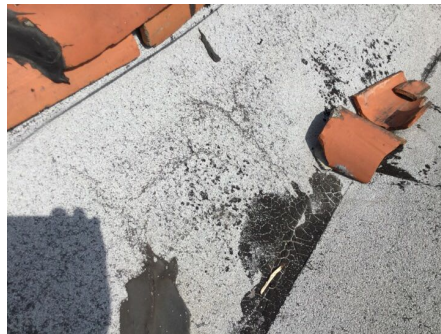
1203. CONDITIONS

Rolled composition roofing installed at the front rotunda and the rear gable face of the roof shows extensive wear and is at or near the end of its useful life. A qualified, licensed roofer is recommended for full evaluation prior to expiration of the inspection contingency period to provide you with the cost to repair or replace this section of the roof.

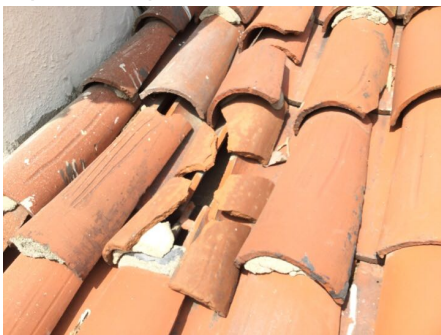
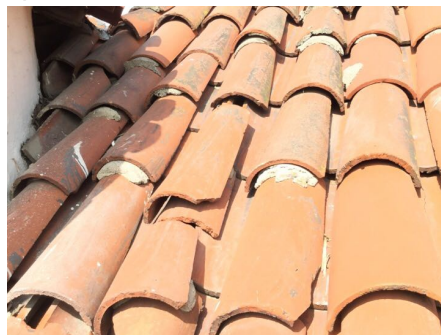
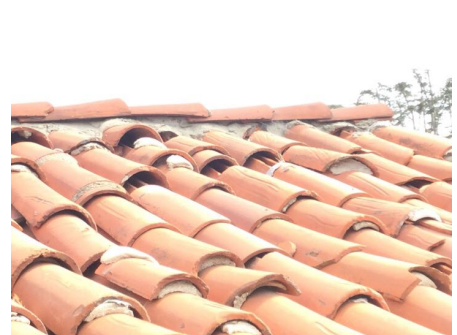
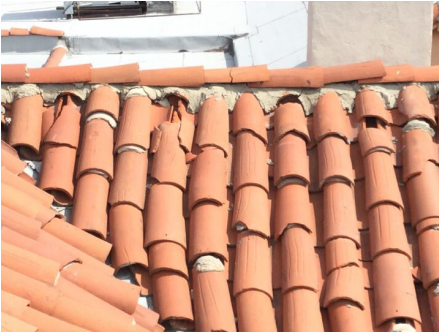
A number of broken, loose, slipped roof tile(s) observed. Recommend review by a qualified roofer for repair or replacement, as necessary, prior to close.

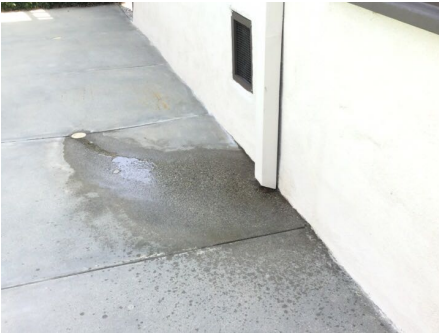
Roof scupper(s) and downspout(s)

Suggest installing extensions to the gutter system and/or routing downspouts to an underground drainage system to help ensure proper drainage away from the foundation.

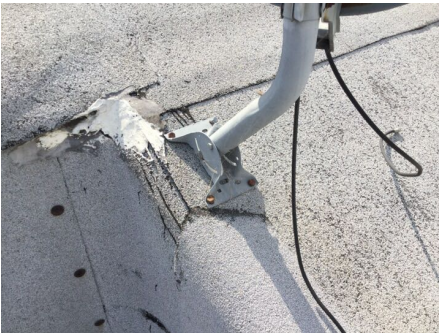
1206. PENETRATIONS

Satellite dish mounting hardware is driven through the roofing system and will require seasonal monitoring and maintenance to prevent moisture intrusion and damage.

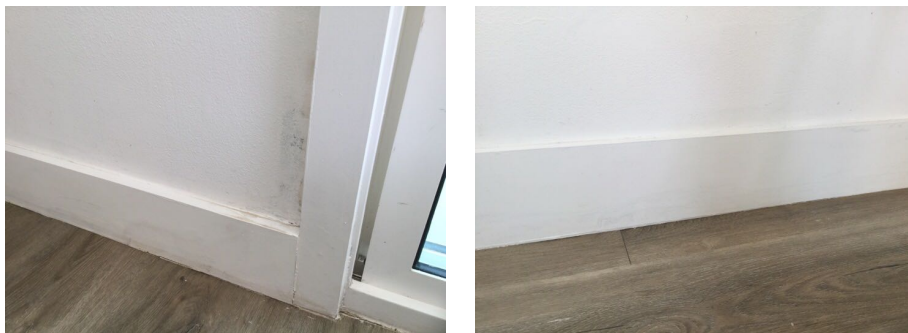
Evidence of moisture damage was observed at the lower right and rear garage walls. The extent or cause of damage cannot be determined without destructive analysis. Hidden damage may exist within inaccessible areas. We recommend review by a qualified, licensed contractor to locate and correct the moisture source and for necessary maintenance and/or repairs to any damaged materials, prior to close of escrow.

Any time water is allowed to intrude or condense within the structure, the possibility of hidden damage, decay and/or mold exists. Inspection for and identification of these conditions is beyond the scope of the CREIA Standards of Practice; we suggest further review by a testing and/or remediation specialist.

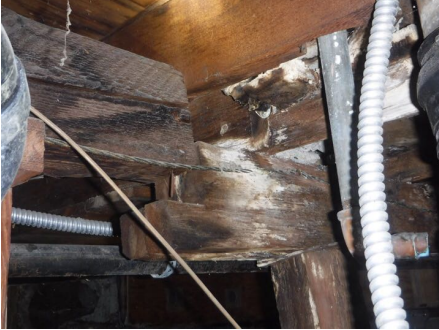
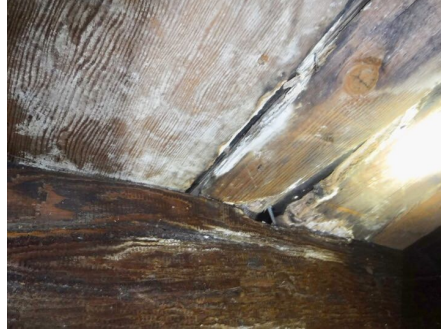
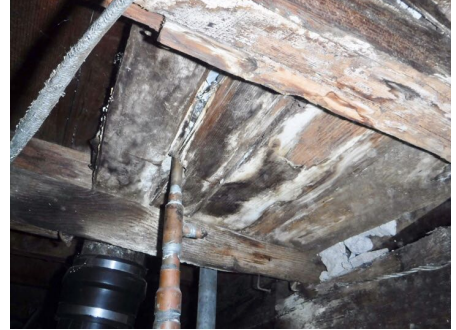
Moisture damaged wood observed at the en-suite bathroom. Review is needed by a licensed contractor for repairs as needed. Refer to the latest Structural Pest Control report for more information.

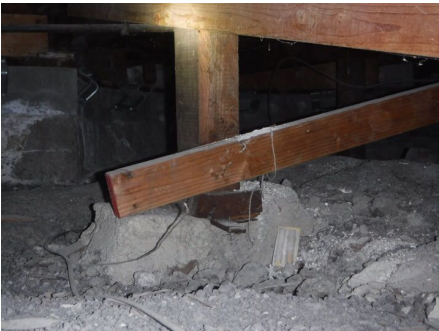
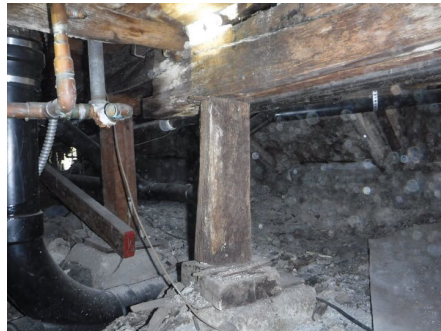
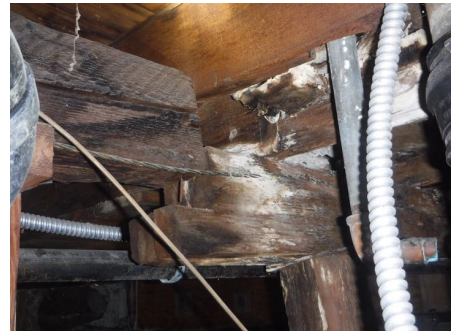
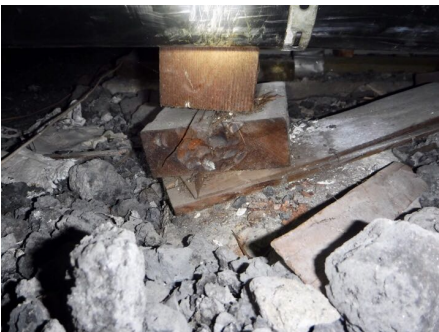
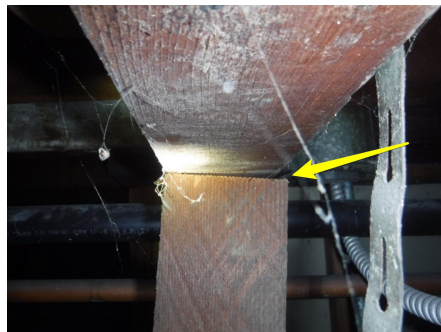
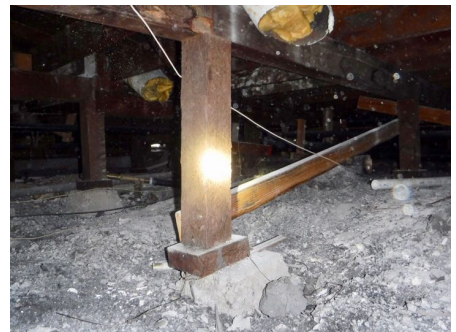
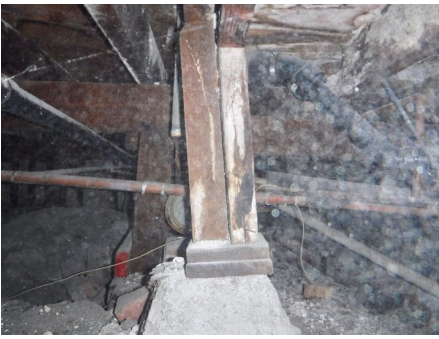
1504. FLOOR FRAMING SYSTEM

A number of floor framing support posts are leaning out of plumb and/or are not properly supported on their concrete piers. A qualified, licensed foundation contractor is recommended for review and any necessary repairs to ensure longevity and structural integrity.

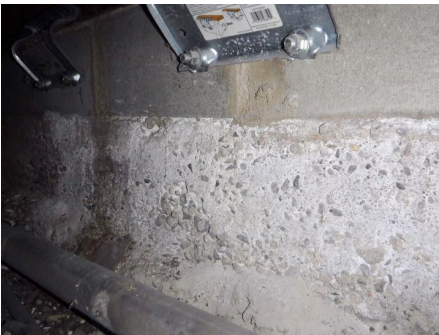
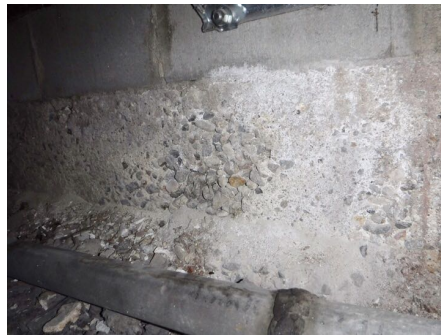
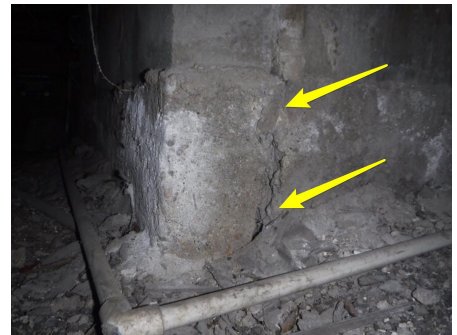
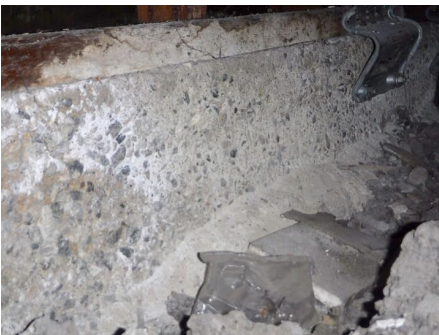
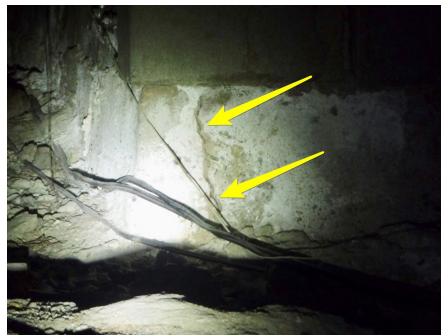
1506. FOUNDATION WALLS

Cracking and concrete deterioration noted at the foundation wall(s). A qualified, licensed foundation contractor is recommended for review and any necessary repairs to ensure longevity and structural integrity.

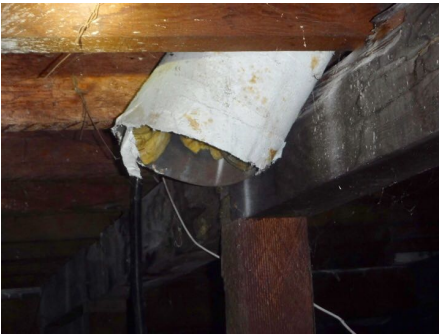
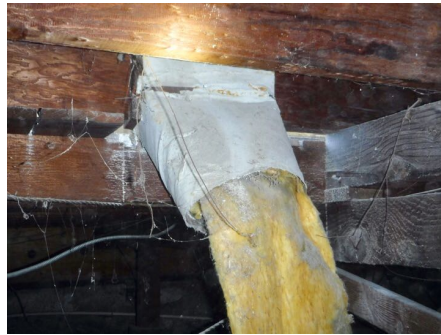
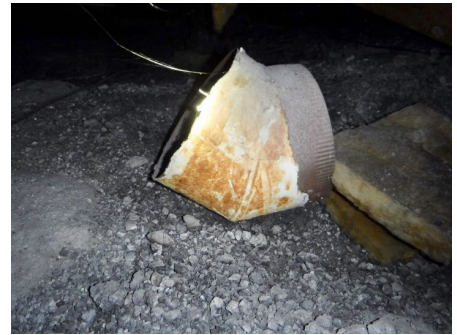
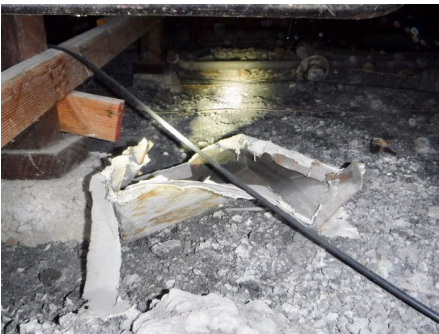
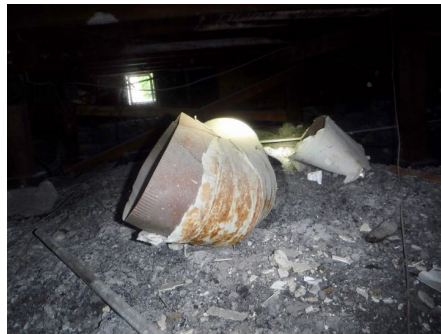
Possible asbestos materials observed (abandoned ducting). The materials were torn, ripped, or damaged at the time of inspection. This is a possible safety hazard. Suggest further review by a licensed asbestos testing and abatement company prior to closing for repairs/replacement needed to ensure safety.

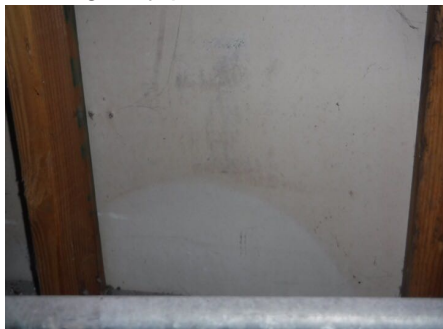
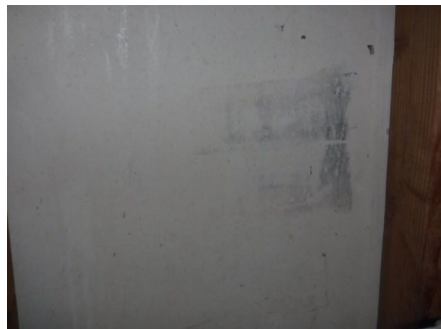
Stains, discoloration, growth and/or evidence of moisture observed at the basement drywall. These conditions may indicate mold and/or fungus growth and were discovered during the home inspection. Because certain types of mold may be toxic and result in adverse health effects, we recommended that a mold inspection be performed by a qualified professional to determine the presence of, and types of, mold in the building and that any necessary remediation and repairs be performed, prior to the expiration of the contingency period.

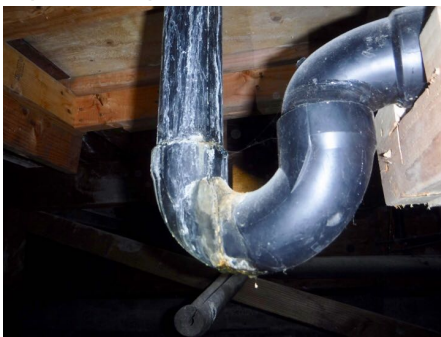
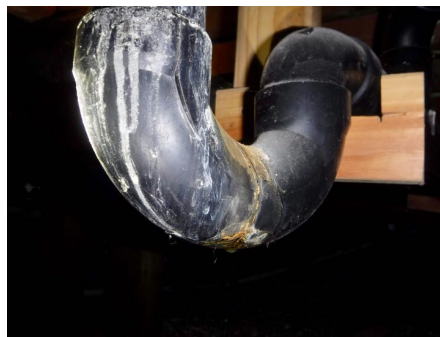
Leaking observed at the hallway bathroom shower drain. Recommend review by a licensed plumber for repair or replacement, as necessary.

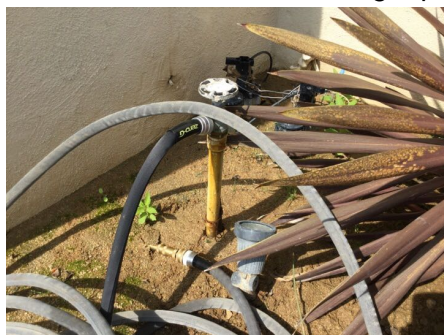
Leak observed at the front right planter faucet; repairs/corrections are needed.

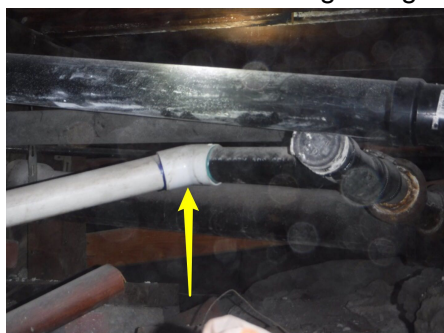
Drain piping, possibly previous sump pump drain, is improperly routed to the building drain. This is not allowed but this drain piping may now be abandoned. We recommend consulting with the seller for any additional information regarding the condition noted and a qualified plumber for any corrections needed.

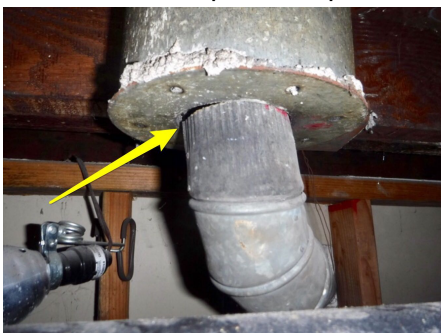
Vent pipe is disconnected or poorly fitted, which is a safety concern. Recommend review by a licensed contractor for repair or replacement, as necessary, prior to close.

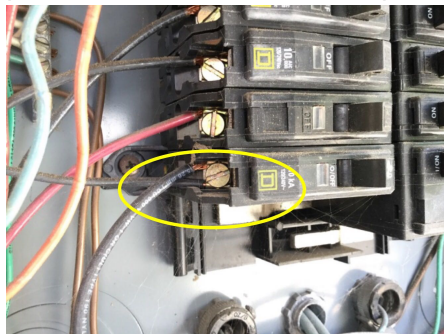
Double tapping observed. Double tapping (i.e. 2 wires on a single pole breaker) can add to the load of the affected circuit causing a possible overload and tripping breakers. Recommend review by a qualified professional electrician for repair or replacement as necessary.

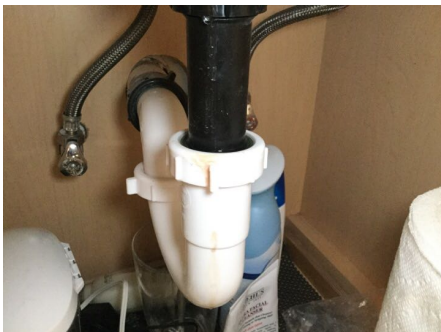
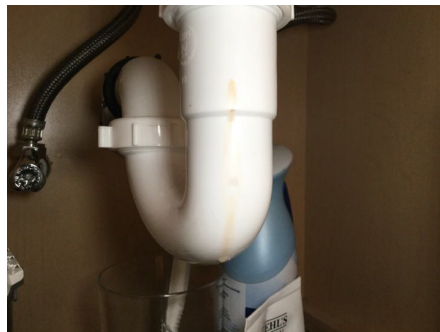
Leaking observed at the right sink drain assembly. Recommend review by a qualified, licensed plumber for repair or replacement as necessary.

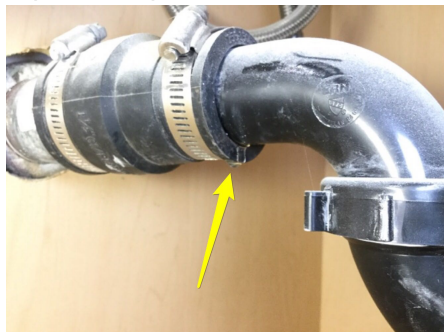
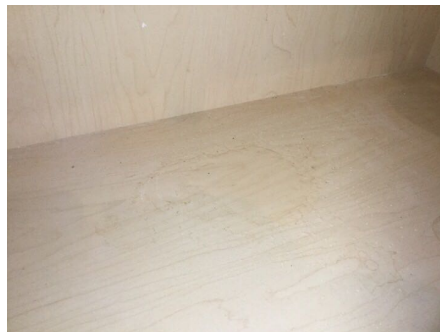
Leaking observed at the sink drain assembly. Recommend review by a qualified, licensed plumber for repair or replacement as necessary.

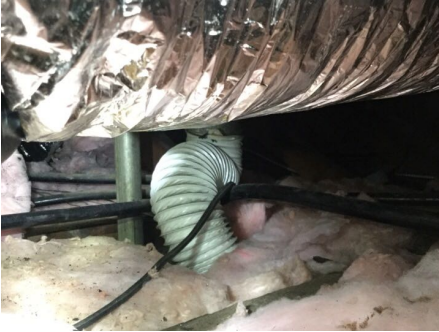
2206. DRYER VENTING

The flex hose at the dryer exhaust is a plastic/vinyl/foil material that, under certain conditions, has been known to be a fire hazard. As a safety measure, we recommend replacing this exhaust hose with an approved metallic dryer vent duct.

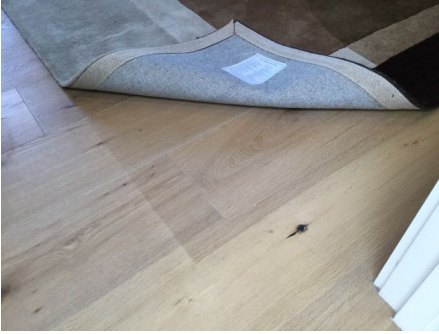
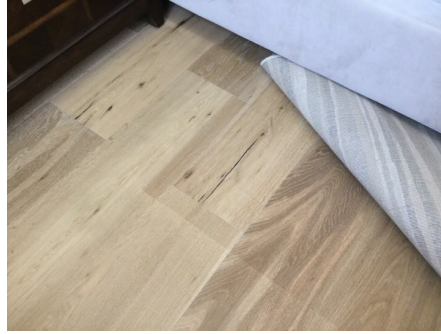
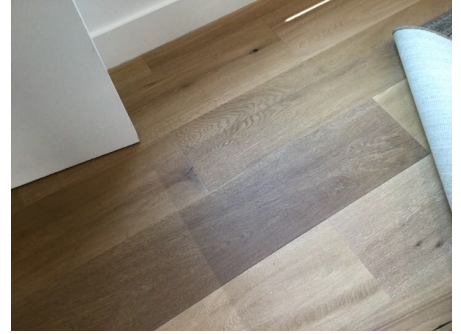
Faded/discolored floors observed at the bedrooms, under the rugs; recommend corrections as needed.

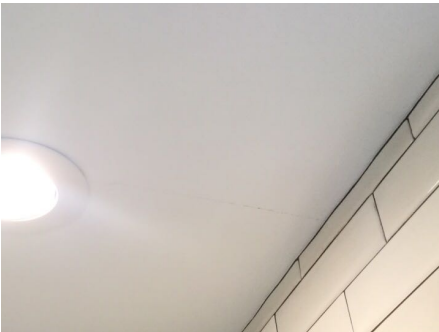
2303. CEILINGS / CEILING STRUCTURE

Conventional wood framing
Plaster/Drywall
Common cracks noted at the en-suite bathroom shower ceiling; appears to be primarily a cosmetic issue.
Recommend corrections as needed.

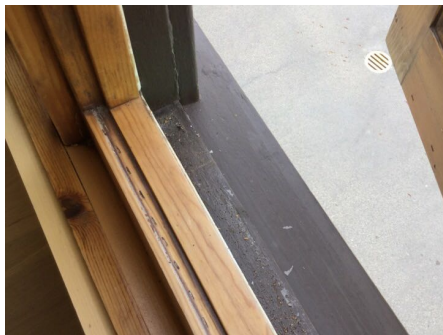
Evidence of wood destroying pests observed at the rear bedroom sitting room windows. Suggest reviewing the latest Structural Pest Control report for a more detailed evaluation and repairs as needed.

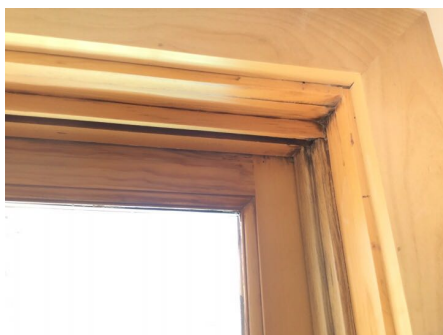
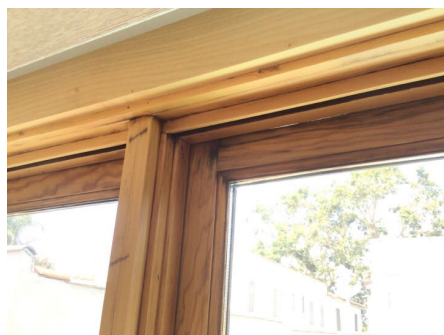
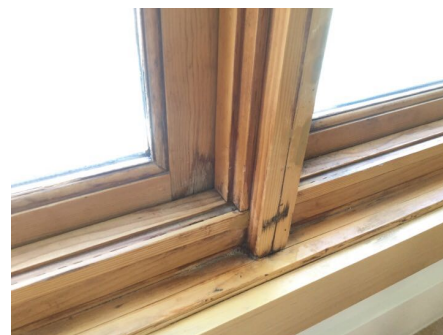
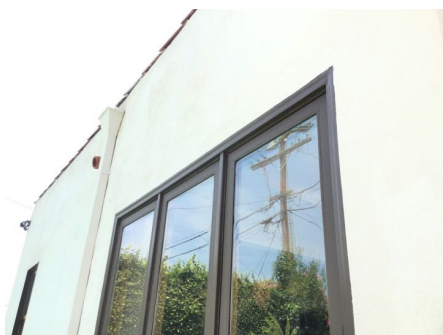
Evidence of moisture damage was observed at the rear bedroom sitting room windows. The extent or cause of damage cannot be determined without destructive analysis. Hidden damage may exist within inaccessible areas. We recommend review by a qualified, licensed contractor to locate and correct the moisture source and for necessary maintenance and/or repairs to any damaged materials, prior to close of escrow.

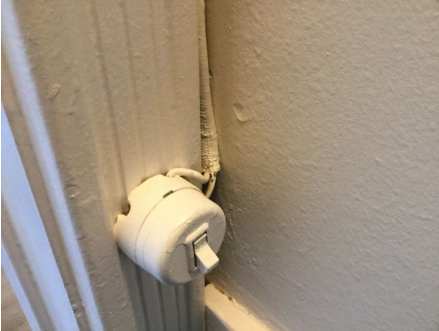
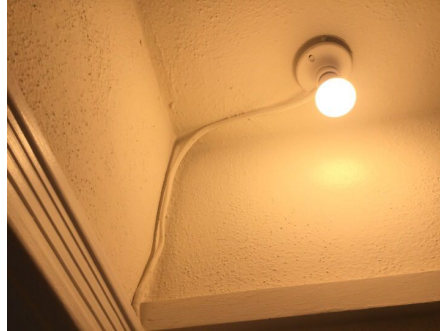
Exposed electrical wiring observed at the closet light in the front den bedroom. This is a safety concern if used where it could be subject to physical damage. Exposed electrical wires are normally encased in conduit to ensure safety. Client should consult with a licensed electrician prior to closing for repairs/replacement as needed to ensure safety.
