Inspection Report

1234 S Main St
Anywhere MN 56789

AmeriSpec Inspection Services

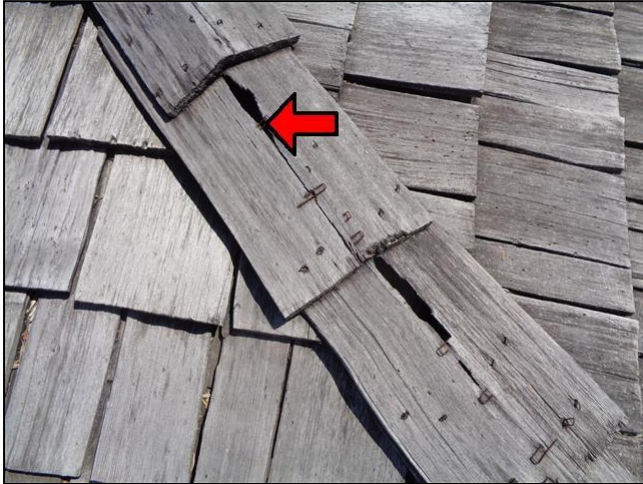
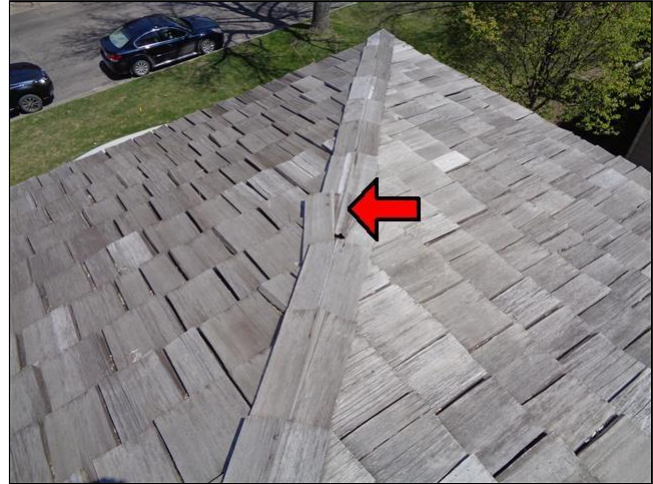
1.0 Roof Conditions

- (1) Wood shakes have an average life expectancy of 25-30 years depending on the grade of shake. Moss is commonly found on this type of roof and regular removal is suggested to prevent premature deterioration.
- (2) Cracked/deteriorated ridge cap shingles noted. We suggest repair/replace as needed to prevent future water entry.

- (2) Cracked/deteriorated ridge cap shingles noted. We suggest repair/replace as needed to prevent future water entry.
- (3) Apparent hail damage was noted. We recommend review by the appropriate insurance carriers and repair by a qualified roofer to the extent necessary to assure that the roof is both serviceable and insurable.

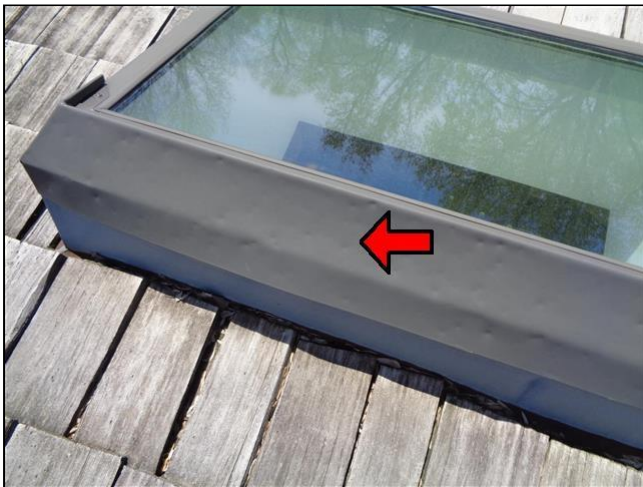
Apparent hail damage was noted. We recommend review by the appropriate insurance carriers and repair by a qualified roofer to the extent necessary to assure that the roof is both serviceable and insurable.

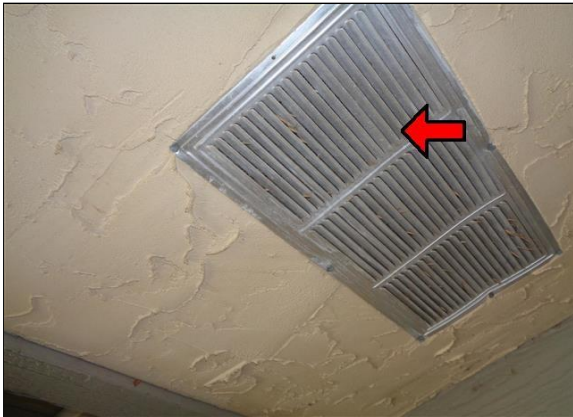
(1) Soffit vents are clogged with dirt, cottonwood and paint. We suggest cleaning to help allow proper attic ventilation.

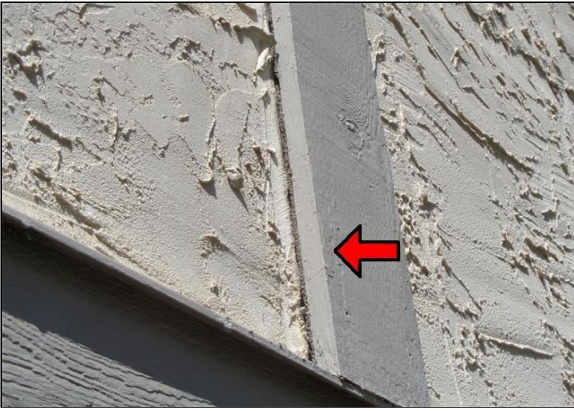
(2) We suggest caulking along the wood trim set into the stucco to help prevent further deterioration and water infiltration.

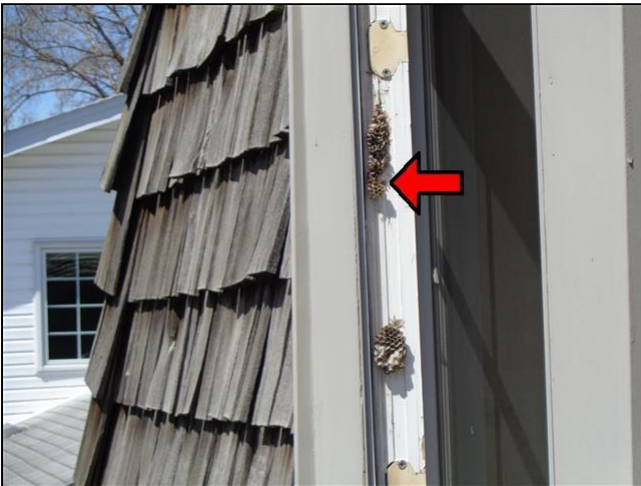
2.5 Windows & Frames

Wasps nests along the upper rear right window frame.

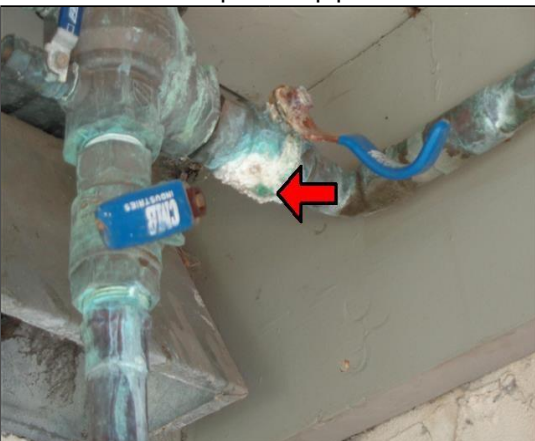
Corrosion on the sprinkler pipe noted. No current leaking noted.

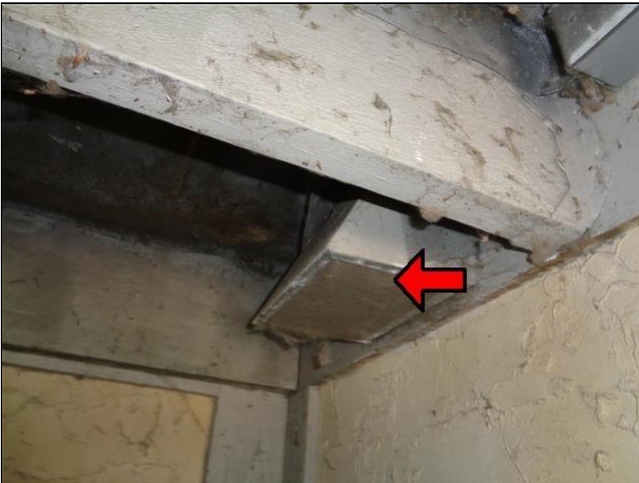
(1) We suggest cleaning fresh air intake now and checking it yearly.

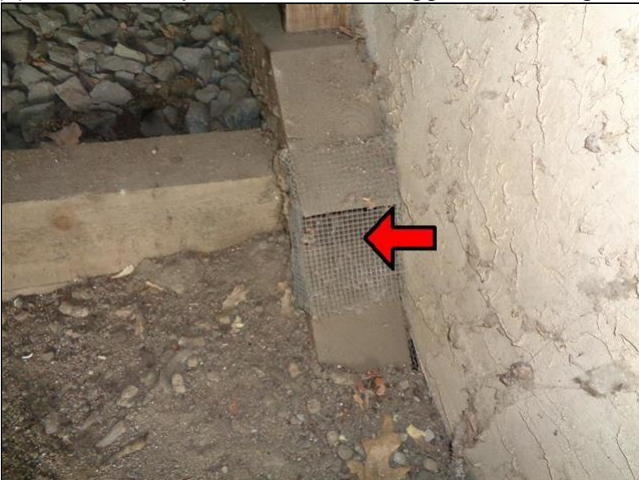
(2) Evidence of pests noted. We suggest reviewing the latest pest control report for more information.

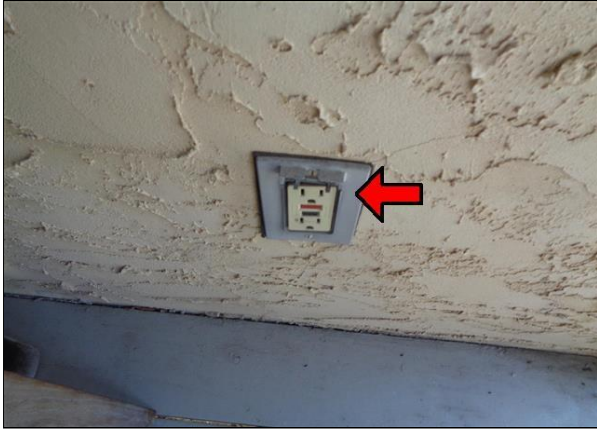
We suggest installing a weatherproof cover on outlet(s) for safety reasons.

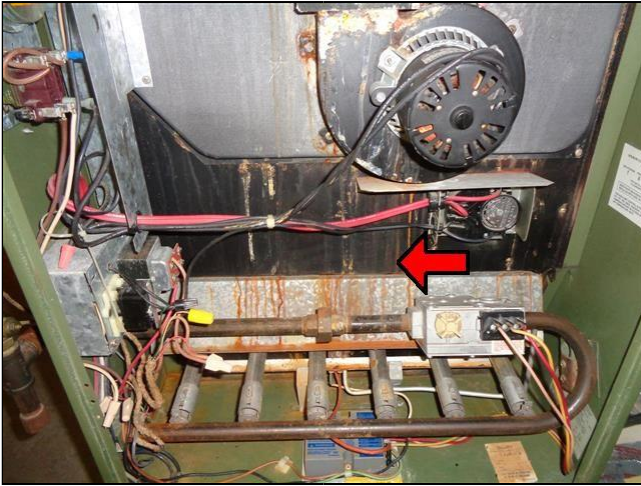
5.0.B Heating Equipment Condition

(1) Average life expectancy is 20 years. This unit is a 1986 and is near the end of its useful life.

(2) Rust behind the cover plate and on the casing appears to be from past Furnace/AC condensation leaks. No current water is present. We suggest verifying when and if repairs for this issue were done with the seller.

5.0. B Heating Equipment Condition

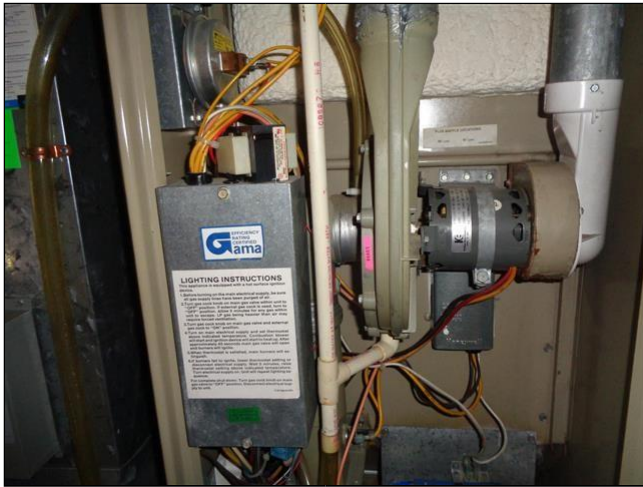
Average life expectancy is 20 years. This unit is a 1988 and is near the end of its useful life.

5.0.C Heating Equipment Condition

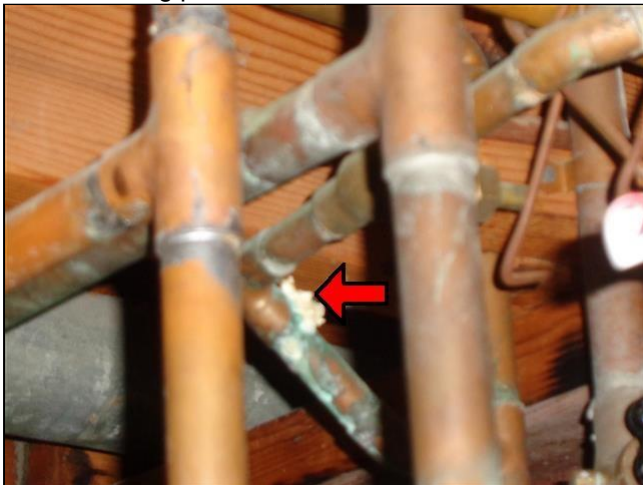
- (1) A water softener is present. It is beyond the scope of this inspection to evaluate this system. We do test the hardness of the water to verify the softener is working and at the time of the inspection it was softening.
- (2) Corrosion/rust on plumbing pipe(s) noted. This appears to be from past leaking that has corroded itself shut. No current leaking present.

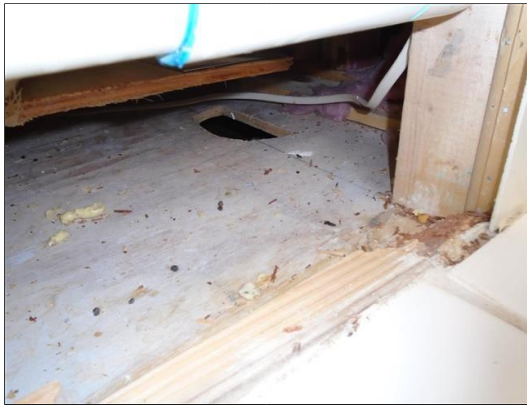
(2) Rodent droppings under tub.

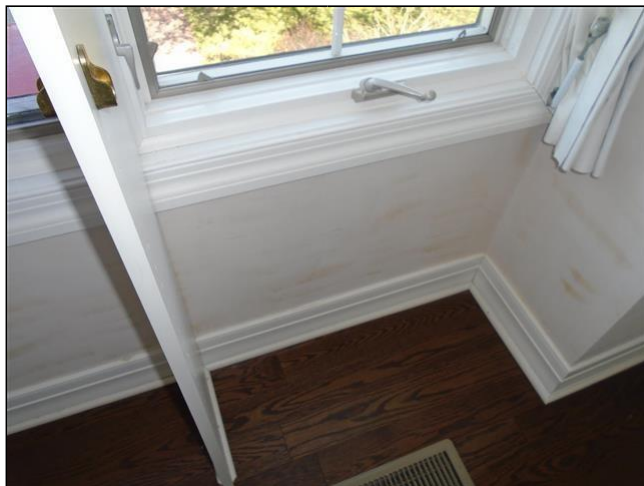
Area of current leaking noted. The area was tested with a moisture meter and high levels were found. Under closet window.

Area of current leaking noted. The area was tested with a moisture meter and high levels were found. Under closet window.

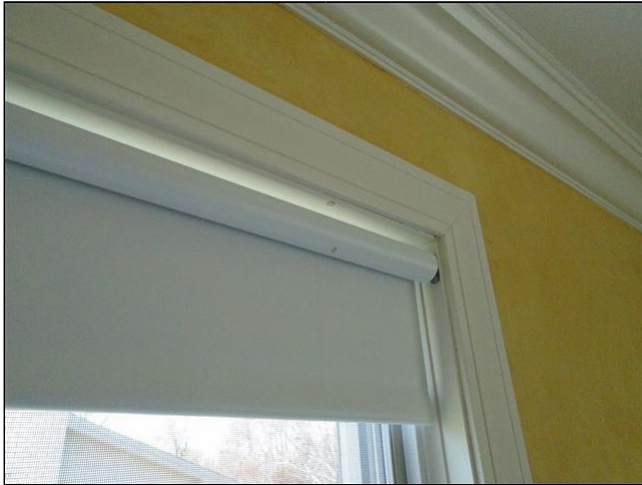
Staining present. The inspector probed stains with a moisture detector, which showed no moisture present at time of inspection. Client is advised to consult seller to determine the source of staining and verify that corrections have been made.

Staining present. The inspector probed stains with a moisture detector, which showed no moisture present at time of inspection. Client is advised to consult seller to determine the source of staining and verify that corrections have been made.
