## Summary

AmeriSpec Inspection Service

Doc #: 042219SH32 Inspector: Sam Herndon IV  
Date: 4/22/2019  
Dwelling Address: Cape Girardeau MO 63701  
Client Name:  
Client's Agent: Real Estate Company:

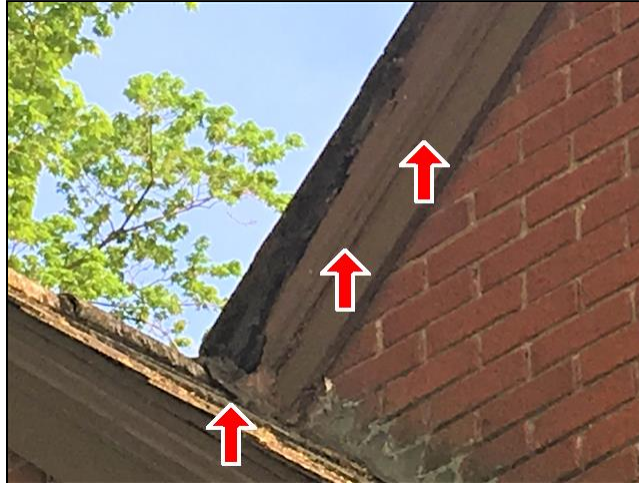
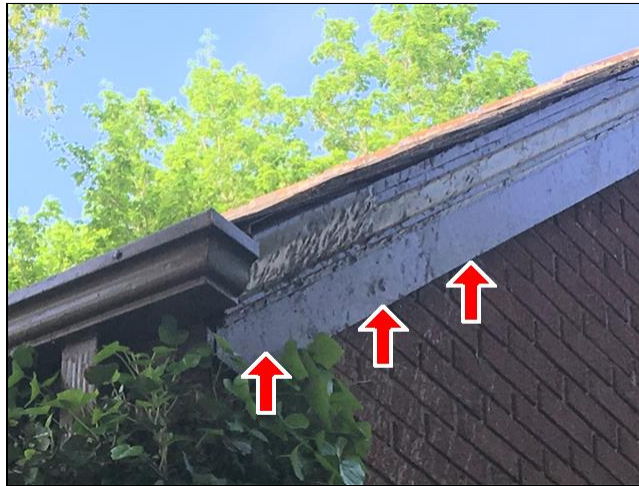
1.3 Trim, Eaves, Soffits and Fascias

**Repair or Replace. Wood deterioration observed at multiple locations. Suggest repairs/replacement as needed.**

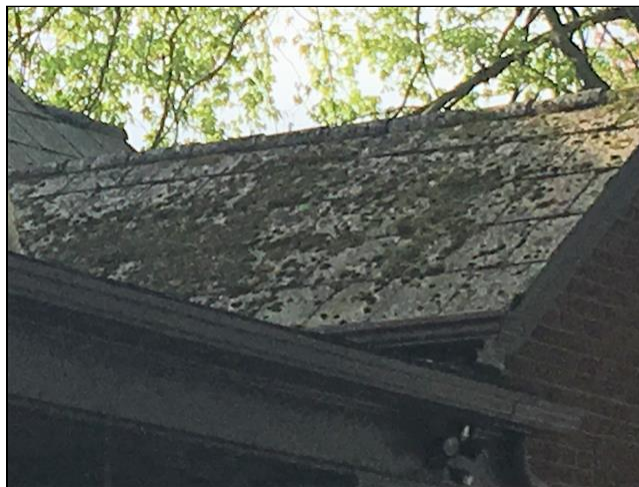
2.0 Item 1(Picture)

**Repair or Replace. Moss observed on roof covering at various locations. Moss tends to hold water and cause moisture related deterioration problems to roof covering. Suggest having moss removed to prevent accelerated roof deterioration.**

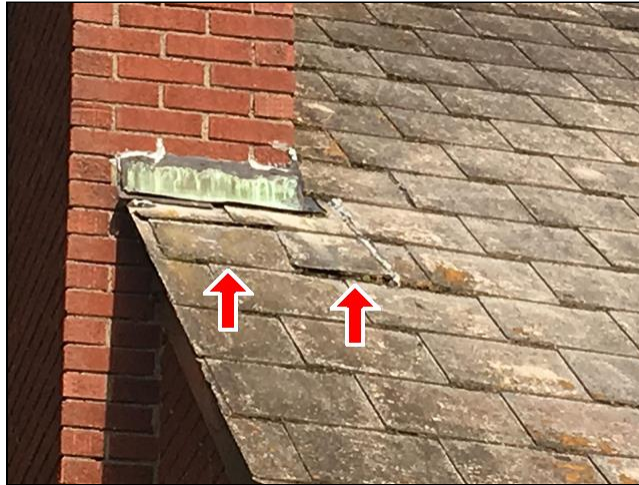
2.0 Item 2(Picture)

**Repair or Replace. Damaged shingles observed at various locations. Recommend review by a licensed roofer for repair or replacement, as necessary prior to close.**

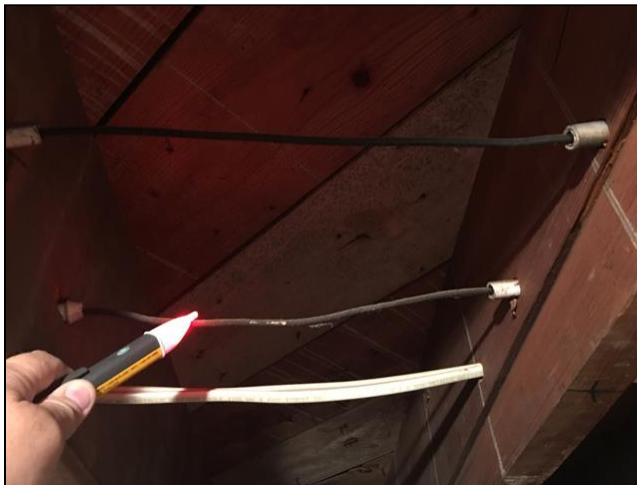
7.8 Item 1(Picture)

- 7.8 (1) Electrical Comments **Safety. Knob and tube electric wiring was observed in this home. This type of wiring was standard at the time of construction. Client should consult with a licensed electrician prior to closing to verify its integrity, and/or if expansion to the system is planned. Expansion or additions to knob and tube wiring normally are not allowed as it can overload the system and cause a fire hazard.**

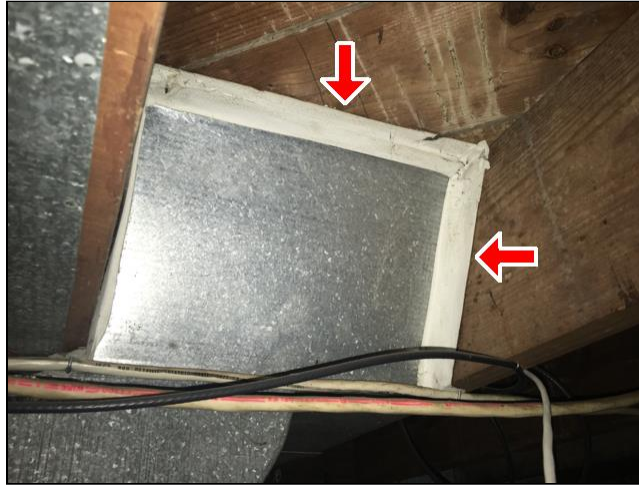
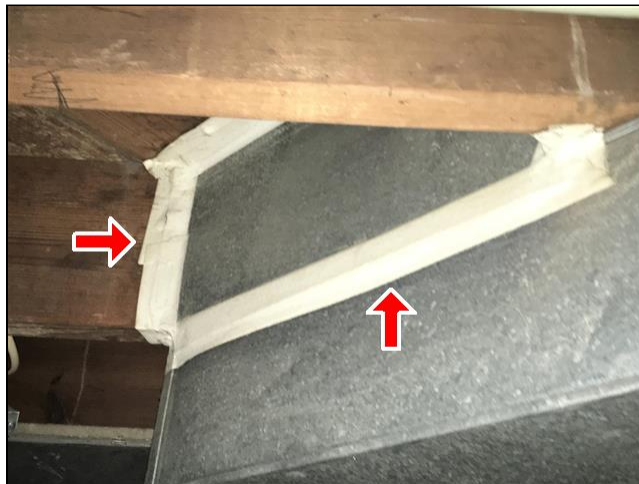
8.5 Distribution / Ducting Systems

**Safety. Possible asbestos materials observed. The materials appeared to be intact at the time of inspection. Asbestos materials are considered safe by the EPA if they are not disturbed, torn, ripped, or damaged. No torn, ripped, or damaged materials were observed. If client has any concerns regarding asbestos materials, an asbestos testing lab should be consulted for further review to ensure safety.**

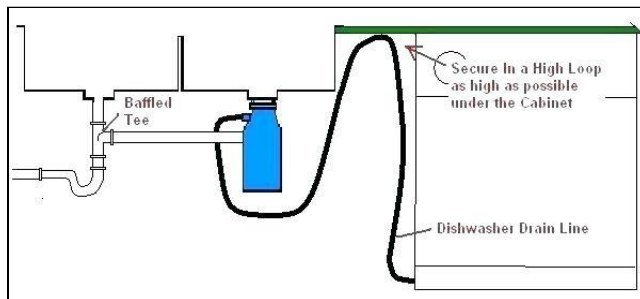
11.11 Item 1(Picture)

**Safety. No loop in drain line. The dishwasher drain line needs to be looped upward near the top of the cabinet underside in order to prevent possible contamination of clean dishes which can occur when water from the sink flows into the dishwasher. This may not have been required when dishwasher was installed, recommend the installation of a drip loop as a plumbing upgrade.**
