Home Inspection Report

1221 175th St

Homewood, IL 60430

Inspected by Robert Barcham, Cal Ramirez,
& Robert McNamara on Mon, Nov 22 2021 at 2:00 PM

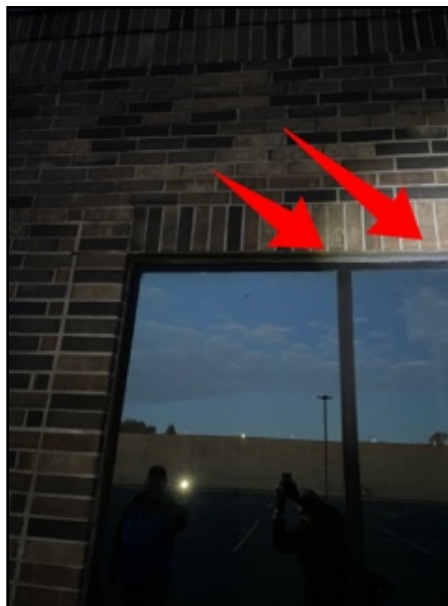
Figure 2-2

At the time of inspection, observed the East side exterior wall, window lenthil mortar has deteriorated also the window lintel needs to be looked at.

Recommend licensed general contractor for repair and reevaluation as desired.

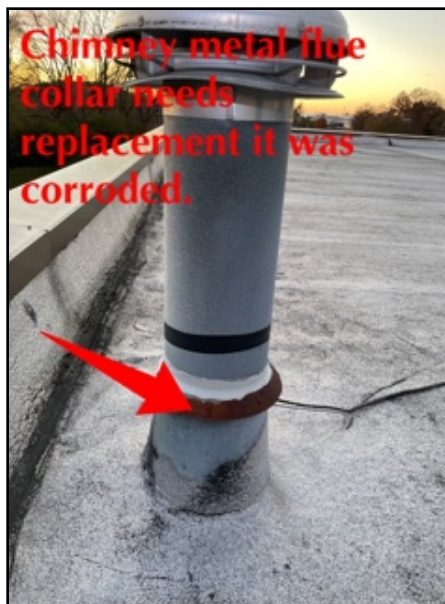
Figure 9-4

Observed roof at the time of inspection, a rolled walkable roof.

- Roof was wavy.
- Roof had water pulling/stray/puddles.
- Roof granular substance has almost faded away.
- The chimney flue was corroded, the one facing south.
- Also observed a noticeable amount of saturated erosion black substance in the center of the roof.

Recommend licensed roofing contractor or licensed general contractor for replace t and re-evaluation as as desired.

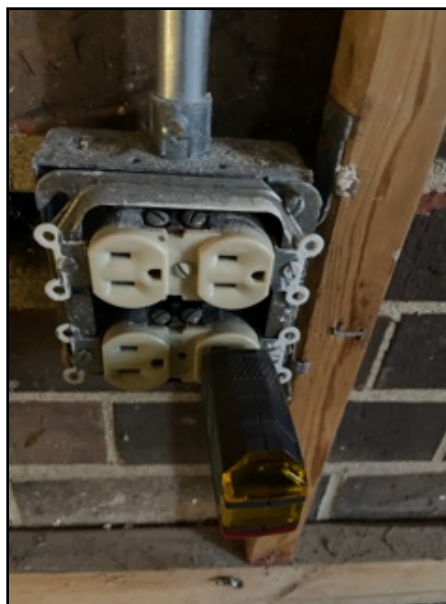
Figure 14-2

At the time of inspection observed quite a few electrical outlets missing cover as well as number representative of electrical outlets had no power or open hot. Recommend a Licensed The Electric in for repair and reevaluation of the entire electrical system in this commercial building as well as electrical panel as desired. Electrical outlet facing west side wall in the corner open heart no power. Recommend a licensed electrician for repair of the entire electrical service of this building as desired.

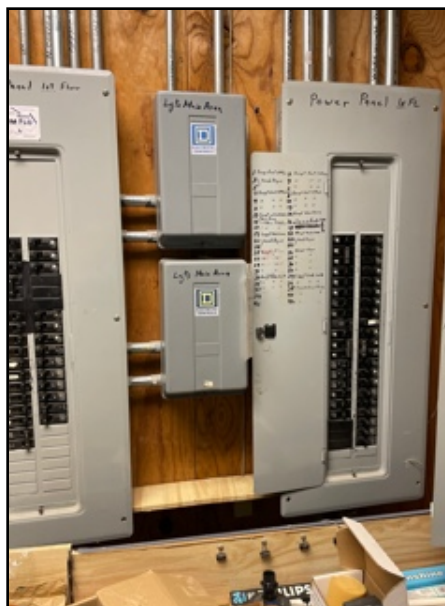
Figure 20-2

Observed at the time of inspection these electrical panel you see with the aero has a wrong size wire attached to a 20 amp breaker.

I am recommending a licensed electrician to look and inspect every single panel, every single outlet, for repair and reevaluation.

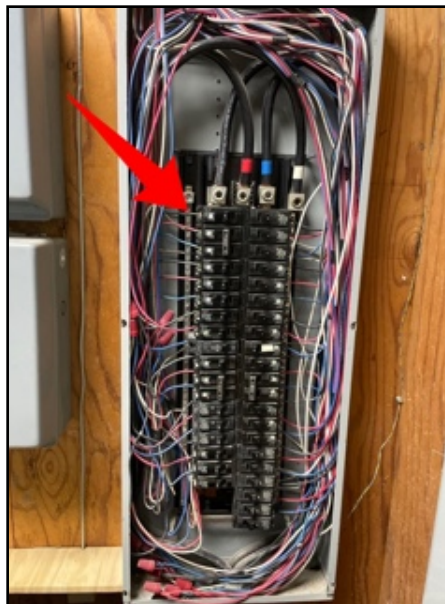
Figure 21-2

Observed at the time inspection number one outlet has a wrong wire size that does not match the 20 amp breaker.

I am recommending a licensed electrician to inspect every electrical panel, inspect every electrical outlet, for repair and re-evaluation as desired.

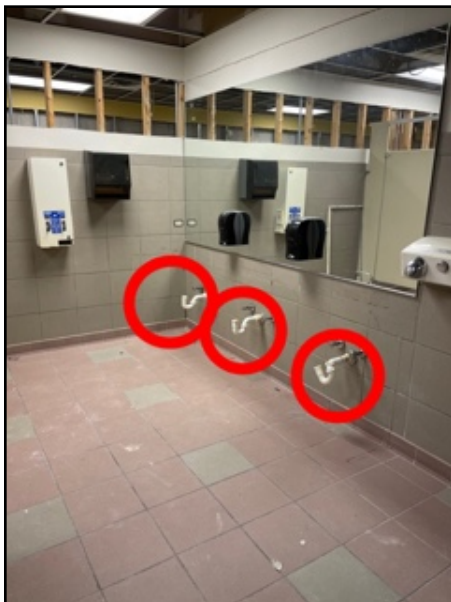
Figure 31-1

At the time of inspection main water and gas were shut off. Plumbing was still under construction as there was only rough work to be finished. Therefore inspection of plumbing was undetermined given the above reason.

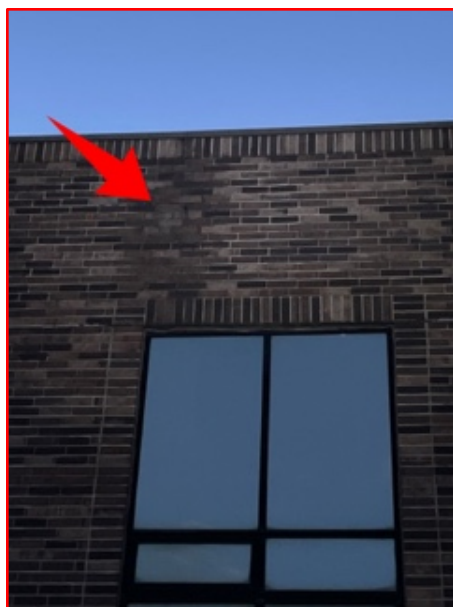
Figure 1-1

1) Observed at the time of inspection exterior wall facing west has a moisture issue at top need to tuck pointing.

Recommend licensed general contractor for repair and reevaluation as desired.

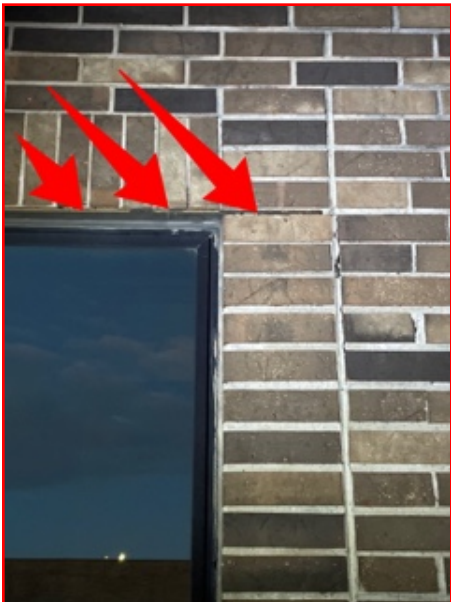
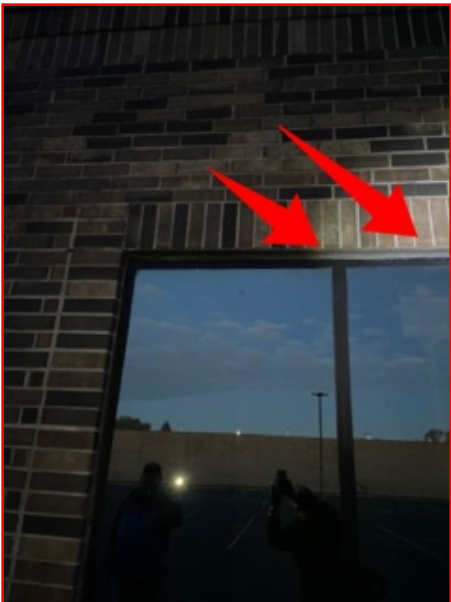
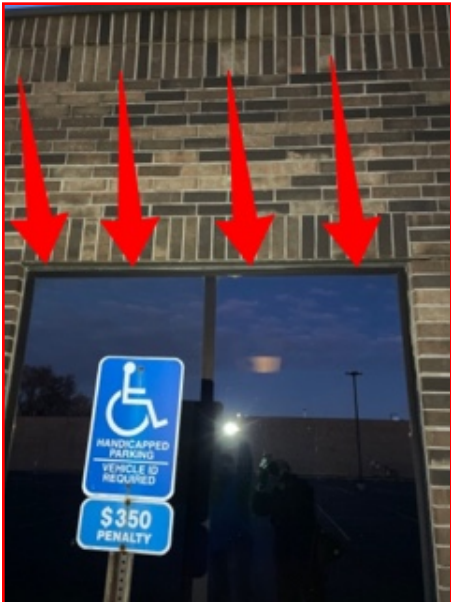
2) At the time of inspection, observed the East side exterior wall, window lenthil mortar has deteriorated also the window lintel needs to be looked at.

Recommend licensed general contractor for repair and reevaluation as desired.

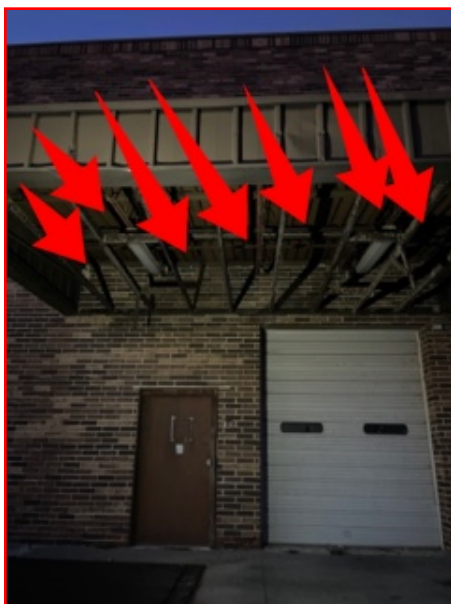
Figure 3-1

3) Observed at the time of inspection the exterior wall where are the dock is in the rear, The above canopy is missing force between joists. Recommend licensed general contractor for repair and reevaluation as desired.

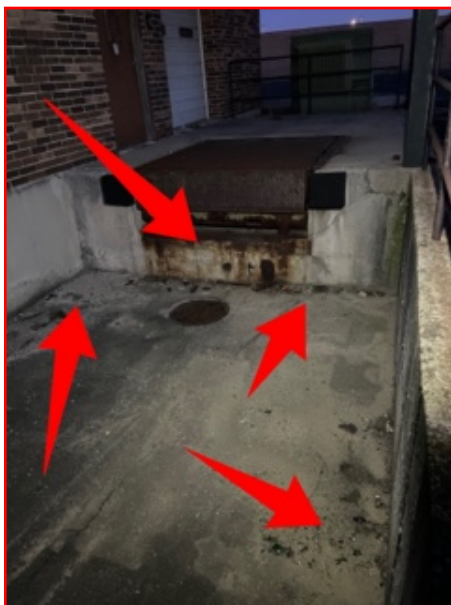
Figure 4-1

4) At the time of inspection, observed the retaining wall of the docking area, the slab how do erosion or perhaps mold like substance that needs to be repaired by a licensed general contractor as desired.

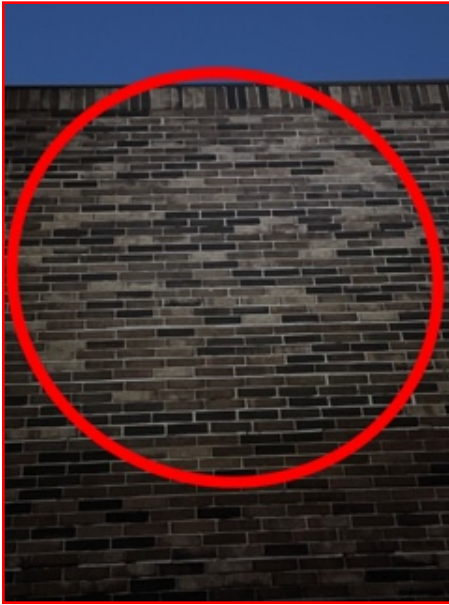
Figure 5-1

5) At the time of inspection observe the south side exterior wall needs tuck pointing. Recommend licensed general contractor for reevaluation and repair as desired.

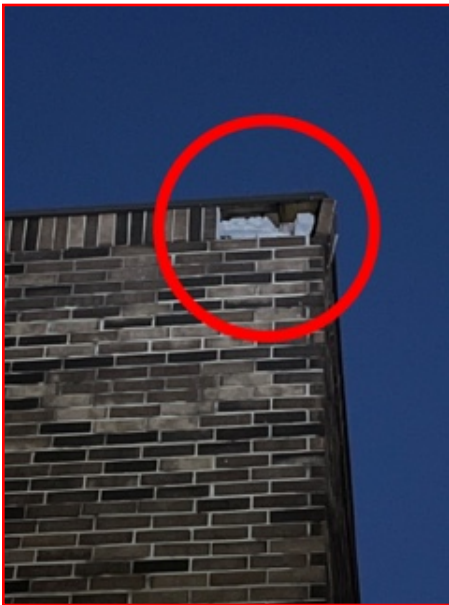
Figure 6-1

6) Observed at the time of inspection, The southwest corner top of the masonry wall is missing bricks.
Recommend replacement by a qualified masonry, or licensed general contractor as desired.

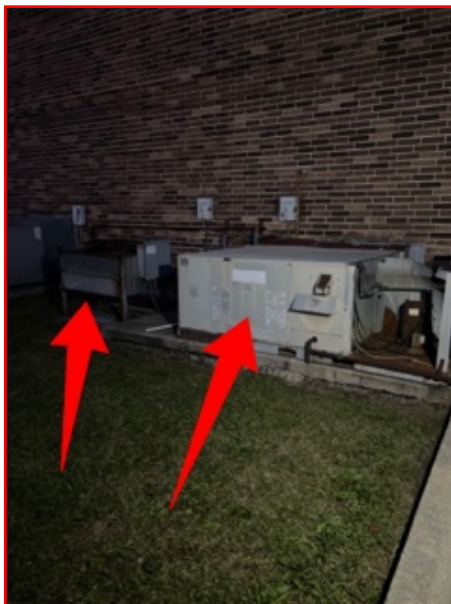
Figure 7-1

7) Observed at the time of inspection while facing west, these HVAC/power components were dismantled at the time of inspection.

Recommend a Licensed The HVACs for evaluation and repair as desired.

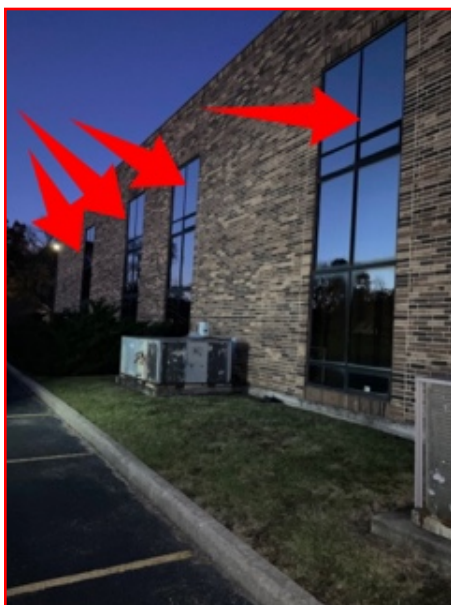
Figure 8-1

8) Observed The The time of inspection exterior wall facing west, these four windows seals need repair oh replace by qualified window and door specialist as desired.

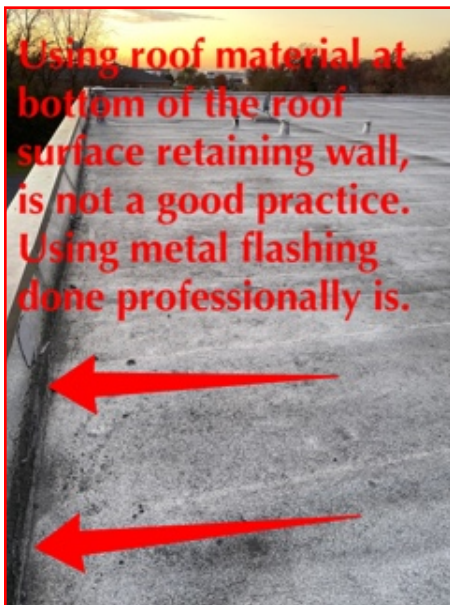
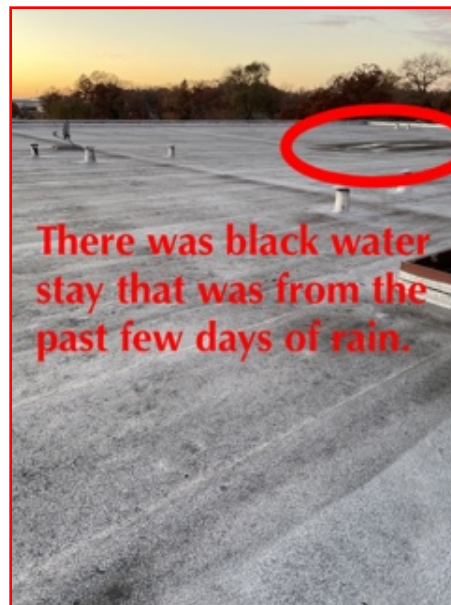
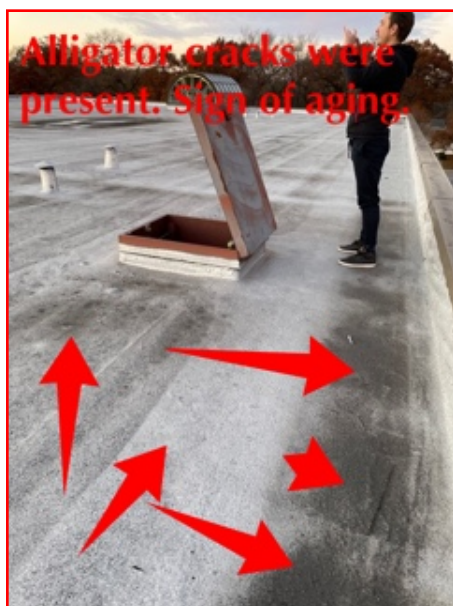
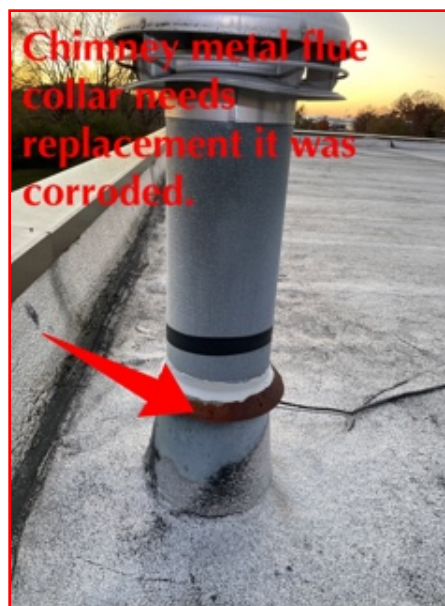
- Roof was wavy.
- Roof had water pulling/stray/puddles.
- Roof granular substance has almost faded away.
- The chimney flue was corroded, the one facing south.
- Also observed a noticeable amount of saturated erosion black substance in the center of the roof.

Recommend licensed roofing contractor or licensed general contractor for replacement and re-evaluation as desired.

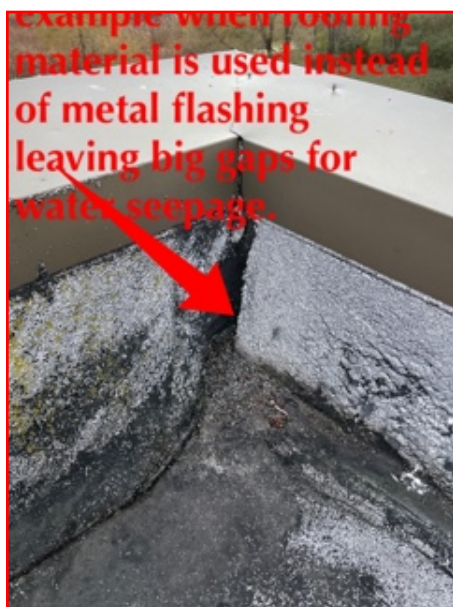
Figure 10-1

10) Observed at south west corner, big gap needs to be redone. Recommend replacement of the entire roof by a roofing contractor or a licensed general contractor.

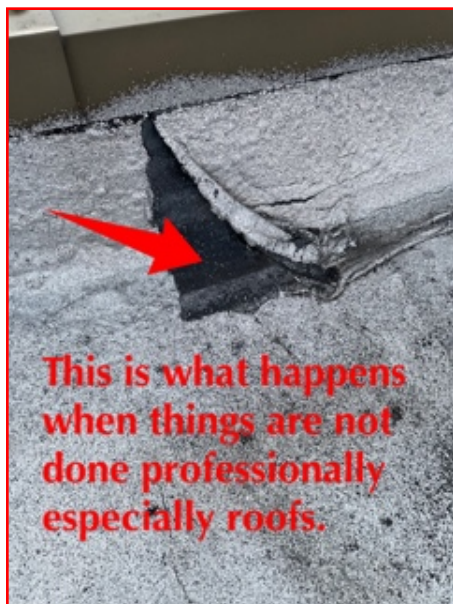
Figure 11-1

11) Observed towards the west side ceiling roof covering needs to be repaired and patched Brian roofing contractor license general contractor at the time of inspection.

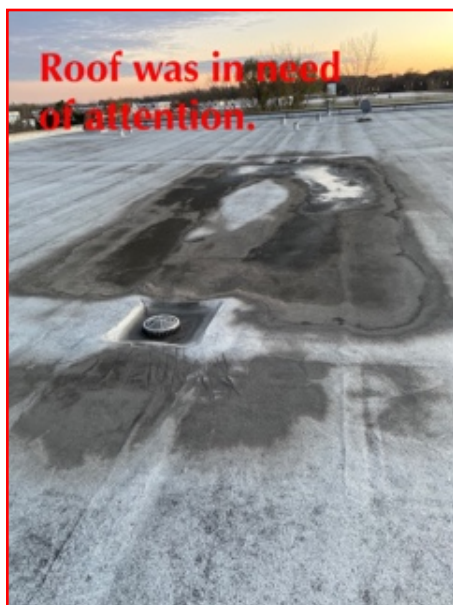
Figure 12-1

12) Observed in the middle of roof, huge puddle of water from few days ago that was rainy.

Recommend remove and replace by roofing contractor or licensed general contractor.

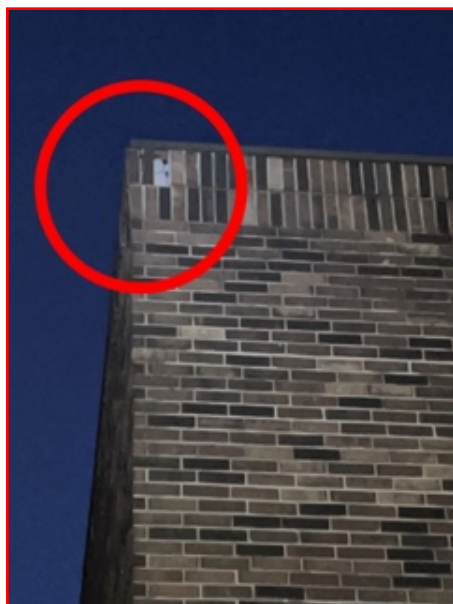
Figure 13-1

13) Observed at northwest corner of building at top brick/ masonry, bricks are starting to tilt/lean need tuck pointing need repair and re-evaluated by licensed contractor as desired.

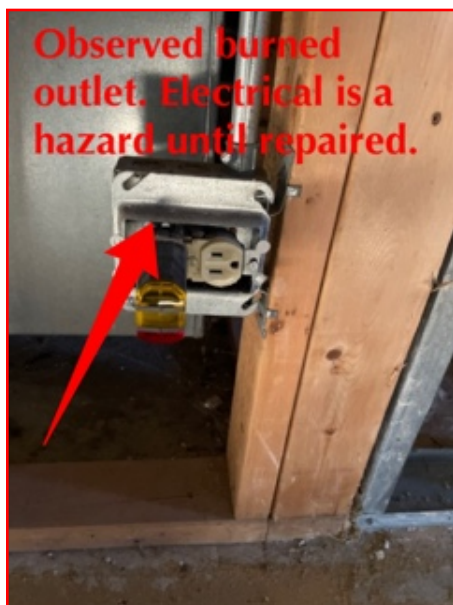
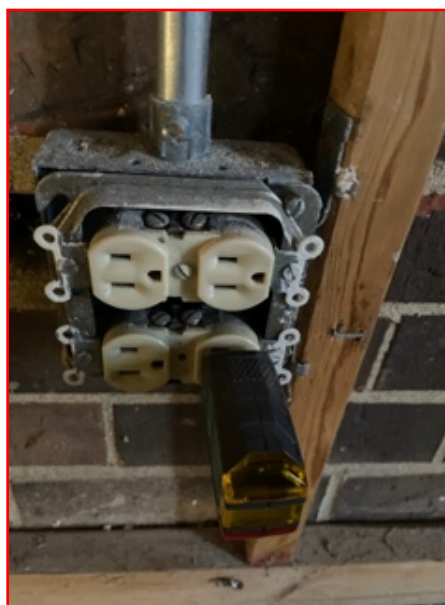
14) At the time of inspection observed quite a few electrical outlets missing cover as well as number representative of electrical outlets had no power or open hot. Recommend a Licensed The Electric in for repair and reevaluation of the entire electrical system in this commercial building as well as electrical panel as desired. Electrical outlet facing west side wall in the corner open heart no power. Recommend a licensed electrician for repair of the entire electrical service of this building as desired.

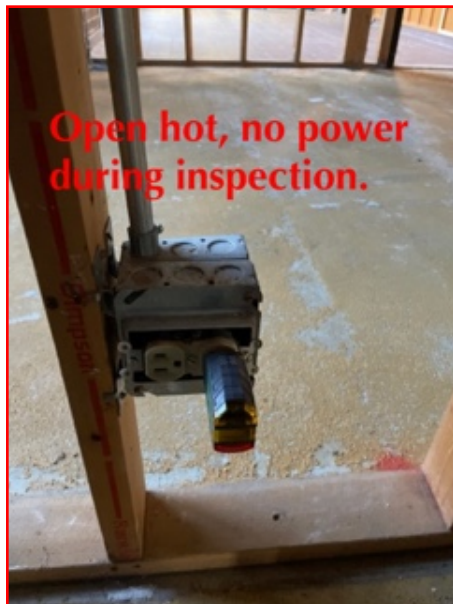
Figure 15-1

15) At the time of inspection observed partition wall across from the previous same issue open-heart recommend licensed electrician for evaluation and repair. The salad is facing east.

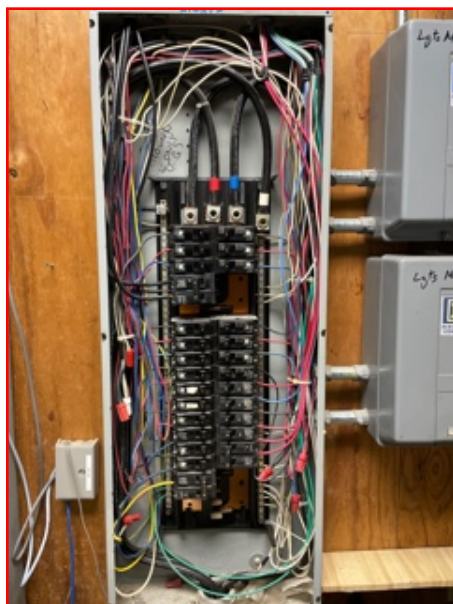
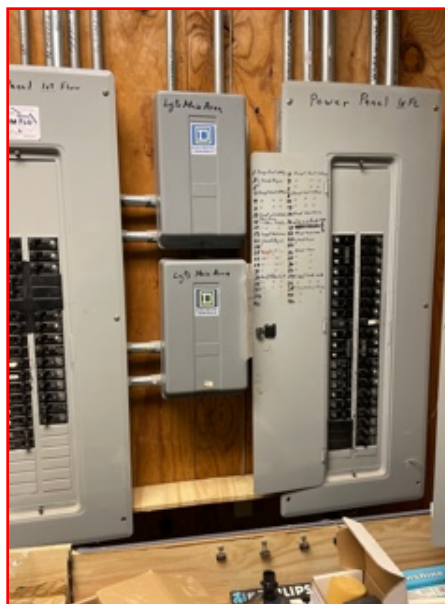
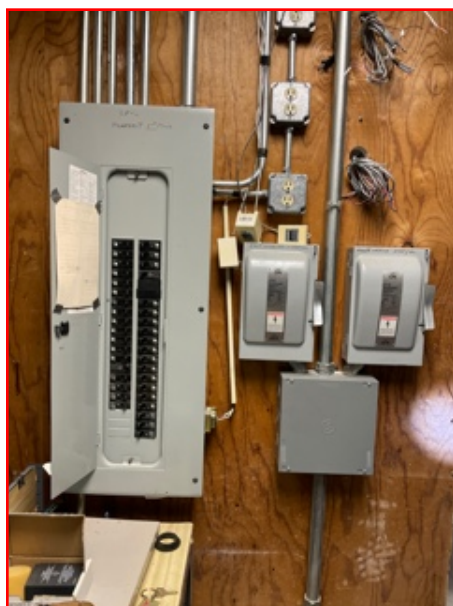
19) Observed at the time of inspection these electrical panel you see with the aero has a wrong size wire attached to a 20 amp breaker.

I am recommending a licensed electrician to look and inspect every single panel, every single outlet, for repair and reevaluation.

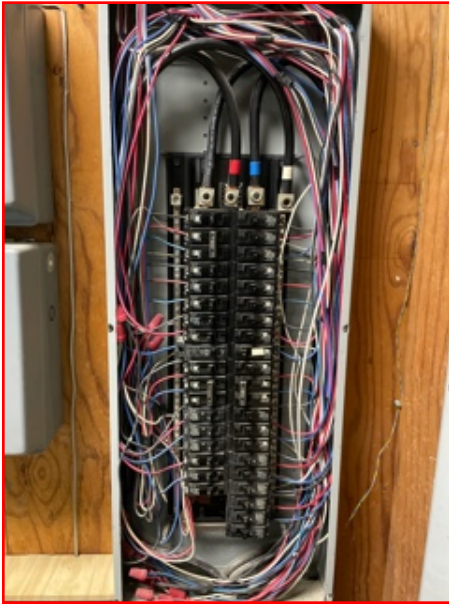
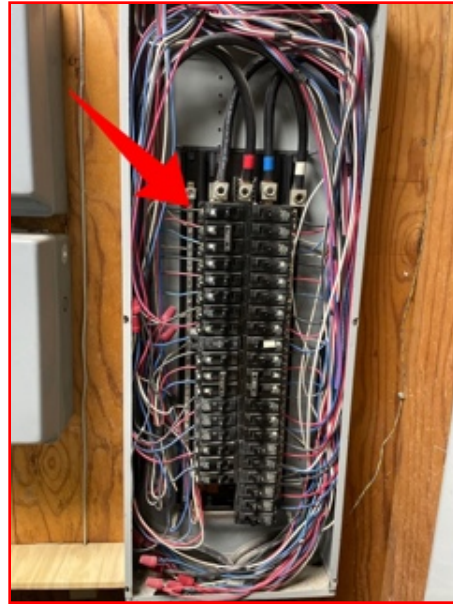
20) Observed at the time inspection number one outlet has a wrong wire size that does not match the 20 amp breaker. I am recommending a licensed electrician to inspect every electrical panel, inspect every electrical outlet, for repair and re-evaluation as desired.

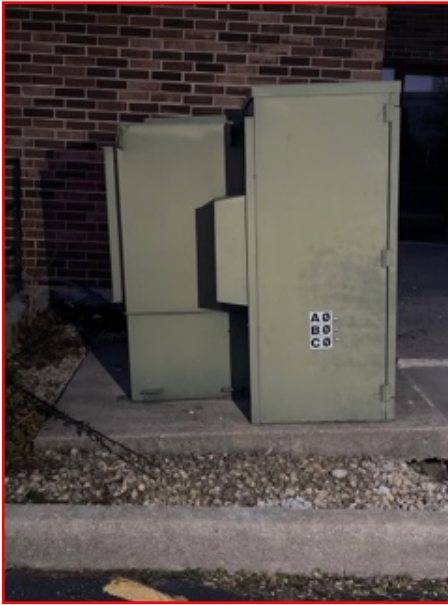
Figure 24-1

23) Observed transformers at south side exterior at the time of inspection that needs re-evaluation by qualified professionals for commercial property.

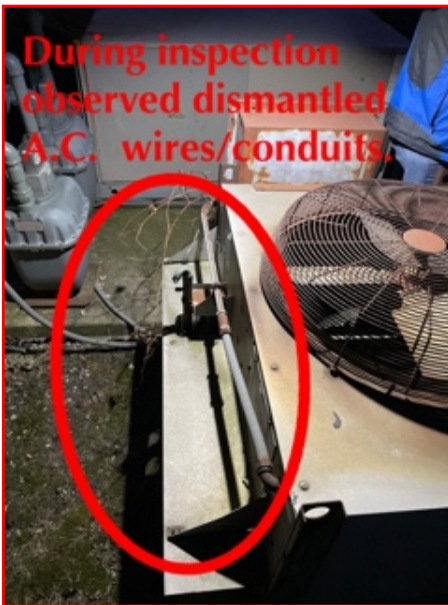
Figure 28-1

24) West side ax dismantked.

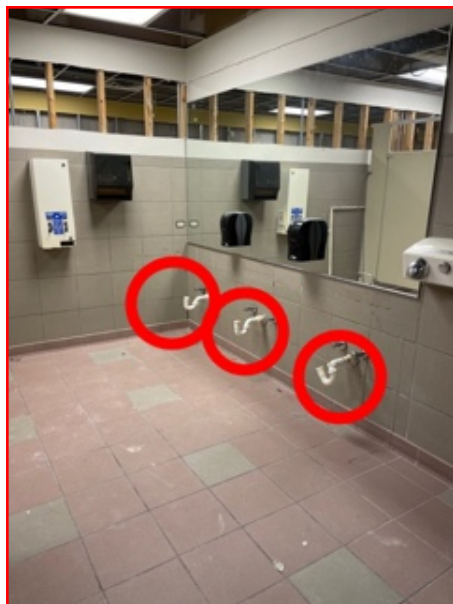
Figure 31-1

27) At the time of inspection main water and gas were shut off. Plumbing was still under construction as there was only rough work to be finished. Therefore inspection of plumbing was undetermined given the above reason.

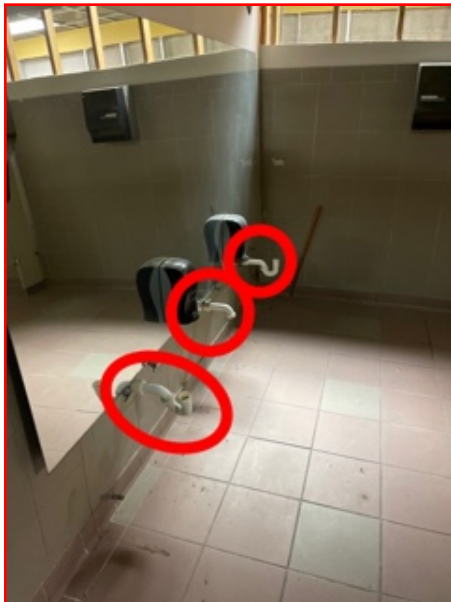
Figure 32-1

28) Again at the time when spec shin plumbing rough work was still not done as this is the other bathroom that was observed. Therefore, inspection of plumbing was undetermined due to the given above reason.

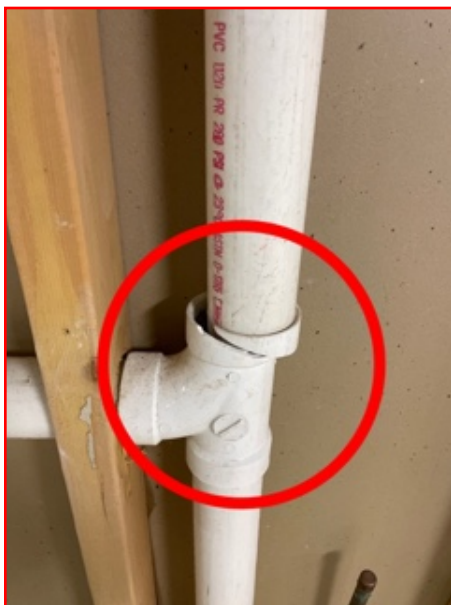
Figure 33-1

29) Recommend this unprofessional cut of PVC plumbing to be replaced. I mean the whole PVC pipe needs to be replaced not just a joint or have it patched. Recommend a License plumber for repair and reevaluation as desired.

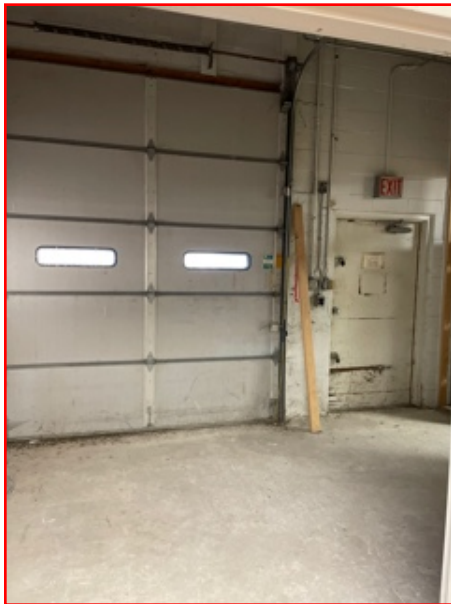
Figure 34-1

30) At the time of inspection this docking door in the rear, did not function. Recommend reevaluation by a qualified specialist.

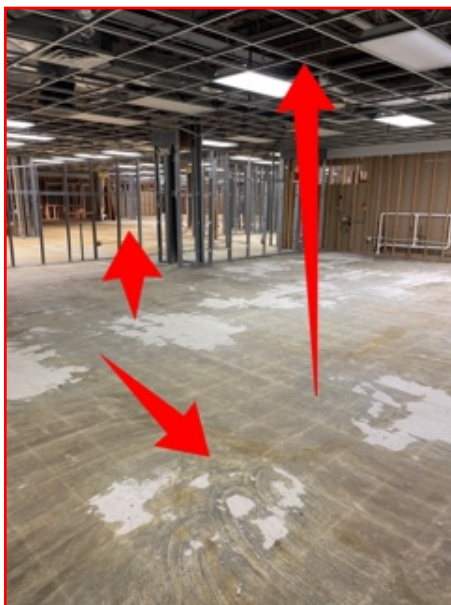
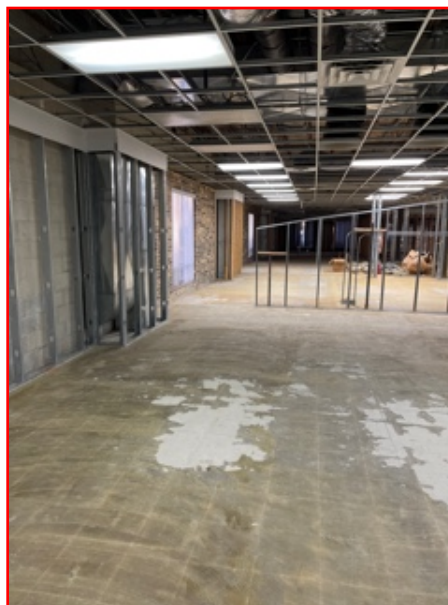
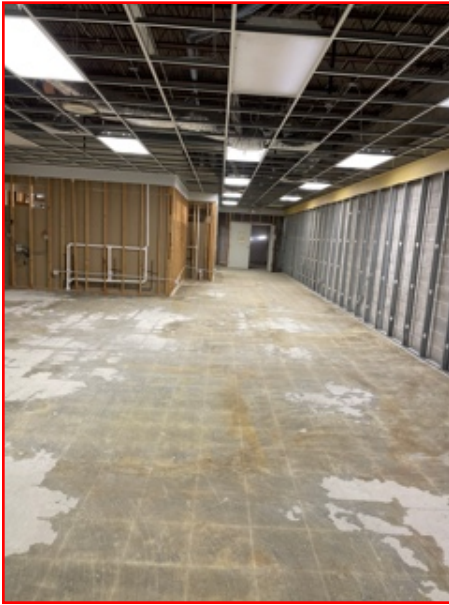
31) At the time of inspection the interior of this entire commercial building, the floors were not done, the ceiling was not done, and the insulation between the studs and the wall was not covered.

Recommend licensed general contractor for reevaluation and repair as desired.

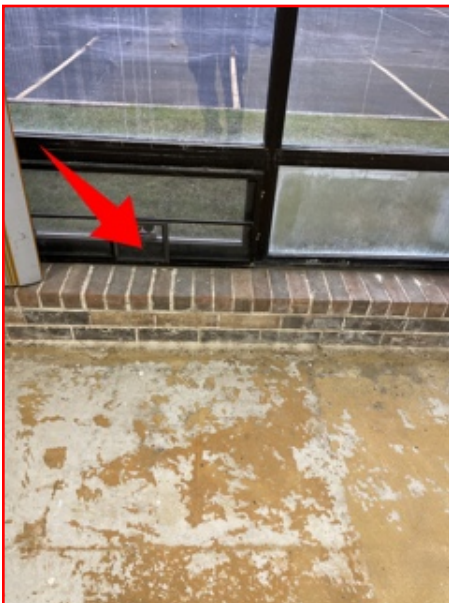
Figure 36-1

32) Observed at the time of inspection this bottom window that opens with the handle is stuck it does not open.
Recommend window and door specialist for repair and reevaluation.

Recommend window and door specialist for repair and reevaluation.

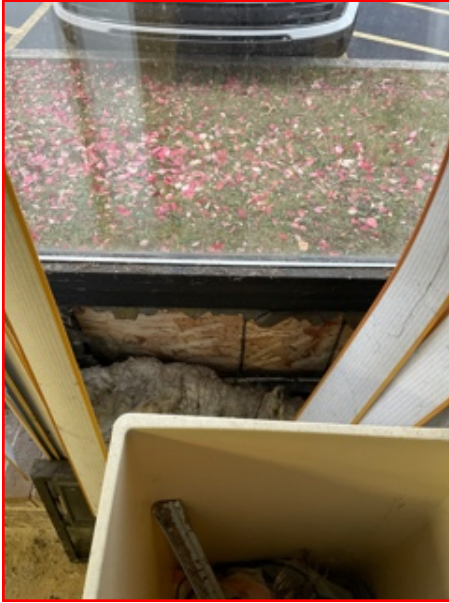
Figure 37-1

33) At the time of inspection observed this front window at bottom facing front property, missing glass.

Recommend window and door specialist for replacement as desired and further evaluation as desired.
