## SUMMARY REPORT

AmeriSpec Inspection Services  
License #450.011551; Expires, 11/30/22

Doc #: Client Name: Carl White Jr.  
Dwelling Address: 10 Hemlock St  
Park Forest IL 60466 Inspector: Cal Ramirez

INSPECTION REPORT  
10 Hemlock St  
Park Forest Illinois 60466

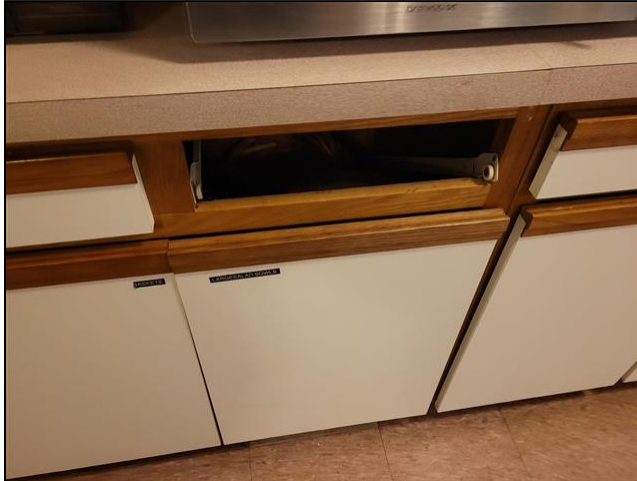
- 1.3 (1) Counters and Cabinets **Comment. Drawers are damaged; corrections needed for proper and smooth operation.**  
(representative number)

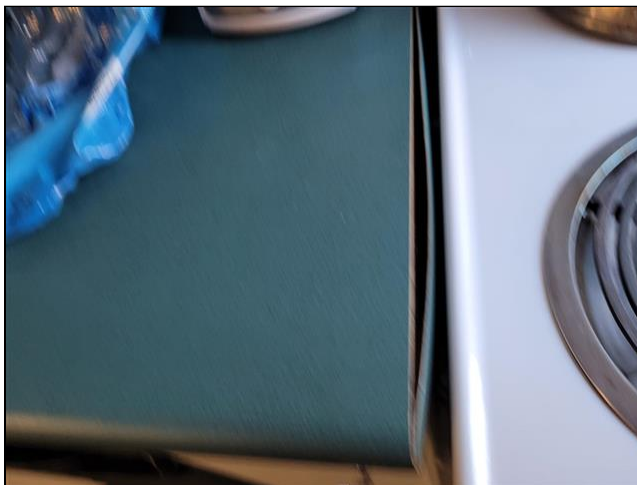
- 1.3 (2) Counters and Cabinets **Comment. Loose laminate touching stove observed at first floor kitchen, suggest corrections as needed.**  
(representative number)

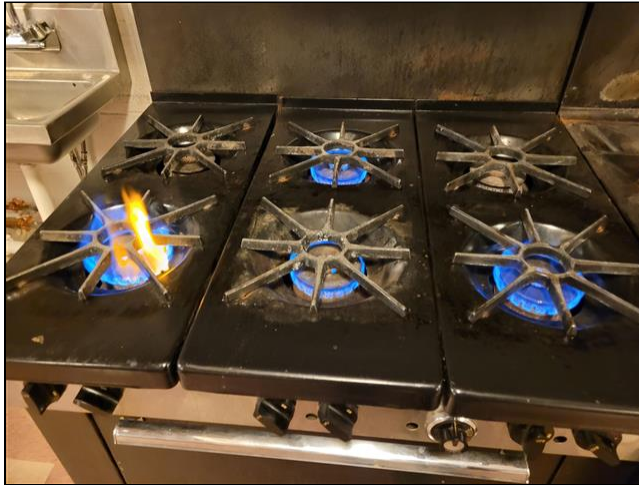
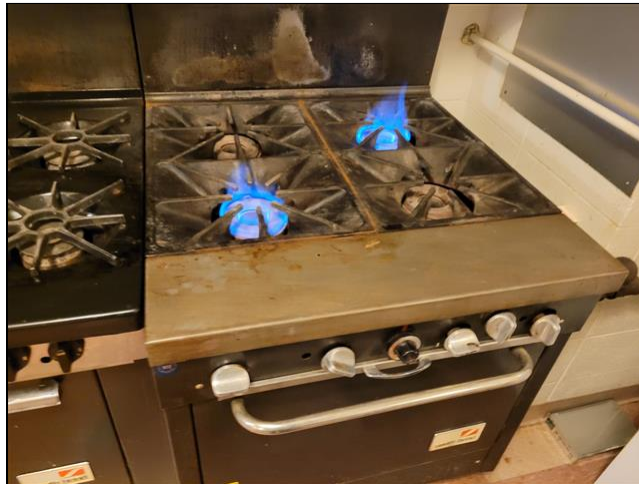
1.4 Ranges/Ovens/  
Cooktops

**Multiple burners are inoperable. Recommend review by a qualified appliance technician for repair or replacement as necessary.**

**Repair or Replace. Multiple burners are inoperable. Recommend review by a qualified appliance technician for repair or replacement as necessary.**

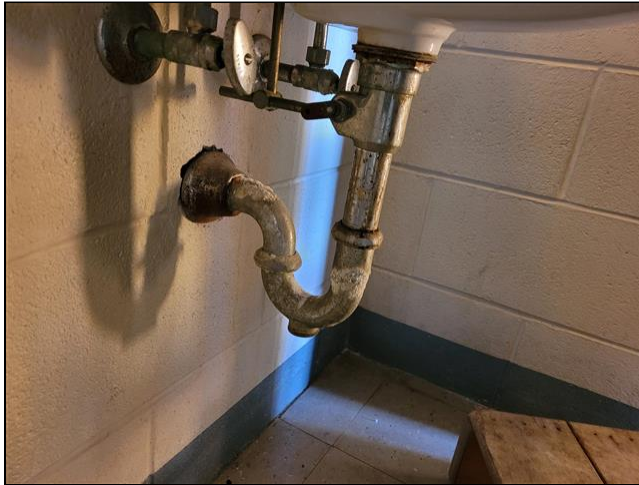
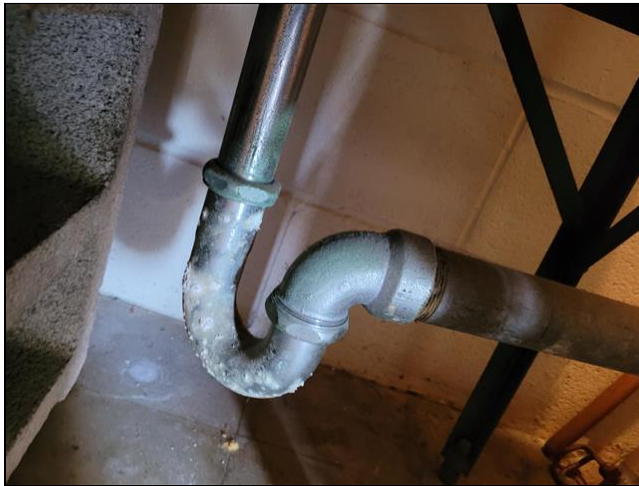
## 2.4 (2) Sinks

**(2) Corrosion observed at sink drain lines at multiple locations, no leaks at the time of inspection. Recommend corrections as needed.**

**Repair or Replace. Corrosion observed at sink drain lines at multiple locations, no leaks at the time of inspection. Recommend corrections as needed.**

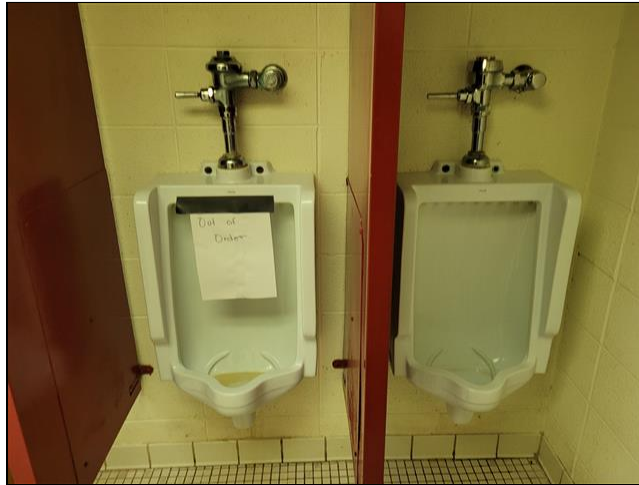
- 2.5 Toilet **Comment. Multiple toilets were labeled out of order at time of inspection. Client is advised to confirm operation, or have reviewed by a licensed/qualified electrician for repairs or replacements as needed prior to close.**

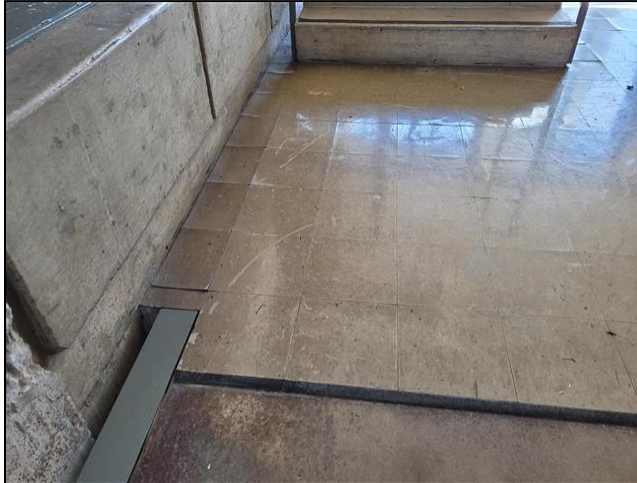
## 3.0 (1) Floors

**(1) Popping floor tile observed in the various locations, suggest corrections to prevent further damage.**

**Repair or Replace. Popping floor tile observed in the various locations, suggest corrections to prevent further damage.**

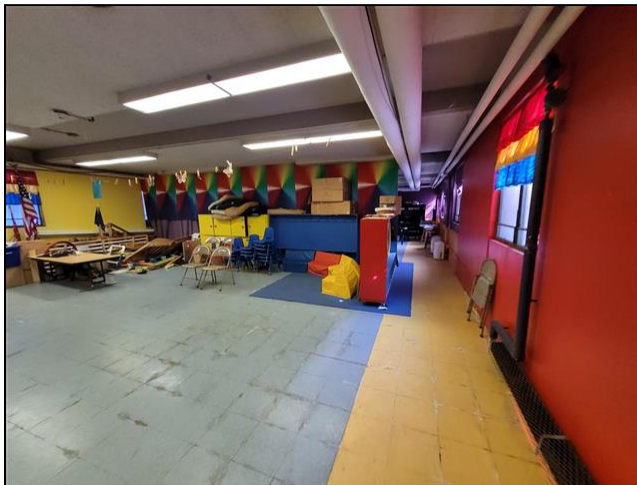
## 3.0 (2) Floors

**(2) Water damage floor observed in the various locations. No moisture noted at time of inspection, client is advised to consult with sellers for additional information prior to close.**

**Repair or Replace. Water damage floor observed in the various locations. No moisture noted at time of inspection, client is advised to consult with sellers for additional information prior to close.**

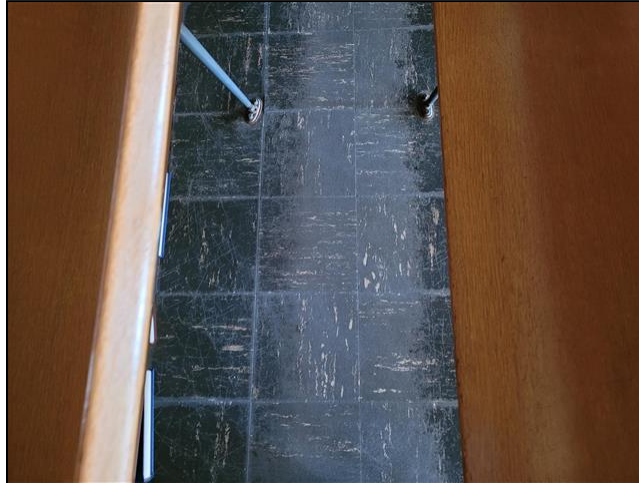
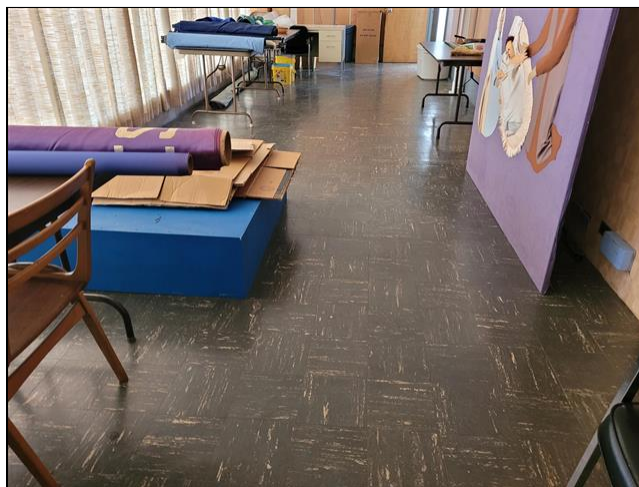
## 3.0 (3) Floors

**(3) Asphalt Asbestos observed in the various locations, Plastic Asbestos, and Vinyl Asbestos floor tiles were sold in 6" x 6", 9" x 9" and in some years 12" x 12" sizes. Recommend review for possible removal if client is concerned.**

**Repair or Replace. Asphalt Asbestos observed in the various locations, Plastic Asbestos, and Vinyl Asbestos floor tiles were sold in**

**6"x6", 9" x 9" and in some years 12" x 12" sizes. Recommend review for possible removal if client is concerned.**

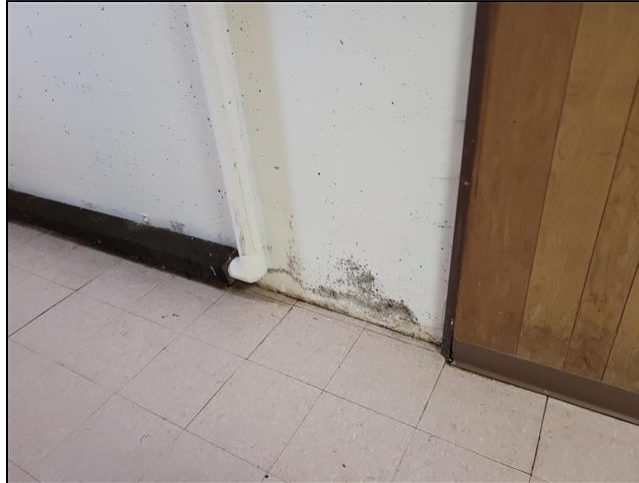
3.1 (1) Walls

**(1) Stains, discoloration, growth and/or evidence of moisture observed in the basement. These conditions may indicate mold and/or fungus growth and were discovered during the home inspection. Because certain types of mold may be toxic and result in adverse health effects, it is strongly recommended that a mold inspection be performed by a qualified professional to determine the presence of, and types of, mold in the house and that corrective measures be taken to limit moisture inside the home.**

**Repair or Replace. Stains, discoloration, growth and/or evidence of moisture observed in the basement. These conditions may indicate mold and/or fungus growth and were discovered during the home inspection. Because certain types of mold may be toxic and result in adverse health effects, it is strongly recommended that a mold inspection be performed by a qualified professional to determine the**

**presence of, and types of, mold in the house and that corrective measures be taken to limit moisture inside the home.**

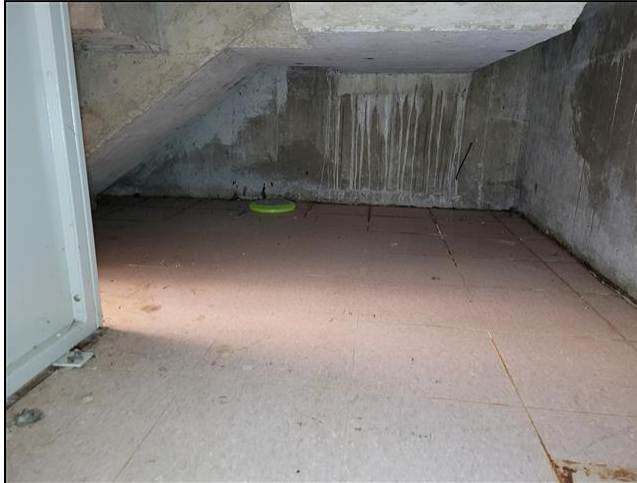
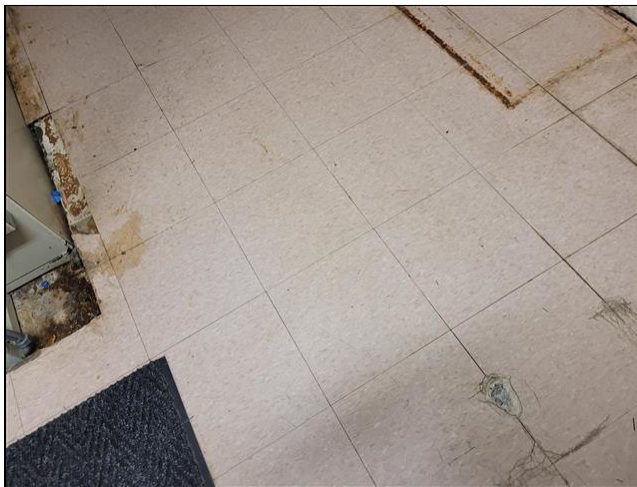
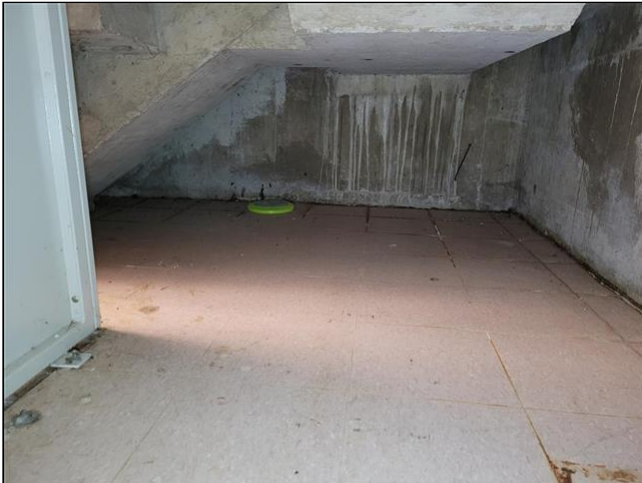
3.1 (3) Walls

**(3) Evidence of water entry observed at lift, suggest consulting sellers for additional information.**

**Repair or Replace. Evidence of water entry observed at lift, suggest consulting sellers for additional information.**

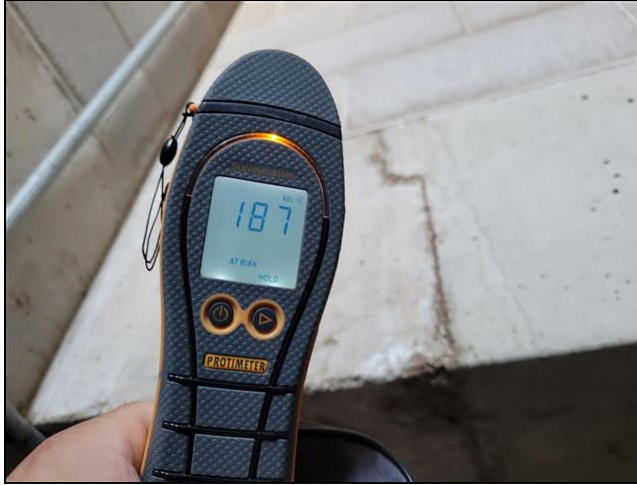
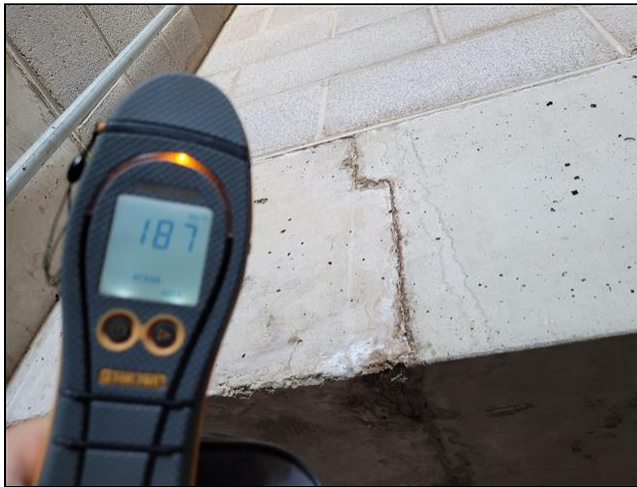
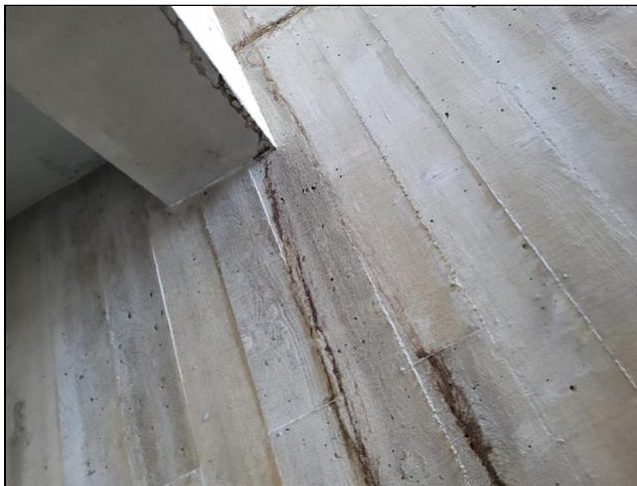
## 3.1 (4) Walls

**(4) Stains observed on wall in the stairwell near main entry. An elevated level of moisture was detected using an electronic moisture meter. A qualified contractor is needed for further review and to perform necessary corrections prior to close.**

**Repair or Replace. Stains observed on wall in the stairwell near main entry. An elevated level of moisture was detected using an electronic moisture meter. A qualified contractor is needed for further review and to perform necessary corrections prior to close.**

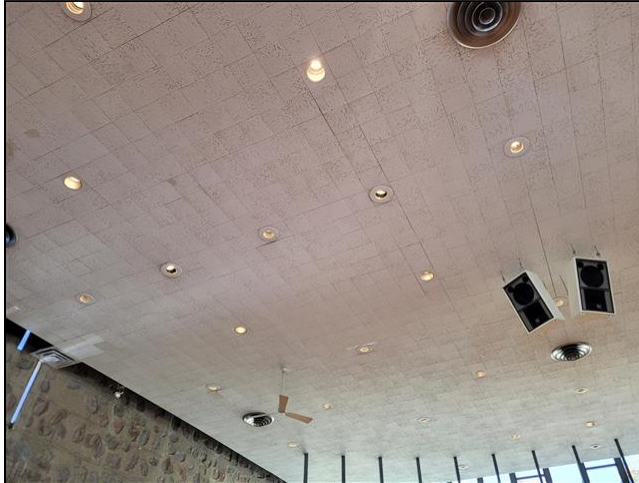
3.2 (1) Ceilings

**Repair or Replace. Loose/hanging ceiling tiles observed at multiple areas, suggest corrections as needed.**

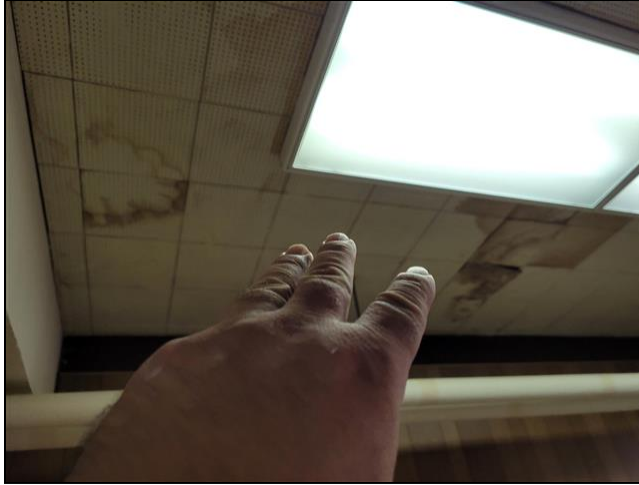
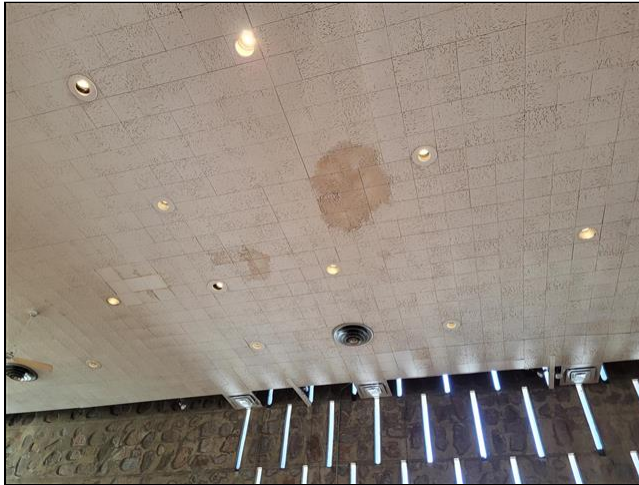
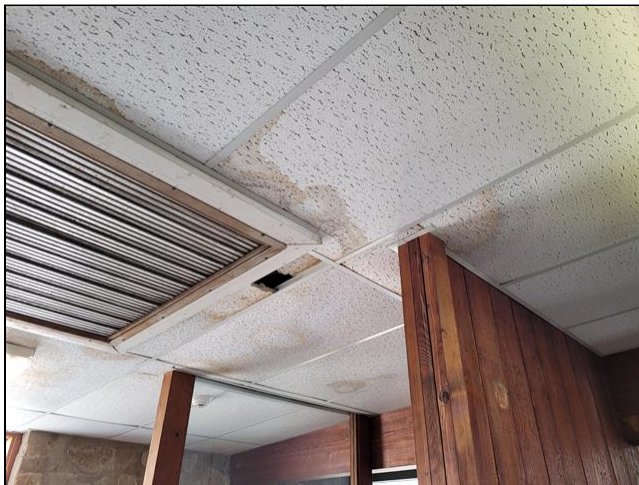
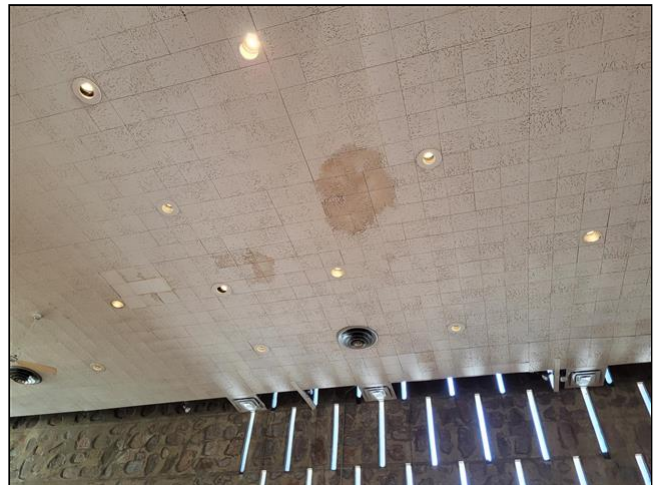
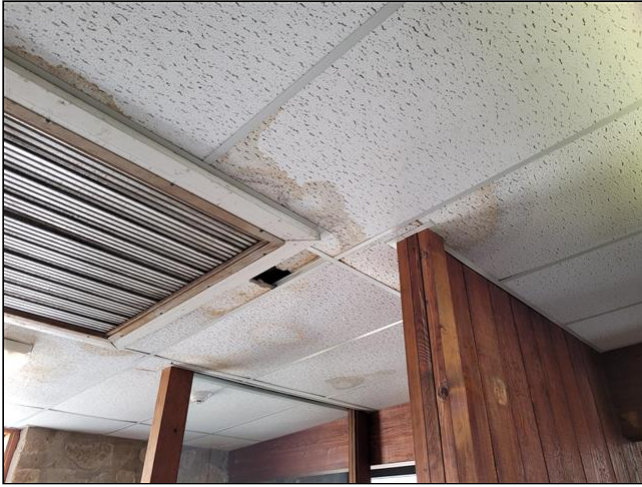
3.2 (2) Ceilings

**(2) Evidence of past water penetration observed in the various locations. Recommend review sellers disclosure statement or have reviewed by licensed professional for repair or replacement as necessary.**

**Repair or Replace. Evidence of past water penetration observed in the various locations. Recommend review sellers disclosure statement or have reviewed by licensed professional for repair or replacement as necessary.**

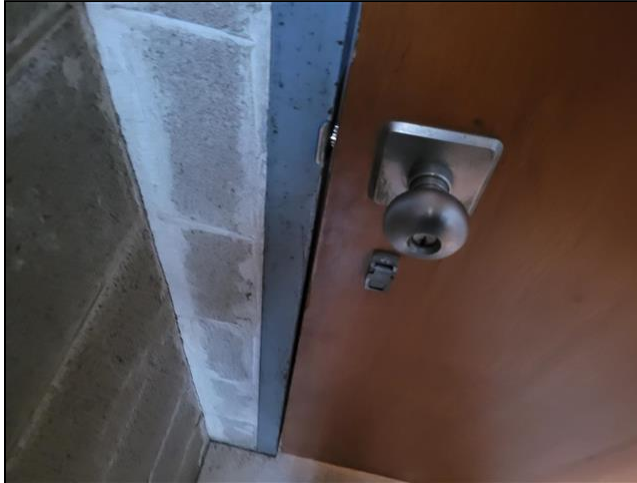
- 3.3 (1) Doors (representative number) **Comment. The basement stairwell door does not latch properly; suggest repairs/adjustments for proper operation.**

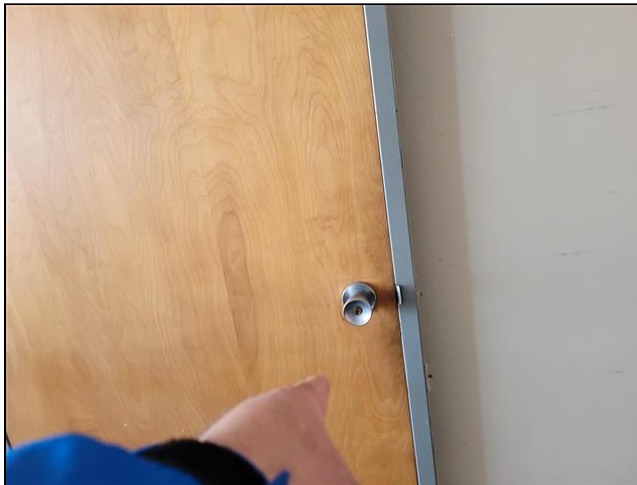
- 3.3 (2) Doors (representative number) **Comment. The door in the various locations rubs the jamb, adjustments are needed for smooth operation.**

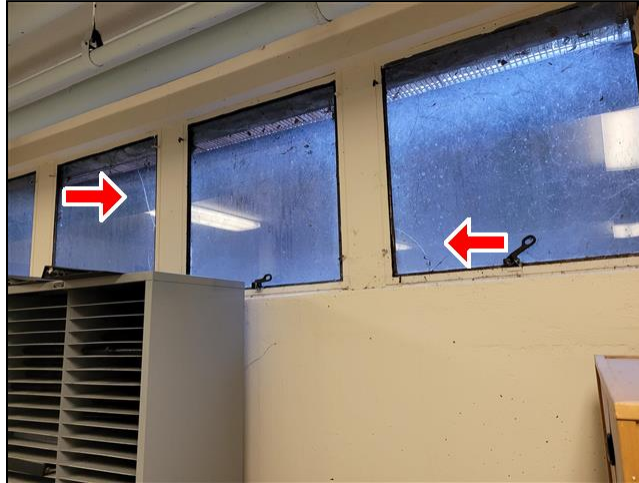
3.4 Windows  
(representative  
number)

**Windows at various locations are broken. Recommend corrections for proper operation.**

**Repair or Replace. Windows at various locations are broken.  
Recommend corrections for proper operation.**

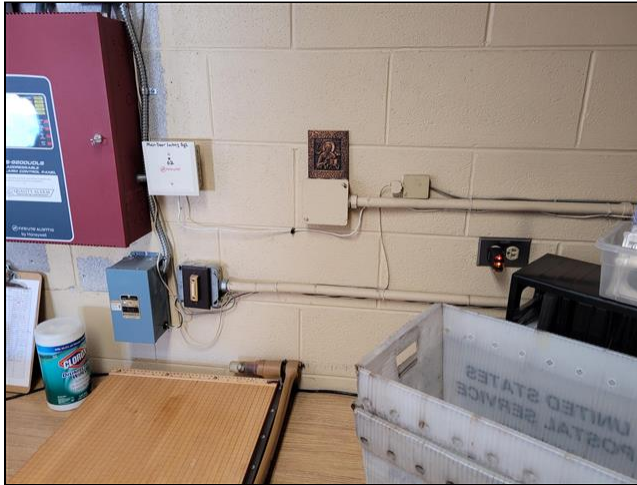
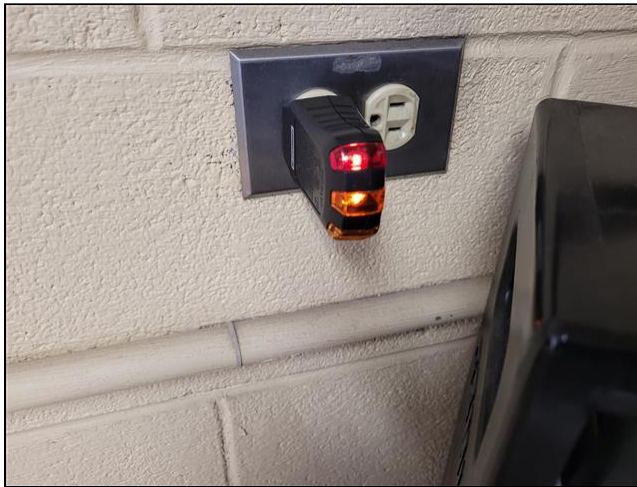
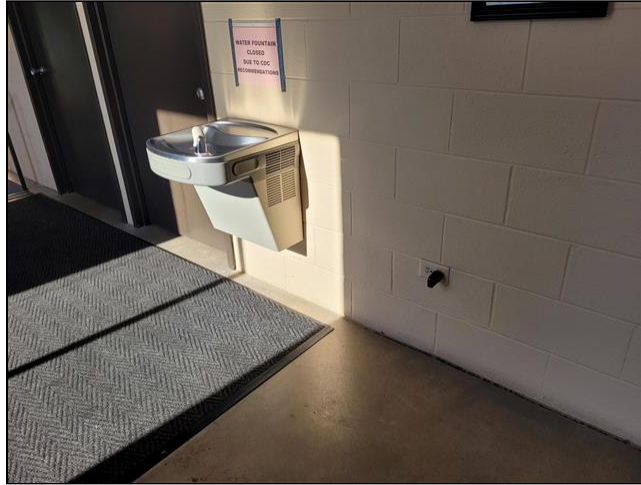
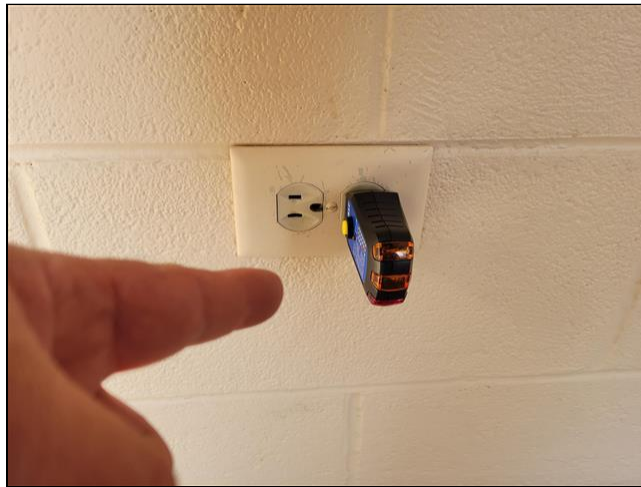
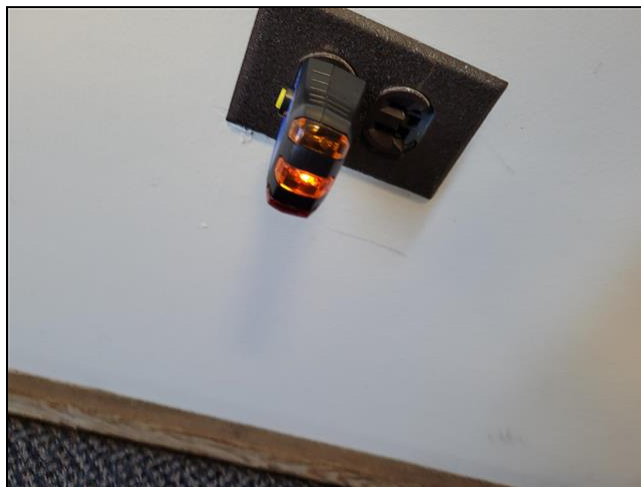
**(1) Multiple outlets are not wired correctly. Recommend review by a licensed/qualified electrician for repairs or replacements as needed prior to close.**

- 3.5 (1) Receptacles, Switches and Fixtures **Repair or Replace. Multiple outlets are not wired correctly. Recommend review by a licensed/qualified electrician for repairs or replacements as needed prior to close.**

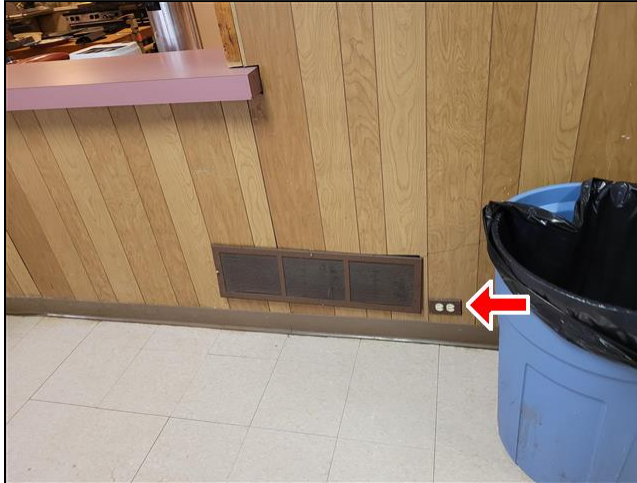
**(2) Broken prong left in wall outlet at basement, suggest corrections as needed.**

3.5 (2) Receptacles, Switches and Fixtures **Repair or Replace. Broken prong left in wall outlet at basement, suggest corrections as needed.**

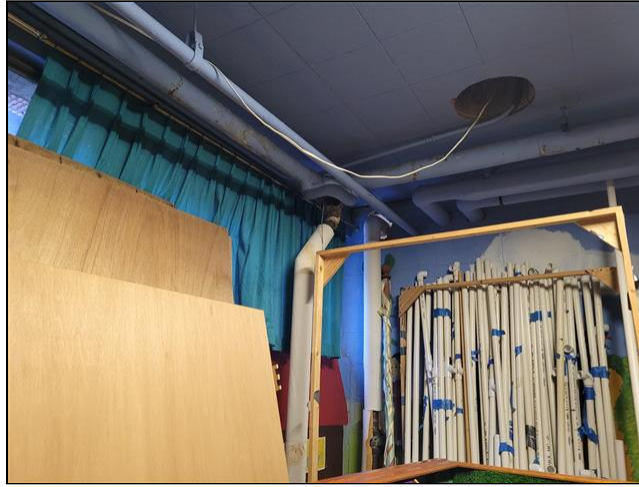
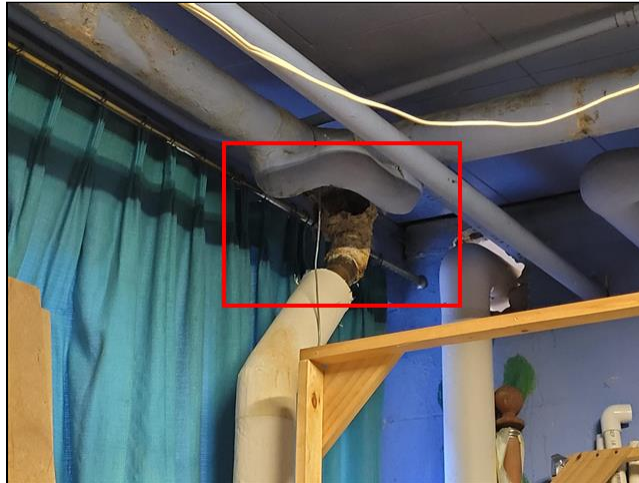
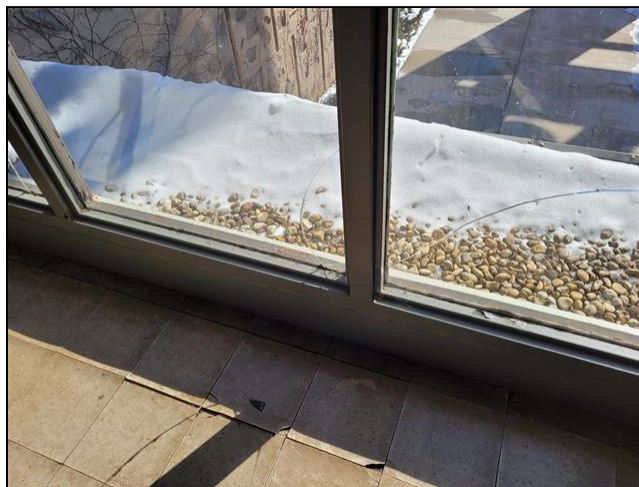
## 3.7 (1) Interior Rooms and Areas Comments

**(1) Possible asbestos materials observed. The materials were torn, ripped, or damaged at the time of inspection. This is a possible safety hazard. Suggest further review by a licensed asbestos testing lab be performed prior to closing for repairs/replacement needed to ensure safety.**

**Repair or Replace. Possible asbestos materials observed. The materials were torn, ripped, or damaged at the time of inspection. This is a possible safety hazard. Suggest further review by a licensed asbestos testing lab be performed prior to closing for repairs/ replacement needed to ensure safety.**

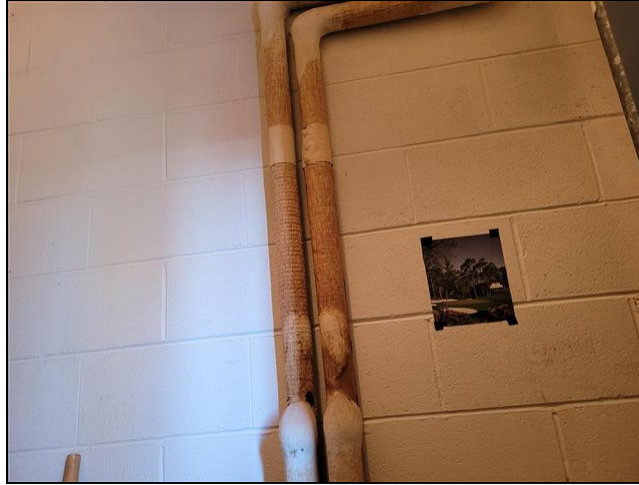
## 3.7 (2) Interior Rooms and Areas Comments

**Repair or Replace. Possible asbestos materials observed. The materials appeared to be intact at the time of inspection. Asbestos materials are considered safe by the EPA if they are not disturbed,**

**torn, ripped, or damaged. No torn, ripped, or damaged materials were observed. If client has any concerns regarding asbestos materials, an asbestos testing lab should be consulted for further review to ensure safety.**

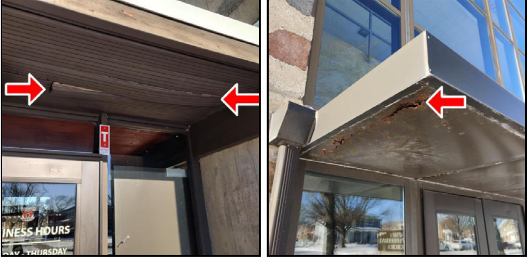
1.2 (2)	Exterior Wall Cladding	<b>Repair or Replace.</b> Caulking should be applied around all windows, doors, and any voids where necessary.
1.3 (1)	Trim, Eaves, Soffits and Fascias	<b>Repair or Replace.</b> Damaged/deteriorated trim observed at the middle building, east entry soffit and north building north entry soffit. Recommend repairs to prevent further damage.

<p>1.3 Item 1(Picture) Wood soffit is damaged, wood is bowing</p> <p>1.3 Item 2(Picture) Soffit panels are rusted at the north building main entrance</p>

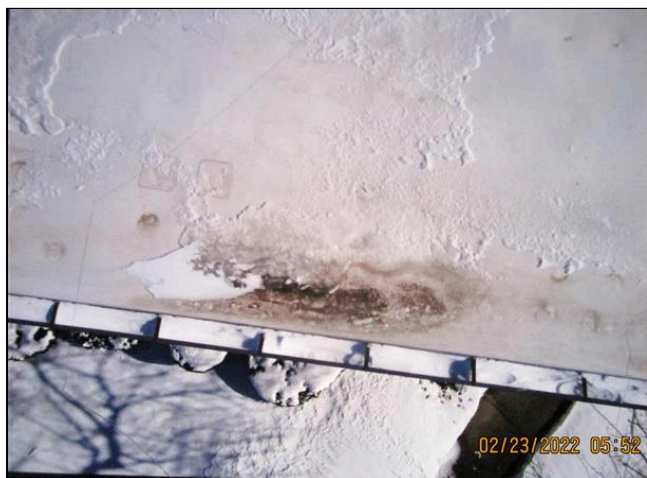
1.0 Item 1(Picture)

**1.0** The flat roof is deteriorated in areas. Unable to determine if this area will leak. This damage should be repaired or replaced. A qualified contractor should inspect and repair as needed.

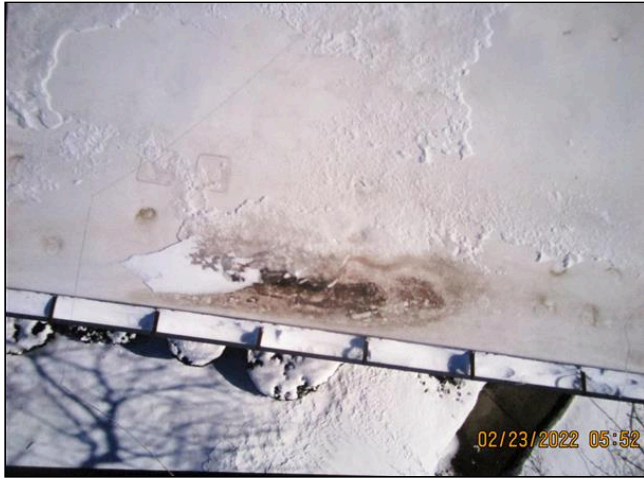
1.0 Item 1(Picture)

The flat roof is deteriorated in areas. Unable to determine if this area will leak. This damage should be repaired or replaced. A qualified contractor should inspect and repair as needed.
