Inspection Report

Property Address:
24703 Ave Asoleada
Calabasas CA 91302

AmeriSpec Inspection Services

Date: 11/19/2022	Time: 09:00:00 AM	Report ID: 111922VM14VH
Property: 24703 Ave Asoleada Calabasas CA 91302	Customer: Ashghar Farhadi	Real Estate Professional: Courtney Van Cott Frontgate Real Estate

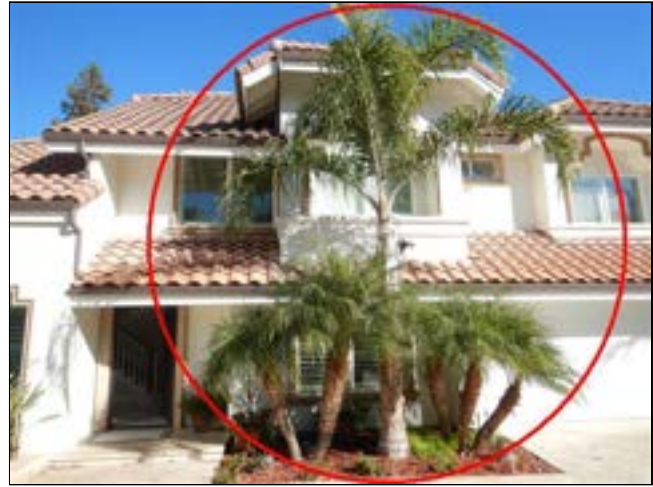
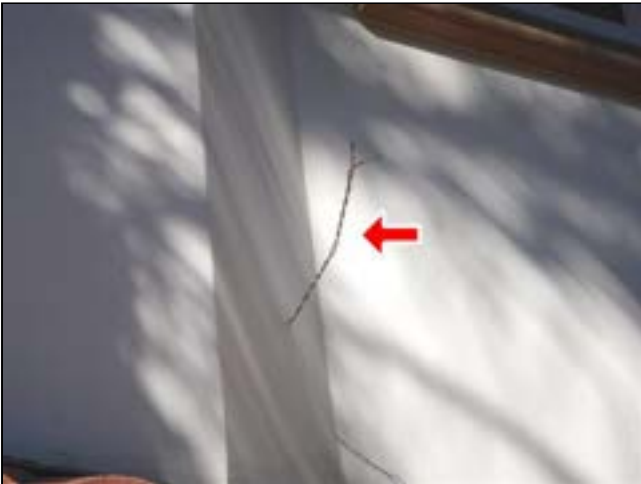
1.2 Item 3(Picture)

(2) There is a braided wire (appears to be metal) that is sticking out of the home's siding, above the first roof line. Unable to determine purpose of wire. Recommend consult with seller for additional information or review by a qualified professional for removal, as needed.

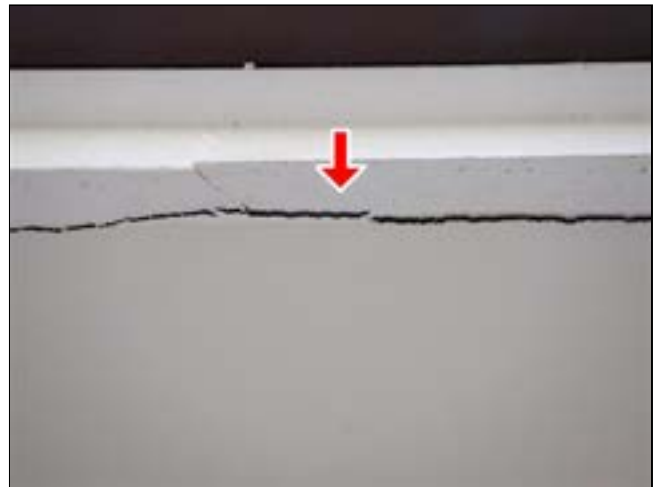
1.3 Item 4(Picture)

(2) Cracked fascia board observed at right side of home, near the pool equipment area. Recommend review by a licensed/qualified contractor for repairs.

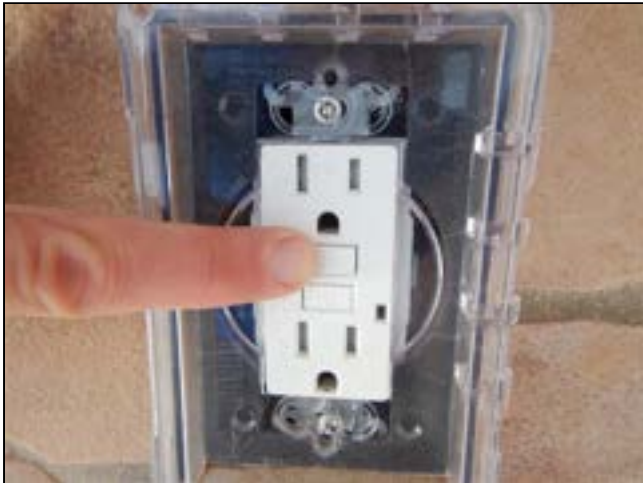
1.7 Item 2(Picture)

(2) The GFCI receptacle at the side of the built-in BBQ was tripped at time of inspection and would not reset. This indicates that the outlet is faulty. Recommend review by a licensed/qualified electrician for repair/replace, as needed.

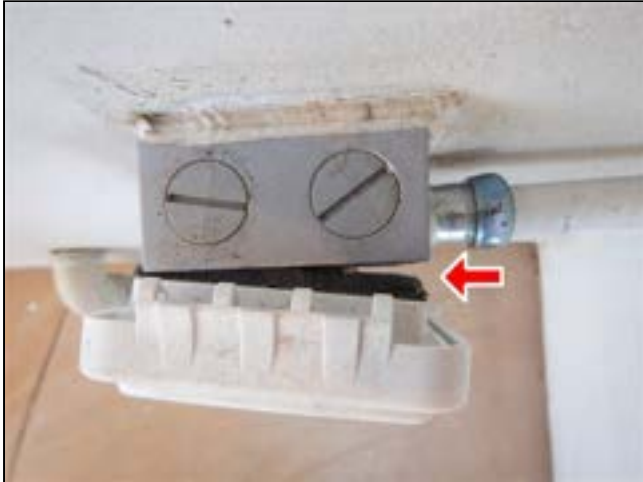
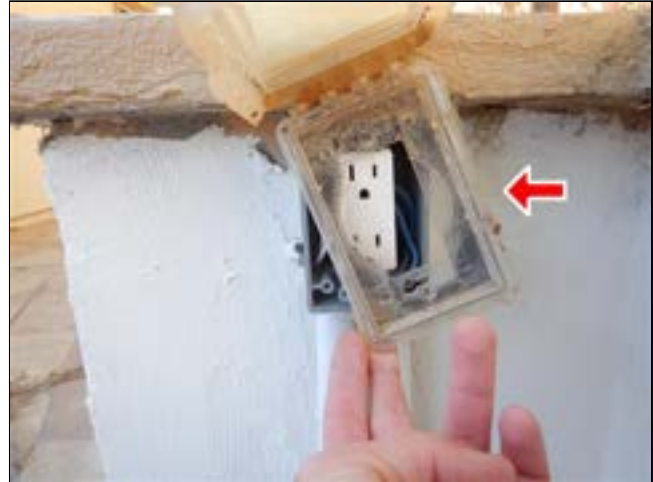
(3) The weatherproof covers for two of the exterior receptacles at the rear of the home are not secured properly. Recommend corrections for safety.

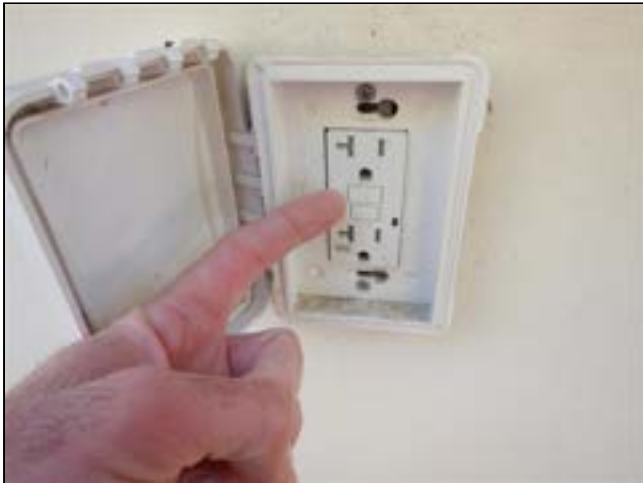
1.7 Item 5(Picture)

(4) One of the exterior GFCI receptacles at the left side of the home was tripped at time of inspection. When inspector tried to reset the GFCI the outlet would make a loud buzzing noise and would not reset. Recommend review by a licensed/qualified electrician to ensure safety.

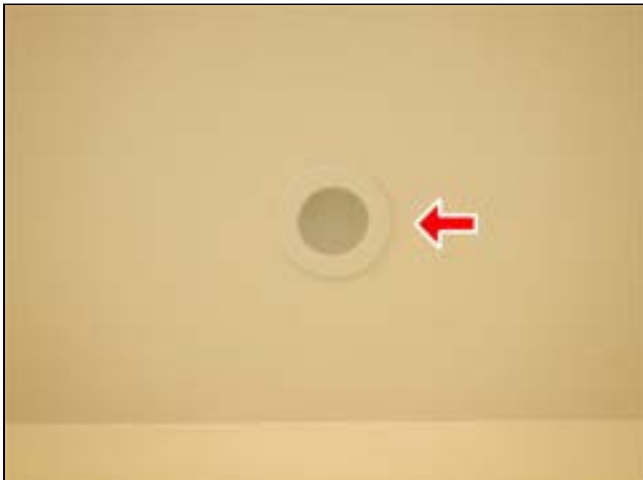
1.7 Item 6(Picture)

(5) One of the exterior recessed light fixtures at the left side of the home was inoperable at time of inspection. Possible spent bulb. Recommend review for repair/replace, as needed.

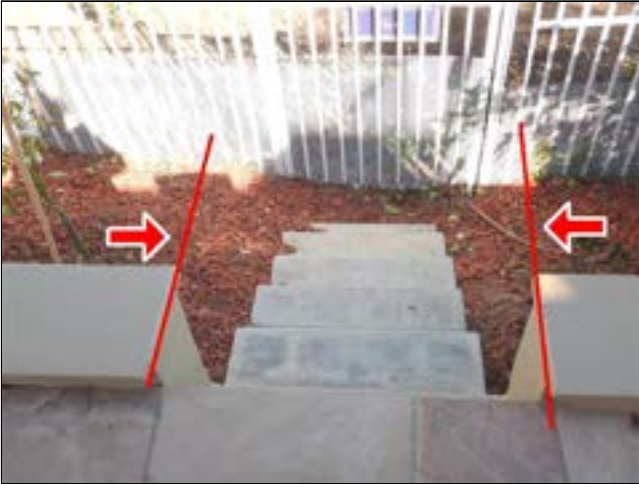
1.12 Item 1(Picture)

(1) No hand railings noted on steps at rear of home, recommend installing hand rail for safety. When ever four or more risers are present a handrail is usually required.

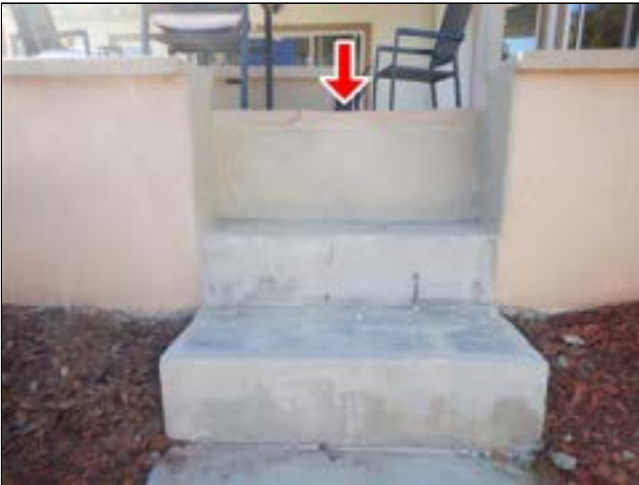
1.12 Item 2(Picture)

(2) The top step for the steps at the rear of the home is nearly twice the height of the rest of the steps. This is a safety concern as it may be a potential trip hazard. Recommend review by a licensed/qualified contractor for corrections to ensure safety.

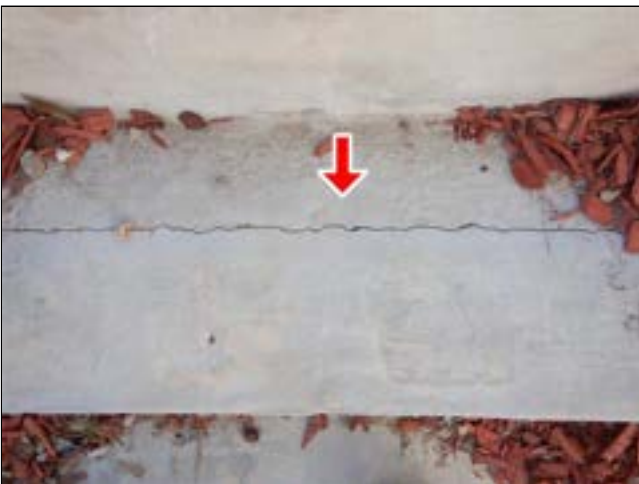
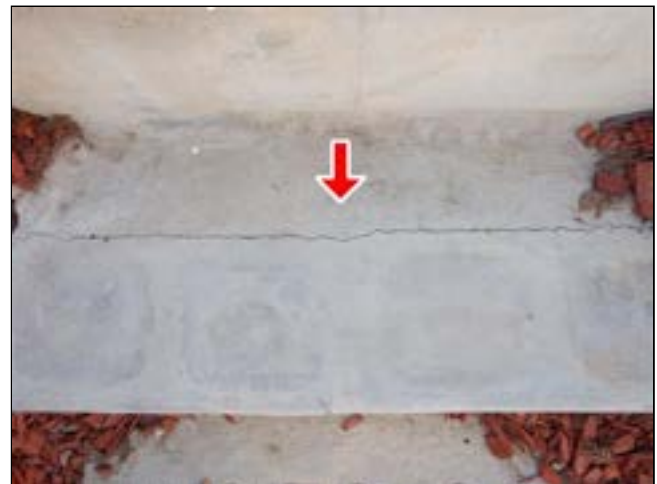
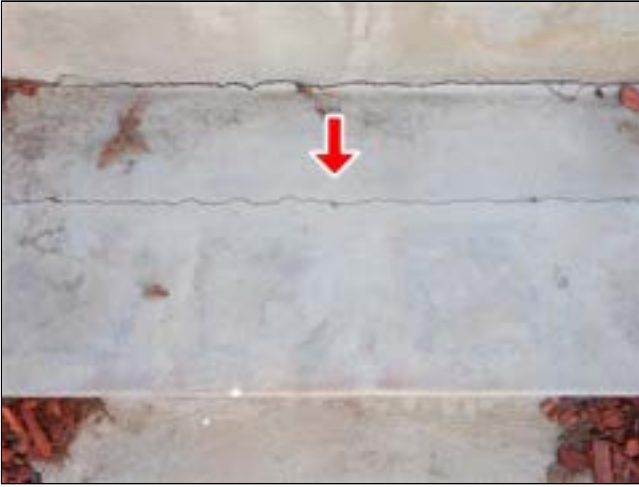
(3) Cracks observed on steps at rear of home. Recommend review by a licensed/qualified contractor for repairs.

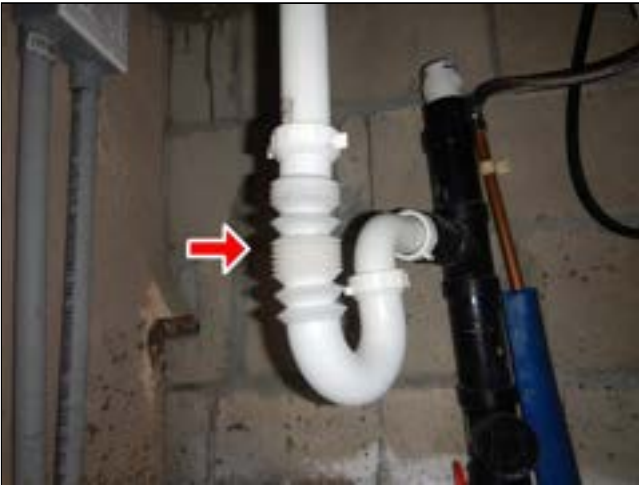
1.13 Item 1(Picture)

(1) Flex drain observed underneath the sink at the built-in BBQ. These are subject to frequent clogging. Recommend consulting with sellers for additional information or replacing to ensure proper operation.

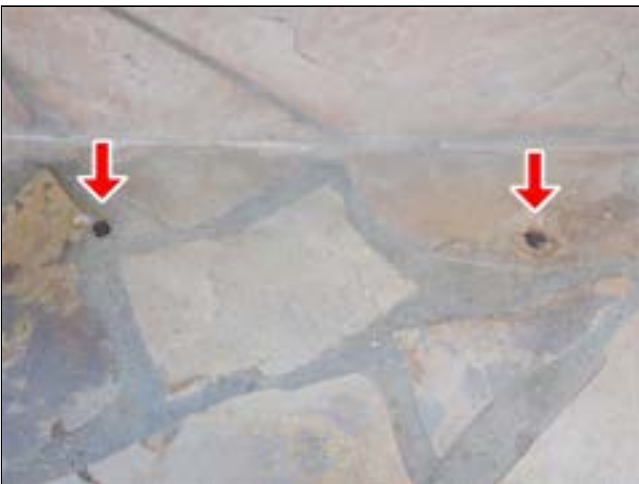
1.13 Item 2(Picture)

(2) Exposed tops of metal re-bar observed sticking up from the natural stone flooring at rear of home, next to the built-in BBQ. Recommend review by a licensed/qualified contractor for repairs, as needed.

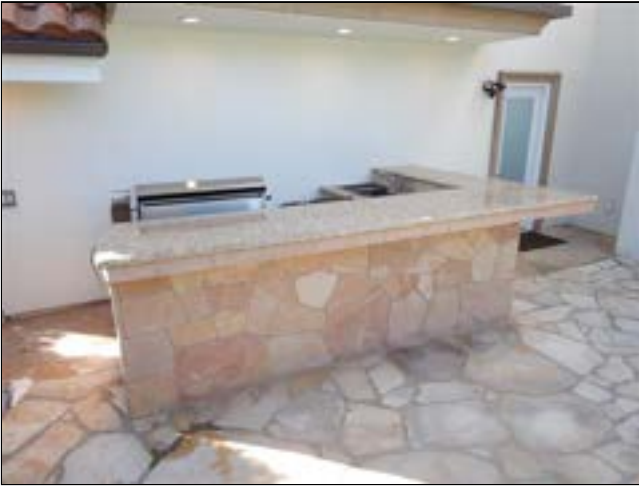
1.14 Item 1(Picture)

(1) The built-in BBQ at the rear of the home is beyond the scope of the inspection. If concerned, recommend consult with seller or review by a qualified professional.

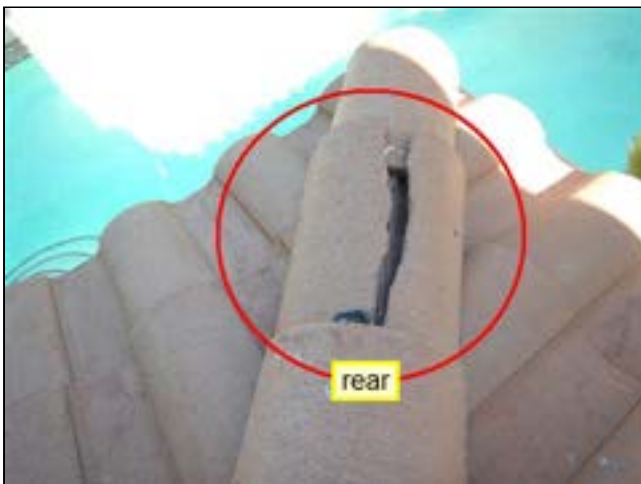
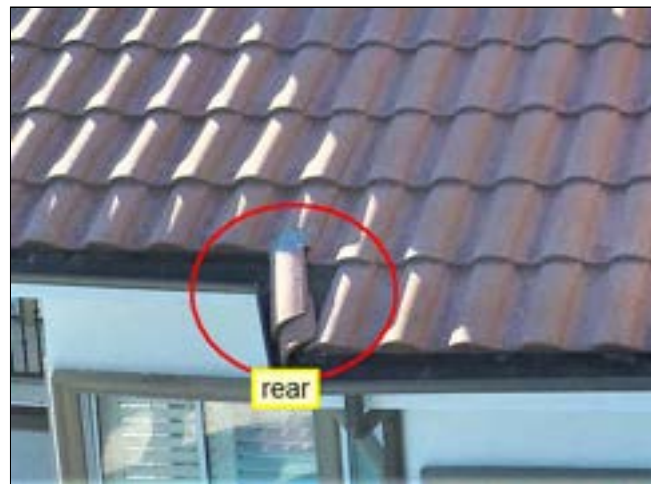
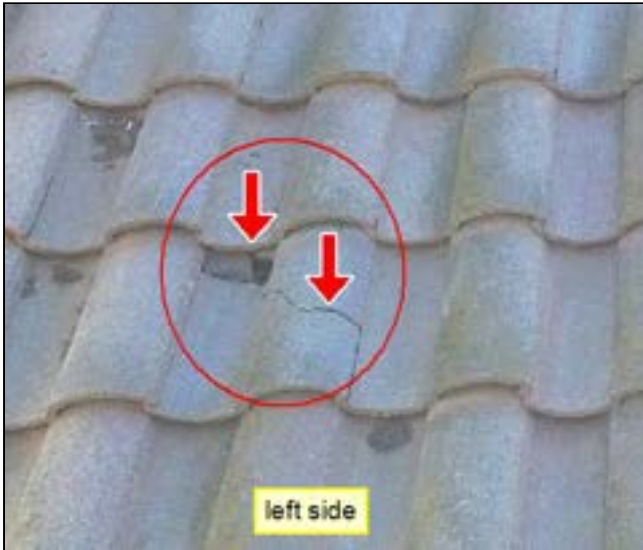
(1) Broken/damaged tile observed at left side and at rear. Recommend review by a qualified contractor for repair or replacement, as necessary, prior to close.

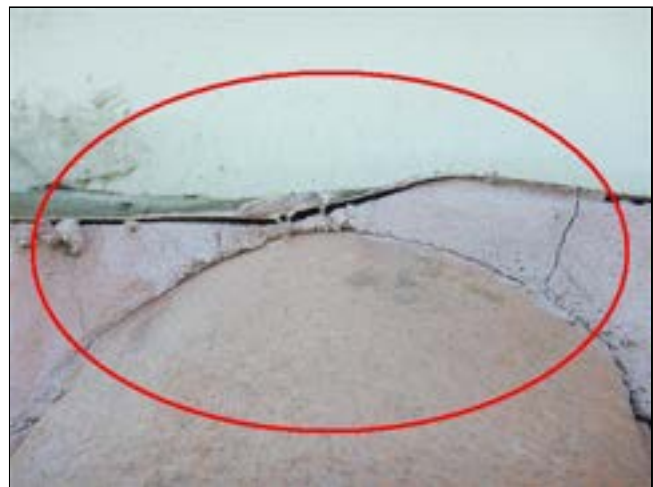
2.0 Item 5(Picture)

(2) The mortar that fills the gap between the flashings and roof tiles are deteriorated/cracked observed at rear. Recommend review for repairs/corrections as needed to prevent further future damages.

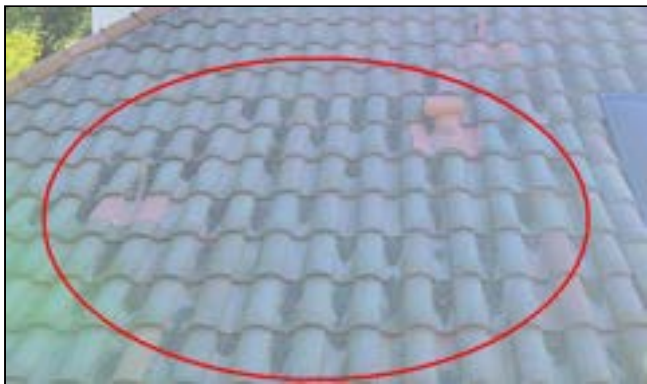
2.0 Item 6(Picture)

(3) Debris observed on the roof/valleys, debris prevents the roof from draining or drying out. Debris in the valleys may cause water to dam and flashing(s) to leak. Suggest periodic removal of debris as part of routine maintenance.

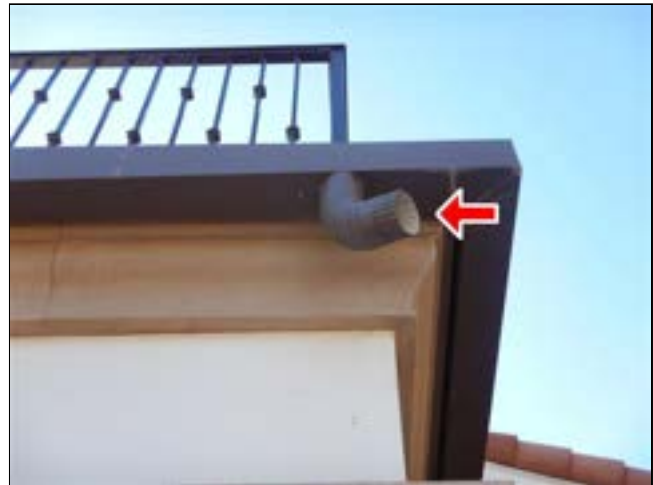
2.2 Item 2(Picture)

Missing downspouts observed at rear of home. Suggest downspouts be installed to ensure proper drainage away from the foundation.

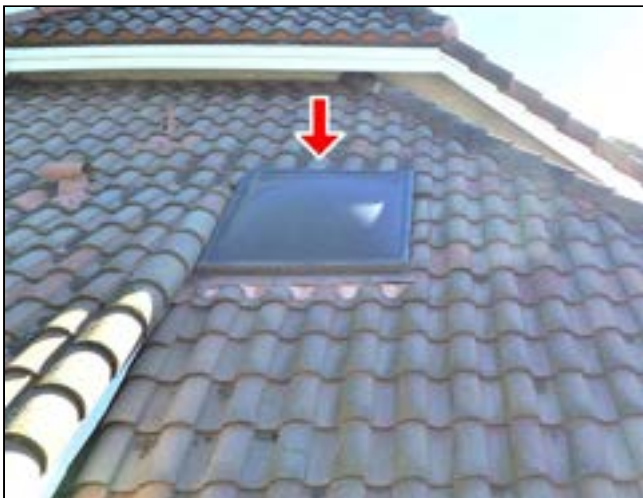
2.3 Item 1(Picture)

Limited review of the skylight due to unable to access or get closer to inspect the skylight. If this is a concern, recommend consult with the sellers for additional information, or review by a licensed roofer.

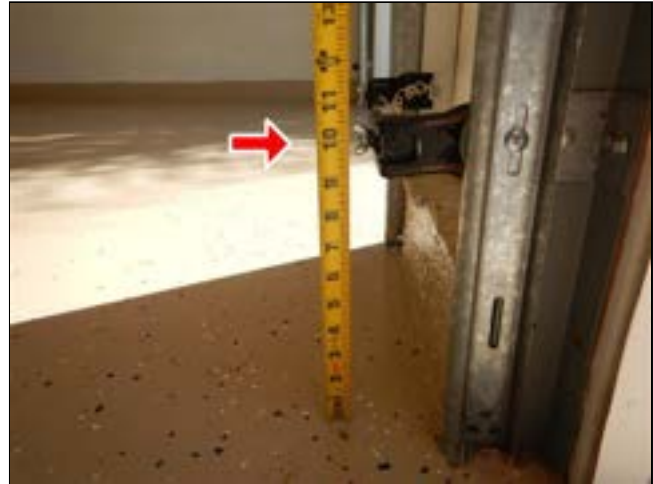
3.4 Item 2(Picture)

(1) The electric eyes are mounted (10" inches) too far above the floor, recommend lowering the eyes to within 6" inches of the floor or manufactures specifications in order to protect small children, pets, or property as intended by the manufacturer.

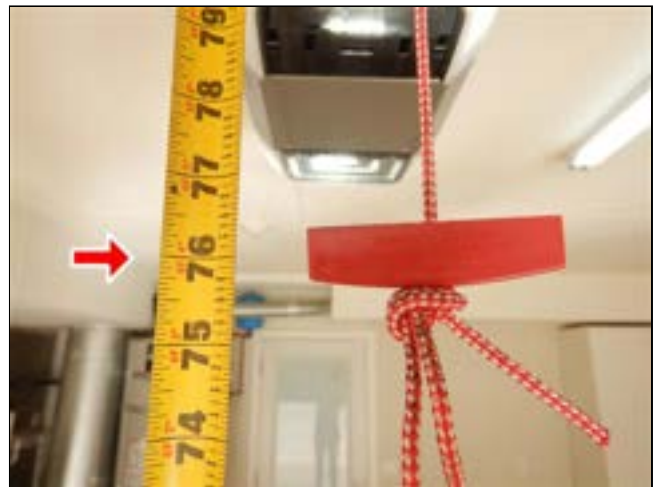
3.4 Item 4(Picture)

(2) The red emergency pull handle/rope for both garage doors are too high (79" for the small door and 76" for the large door). Should be maximum 72" high from the floor. Recommend corrections for proper operations at the time of emergency.

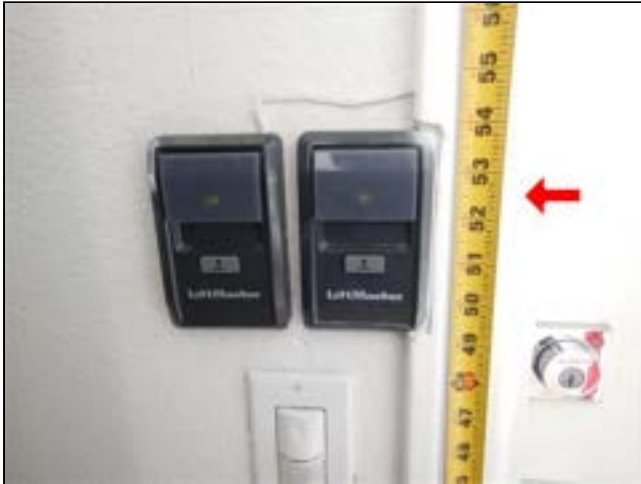
3.4 Item 5(Picture)

(3) The garage door operator buttons are installed at approximately 52" inches high. The buttons should be minimum 60" inches high to ensure a child is not able to operate the button when unattended. Recommend review by garage door specialist for corrections as needed for safe and proper operation.

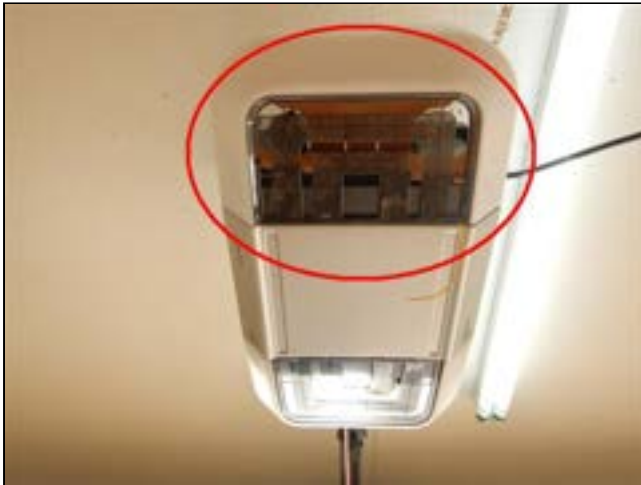
3.4 Item 6(Picture)

(4) One of the bulbs is missing for the small garage door auto-opener. Recommend replacing to ensure proper lighting.

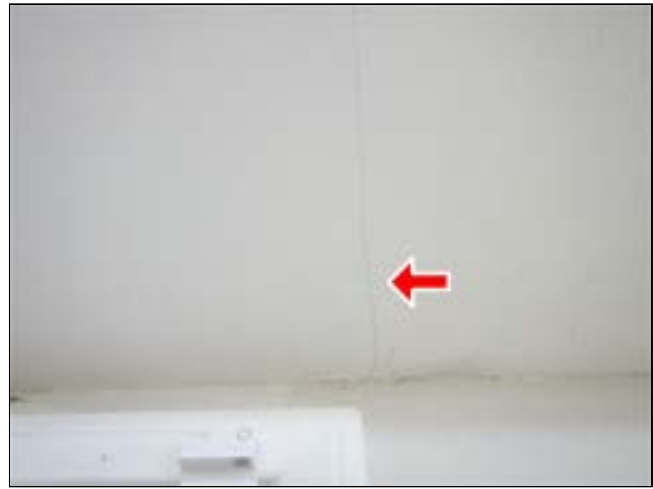
3.6 Item 2(Picture)

(1) Common cracks noted on garage walls. Appear to be primarily a cosmetic concern. Suggest repairs as needed.

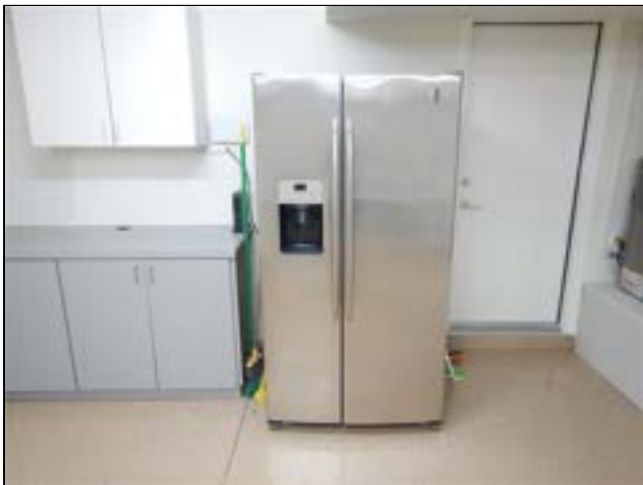
3.9 Item 1(Picture)

The refrigerator in the garage is beyond the scope of the inspection. If concerned, recommend consult with seller for additional information.

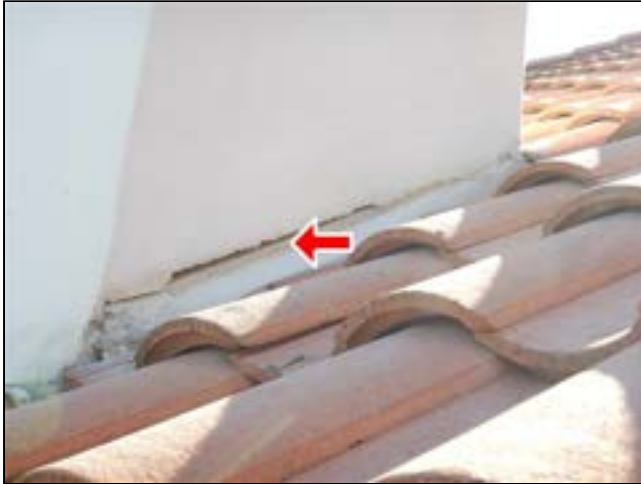
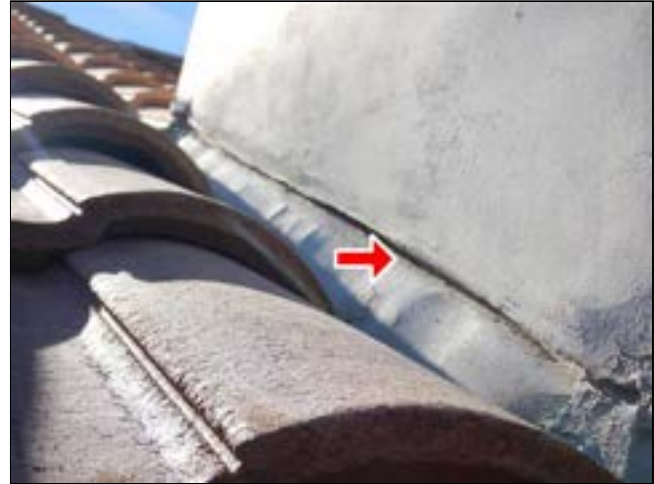
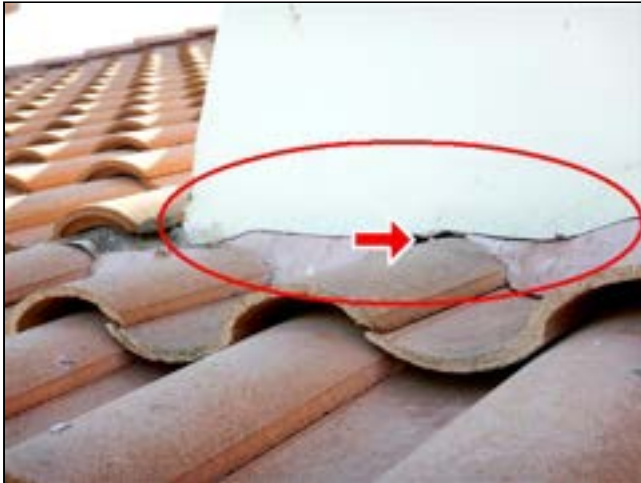
Recommend caulking/seal all gaps/voids between the roof tiles and the chimney flashings where necessary. Review by a licensed roofer for repairs to prevent further future damages.

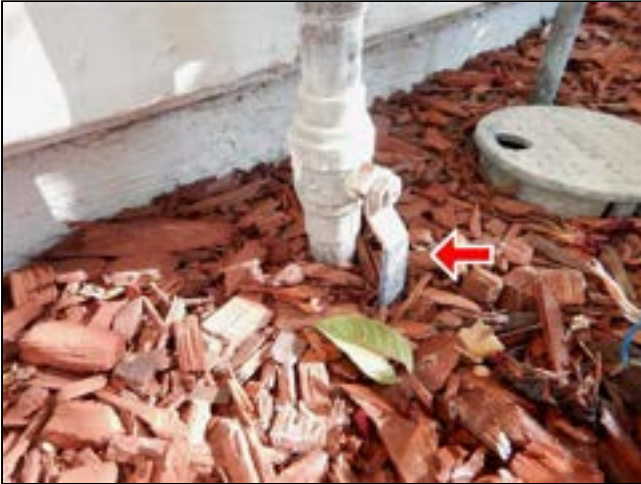
6.0 Item 1(Picture)

The shutoff handle at the main water shutoff is partially buried. Recommend clearing the area of dirt/mulch to ensure you are able to shut the water off in the event of an emergency.

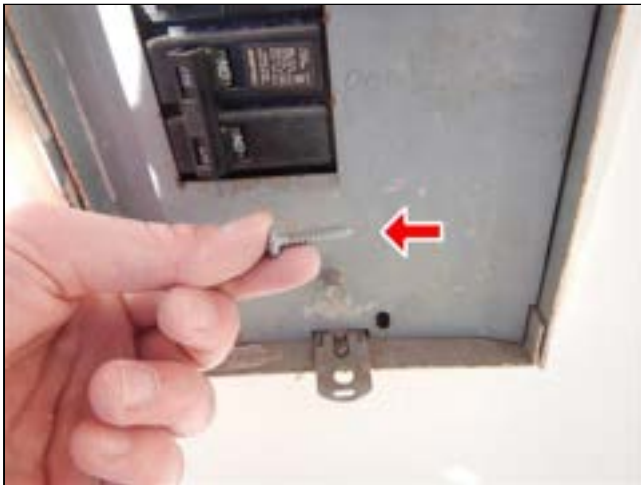
7.2 Item 1(Picture)

(1) The main electrical panel cover screw is a pointed screw. This may damage the wiring insulation over time when cover is removed/replaced. Recommend replacing with a proper flat-ended screw to ensure safety.

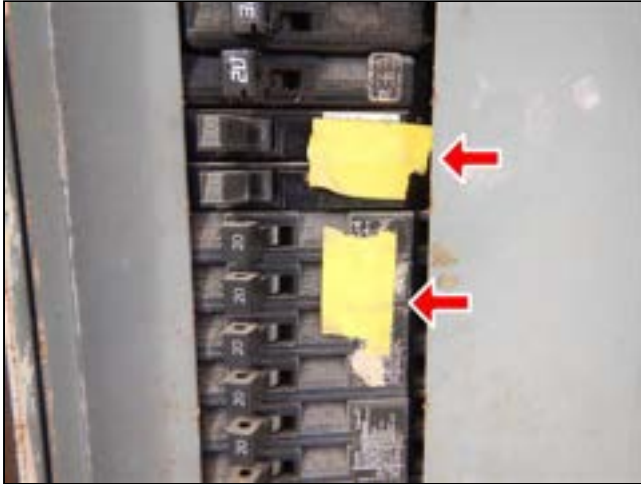
7.2 Item 2(Picture)

(2) Some of the breakers in the main panel have been taped with a yellow tape. Unable to determine reason. Recommend consult with seller for additional information.

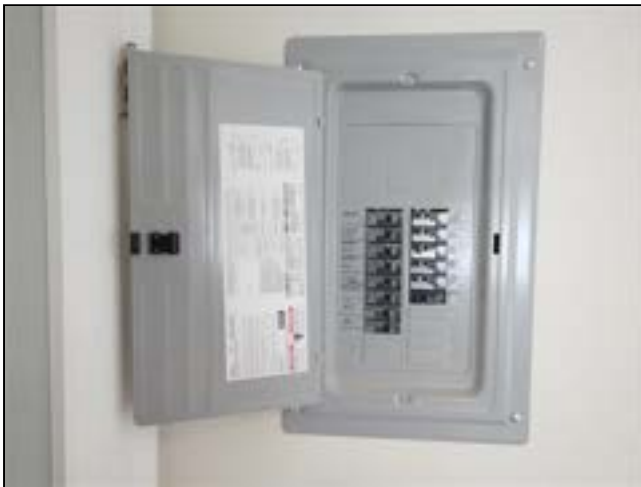
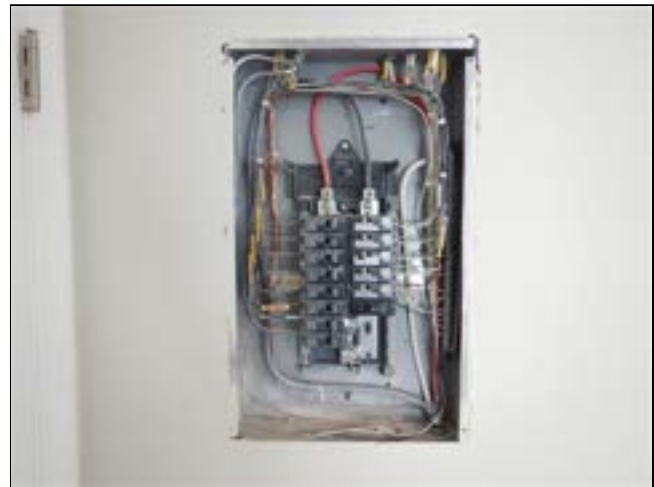
The sub panel box is located in bedroom #2.

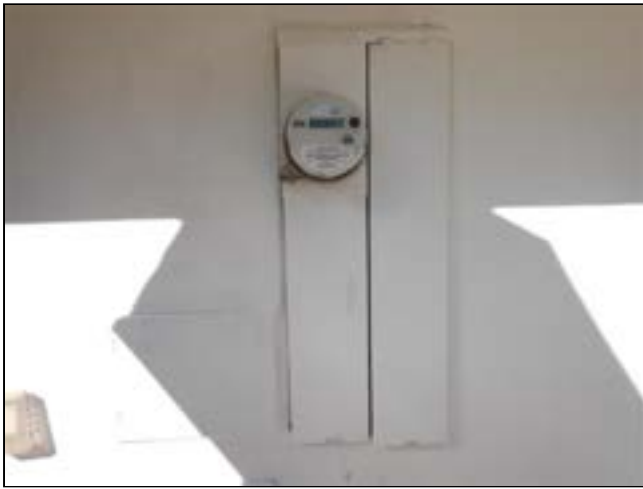
7.8 Item 1(Picture)

The main electric panel box and service disconnect are located outside at right side of home.

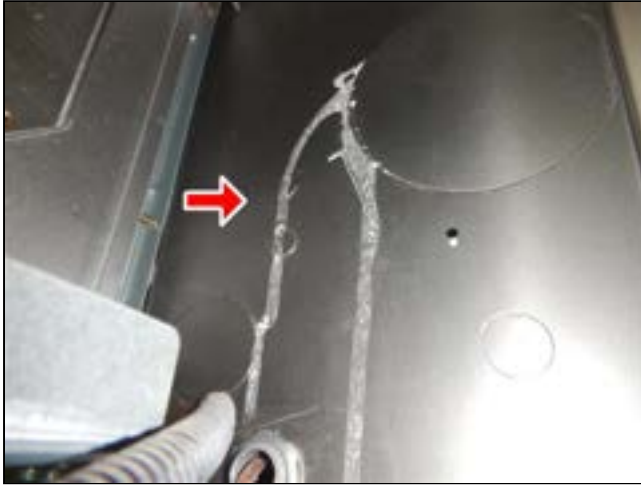
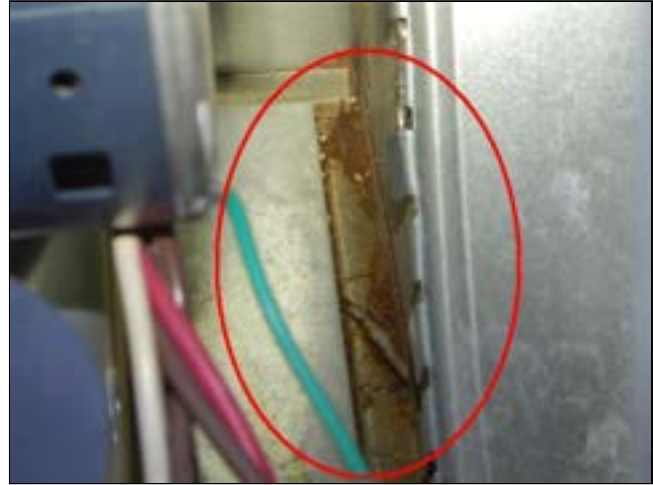
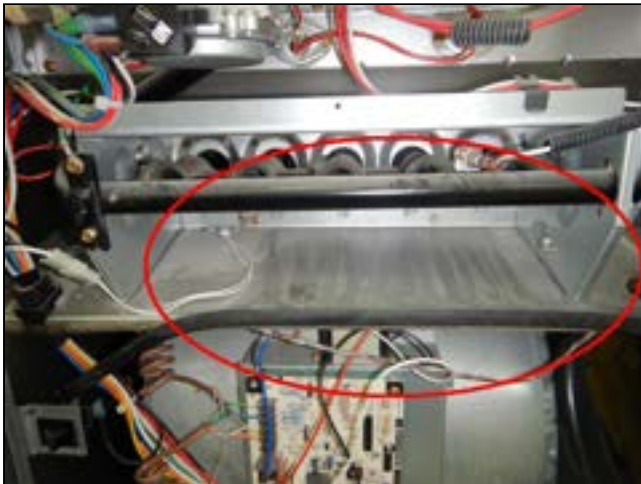
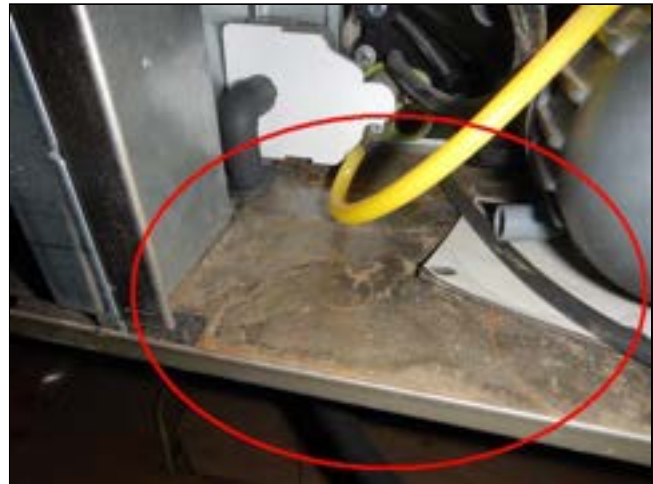
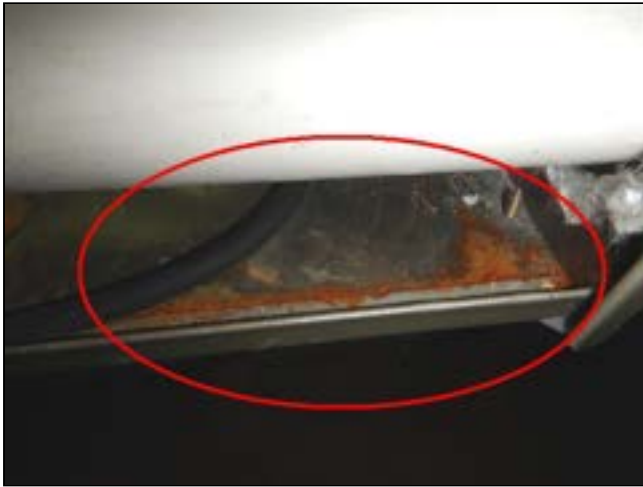
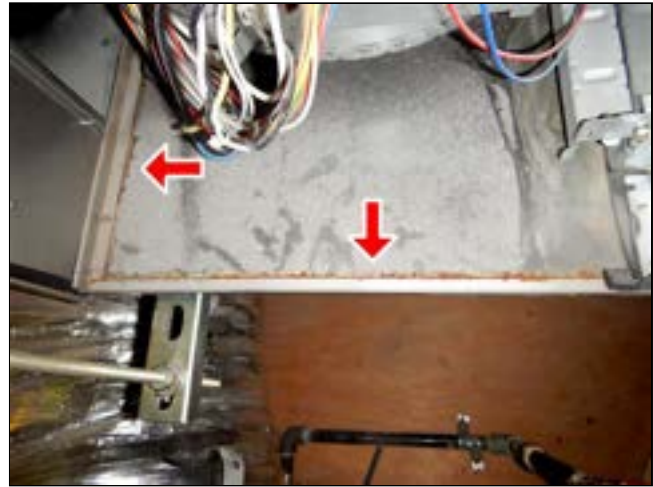
(1) Rust and streaking observed inside both furnaces burner and blower compartments. This indicates that moisture may have entered inside the units at some point in the past. Recommend further evaluation by a licensed/qualified HVAC contractor for repairs/corrections, as needed, to ensure safe and proper operation.

Note: first three images are of the garage furnace and the next three are of the attic furnace.

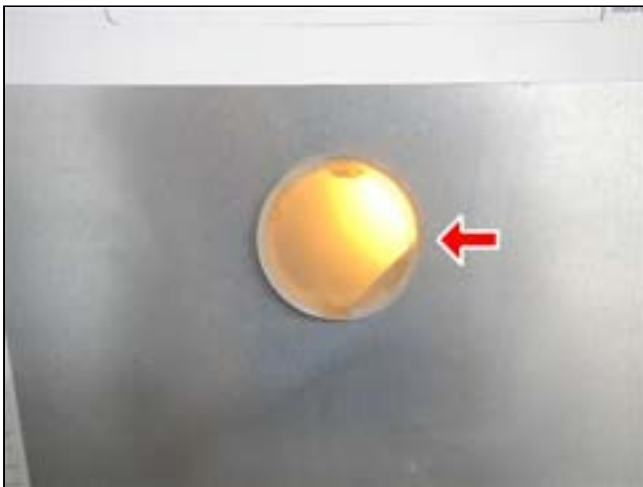
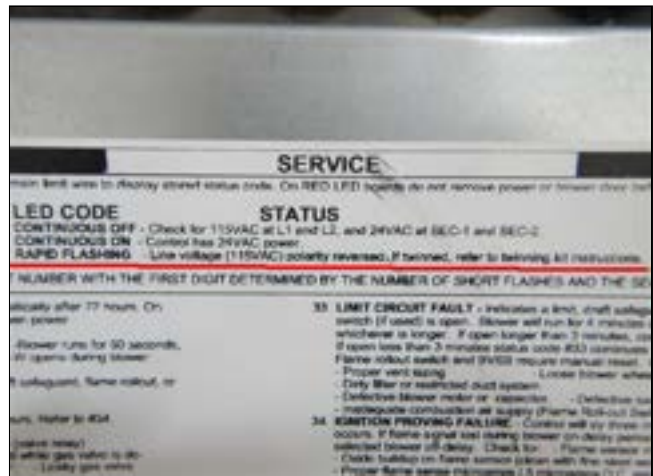
(2) The indicator light inside the garage furnace was flashing rapidly at time of inspection. According to the label inside the furnace, this indicates the following: "Line voltage (115VAC) polarity reversed. If twinned, refer to twinning kit instructions."

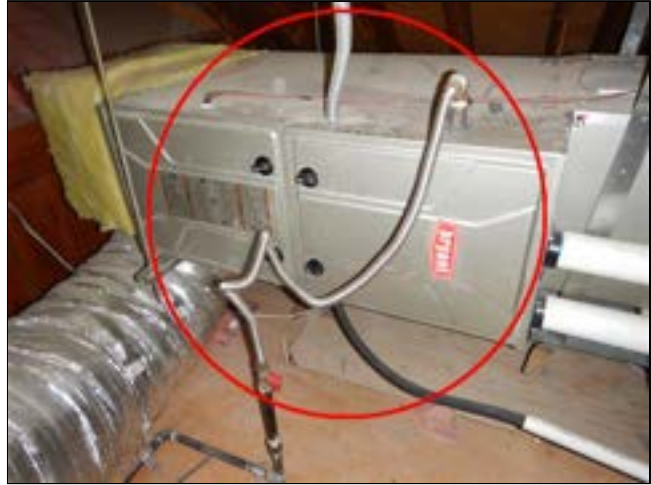
8.1 Item 2(Picture)

No sediment trap observed on either heating unit/furnace gas supply piping. Suggest upgrading/installing sediment trap to help prevent sediment in the gas piping from getting into the gas valve or burner area of an appliance and fouling things up.

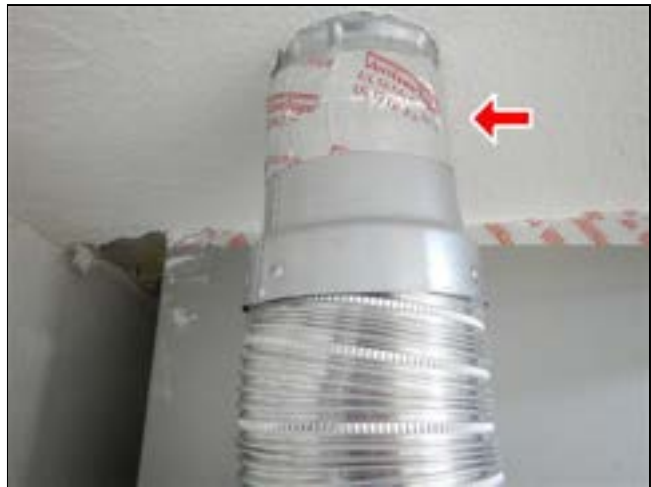
8.2 Item 2(Picture)

(1) Unable to determine if the flue pipe sections are connected using sheet metal screws. The screws will prevent separation of the flue pipe sections in the event of an earthquake. Sheet metal screws are required in each joint. Recommend review by a licensed/qualified plumber for repair or replacement, as necessary.

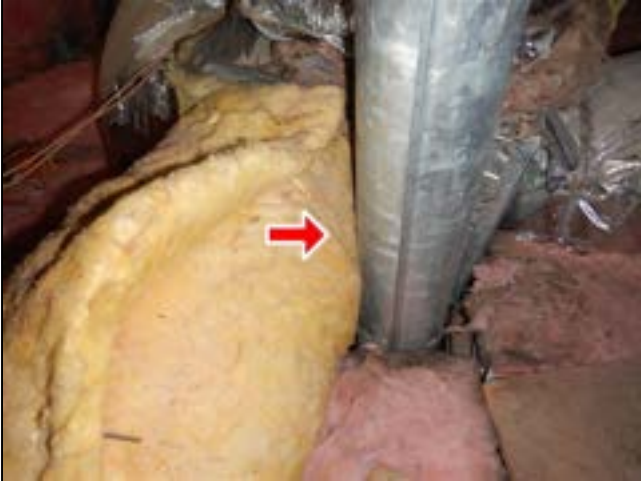
8.2 Item 3(Picture)

(2) The garage furnace vent pipe, as it runs through the attic, is in direct contact with insulation and one of the rafters at the roof line. This is a potential fire safety hazard as the vent pipe can reach high temperatures during furnace operation. Recommend review by a licensed/qualified HVAC contractor for corrections to ensure safety.

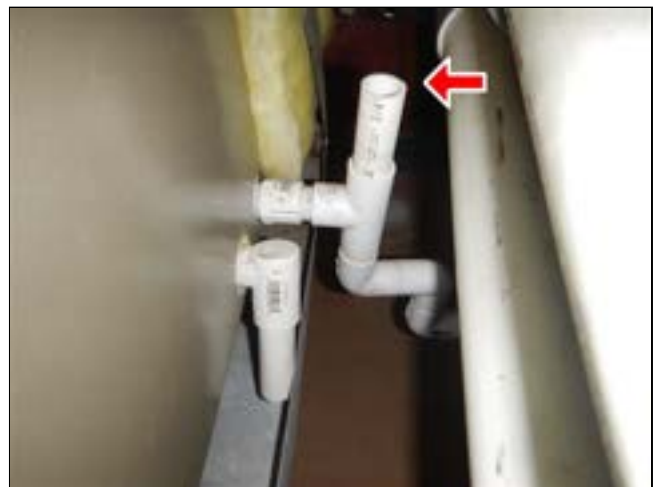
8.6 Item 2(Picture)

No emergency overflow safety switch observed on the condensate drain lines for either of the furnaces. The switch will shut the furnace off in the event of a condensation overflow. Suggest client consider upgrading as a safety enhancement.

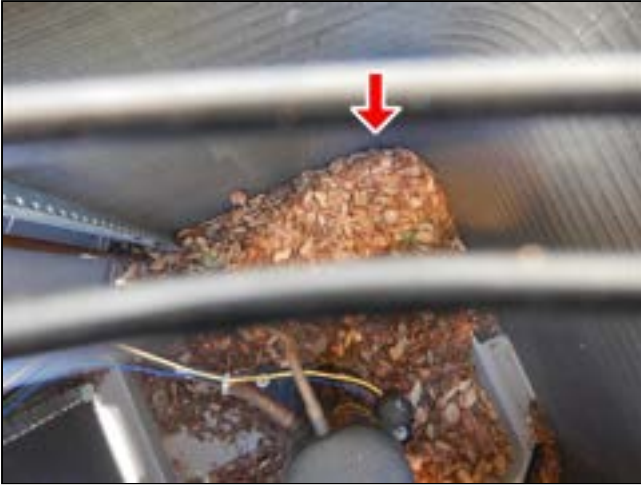
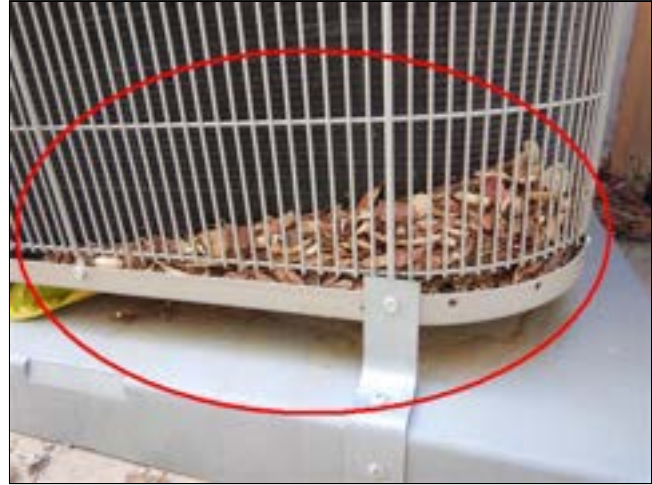
Debris observed inside the Bryant condenser at the left side of the home. Recommend removal of debris and regular maintenance to ensure proper operation of unit and prevent deterioration.

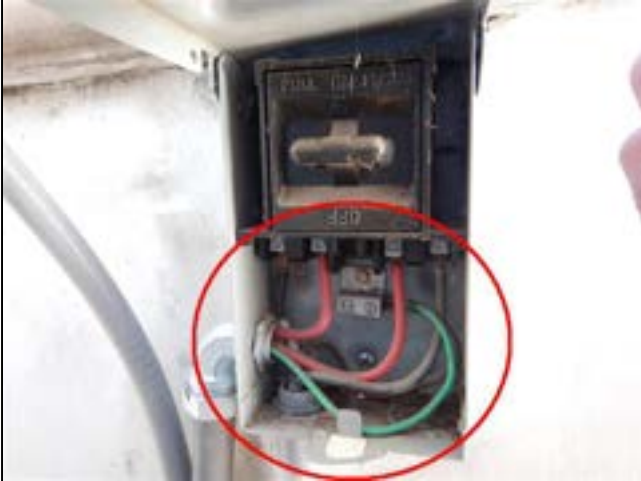
9.2 Item 1(Picture)

Missing electric wiring protective insulator observed at the condenser electric disconnect for the condenser at the right side of the home, near the pool equipment. Recommend review by a licensed electrician or HVAC specialist for corrections to enhance safety.

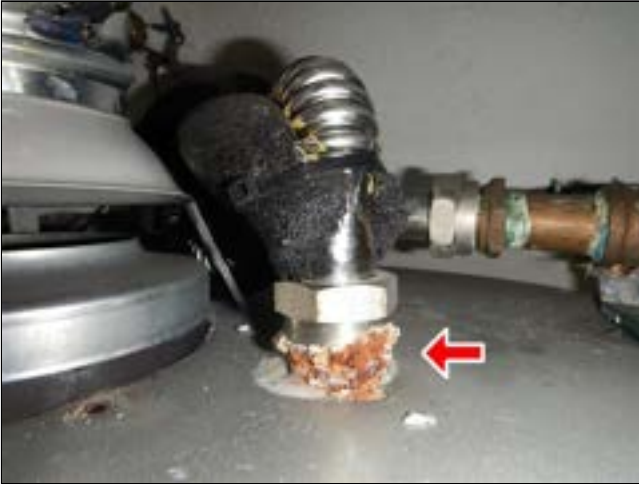
10.1 Item 1(Picture)

(1) Corrosion observed on cold water pipe fitting on top of water heater; no leaks visible at time of inspection. Recommend review by a licensed plumber for repair or replacement, as necessary, prior to close.

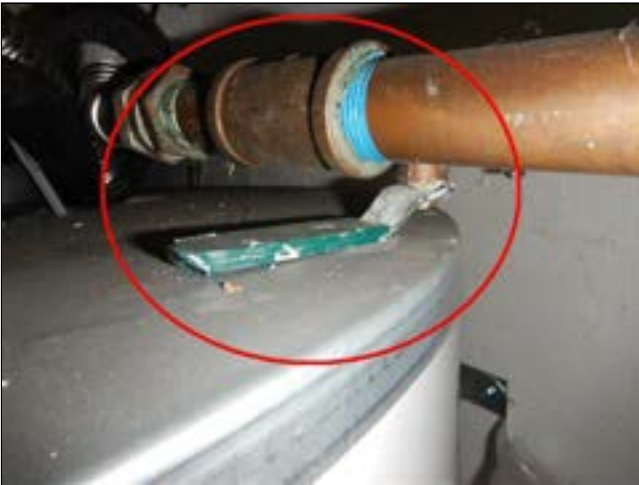
10.1 Item 2(Picture)

(2) The cold water shutoff handle is obstructed by the top of the water heater. This is a safety concern as it may prevent you from shutting off the water supply in the event of an emergency. Recommend review by a licensed/qualified plumber for corrections to ensure safety.

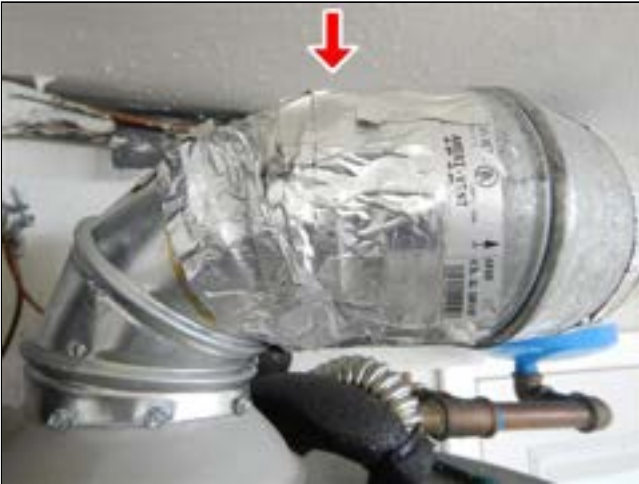
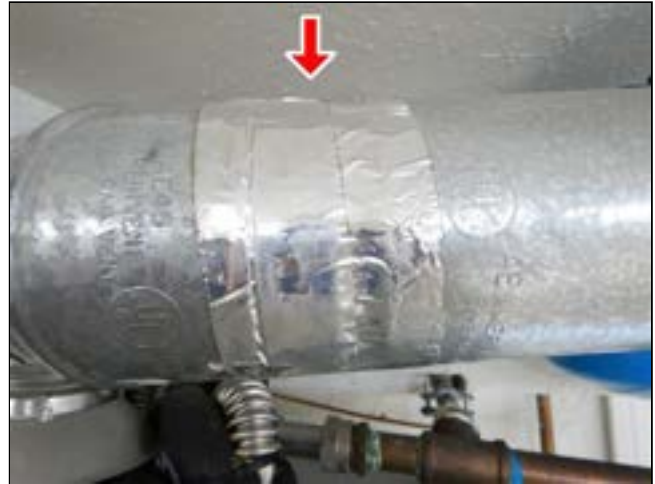
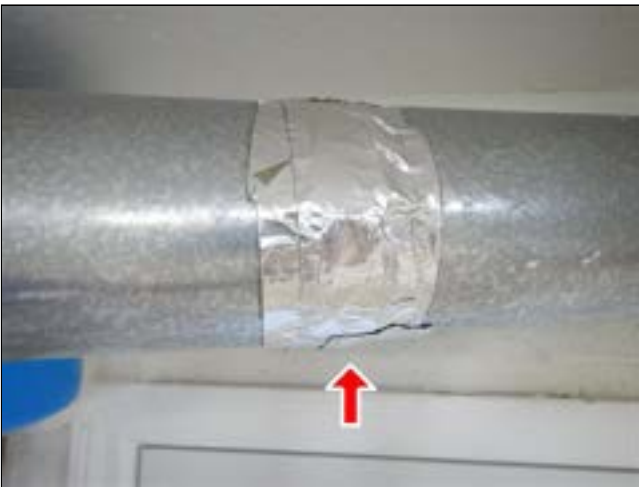
Some of the flue pipe sections appear to have been connected without using sheet metal screws. The screws will prevent separation of the flue pipe sections in the event of an earthquake. Sheet metal screws are required in each joint. Recommend review by a licensed/qualified plumber for repair or replacement, as necessary.

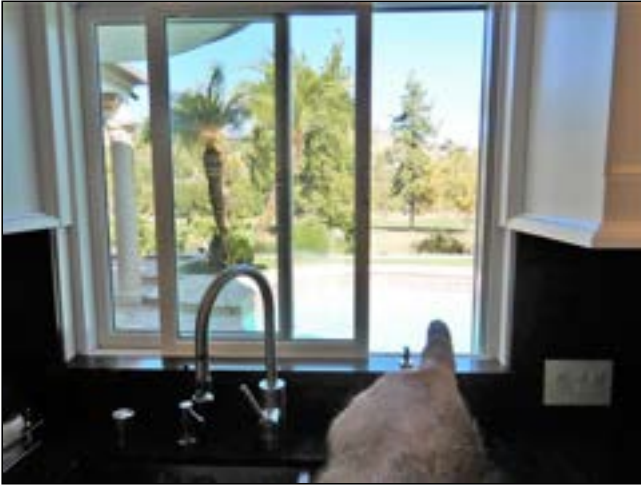
11.4 Item 1(Picture)

(1) Missing screen observed. Recommend corrections for proper operation.

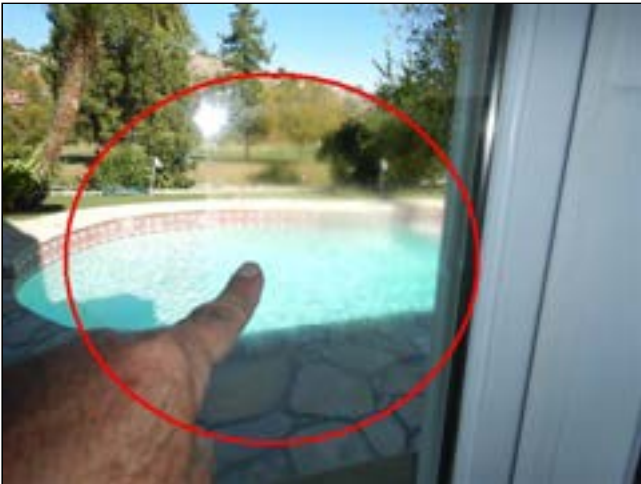
11.4 Item 2(Picture)

(2) Residue of a peeled sticker on window glass observed in the kitchen. Recommend review for corrections/clean.

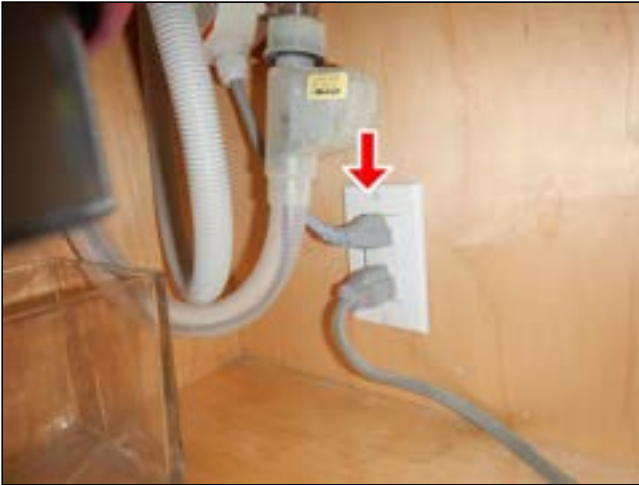
11.6 Item 1(Picture)

A Ground Fault Circuit Interrupter (GFCI) is not present under the kitchen sink. Ground Fault Circuit Interrupters (GFCI) may not have been required under the kitchen sink when the home was built. Suggest client consider upgrading with ground fault circuit interrupters (GFCI's) at all receptacles near water sources. Upgrades should be performed by a licensed electrician.

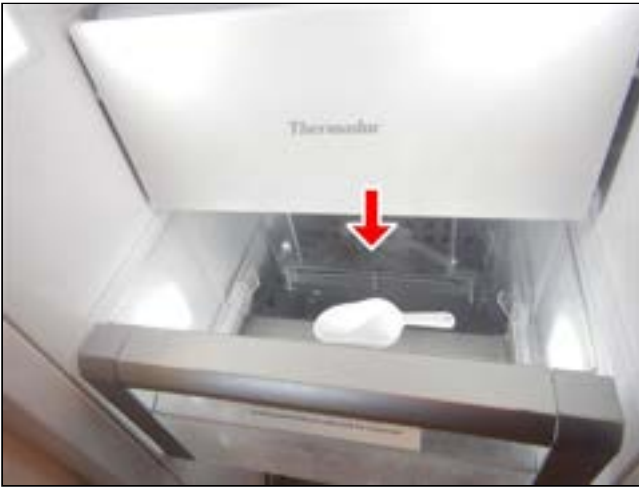
11.15 Item 1(Picture)

The refrigerator is serviceable and was inspected to verify that unit is cooling at time of inspection. Freon levels, icemaker operation and other specialty items are beyond the scope of this inspection, recommend consulting sellers for additional information. However, there was no ice in the ice pan, possibly the water source was disconnected. Recommend consult with the seller(s) for more information.

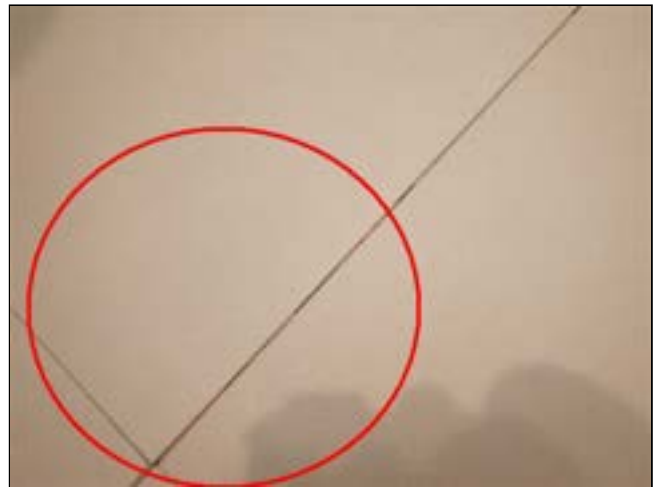
12.0 Item 2(Picture)

(1) Loose/missing grout at several areas observed in the upstairs hall bathroom #2; recommend re-grouting as necessary to prevent water intrusion.
