Inspection Report

Property Address:
24703 Ave Asoleada
Calabasas CA 91302

AmeriSpec Inspection Services

Date: 11/19/2022	Time: 09:00:00 AM	Report ID: 111922VM14VH
Property: 24703 Ave Asoleada Calabasas CA 91302	Customer: Ashghar Farhadi	Real Estate Professional: Courtney Van Cott Frontgate Real Estate

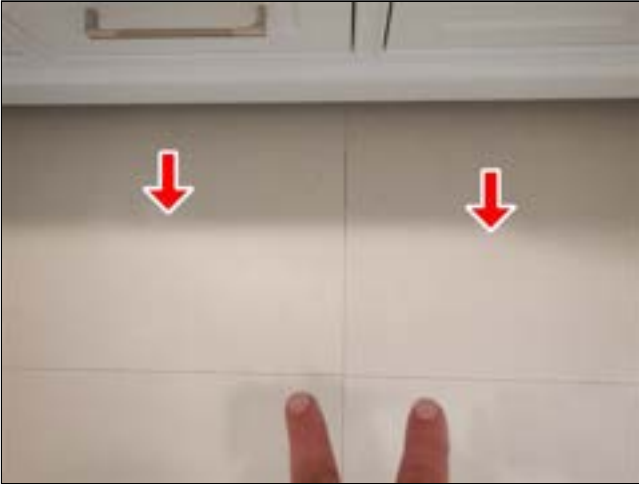
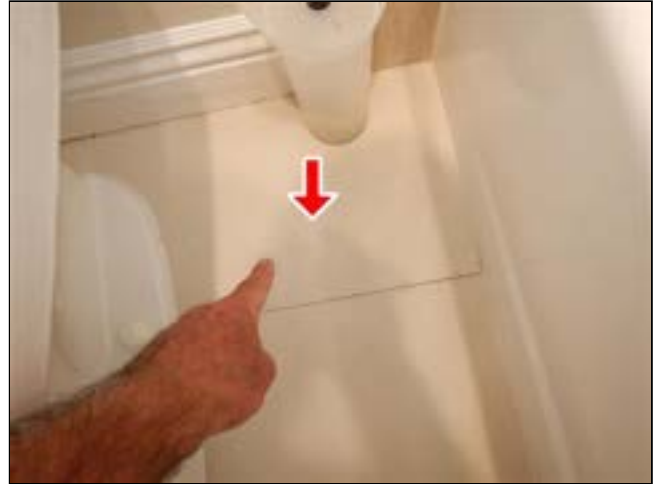
(2) Loose floor tiles at several areas observed in the upstairs hall bathroom #2, suggest corrections to prevent further damage.

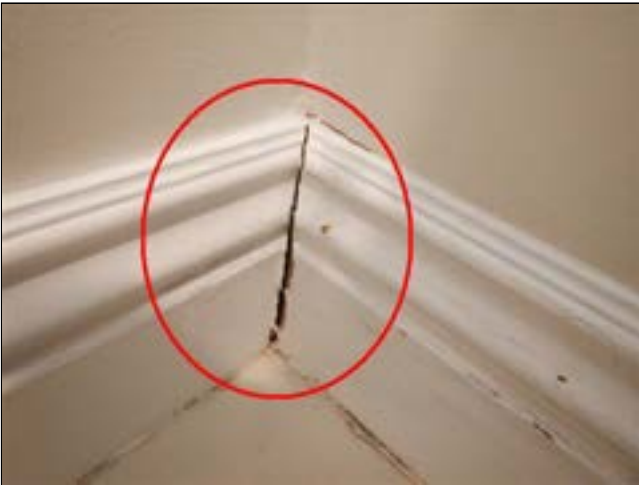
12.0 Item 5(Picture)

(3) Gap at baseboard observed in upstairs hall bathroom #2. Caulking should be applied around any gaps/voids where necessary, to prevent water intrusion.

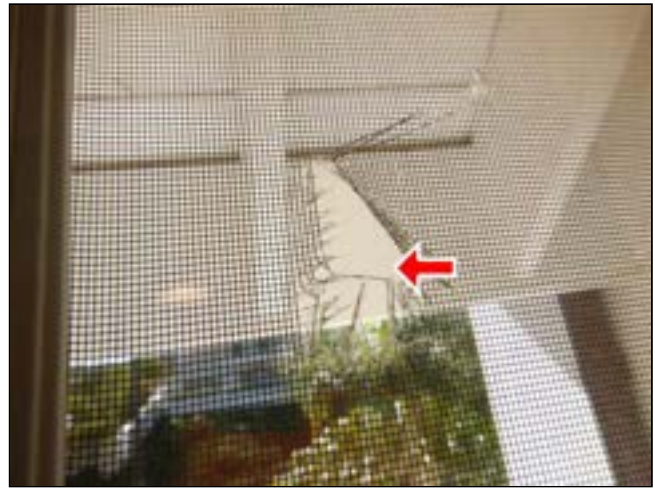
12.4 Item 2(Picture)

Damaged screen observed in the upstairs hall bathroom #2. Recommend corrections for proper operation.

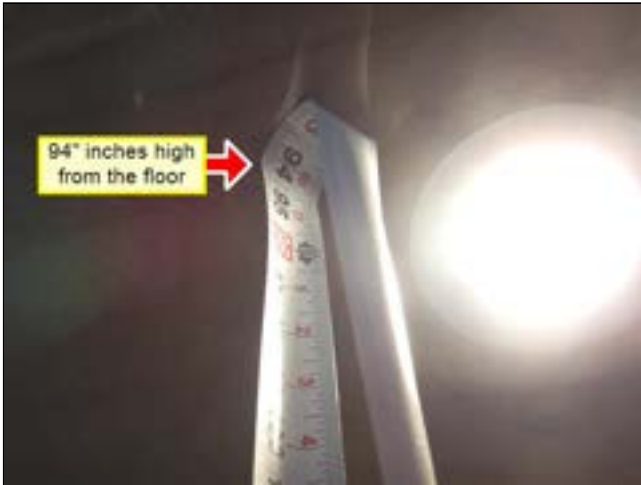
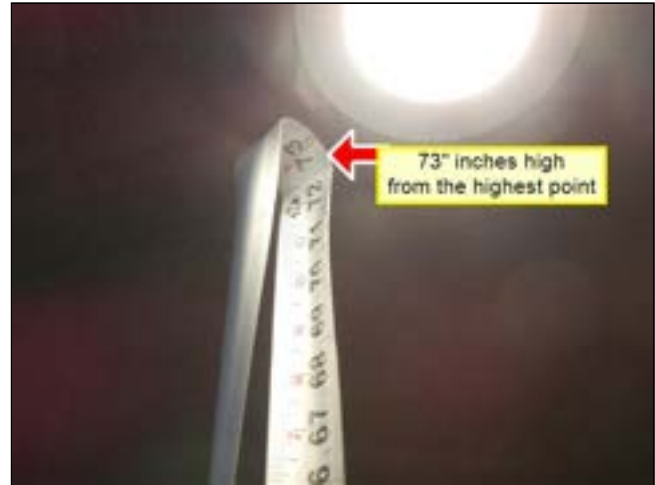
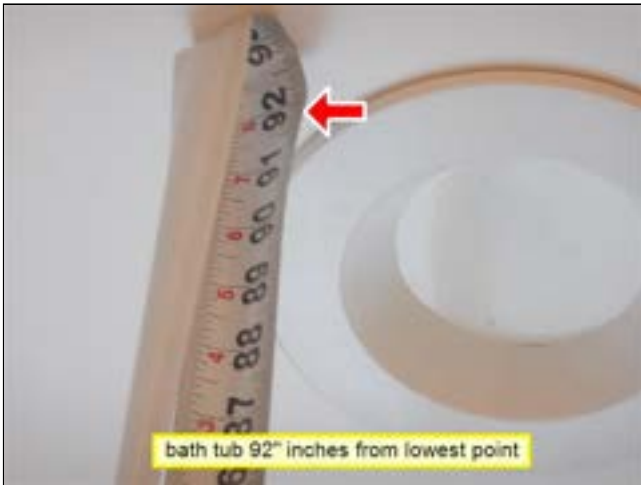
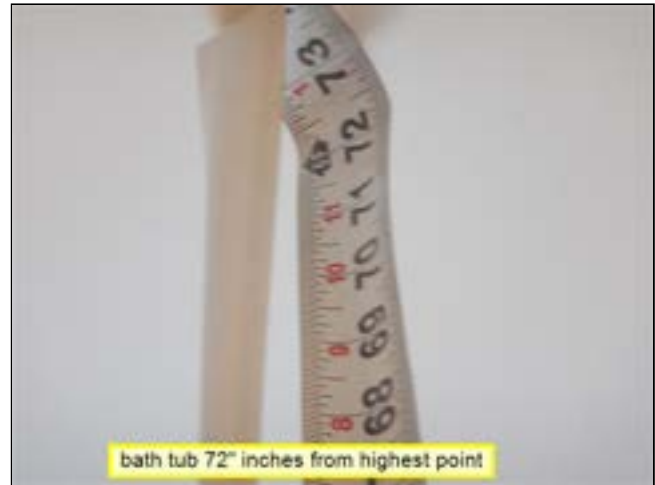
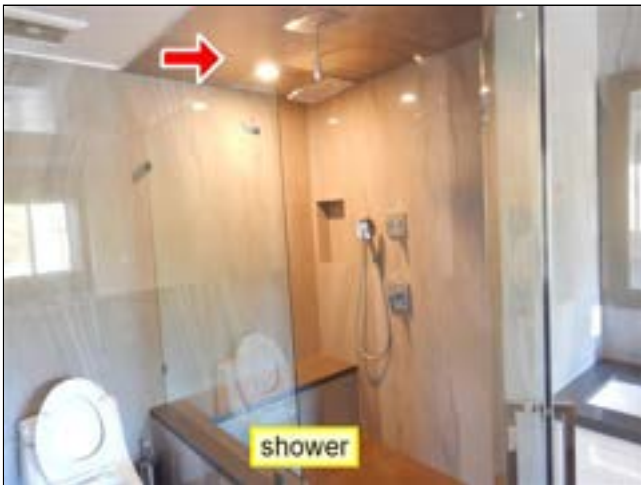
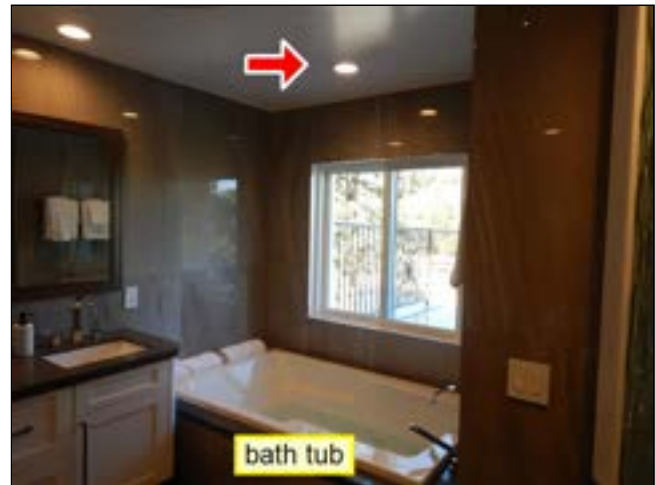
(2) Recessed light fixtures at the shower and bath tub ceilings observed in bathroom #3 (master). The National Electric Code (NEC) from 2011 requires that any part of a light fixture must be a minimum of 8 feet above the highest portion of a shower walls and the zone extends out horizontally 3 feet around the shower floor. The requirement promotes safety. The installed light should also be rated for a moist or wet location. Recommend review by a licensed electrician for correction/replacement to ensure safety.

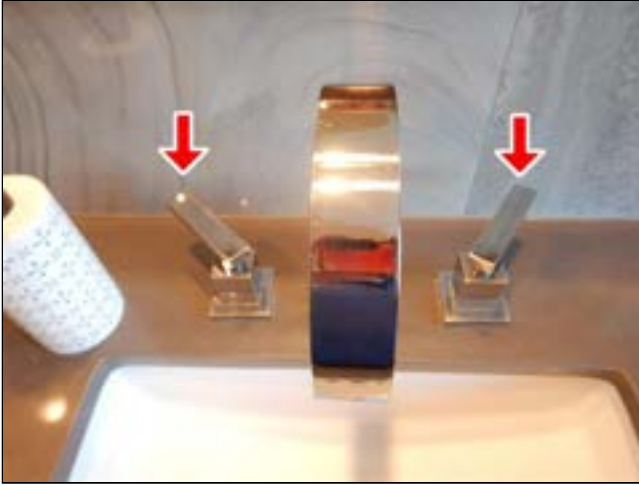
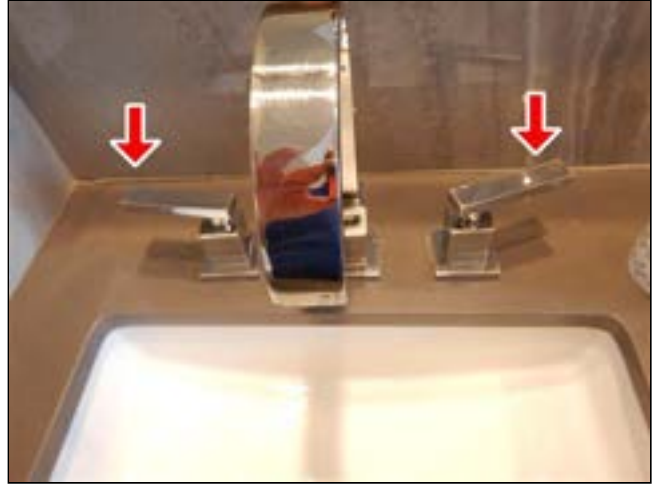
The levers for the water faucets are out of alignment observed on both sinks in bathroom #3 (master). A qualified licensed plumber should repair or correct as needed.

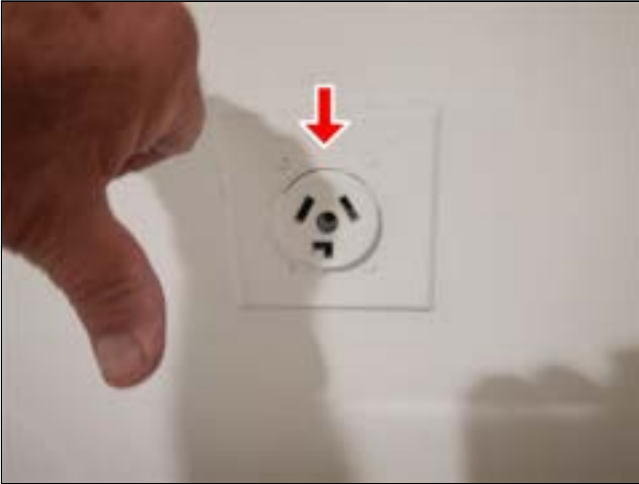
13.4 Item 2(Picture)

(2) The 220 outlet was inoperable observed in the laundry room. Recommend review by licensed electrician for repairs/replacement as needed for safety.

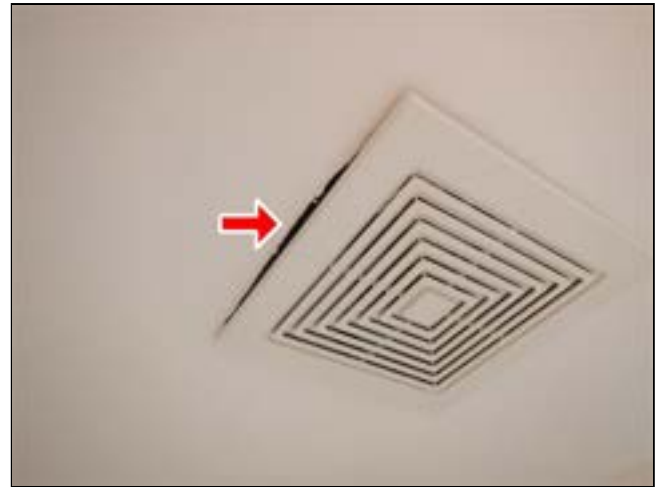
13.6 Item 2(Picture)

Exhaust fan cover is smaller than the opening observed in the laundry room. If this is a concern, recommend review for corrections as needed.

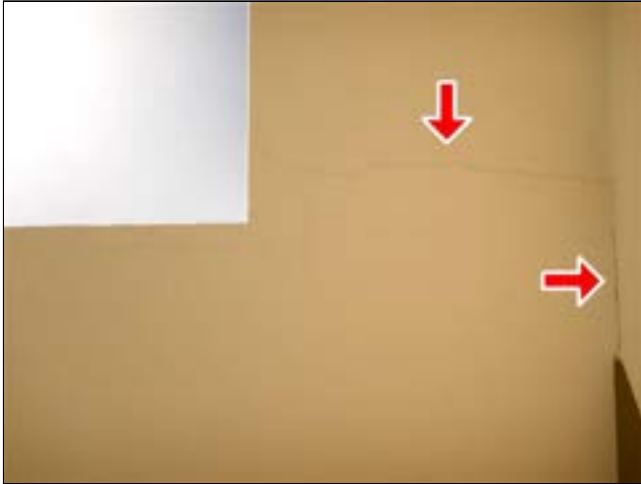
14.2 Item 1(Picture)

Cracks observed on ceiling next to the skylight above the stairway. Recommend review by a licensed/qualified contractor for repairs, as needed.

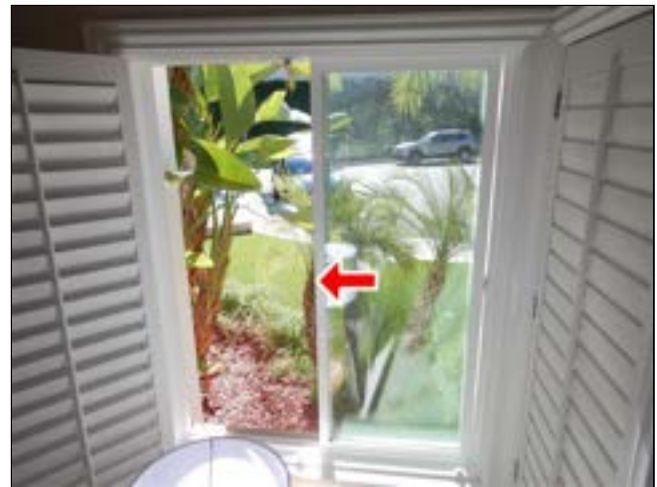
14.5 Item 2(Picture)

Missing screens observed at several windows in the living room. Recommend corrections for proper operation.

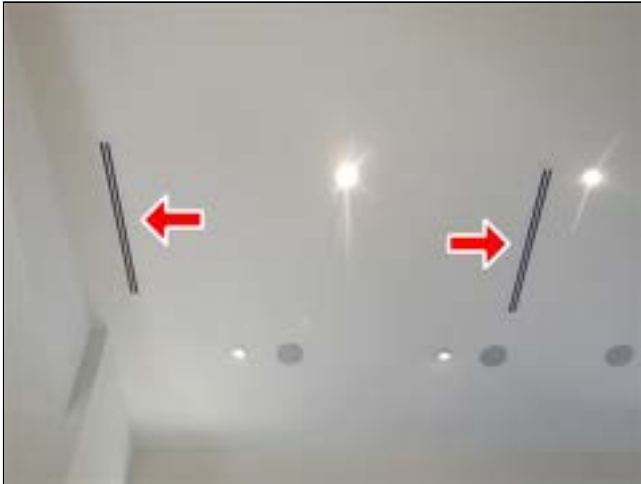
14.6 Item 1(Picture)

The supply registers above the family room do not appear to be supplying conditioned air. this indicates a possible blocked or disconnected duct. Recommend further evaluation by a licensed/qualified HVAC contractor for repairs/ corrections.

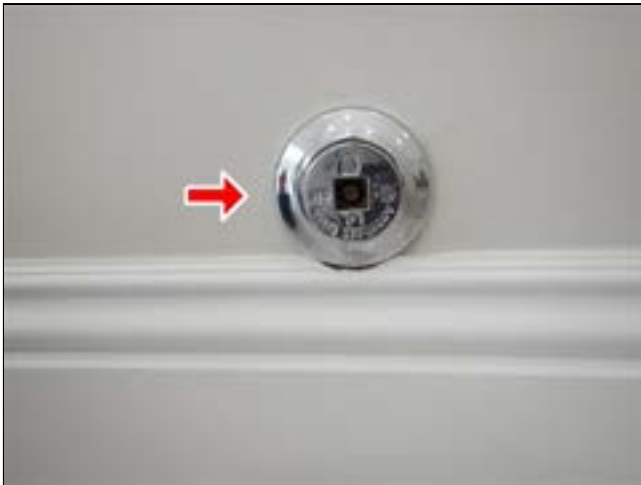
14.8 Item 1(Picture)

Unable to operate the gas valve at the living room fireplace due to key for fireplace not present and inspector's keys did not fit. Recommend consult with seller for additional information and suggest verifying operability prior to close.

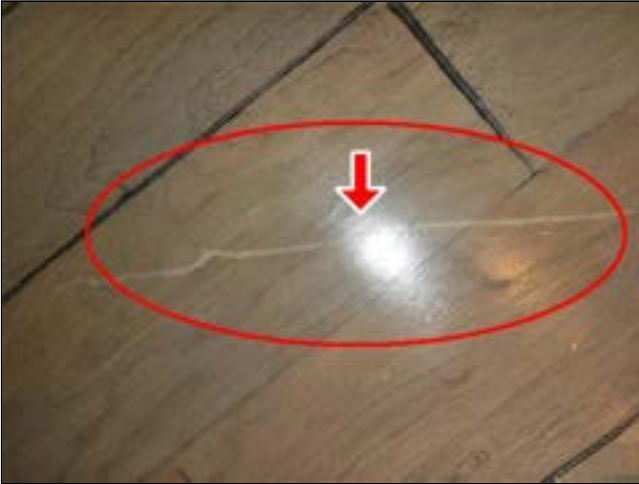
15.0 Item 1(Picture)

The bedroom #2 wood floors need to be refinished. Primarily a cosmetic concern. Recommend review for refinishing as necessary.

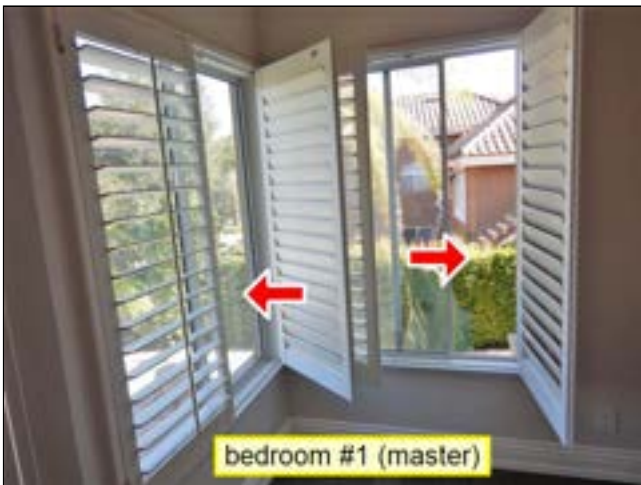
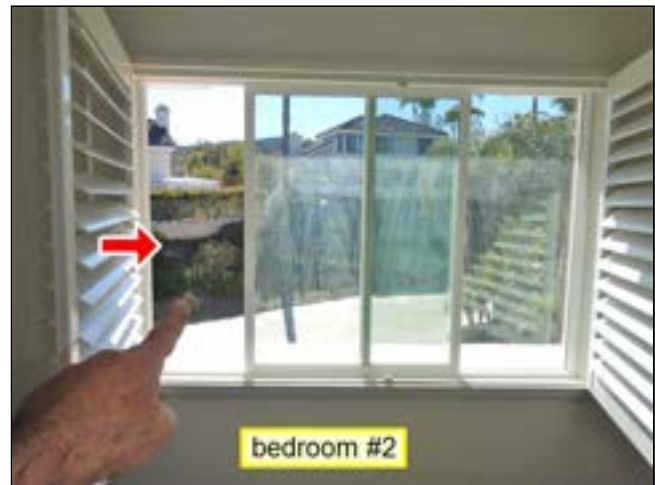
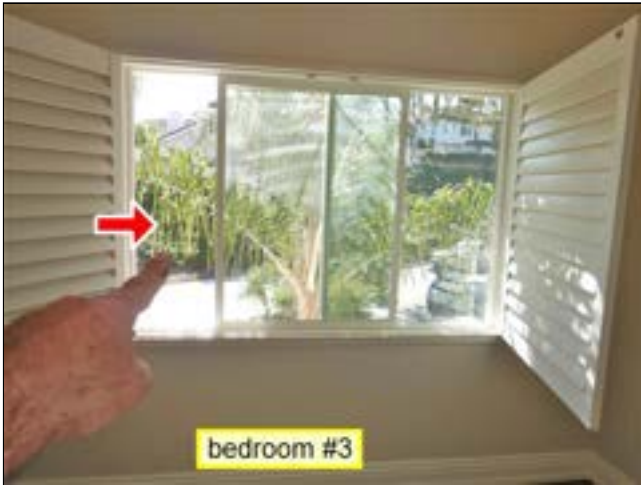
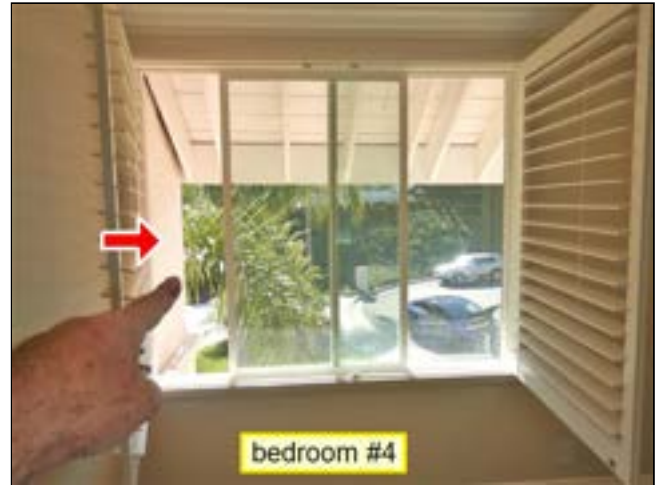
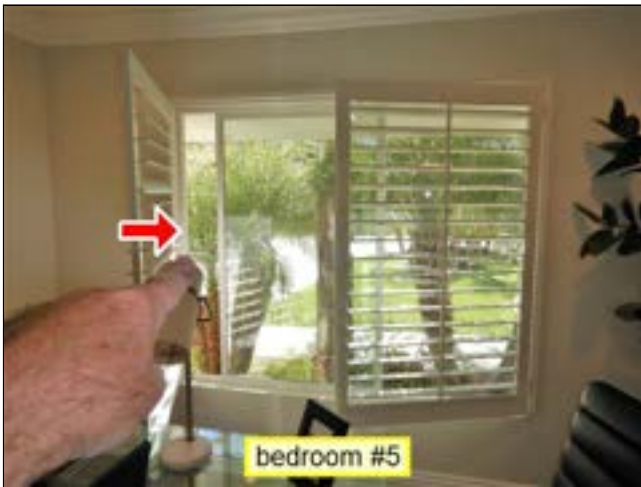
Window screens are missing in all the bedrooms. Recommend corrections for proper operation.

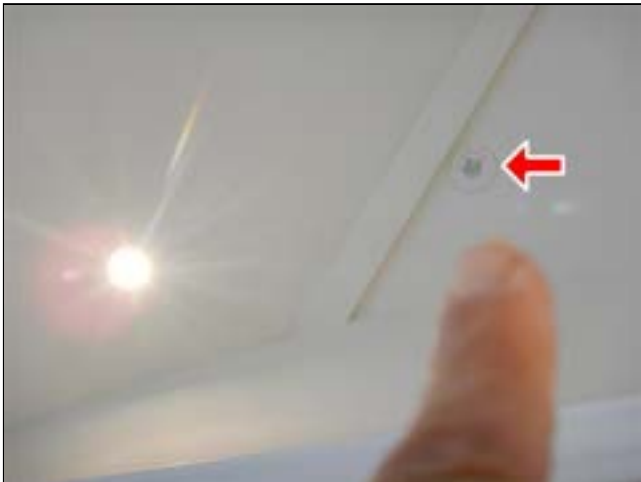
15.7 Item 1(Picture)

Recessed light fixture in the bedroom #1 (master) was inoperative at time of inspection. Possible spent bulb. Suggest client verify fixture for proper operation prior to closing.

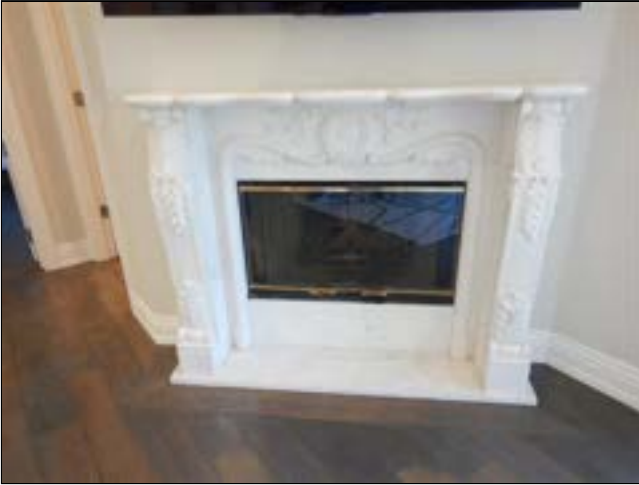
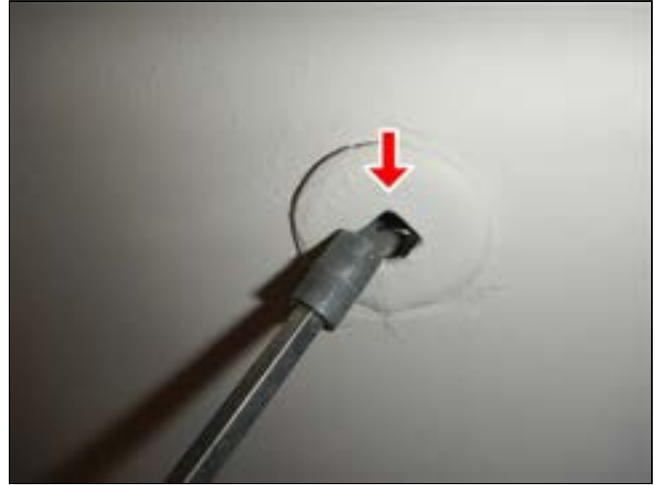
(1) Unable to operate the gas for the fireplace in the bedroom #1 (master) due to the gas key was missing and our gas key did not fit key hole. Suggest consulting with sellers as to any issues with this system prior to close to ensure safe and proper operation.

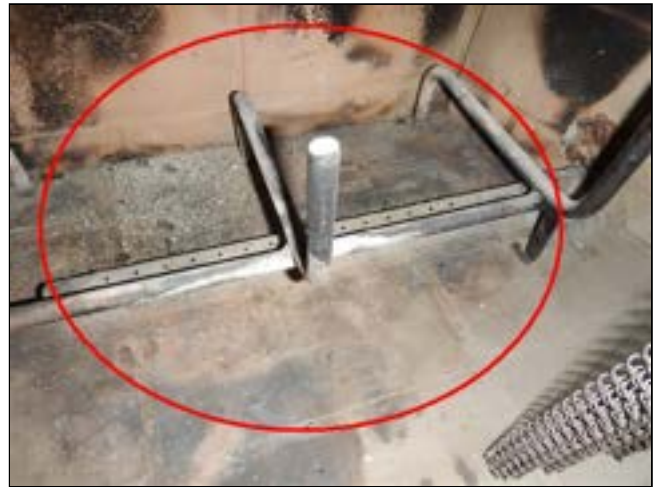
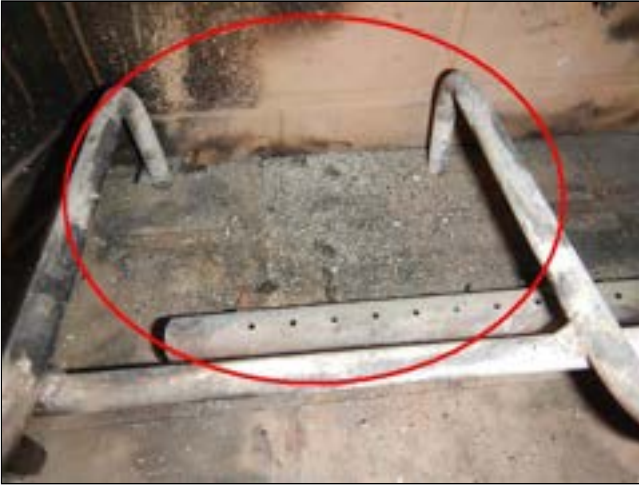
(2) Debris/Creosote build-up was observed in the fireplace located in the bedroom #1 (master). Creosote is a naturally produced flammable by-product of combustion. Its presence is a limiting factor on a visual review. We suggest having cleaned and inspected by a fireplace and chimney specialist to assure safe operation prior to close.

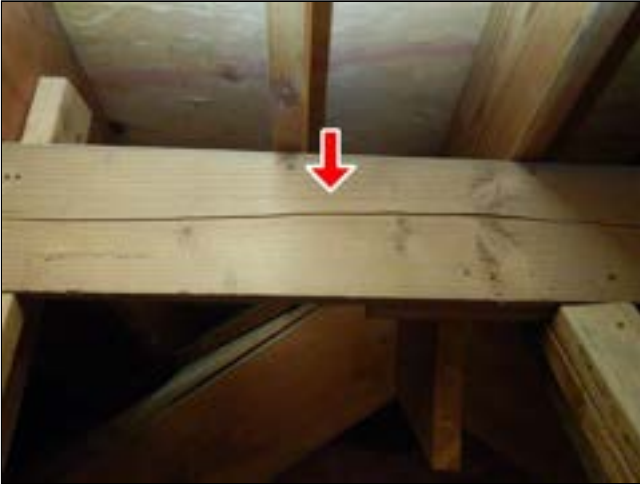
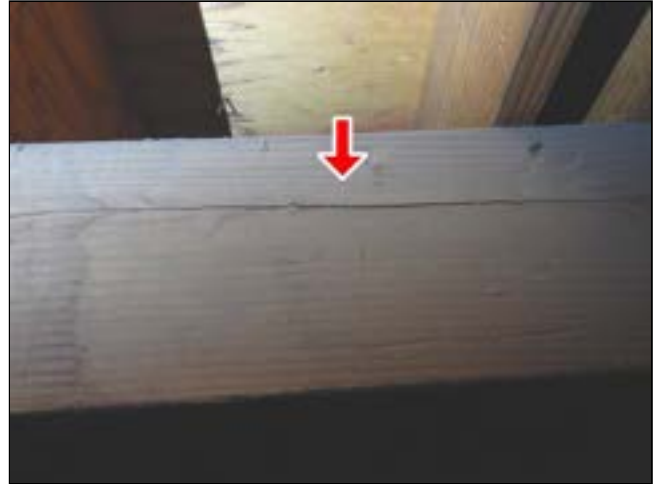
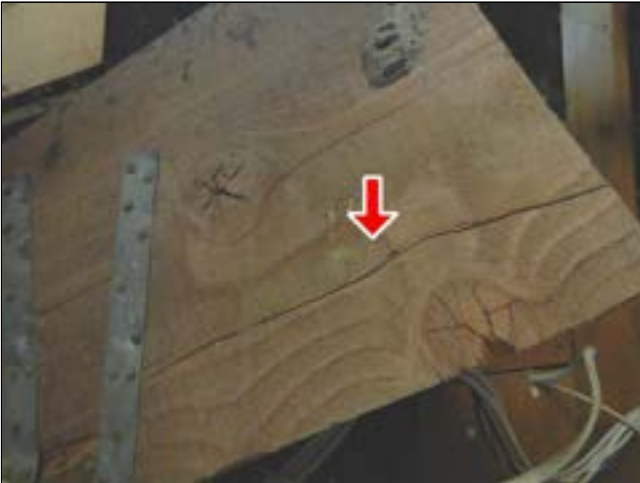
(2) Cracks observed on some of the framing members in the attic. Recommend review by a licensed/qualified contractor for repairs, as needed.

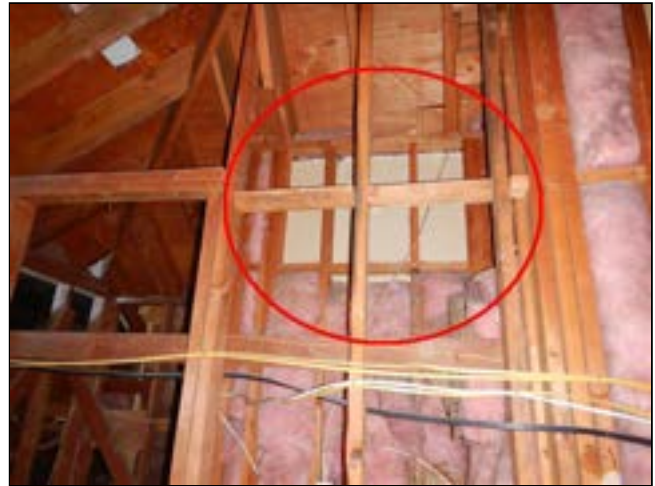
16.3 Item 2(Picture)

Insulation coverage of the attic walls is partial. Recommend adding additional insulation.

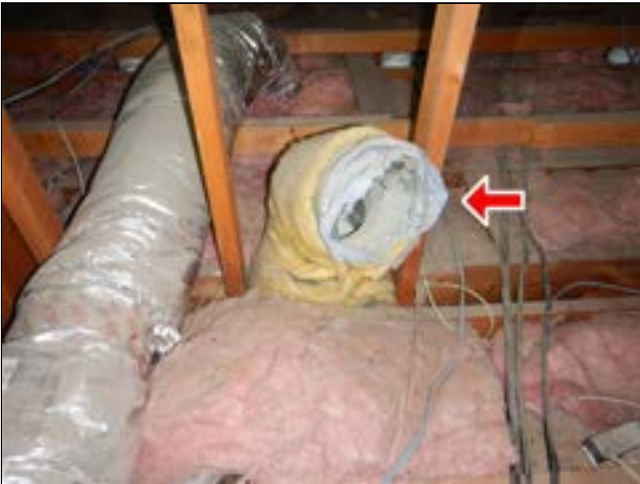
16.6 Item 1(Picture)

There is a disconnected ductwork connection in the attic. Possibly no longer in use. The ductwork connection is approximately above bedroom #2. Recommend consult with seller for more information or further evaluation by a licensed/qualified HVAC contractor, as needed.

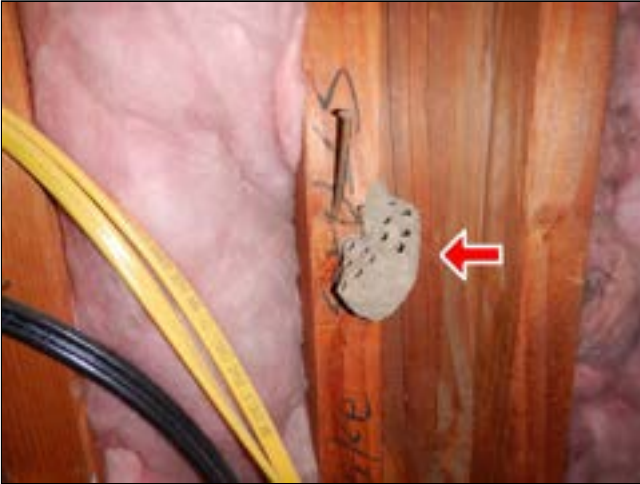
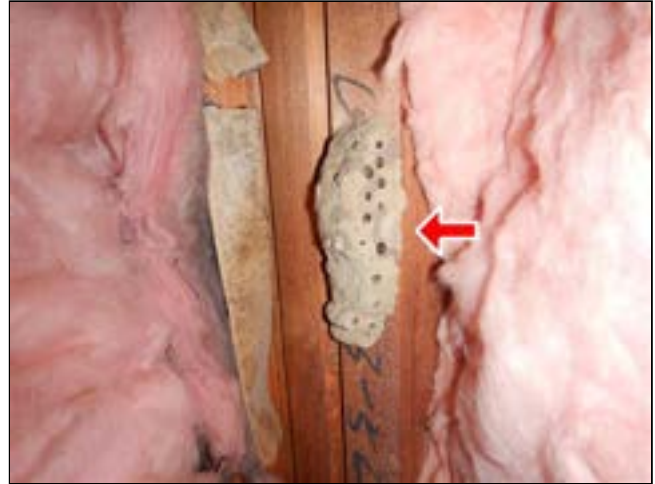
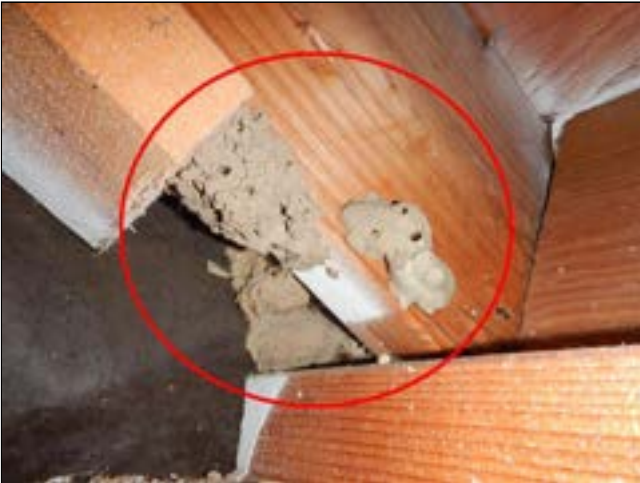
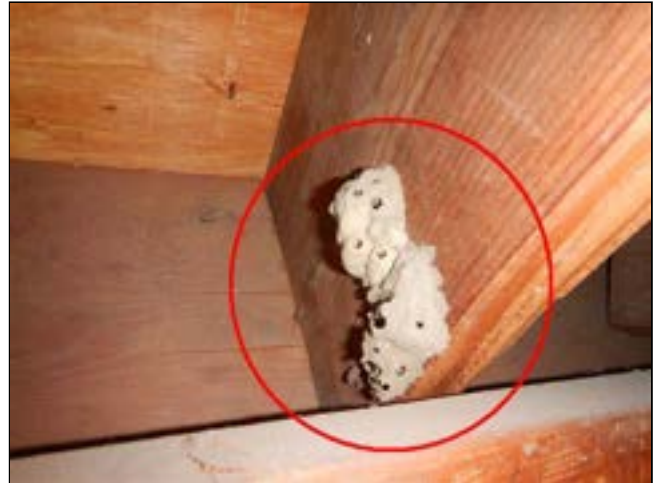
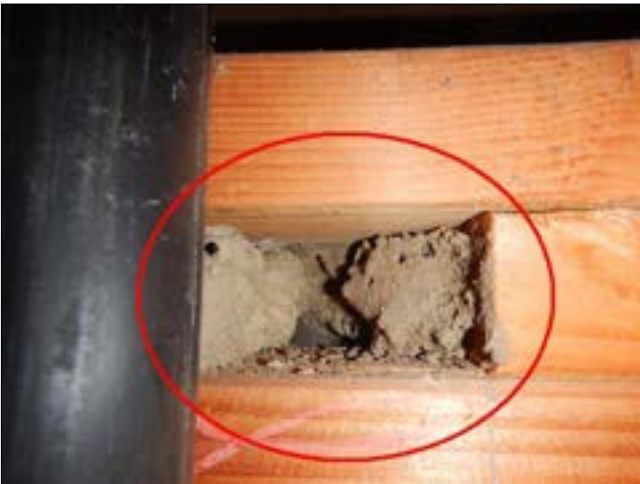
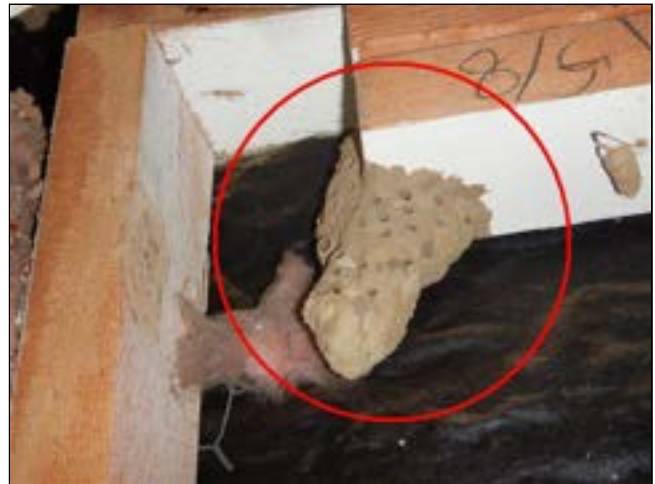
(1) Evidence of termite infestation observed in the attic. Per seller's agent, a pest control expert has already addressed the issue and provided clearance. Recommend consult with seller for additional information.

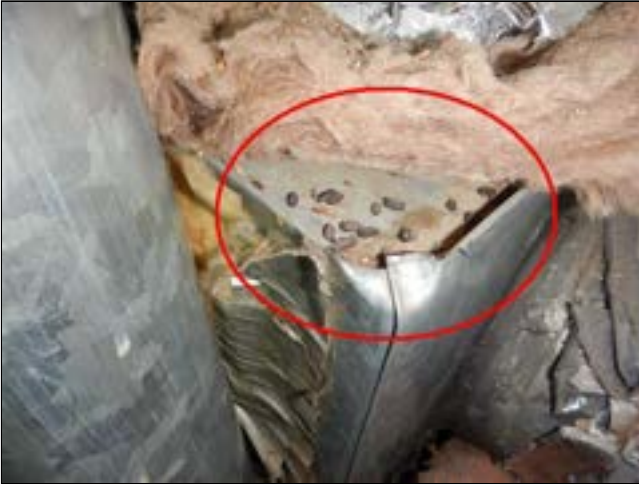
16.7 Item 7(Picture)

(2) Rodent droppings observed in the attic. Recommend review by a licensed/qualified pest control expert for corrections.

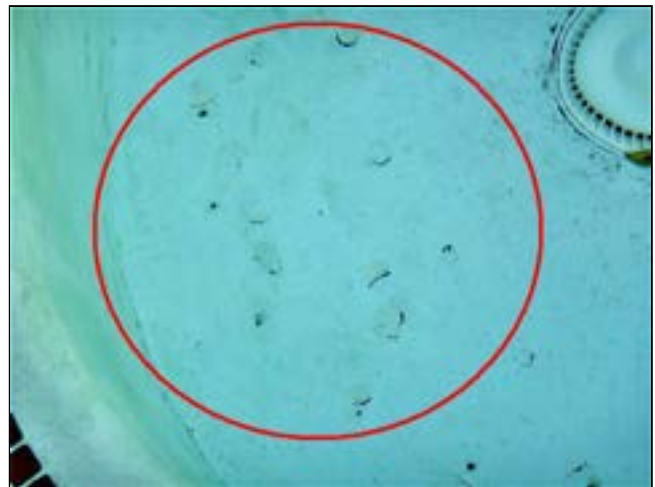
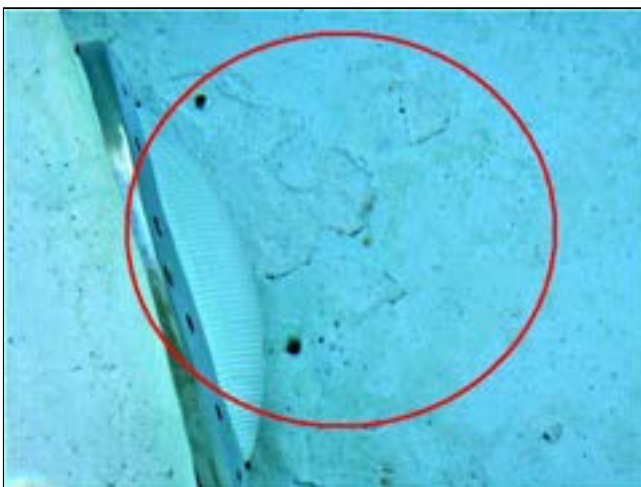
(1) Surface deterioration observed at several areas of the pool/spa. Recommend review by a licensed qualified professional for repair or replacement, as necessary.

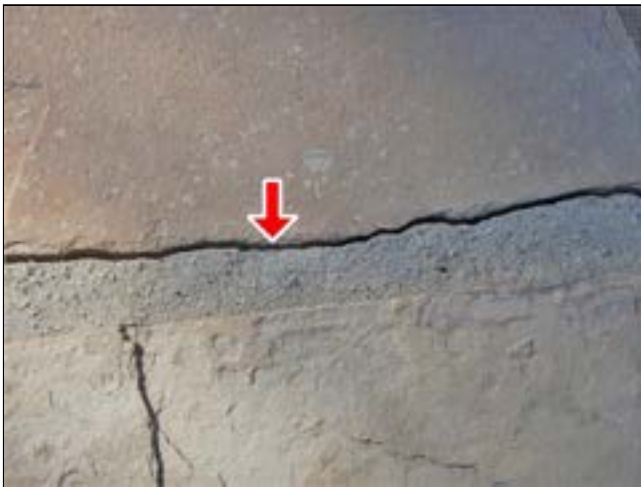
17.1 Item 1(Picture)

Gaps/voids observed around the joints between the pool coping and pool deck. Recommend gaps/voids should be sealed to provide a uniform watertight seal, further review by a licensed pool specialist for repairs.

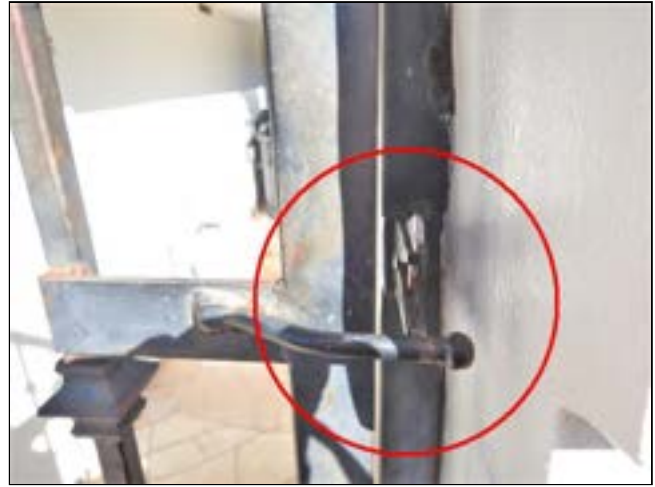
17.5 Item 2(Picture)

(1) The self-closing device or gate hardware needs adjustment or repair to properly close completely and maintain the intended safety enhancement to prevent pool access by small or unattended children.

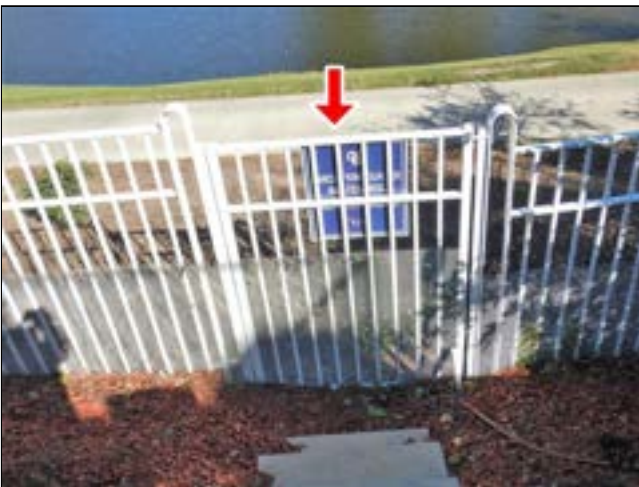
17.5 Item 3(Picture)

(2) Missing auto-closer. Client should consider installing a self-closer with automatic latch as a safety enhancement to prevent pool access by small or unattended children.

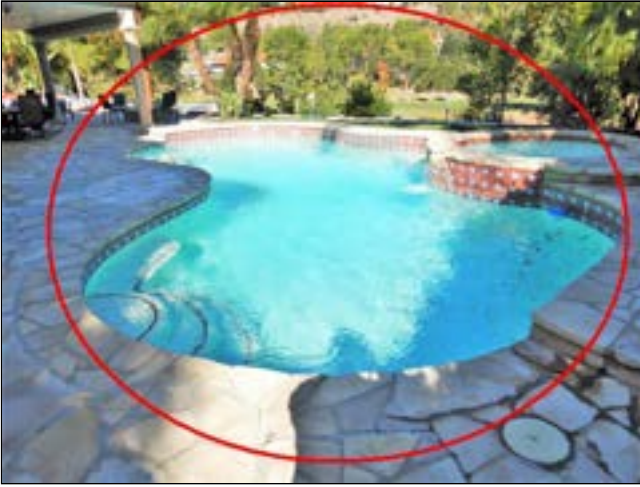
17.6 Item 1(Picture)

No pool barrier present, suggest installing pool barrier to ensure child safety. *The top of the barrier shall be at least 60 inches (1,530 mm) above grade measured on the side of the barrier that faces away from the swimming pool. The maximum vertical clearance between grade and the bottom of the barrier shall be 2 inches (51 mm) measured on the side of the barrier that faces away from the swimming pool. Where the top of the pool structure is above grade, the barrier is authorized to be at ground level or mounted on top of the pool structure, and the maximum vertical clearance between the top of the pool structure and the bottom of the barrier shall be 4 inches (102 mm). The enclosure shall isolate the swimming pool or spa from the private single-family home.*

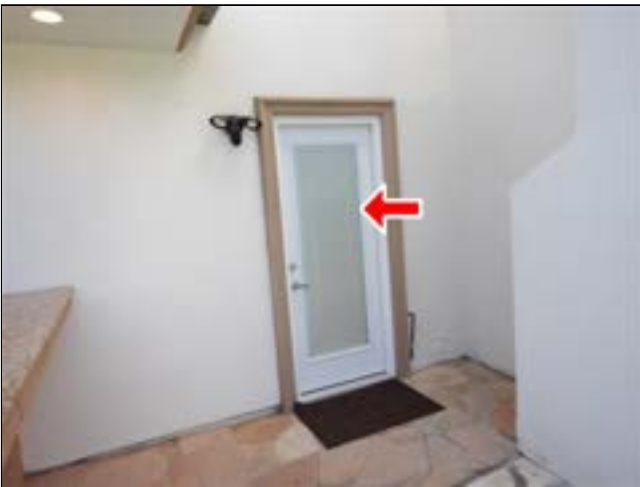
17.7 Item 1(Picture)

All doors (including the garage side door) and windows with direct access to the pool through that wall shall be equipped with an alarm which produces an audible warning when the door or window and/or its screen, if present, are opened. The alarm shall be listed and labeled in accordance with UL 2017. The deactivation switch shall be located at least 54 inches (1372 mm) above the threshold of the door.

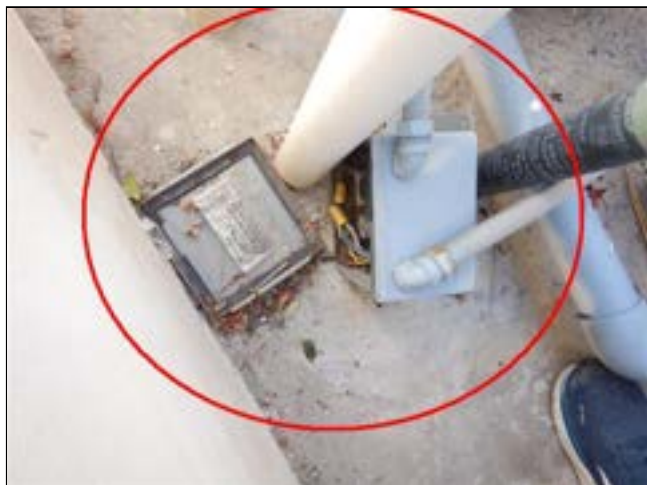
17.8 Item 1(Picture)

(1) Open junction box observed resting on the floor at the pool equipment area. Recommend review by a licensed pool specialist or licensed contractor for corrections to ensure safety.

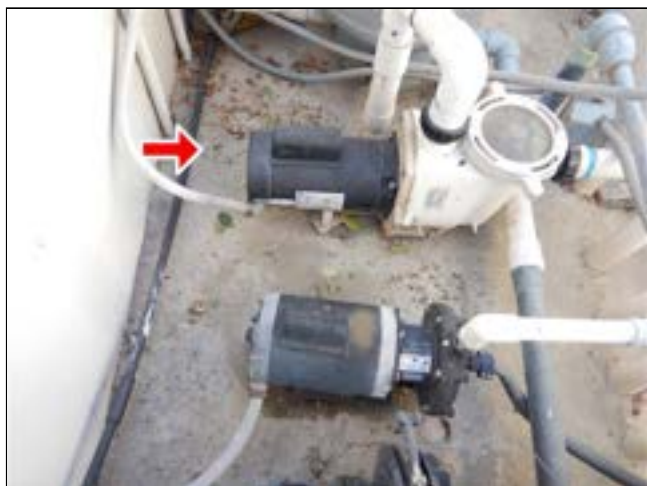
17.8 Item 2(Picture)

(2) The pool pump is not bonded/grounded observed, recommend extending the bond wire to the pump. Review for corrections/repair as a safety enhancement.

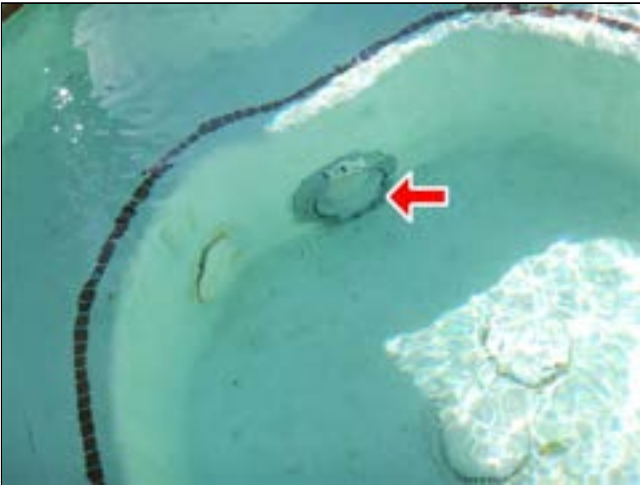
17.9 Item 1(Picture)

Spa light inoperable at time of inspection, possibly due to burnt bulbs. Client is advised to verify operability prior to close.

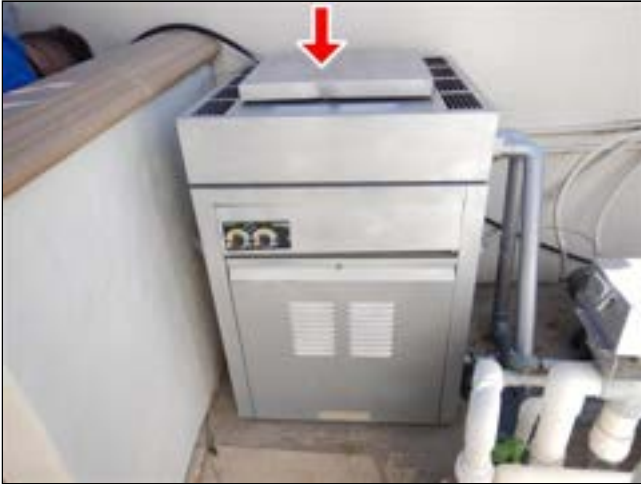
17.12 Item 1(Picture)

Pool heater was Inoperable at time of inspection. Recommend review by a licensed pool specialist contractor or pool equipment specialist for repairs or replace as necessary, prior to close.

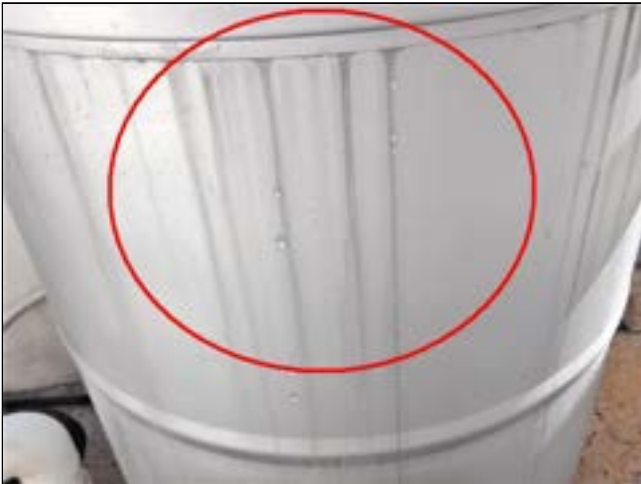
17.13 Item 1(Picture)

Leak observed at filter system around the o-ring, a pool/spa specialist is needed for maintenance/repairs be performed, prior to close.

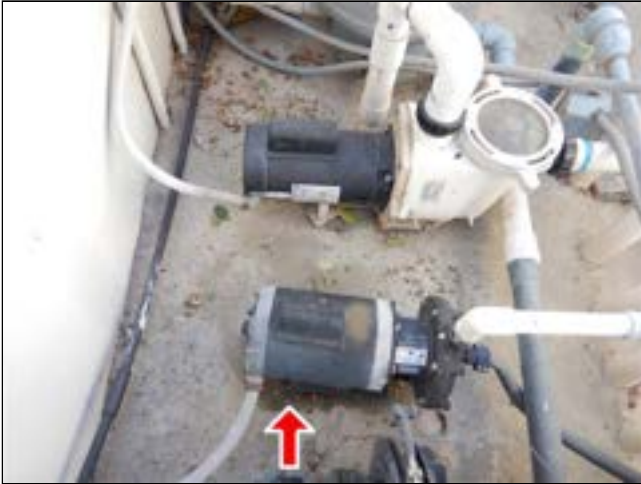
17.14 Item 1(Picture)

Wet floor observed under the pump/motor. Suggest further review by a qualified pool specialist for repairs/ replacement as needed.

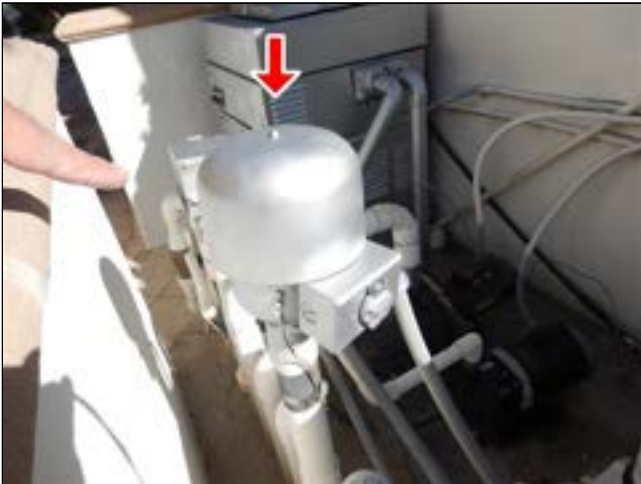
17.15 Item 1(Picture)

The air blower for the SPA runs for a few minutes then stops. Recommend further evaluation by a licensed pool specialist contractor or pool equipment specialist for review and make the necessary repairs/corrections or replace as necessary.

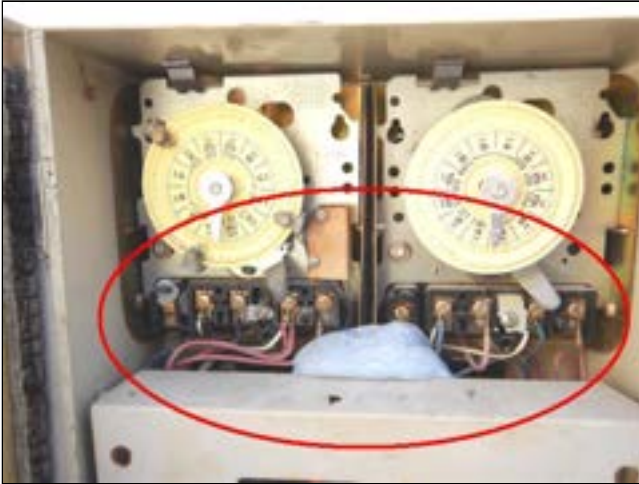
17.16 Item 1(Picture)

The timer interior wiring insulator/guard is missing. This is a safety concern. Suggest further review by a qualified licensed electrician for repairs/replacement as needed to ensure safety.

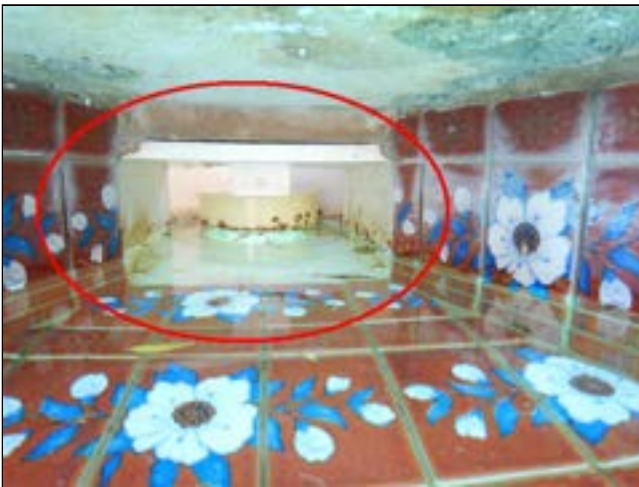
17.17 Item 1(Picture)

- (1) The original Pool Safety Act was passed in 1996 to address residential pool drowning. It required all new swimming pools constructed at single-family homes be equipped with either a permanent fence, a pool cover, exit alarms or self-closing devices on all doors providing access to the pool, or another safety feature providing as least as much protection as the specified four. The act was amended in 2006 to reflect the availability of two additional drowning-prevention features: removable mesh fencing and pool alarms that sound when a person enters the water.
- (2) Pool skimmer floating weir door is detached observed. Recommend review by a licensed pool specialist for repairs/corrections for proper operations.
