## AmeriSpec Inspection Services

Doc #:	SAMPLE	Inspector:	Certified Inspector
Date:	1/2/2023		
Address:	123 S Main St Any City CA		
Client Name:	Mr. & Mrs. Buyer

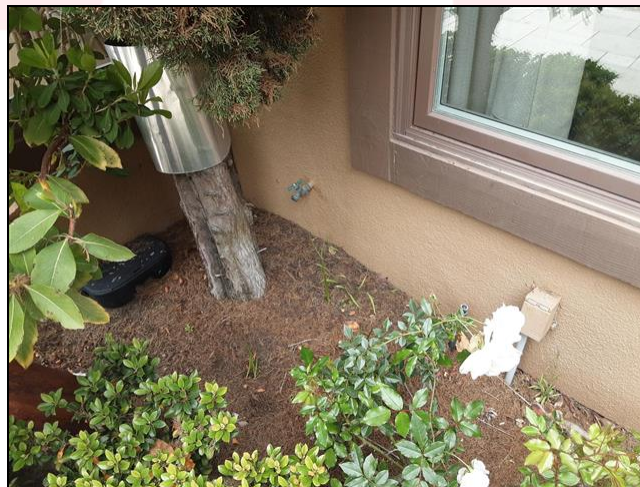
**WEEP SCREED**

**Home is built on a flat lot with a slope in the rear. Geological evaluations are beyond the scope of this report. We recommend consulting with a geotechnical engineer if concerned by conditions listed in this report or which you have observed. Grade at the foundation appears to be inadequate; Soil is above the weep screed (bottom flashing).**

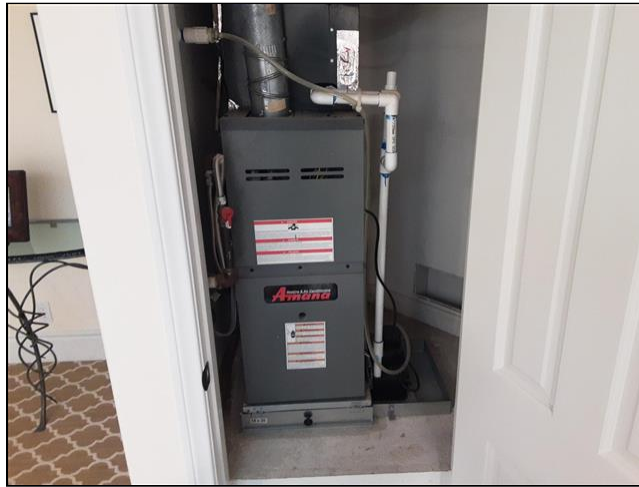
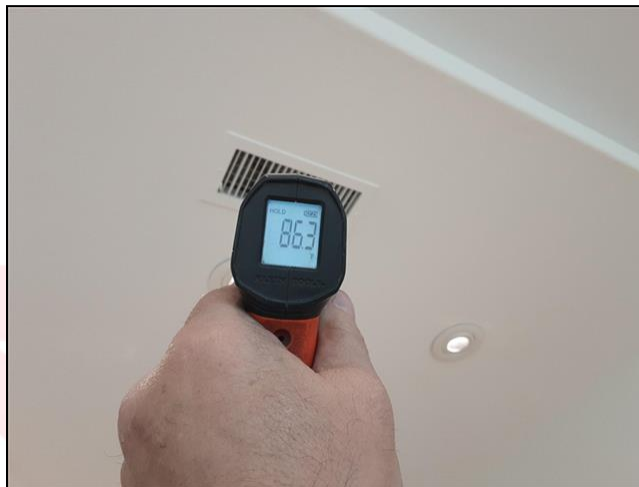
7.0 Heating

**Operable.**
