Home Inspection Report for: John & Jane Smith

Property Address: 12345 Anywhere Street, Bend, OR

Date of Inspection: 10/10/2017

Inspected By: Clare Langford, OCHI #1965. CCB #213891

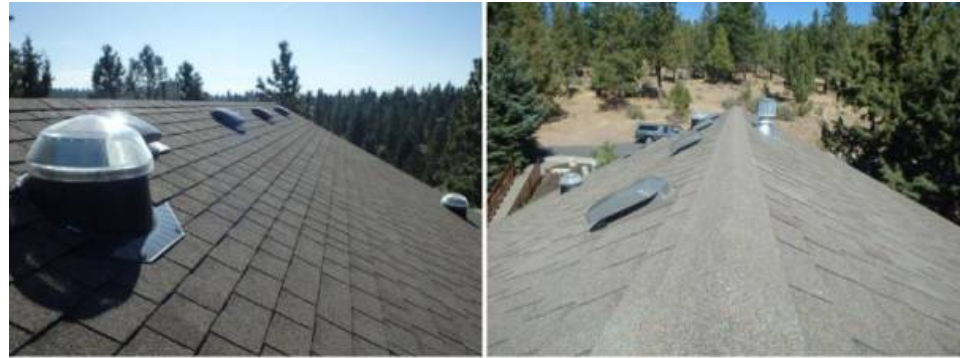
Number of Layers	One.
Conditions	The roofing material shows normal wear for its age and type. No damaged, deteriorated, or missing roofing material of any significance was noted. The roof appears to be in serviceable condition.
Flashings	Serviceable.
Roof Penetrations	Serviceable.
Chimney	Pre-fabricated metal flue. Gas appliance flue.
Skylights	Solatubes.
Gutters & Downspouts	Metal. Continuous gutter system. Observed in dry weather.

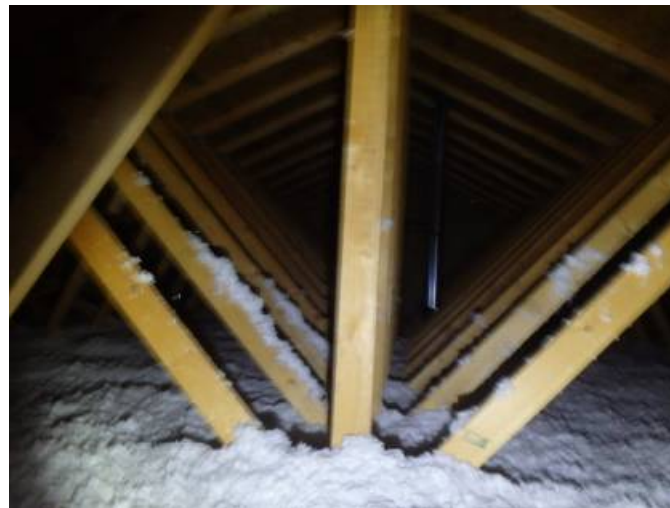
Attic access is provided in the pantry.
Trusses support both the roof sheathing above and the ceiling material below.

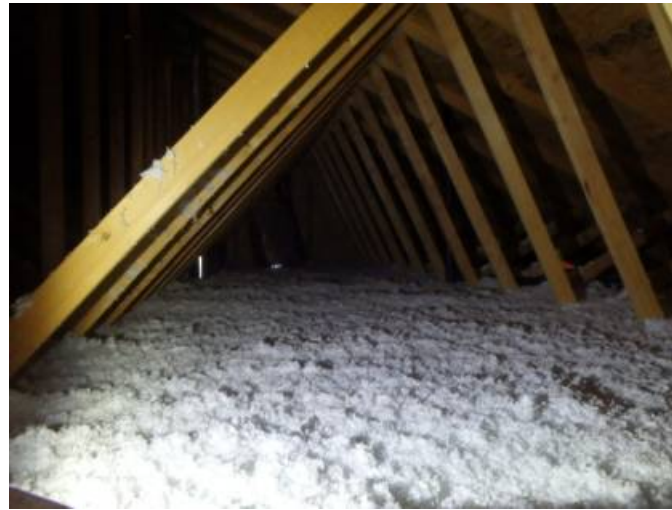
Oriented strand board.
Eave vents. Hooded roof vents.
Fiberglass. Blown in. Insulation thickness where visible above the living spaces varies from approximately 12-16".

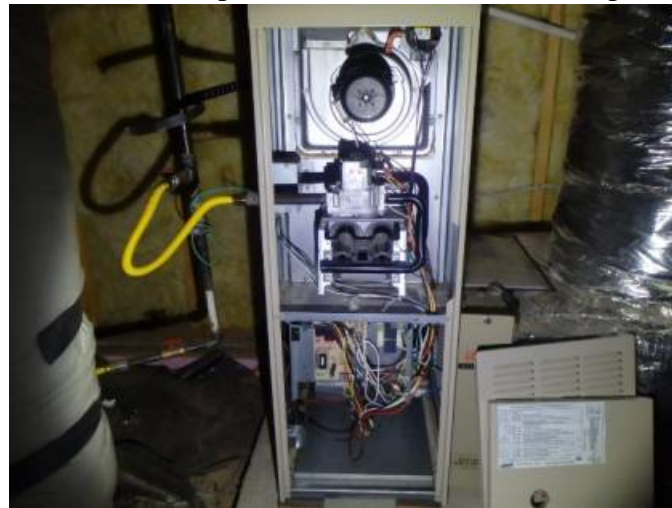
Heating	Gas fired. Forced air system. Located in the crawlspace. Branded Lennox. Cadet wall heaters downstairs. These are not the recalled units. Gas shut off valve noted near this appliance.
Conditions	The systems were tested using normal operating controls.
Air Handler/Plenum	The blower compartment was accessed and inspected.

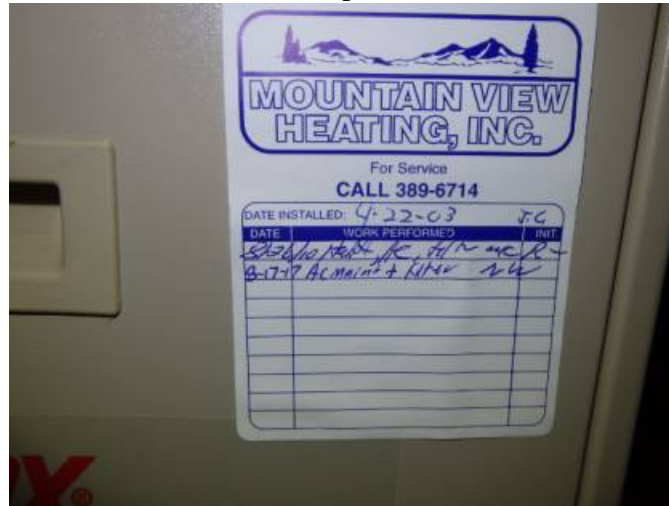
Heating & A/C Comments The best preventative maintenance for air conditioners, heat pumps, and forced air systems in general is regular cleaning or changing of air filters. Evaporator cooling coils periodically need cleaning by an air conditioning contractor to insure optimum performance. The maintenance sticker on this unit indicates the last professional visit was in August 2017.

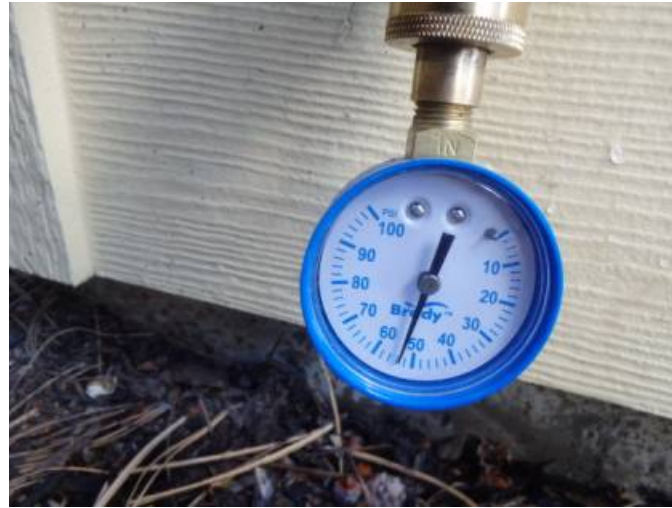
Plumbing Supply System Property has a public water supply. Water pressure at time of inspection was 55 psi. Pressure was within the normal range of 40 to 80 psi. Apparent main water shut off was observed at the meter. The secondary main water shut off was not observed; review with the owner for possible location.

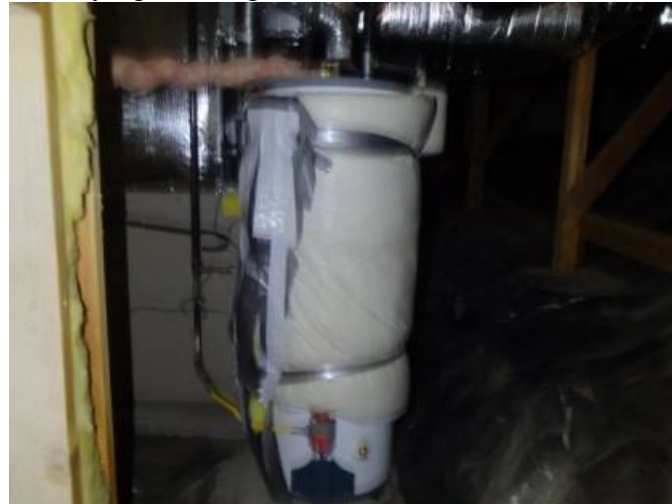
Unable to determine size or manufacturer; insulating wrap conceals identifying markings.

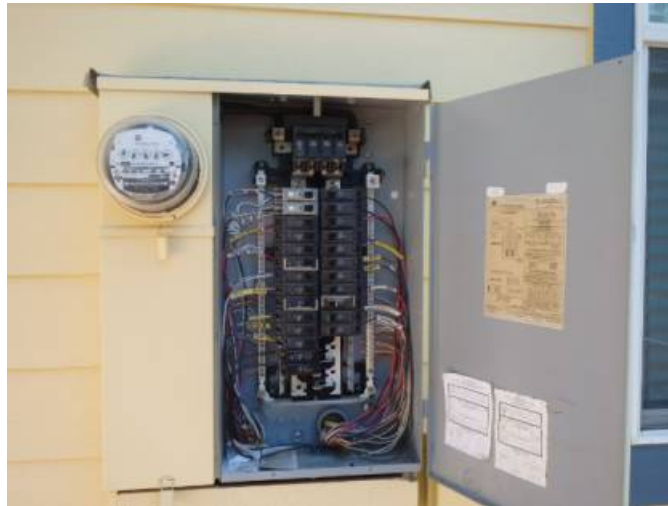
Main Panel

Serviceable.

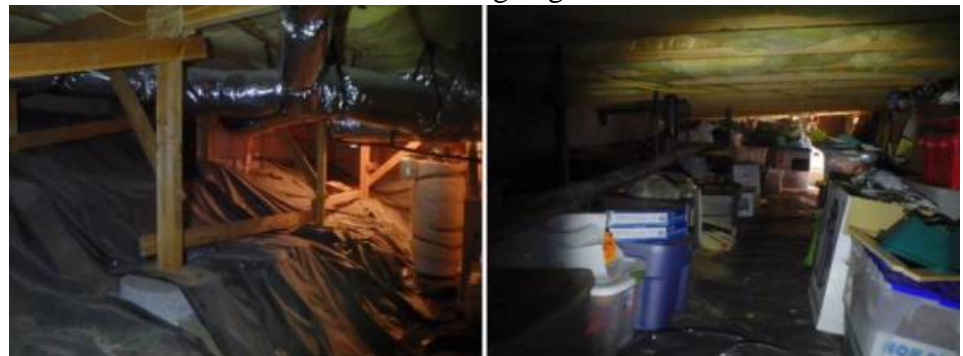
Access Serviceable. Crawlspace was entered for inspection. Located in the bedroom closet downstairs and in the garage.
