AmeriSpec Inspection Services

Doc #:	202201-00001	Inspector:	Justin Spinks
Date:	1/13/2022		
Dwelling Address:	898 SampleTrail SW Loganville GA 30052		
Client Name:	Bob Sample		
Client's Agent:		Real Estate Company:

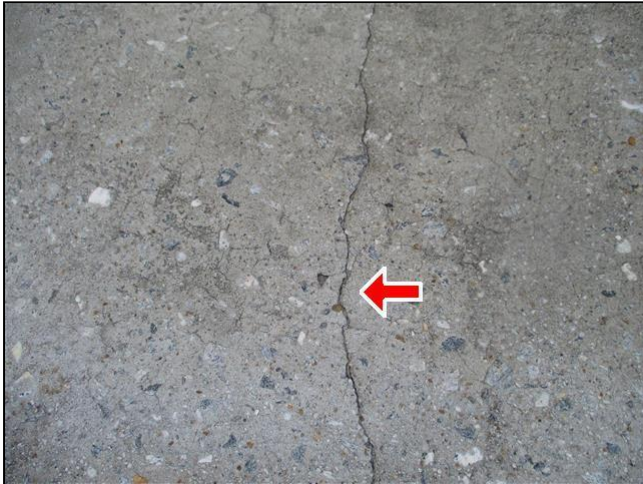
Common settlement cracking observed in the driveway, this appears to be primarily a cosmetic concern. We suggest sealing all cracks in concrete/asphalt/brick surfaces to prevent water penetration as a routine maintenance effort. Recommend review by a qualified contractor for corrections as needed.

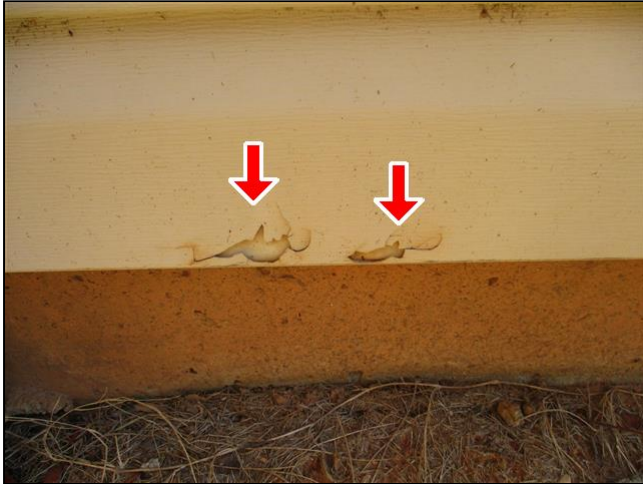
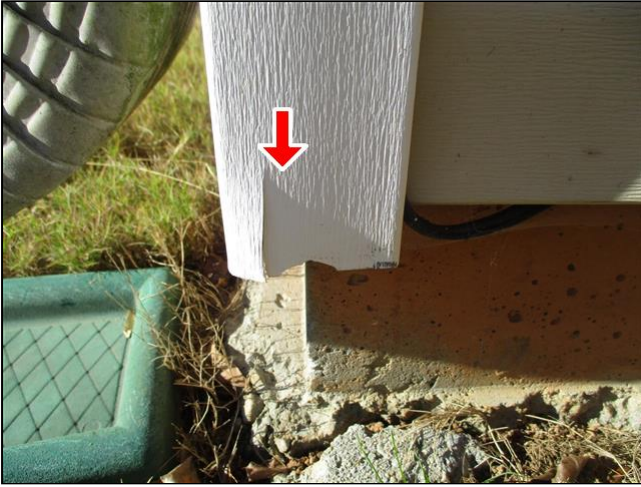
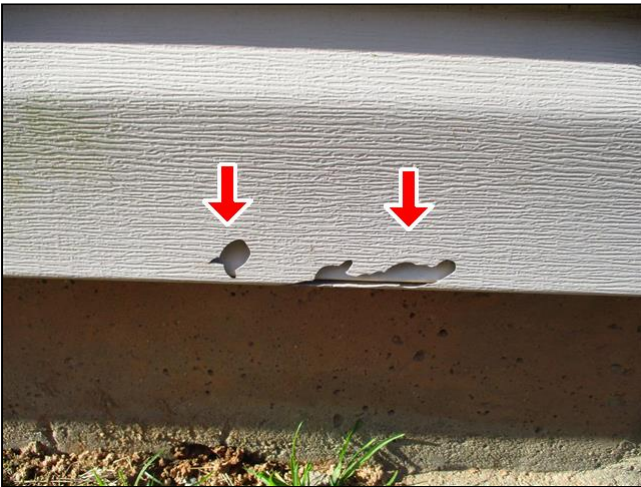
(2) Minor damage to the vinyl siding and trim observed at multiple locations. Damage appears to be primarily cosmetic. Suggest review by a qualified contractor for repairs or replacement as needed.

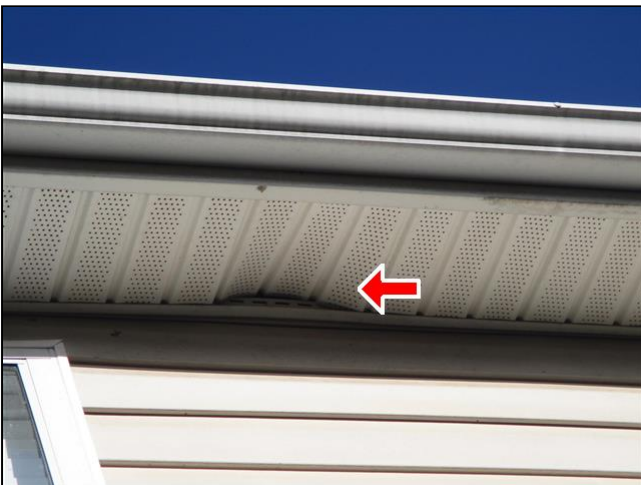
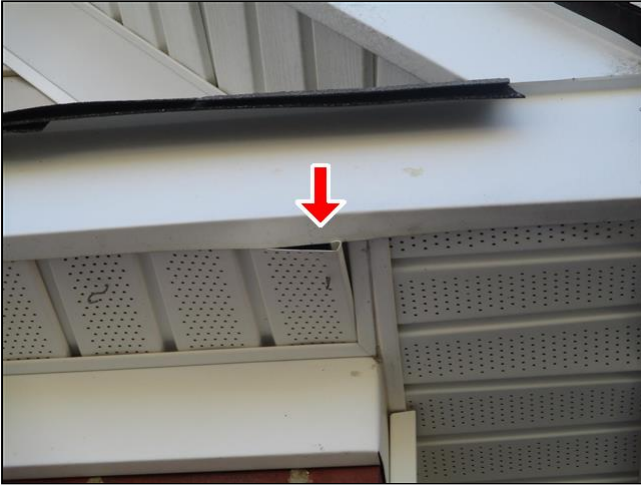
(2) Damaged/loose vinyl soffit sheathing observed at the front of home and rear of home. Recommend review by a qualified contractor for repairs or replacement as needed.

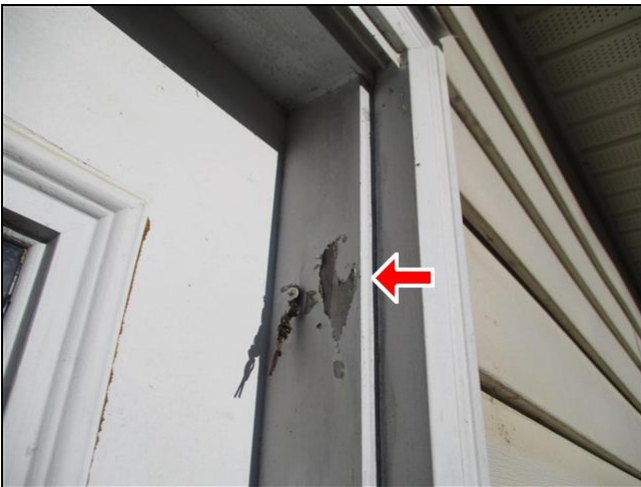
Peeling paint observed at the rear entry door; suggest scraping and painting as necessary as part of normal maintenance.

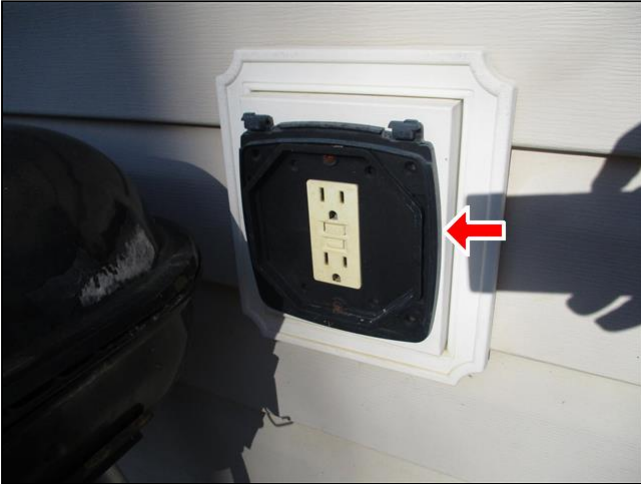
(2) Weatherproof cover at rear of home (at patio) is missing. Suggest repairs/replacement of weatherproof cover as needed to ensure safety.

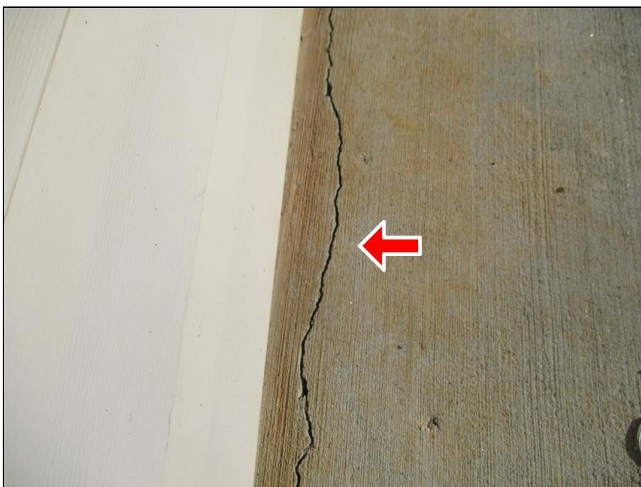
Common cracks observed, primarily a cosmetic concern. We suggest sealing all cracks in concrete/asphalt/brick surfaces to prevent water penetration as a routine maintenance effort.

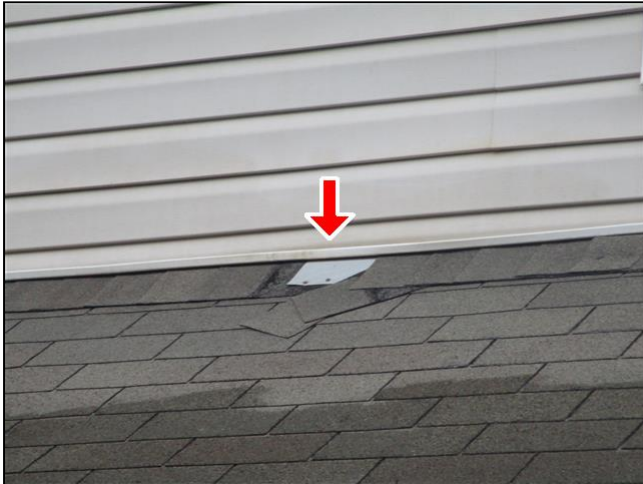
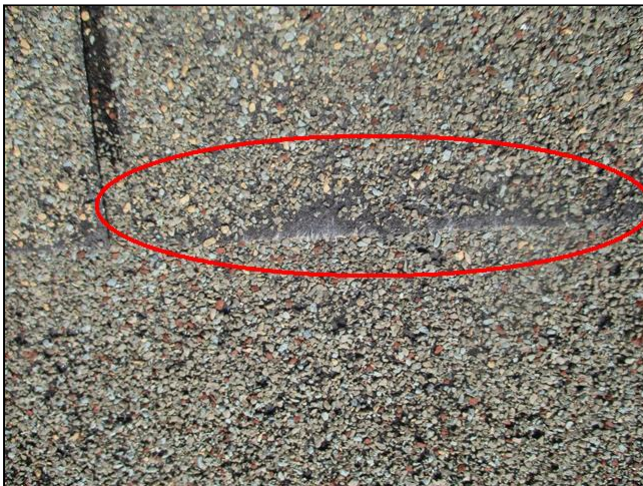
Loose shingles, deterioration and granular loss observed at multiple sides of the roof. Recommend further evaluation by a licensed roofer prior to close to determine the serviceability of the roof, estimate the remaining life of the shingles, and for repairs or replacement as needed.

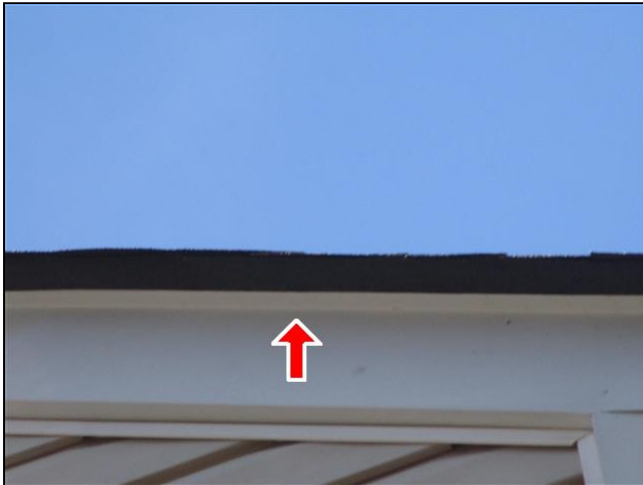
No drip edge flashing present. Drip edge is a piece of metal flashing installed to cover the gap between the roof deck and the fascia board. Drip edge flashing is required to prevent potential damage the trim, soffit, and roof sheathing. Recommend further evaluation by a licensed roofer for the installation of drip edge flashing prior to close.

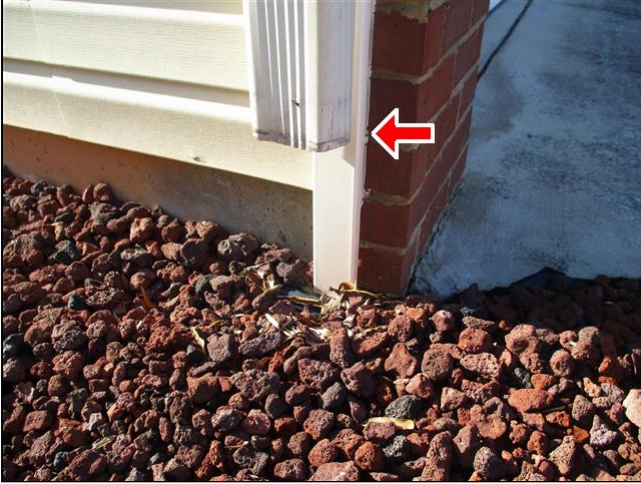
(2) The downspouts need elbows and splash-blocks at multiple locations to properly divert water away from the foundation. Recommend review for corrections prior to close.

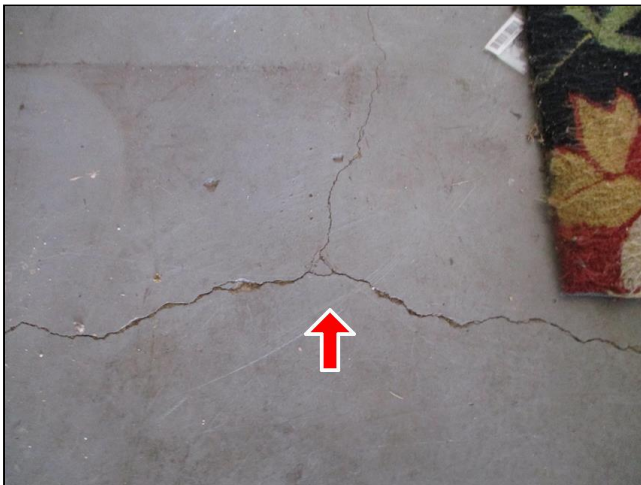
Minor settlement cracking observed in the garage slab. Inspector is unable to determine when the cracking occurred or if additional cracking is likely. It is suggested to seal all cracks in the slab to prevent moisture or pest intrusion. Cracking does not appear to be affecting the serviceability of the structure. Recommend review by licensed contractor for corrections prior to close.

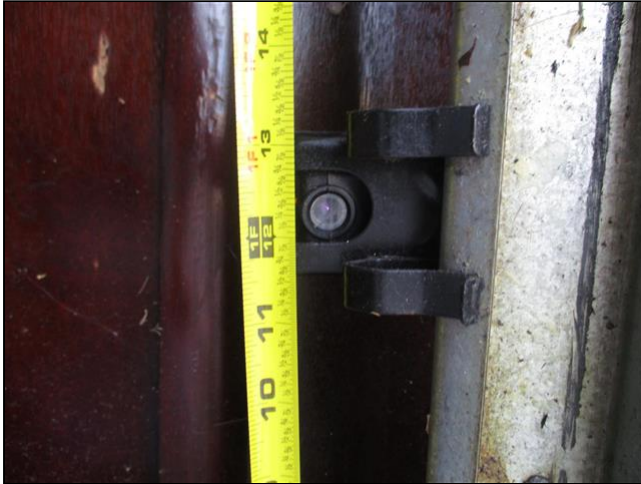
(2) The electric eyes are mounted too far above the floor to protect small children, pets, or property as intended by the manufacturer. We recommend lowering the eyes to within 6 inches of the floor or manufactures specifications.

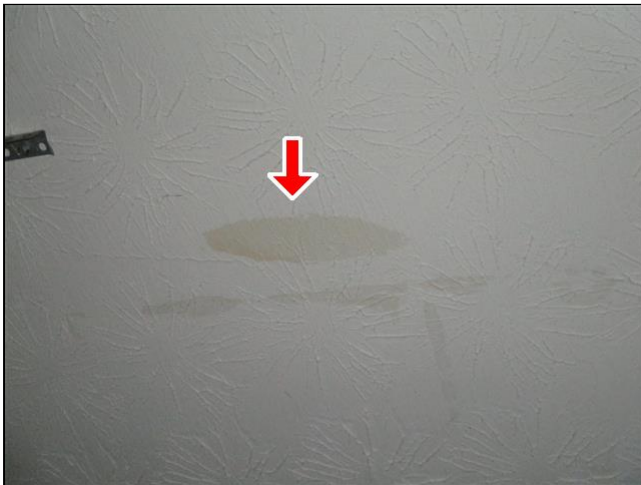
Stains observed on ceiling in the garage. The inspector probed stains with a moisture detector, which showed no moisture present at time of inspection. Client is advised to consult seller to determine the source of staining and verify that corrections have been made or have reviewed by a qualified contractor for corrections as needed.

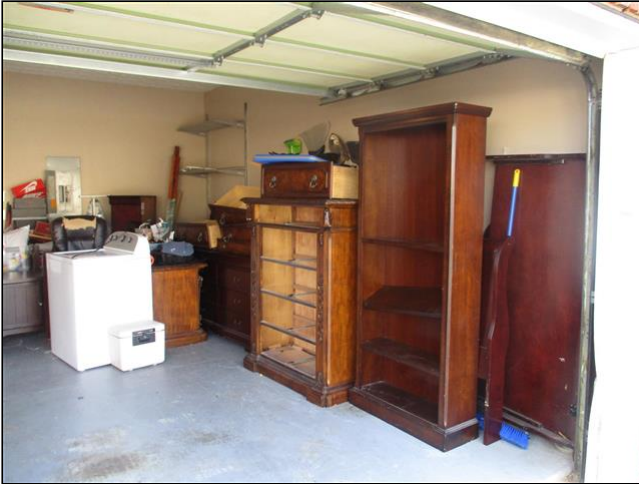
(1) Limited review of the garage due to personal property. Client is advised to verify the condition of all unobserved areas prior to close.

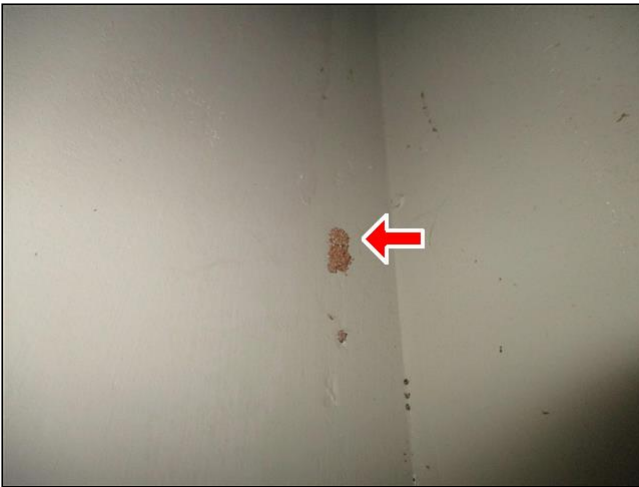
(2) Although identification of termites is beyond the scope of a general home inspection, mud tubes or damaged areas indicative of possible termite activity were observed at right side of garage (near garage door). We are unable to determine if it is currently active or the extent of any potential damage. We suggest consulting with homeowner regarding any past history of treatment. We recommend arranging for further review by a licensed pest control specialist prior to close and review by a qualified contractor for repairs of any potential damage.

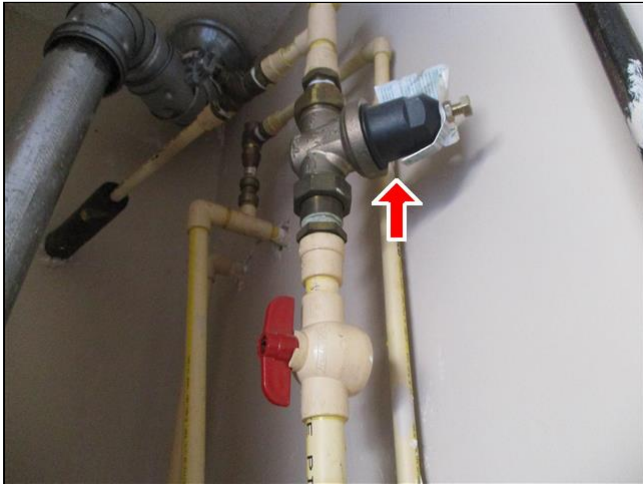
The pressure regulating valve is located in the garage.

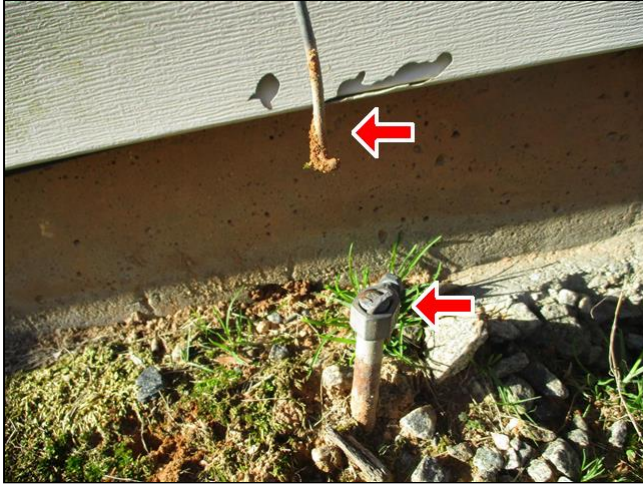
A ground wire to ground rod is present at meter base, but the wire is no longer attached to the rod. This is a safety concern. A licensed electrician is needed to review this and make all corrections necessary to ensure safe and proper operation of the system.

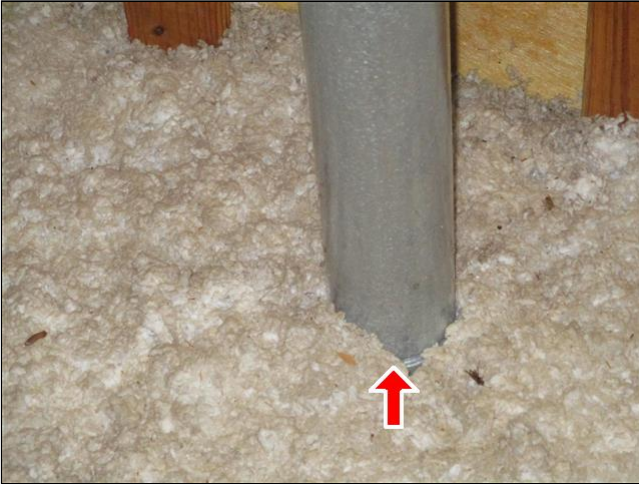
Exhaust vent pipe has inadequate clearance to combustibles in the attic, which is a safety concern. Recommend review by licensed specialist for corrections as needed prior to close.

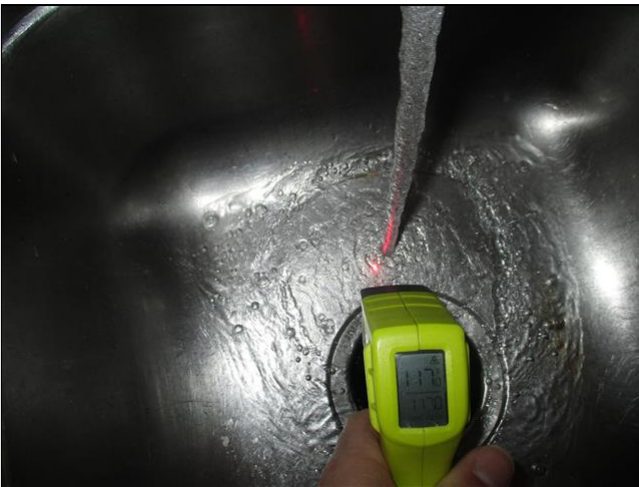
The water temperature at time of inspection was 117 degrees, which is in the normal operating range of 110 to 130 degrees.

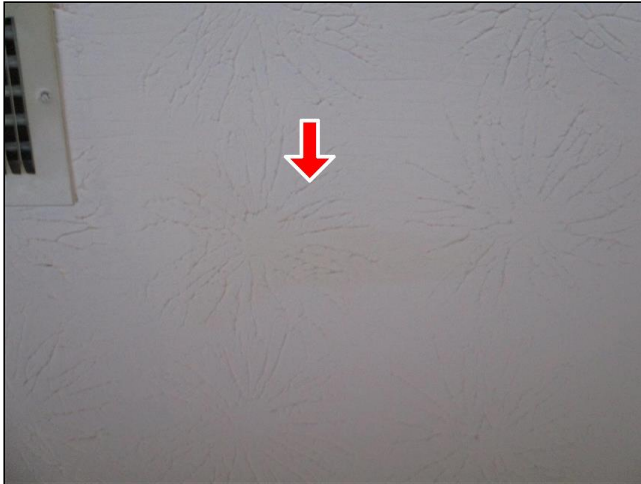
Stains observed on ceiling. The inspector probed stains with a moisture detector, which showed no moisture present at time of inspection. Client is advised to consult seller to determine the source of staining and verify that corrections have been made or have reviewed by a qualified contractor for corrections prior to close.

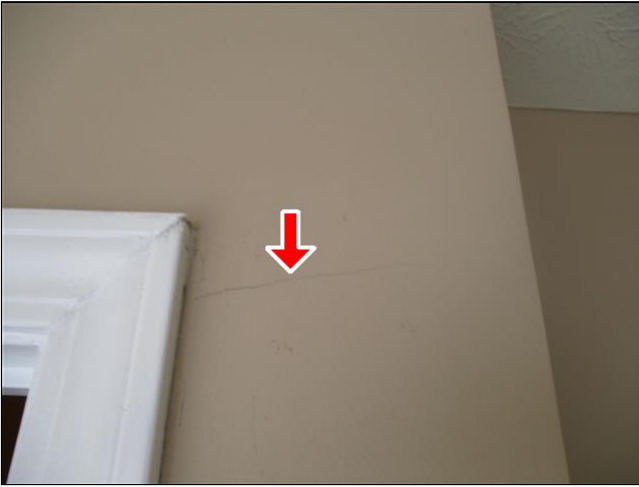
Common cracks noted in the master bathroom. Appear to be primarily a cosmetic concern. Suggest repairs as needed.

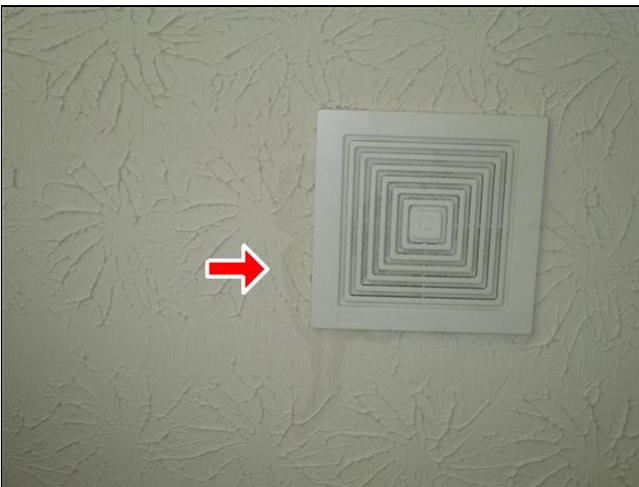
Stains observed on ceiling in the master bathroom. The inspector probed stains with a moisture detector, which showed no moisture present at time of inspection. Client is advised to consult seller to determine the source of staining and verify that corrections have been made or have reviewed by a qualified contractor for corrections prior to close.

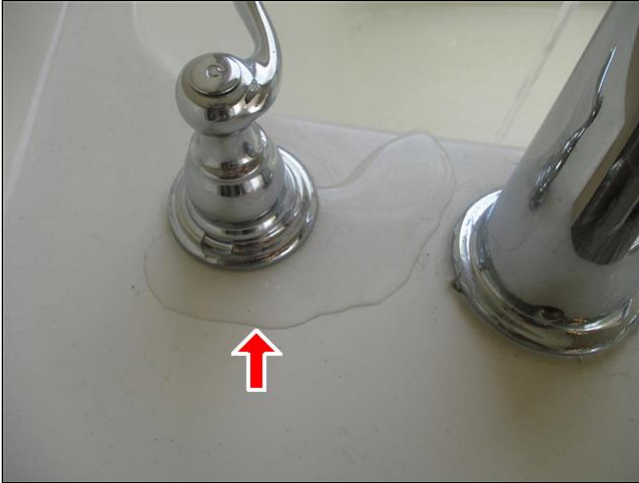
- (1) The master bathroom cold water faucet handle is improperly installed, handle spins 360 degrees with no defined starting or stopping point. Recommend review prior to close by a licensed plumber for repair or replacement.
- (2) The master bathroom cold water faucet handle leaks. Recommend review prior to close by a licensed plumber for repair or replacement.

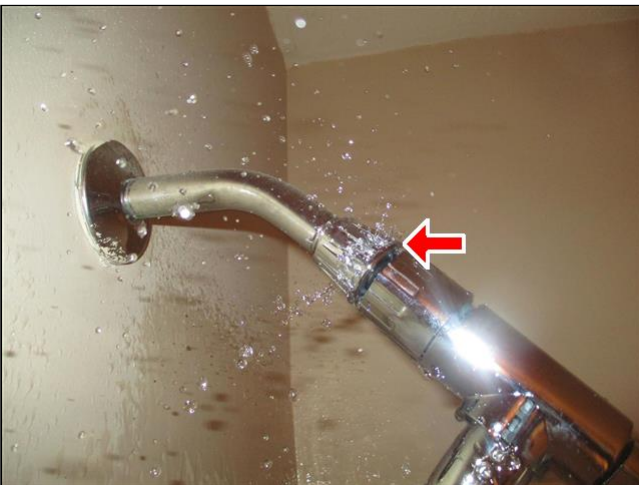
- (1) The seams/edges of the tub/shower walls should be caulked or sealed to prevent moisture penetration. Failure to keep walls sealed can cause deterioration and moisture damage to the interior walls, which is not always visible to the inspector at the time of inspection.
- (2) Shower head in the shared bathroom leaks severely. Corrections are needed to prevent potential wall damage. Recommend review by a qualified plumber for repairs prior to close.

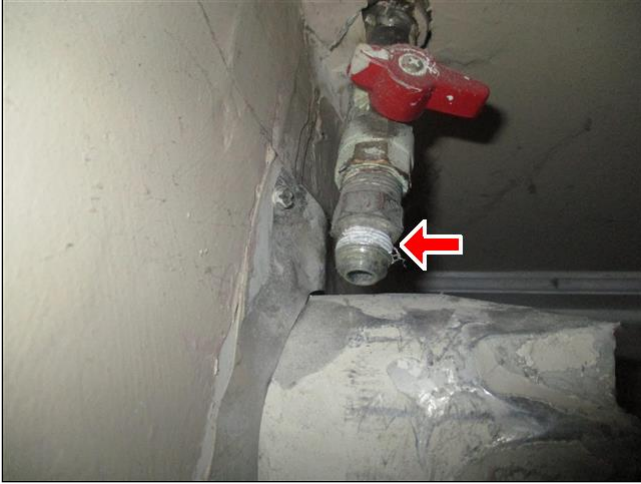
Uncapped gas line observed. This is a potential safety hazard as the valve could fail or be opened accidentally. Recommend review by a qualified contractor or plumber for corrections prior to close.

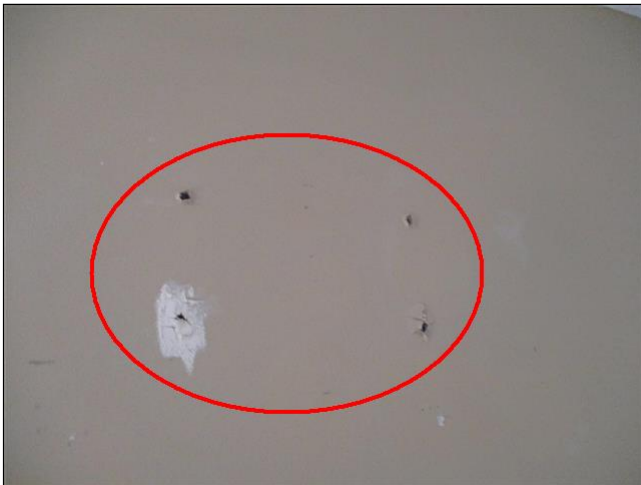
Large holes observed on the wall in the family room. Recommend review by a qualified contractor for corrections as needed.

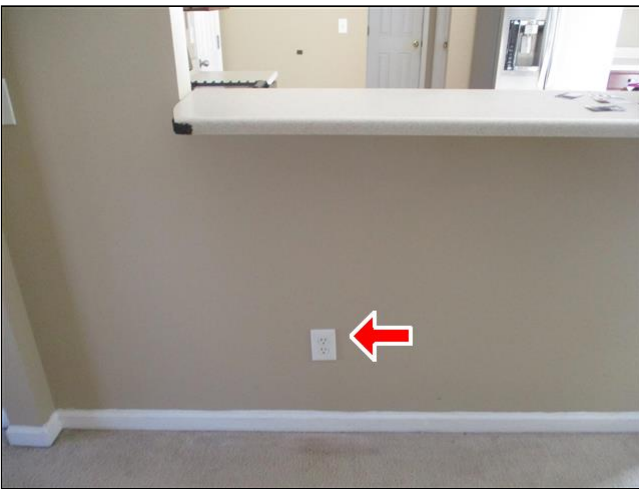
(1) A Ground Fault Circuit Interrupter (GFCI) is not present in the family room on wall opposite of kitchen sink, suggest installing GFCI for safety. A qualified electrical contractor is needed for further review and to make necessary repairs/ corrections

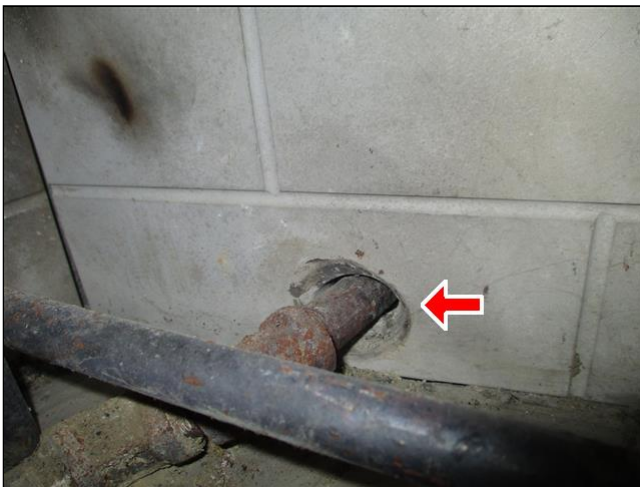
Minor gaps observed around the gas line where it penetrates the fire brick. Suggest sealing with a fire rated sealant prior to use. Suggest review by a qualified contractor for corrections.

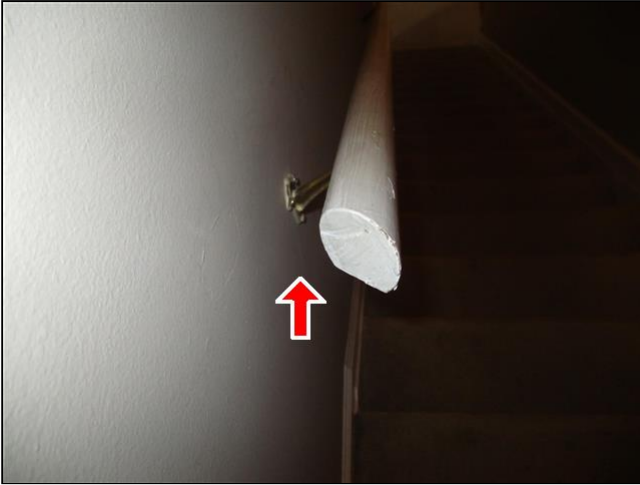
Returns and safety stops must attach a return to the end of handrails or connect them to a post, pillar, or wall. This avoids people catching their clothes or bumping into the end of handrails. This may not have been required when home was built. Client should consider corrections as a safety enhancement.

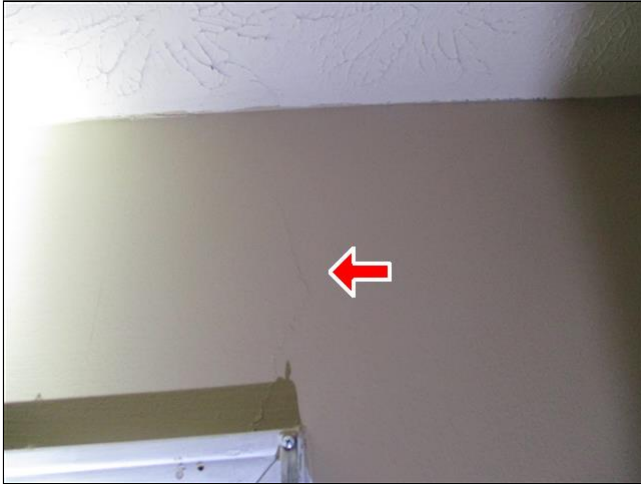
Common cracks noted in the upper left rear bedroom. Appear to be primarily a cosmetic concern Suggest repairs as needed.

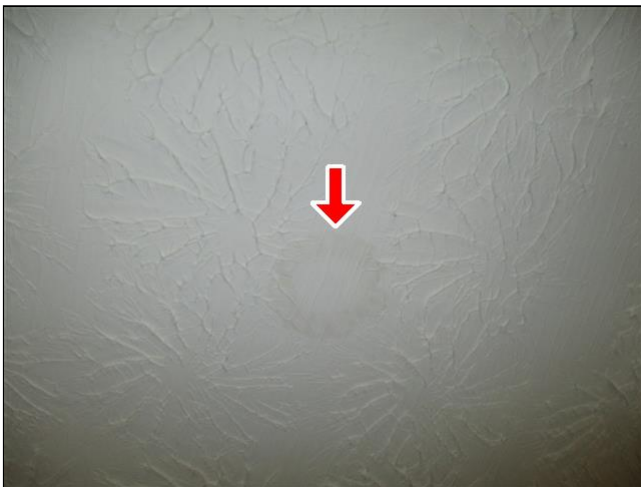
Stains observed on ceiling in the upper left rear bedroom. The inspector probed stains with a moisture detector, which showed no moisture present at time of inspection. Client is advised to consult seller to determine the source of staining and verify that corrections have been made or have reviewed by a qualified contractor for corrections as needed.

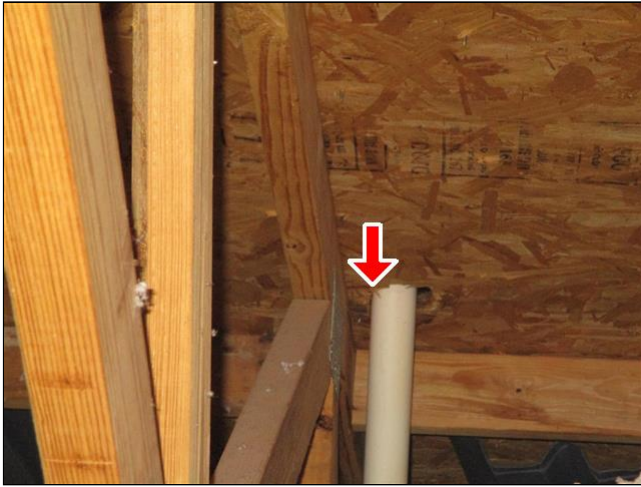
Stains observed on roof decking in the attic at the left rear plumbing vents. Inspector is unable to determine if the stains are active due to the height or location of the stain. Client is advised to consult seller to determine the source of staining and verify that corrections have been made or have reviewed by a qualified contractor for corrections prior to close.

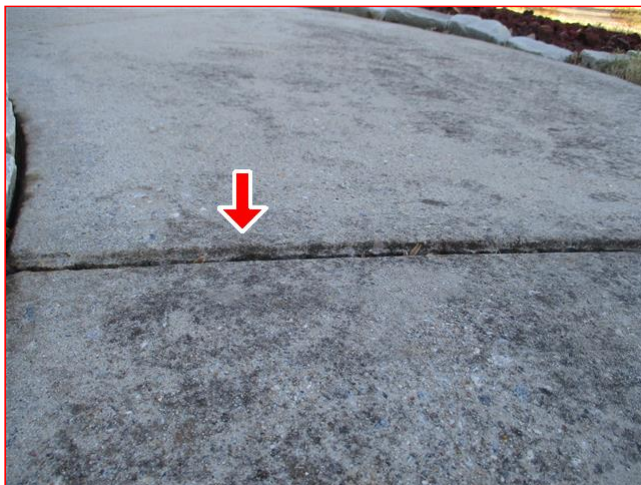
Heaving observed at the front walkway. Possible trip hazard noted. We recommend further evaluation by a licensed contractor for repairs or replacement prior to close.

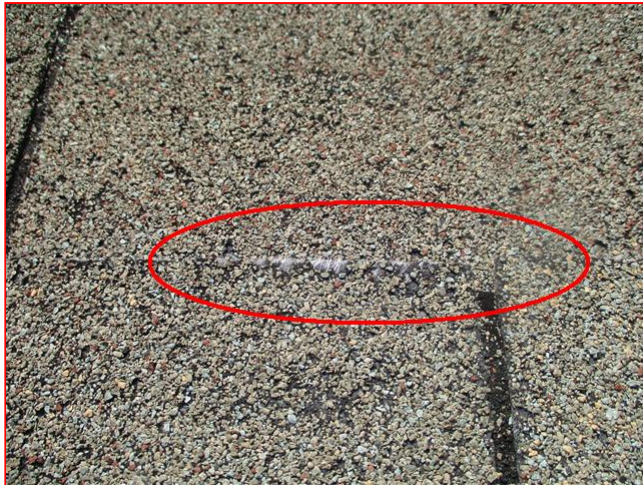
Loose shingles, deterioration and granular loss observed at multiple sides of the roof. Recommend further evaluation by a licensed roofer prior to close to determine the serviceability of the roof, estimate the remaining life of the shingles, and for repairs or replacement as needed.

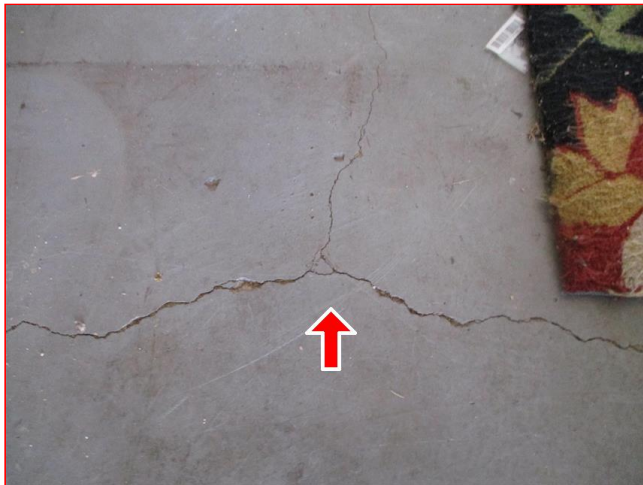
Minor settlement cracking observed in the garage slab. Inspector is unable to determine when the cracking occurred or if additional cracking is likely. It is suggested to seal all cracks in the slab to prevent moisture or pest intrusion. Cracking does not appear to be affecting the serviceability of the structure. Recommend review by licensed contractor for corrections prior to close.

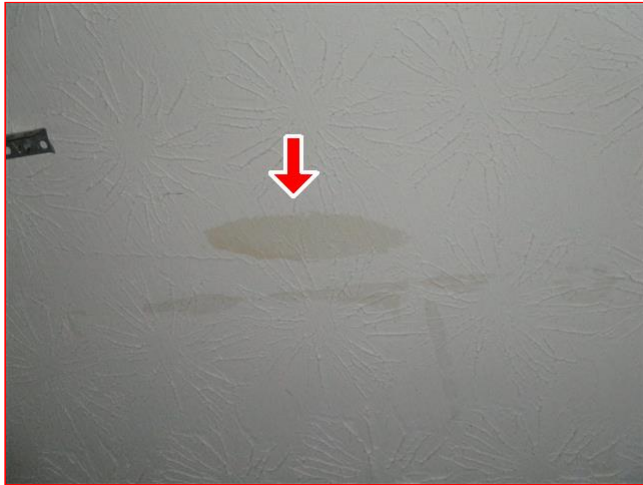
Stains observed on ceiling in the garage. The inspector probed stains with a moisture detector, which showed no moisture present at time of inspection. Client is advised to consult seller to determine the source of staining and verify that corrections have been made or have reviewed by a qualified contractor for corrections as needed.

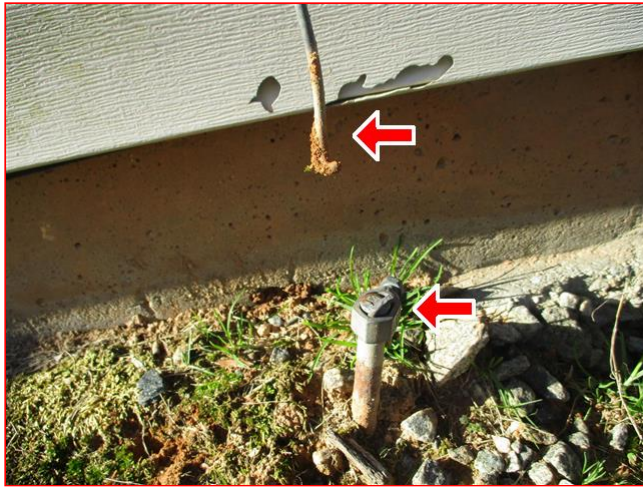
A ground wire to ground rod is present at meter base, but the wire is no longer attached to the rod. This is a safety concern. A licensed electrician is needed to review this and make all corrections necessary to ensure safe and proper operation of the system.

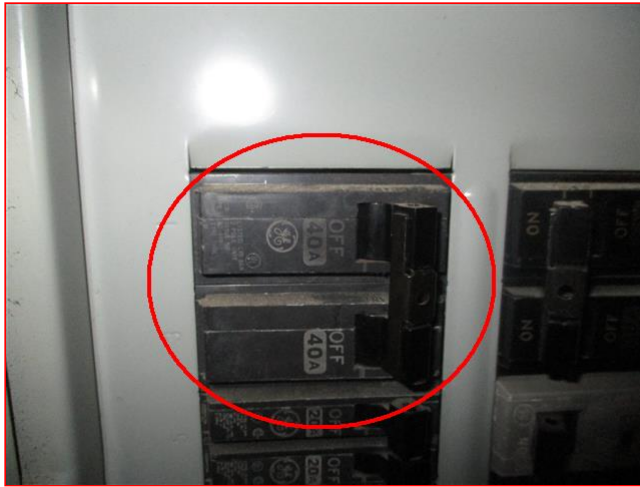
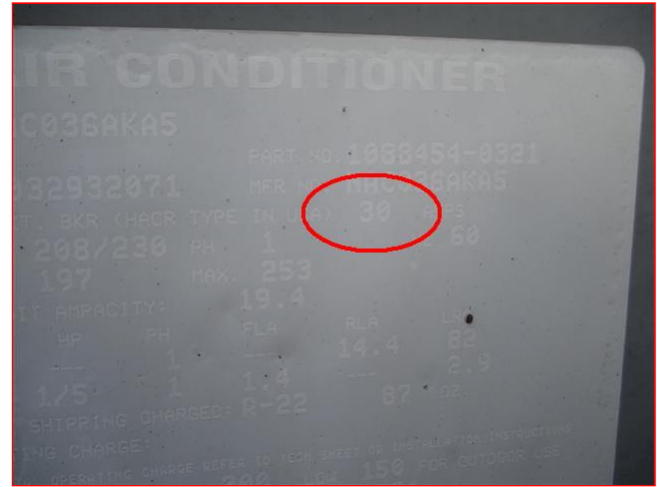
According to the air-conditioning units' specification label, the breaker protecting the condenser is not properly sized. A 40 amp breaker has been installed with a labeled demand that calls for a maximum breaker size of 30 amps. We recommend a licensed heating and air contractor perform any corrections necessary to assure proper protection.

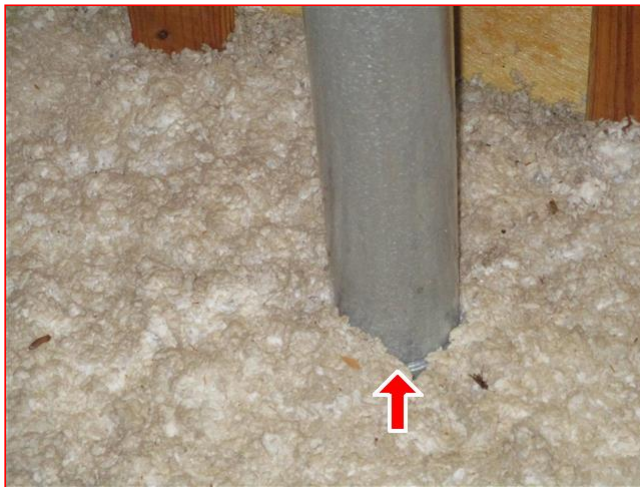
Exhaust vent pipe has inadequate clearance to combustibles in the attic, which is a safety concern. Recommend review by licensed specialist for corrections as needed prior to close.

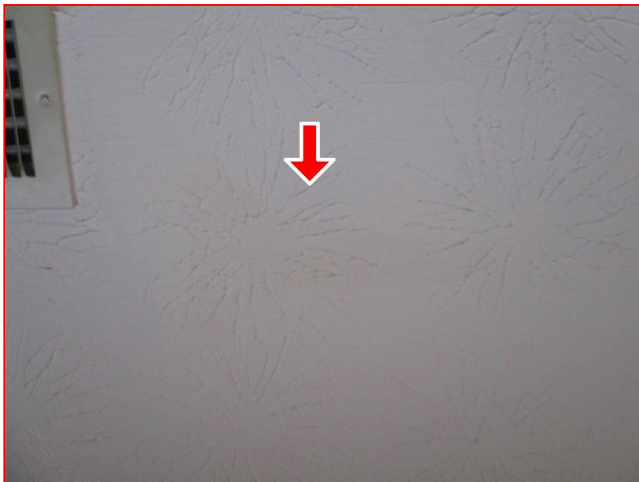
Stains observed on ceiling. The inspector probed stains with a moisture detector, which showed no moisture present at time of inspection. Client is advised to consult seller to determine the source of staining and verify that corrections have been made or have reviewed by a qualified contractor for corrections prior to close.

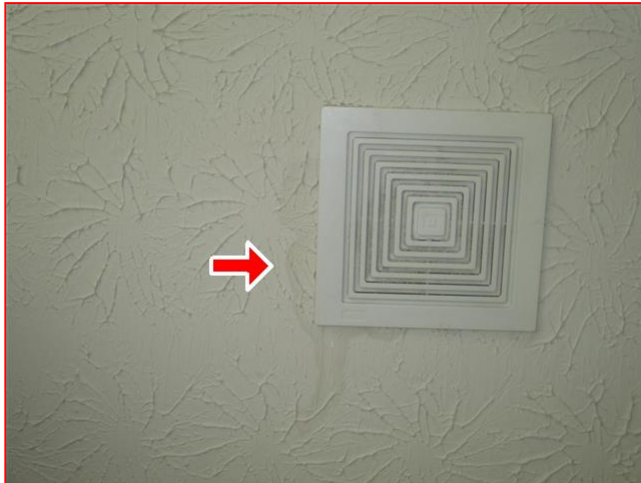
Stains observed on ceiling in the master bathroom. The inspector probed stains with a moisture detector, which showed no moisture present at time of inspection. Client is advised to consult seller to determine the source of staining and verify that corrections have been made or have reviewed by a qualified contractor for corrections prior to close.

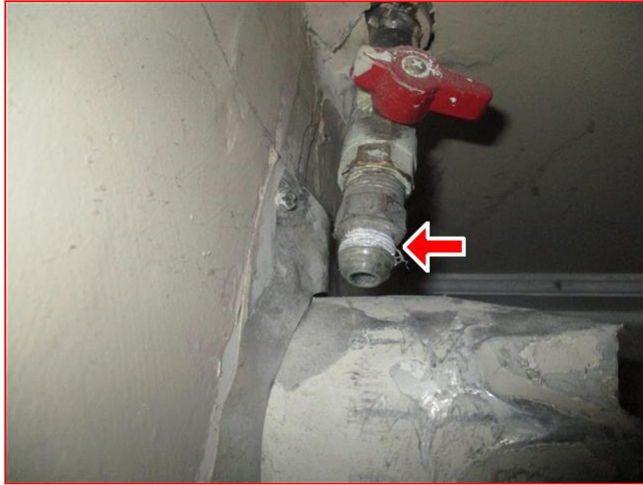
Uncapped gas line observed. This is a potential safety hazard as the valve could fail or be opened accidentally. Recommend review by a qualified contractor or plumber for corrections prior to close.

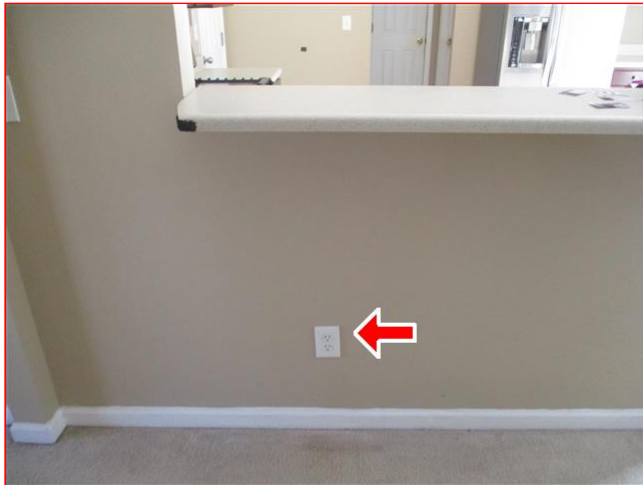
(1) A Ground Fault Circuit Interrupter (GFCI) is not present in the family room on wall opposite of kitchen sink, suggest installing GFCI for safety. A qualified electrical contractor is needed for further review and to make necessary repairs/corrections

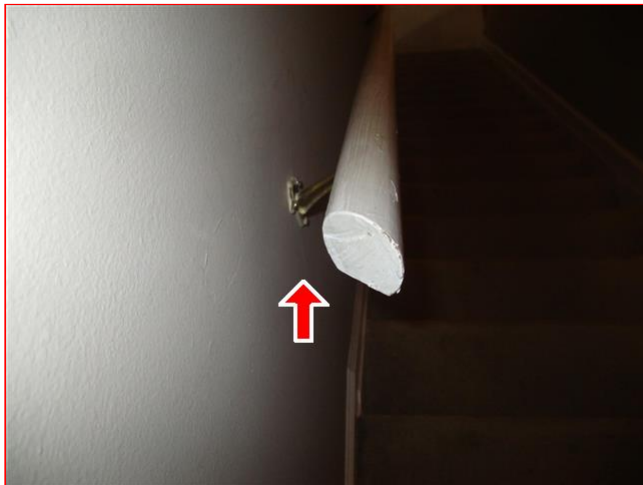
Returns and safety stops must attach a return to the end of handrails or connect them to a post, pillar, or wall. This avoids people catching their clothes or bumping into the end of handrails. This may not have been required when home was built. Client should consider corrections as a safety enhancement.

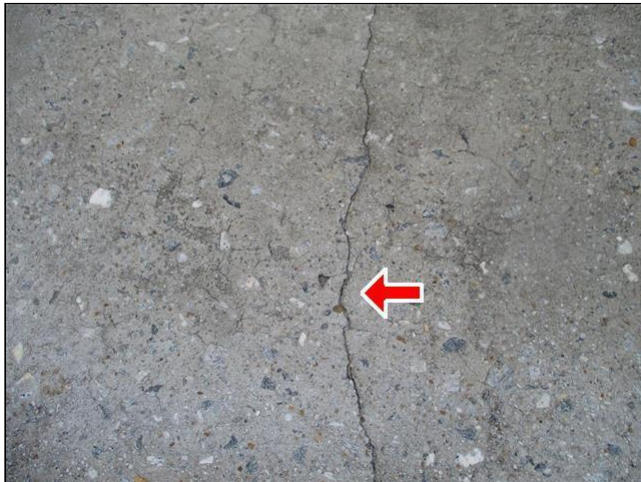
Common settlement cracking observed in the driveway, this appears to be primarily a cosmetic concern. We suggest sealing all cracks in concrete/asphalt/brick surfaces to prevent water penetration as a routine maintenance effort. Recommend review by a qualified contractor for corrections as needed.

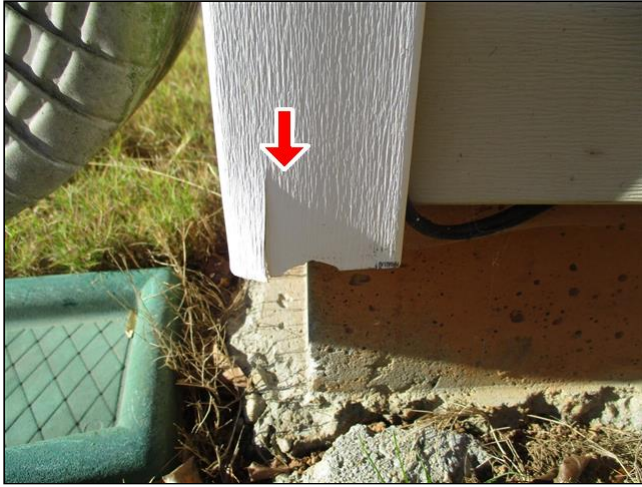
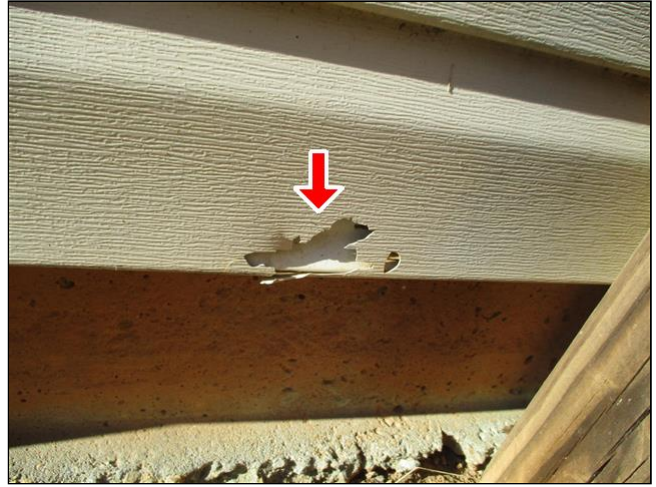
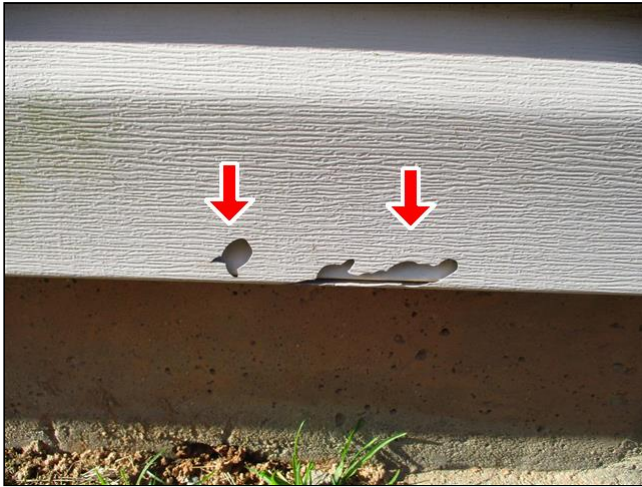
(2) Minor damage to the vinyl siding and trim observed at multiple locations. Damage appears to be primarily cosmetic. Suggest review by a qualified contractor for repairs or replacement as needed.

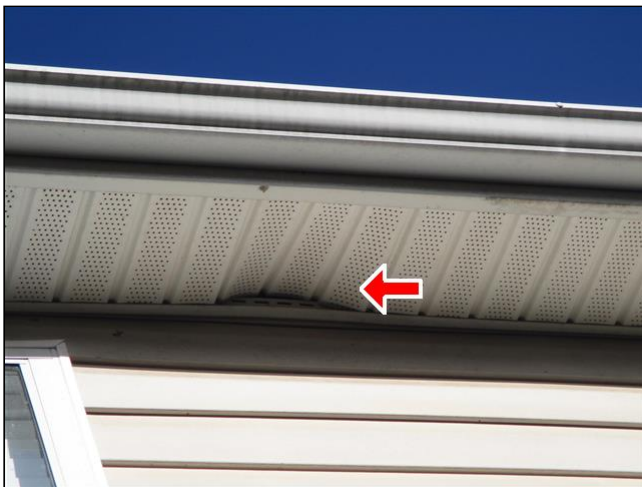
(2) Damaged/loose vinyl soffit sheathing observed at the front of home and rear of home. Recommend review by a qualified contractor for repairs or replacement as needed.

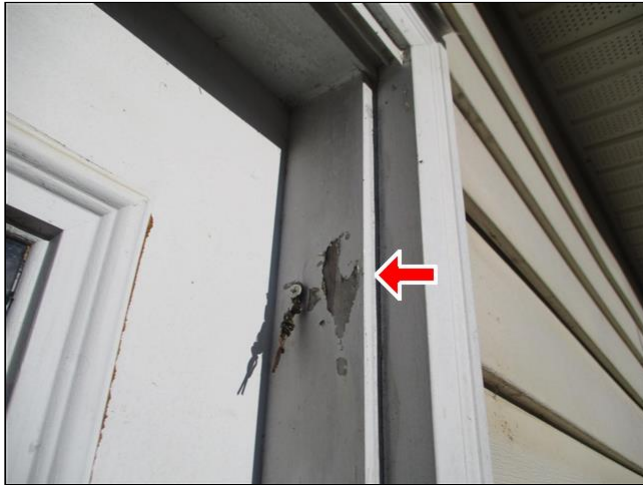
Peeling paint observed at the rear entry door; suggest scraping and painting as necessary as part of normal maintenance.

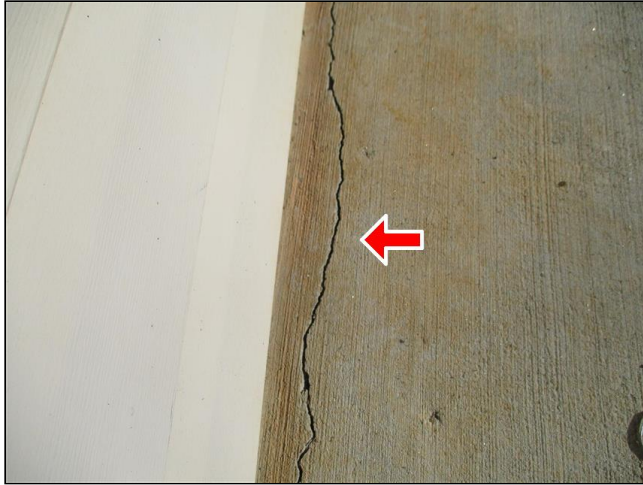
Common cracks observed, primarily a cosmetic concern. We suggest sealing all cracks in concrete/asphalt/brick surfaces to prevent water penetration as a routine maintenance effort.

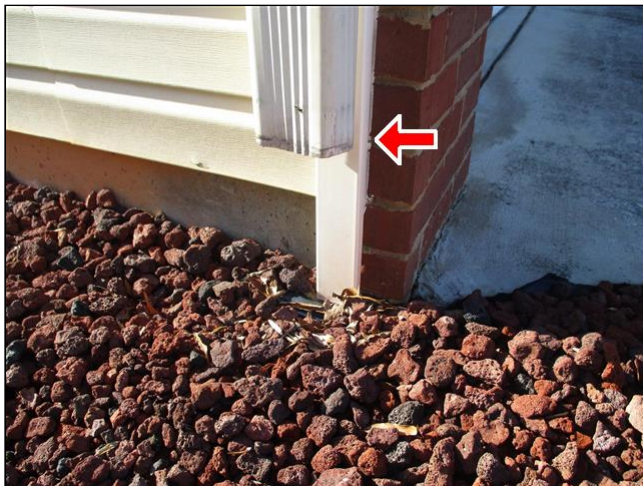
(2) The downspouts need elbows and splash-blocks at multiple locations to properly divert water away from the foundation. Recommend review for corrections prior to close.

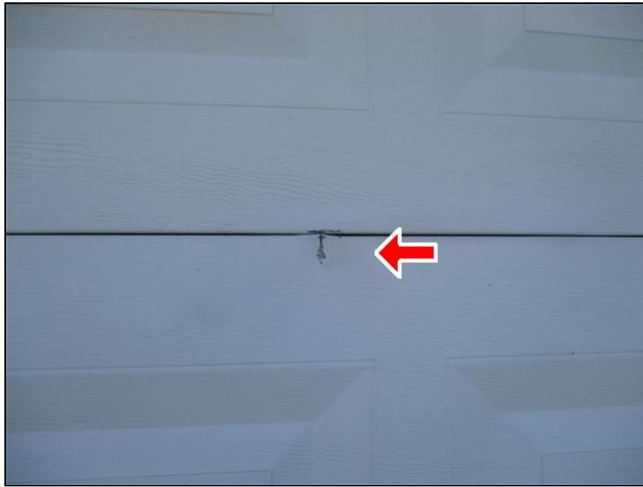
(1) Panels of the garage door are slightly bent or damaged. This does not appear to be affecting the serviceability of the door. Recommend review for repairs as needed.

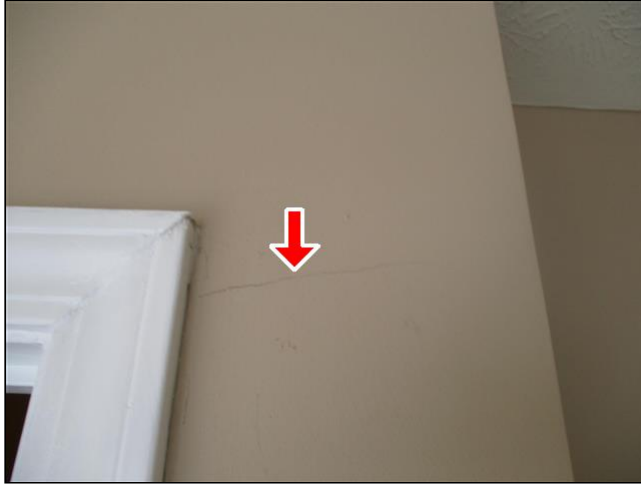
Common cracks noted in the master bathroom. Appear to be primarily a cosmetic concern Suggest repairs as needed.
